**Environmental Impact Statement
6150 Thunder Road, Ottawa**

Updated Report

April 26, 2021

KILGOUR & ASSOCIATES LTD.
www.kilgourassociates.com

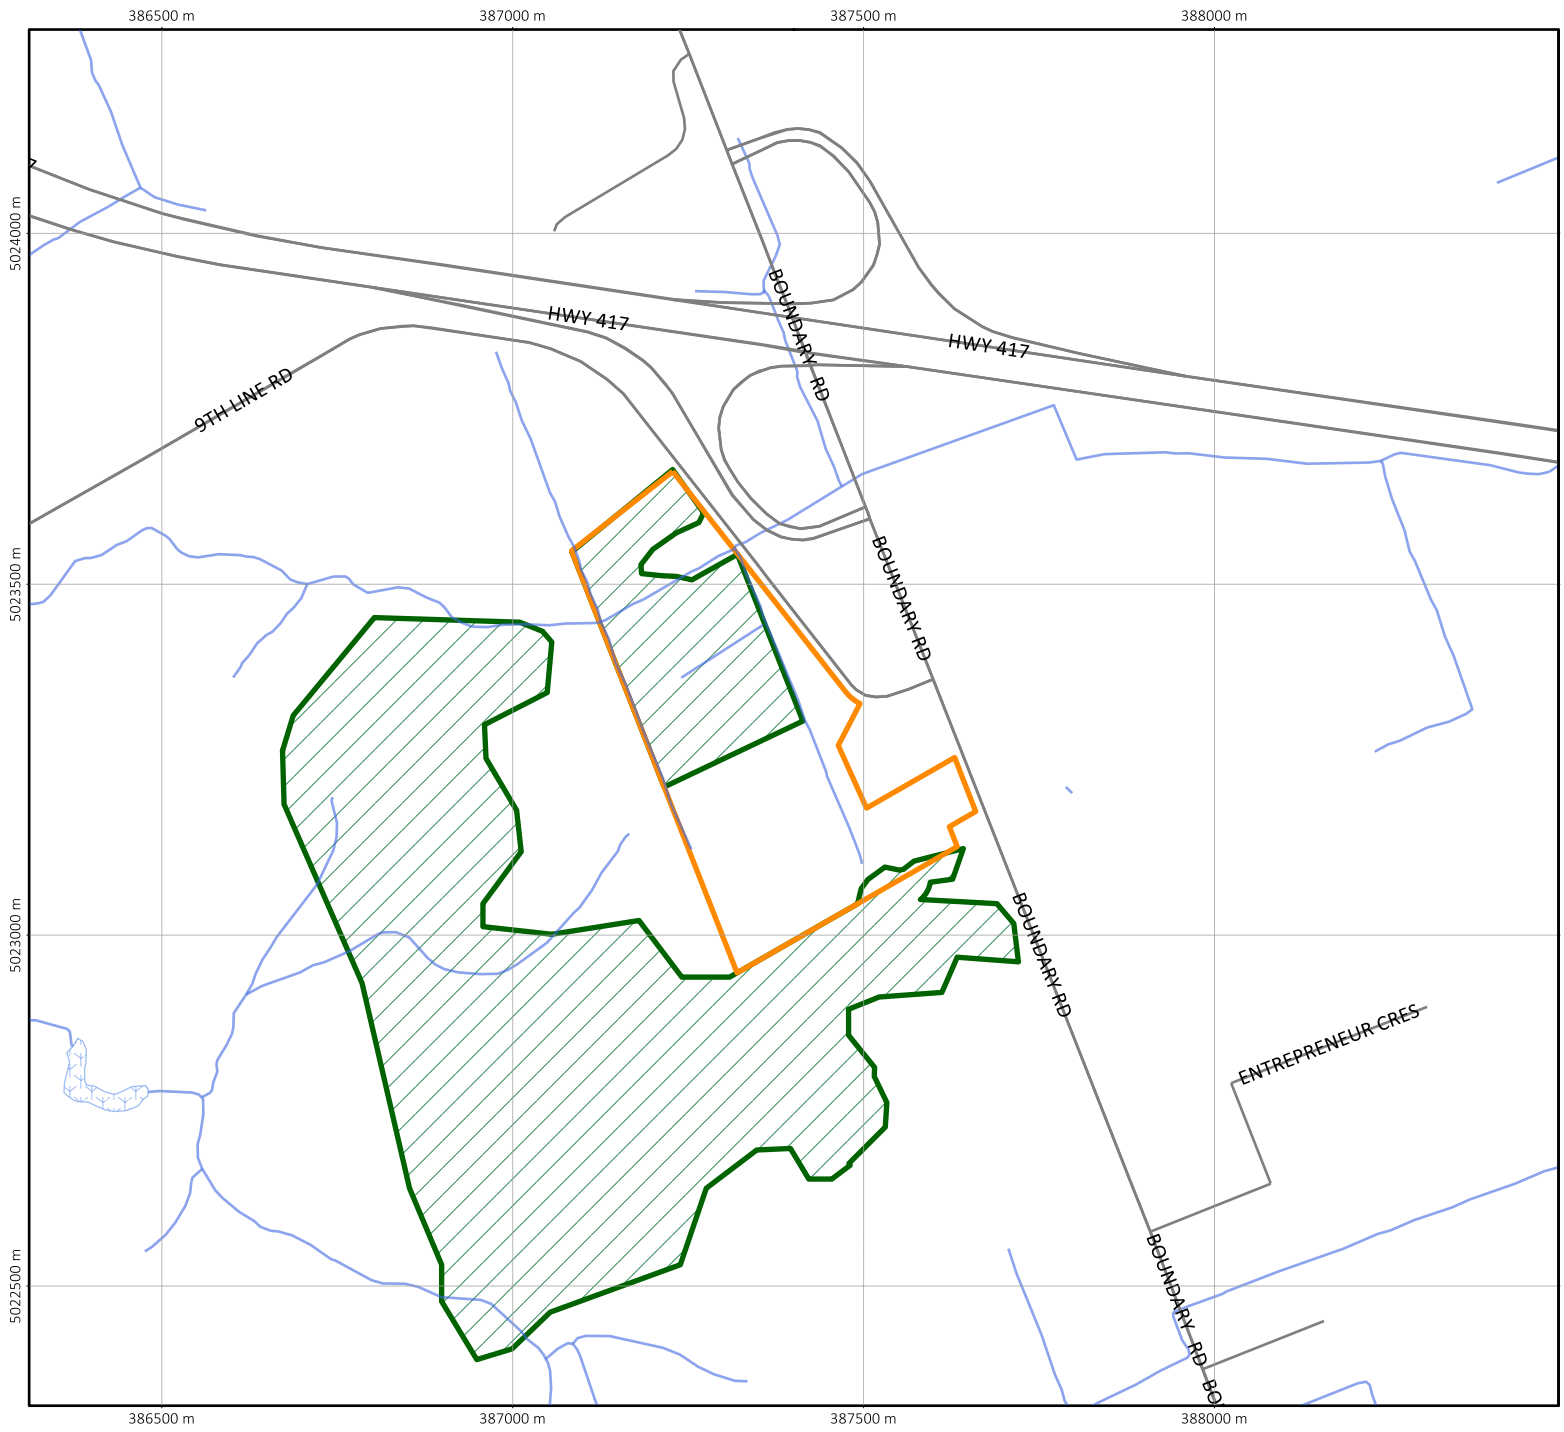
Figure 1 Site context

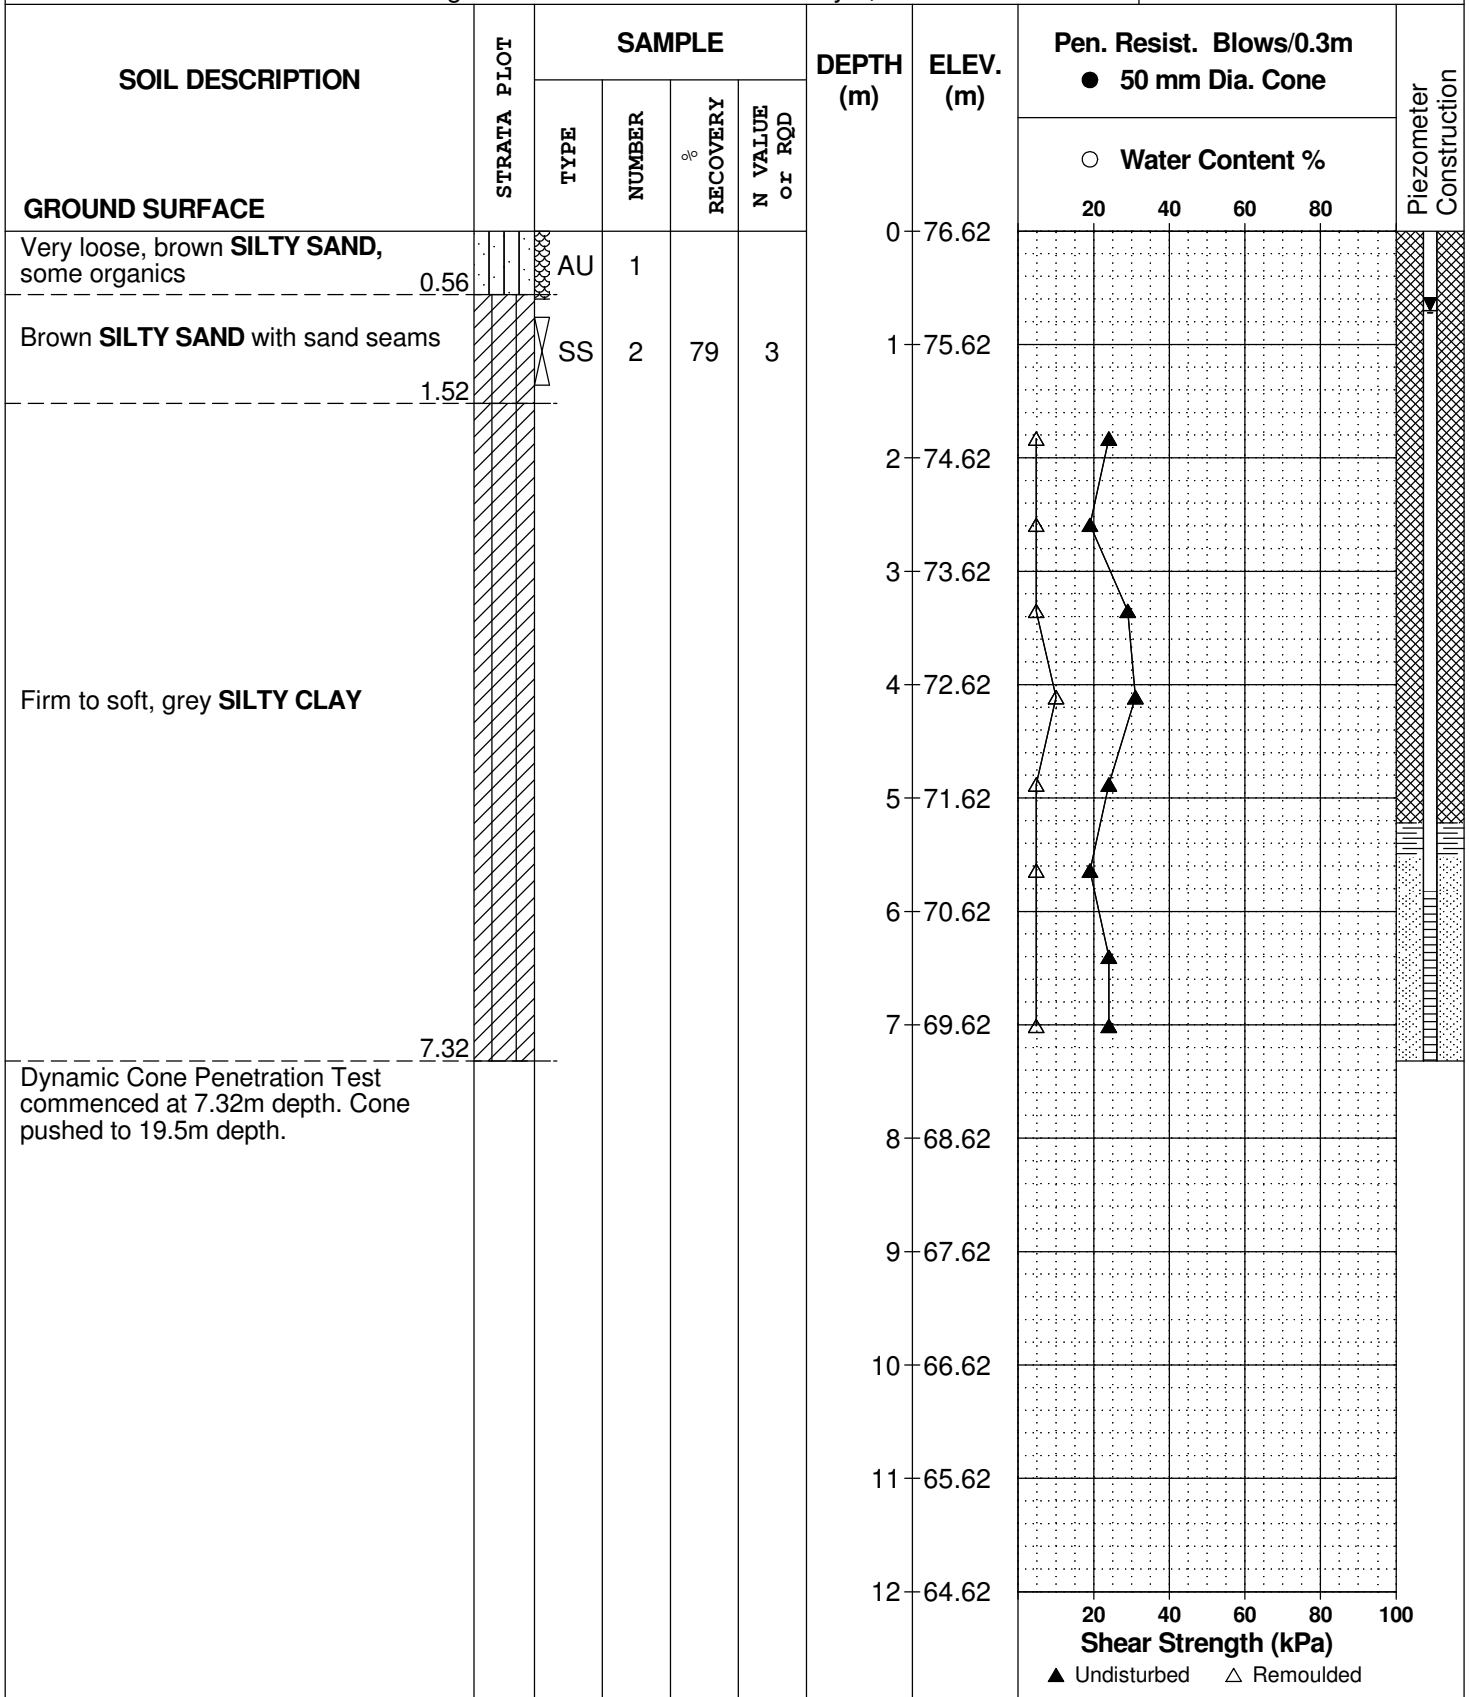
HOLE NO. **BH 2-20**

SOIL PROFILE AND TEST DATA

Geotechnical Investigation
 Prop. Warehouse Development - Thunder Road
 Ottawa, Ontario
