McKINLEY
ENVIRONMENTAL
SOLUTIONS

Combined Environmental Impact Statement &
Tree Conservation Report
Brigil Kanata North Development

September 2020
Prepared for Brigil

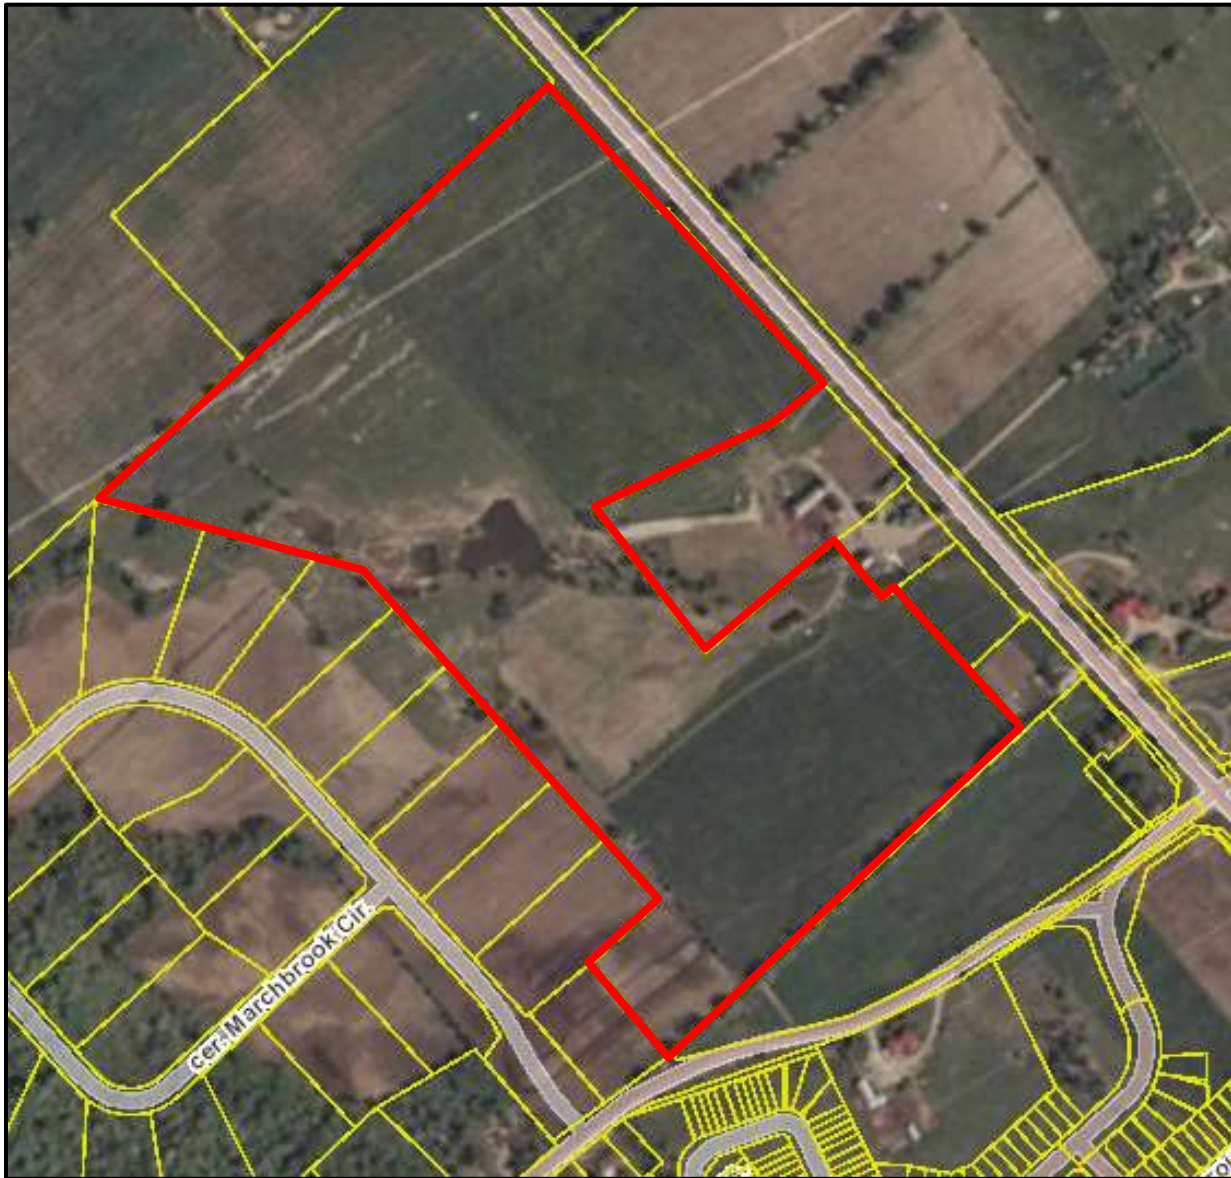
Historic Air Photograph 1: Historic Air Photo from 1976 (Site development limits shown in red). Note that the Site was intensively farmed and tree cover was limited to the Deciduous Hedgerows and portions of the Tree Stands in 1976. Portions of two of the (2) Deciduous Hedgerows (Features A and B) and two (2) of the Tree Stands (Features D and E) are visible in 1976 (Photos from City of Ottawa 2020).

Air photos from 1976, 1991 and 2005 are included below (Photos from City of Ottawa 2020). Recent air photos are included in the report figures. The oldest available air photo (from 1976) shows that the overall composition of the Site was similar in 1976, with most of the Site intensively farmed. Portions of two (2) of the Deciduous Hedgerows (Features A and B) and two (2) of the Tree Stands (Features D and E) are visible in 1976. The Site remains relatively unchanged in 1991 and 2005. One (1) Tree Stand (Feature F) and the Cultural Thicket (Feature C) are not visible in the historic air photos, which suggests that most trees and shrubs found in Features C and F represent recent regrowth (approximately 10 years of age). Some individual trees found within Features A, B, D, and E may be older than approximately 40 years of age.

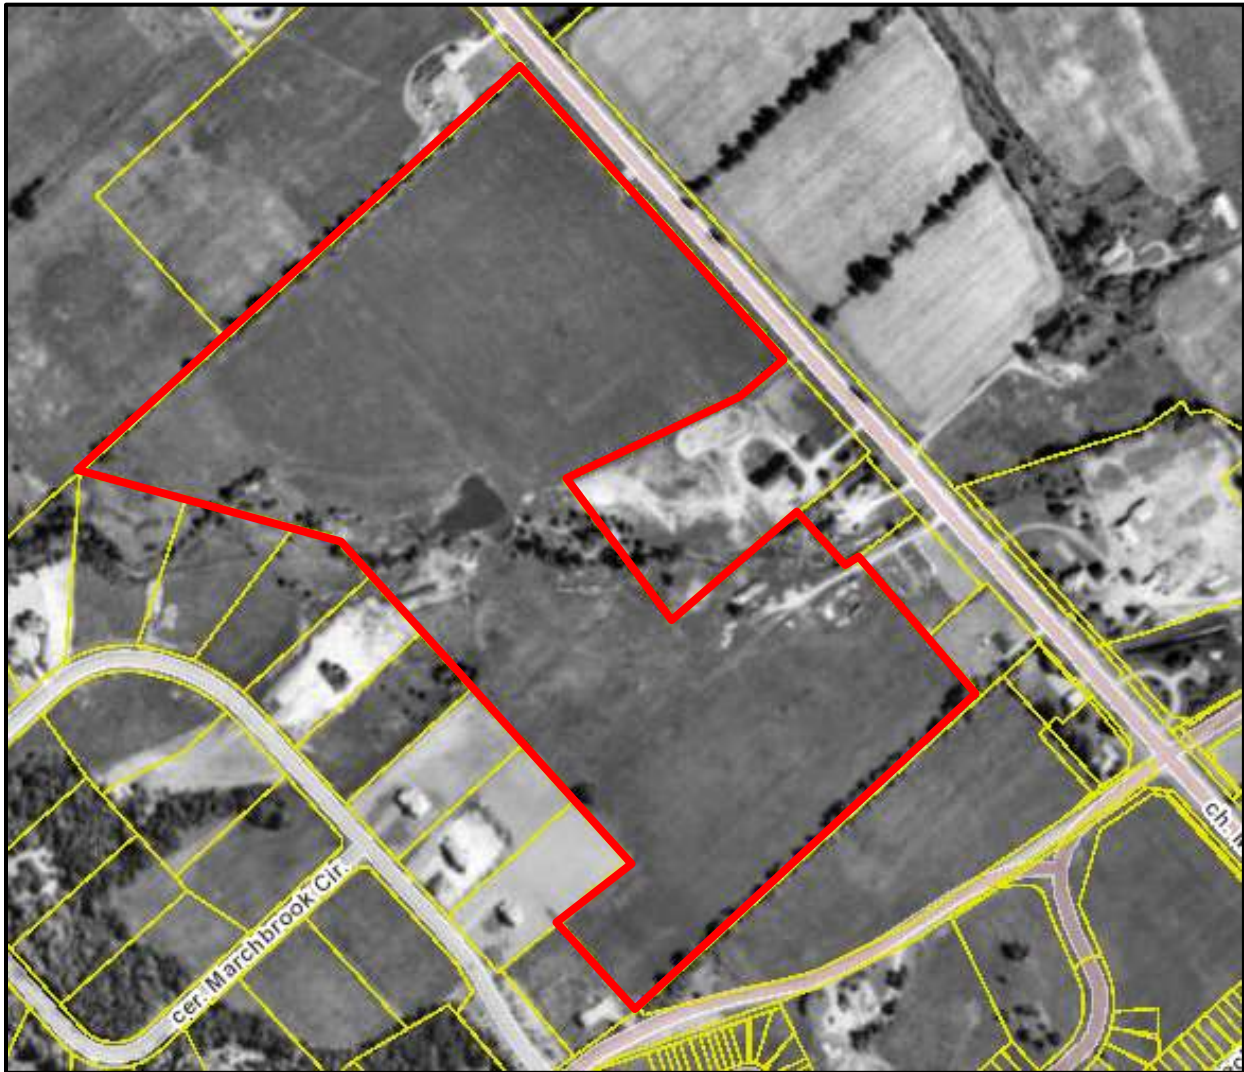
Historic Air Photograph 2: Historic Air Photo from 1991 (Site development limits shown in red). Note that the Site was intensively farmed and tree cover was limited to the Deciduous Hedgerows and portions of the Tree Stands in 1991. Portions of two (2) of the Deciduous Hedgerows (Features A and B) and two (2) of the Tree Stands (Features D and E) continue to be visible in 1991 (Photos from City of Ottawa 2020).

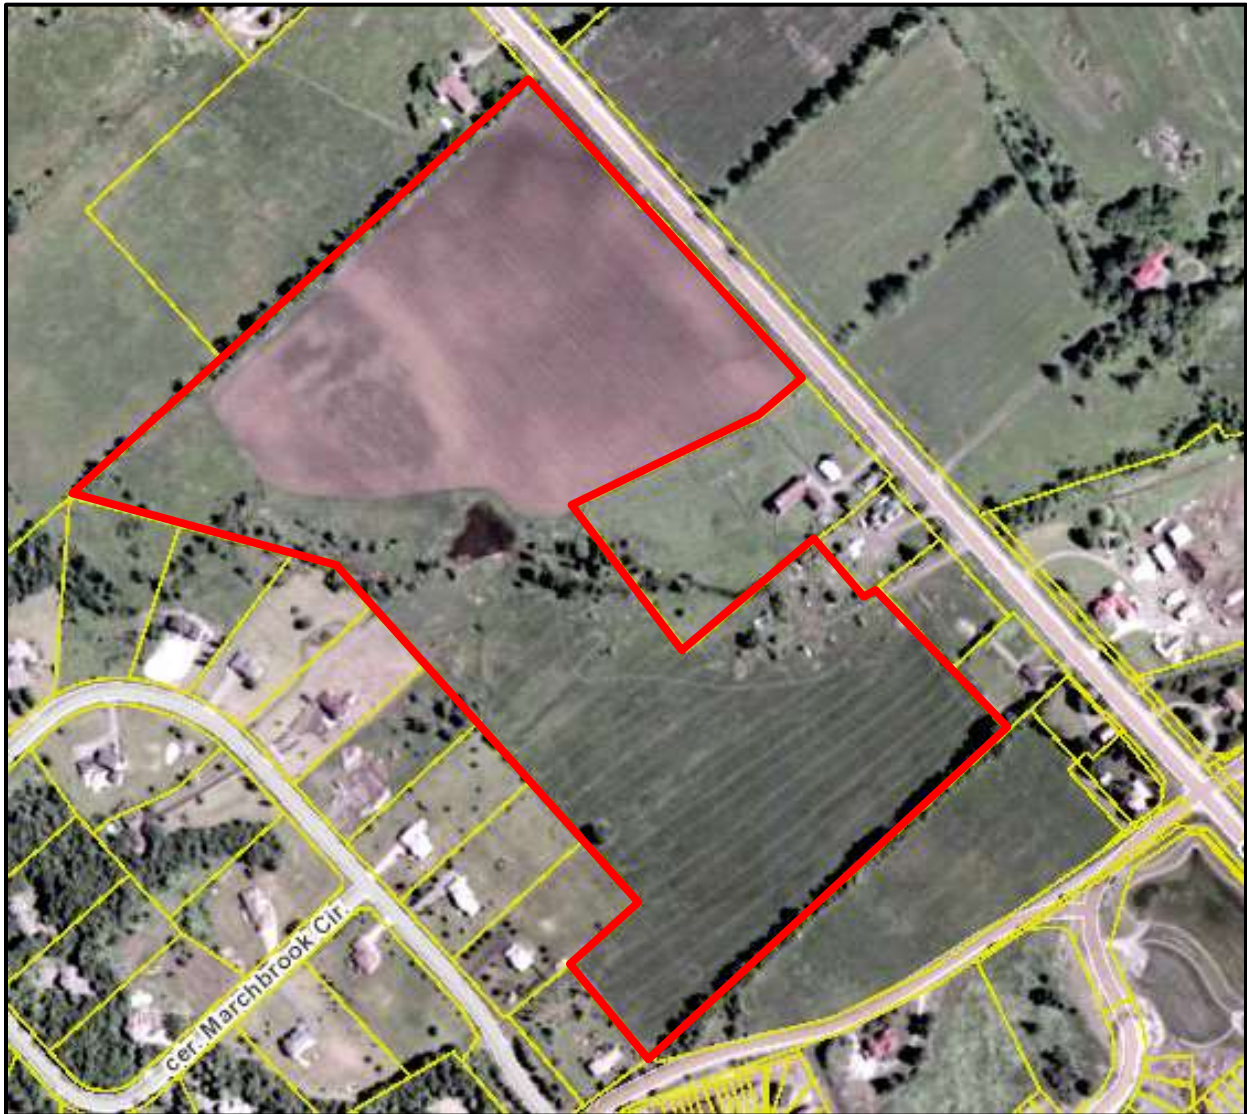
Historic Air Photograph 3: Historic Air Photo from 2005 (Site development limits shown in red). Note that the Site was intensively farmed and tree cover was limited to the Deciduous Hedgerows and portions of the Tree Stands in 2005. Portions of two (2) of the Deciduous Hedgerows (Features A and B) and two (2) of the Tree Stands (Features D and E) continue to be visible in 2005 (Photos from City of Ottawa 2020).

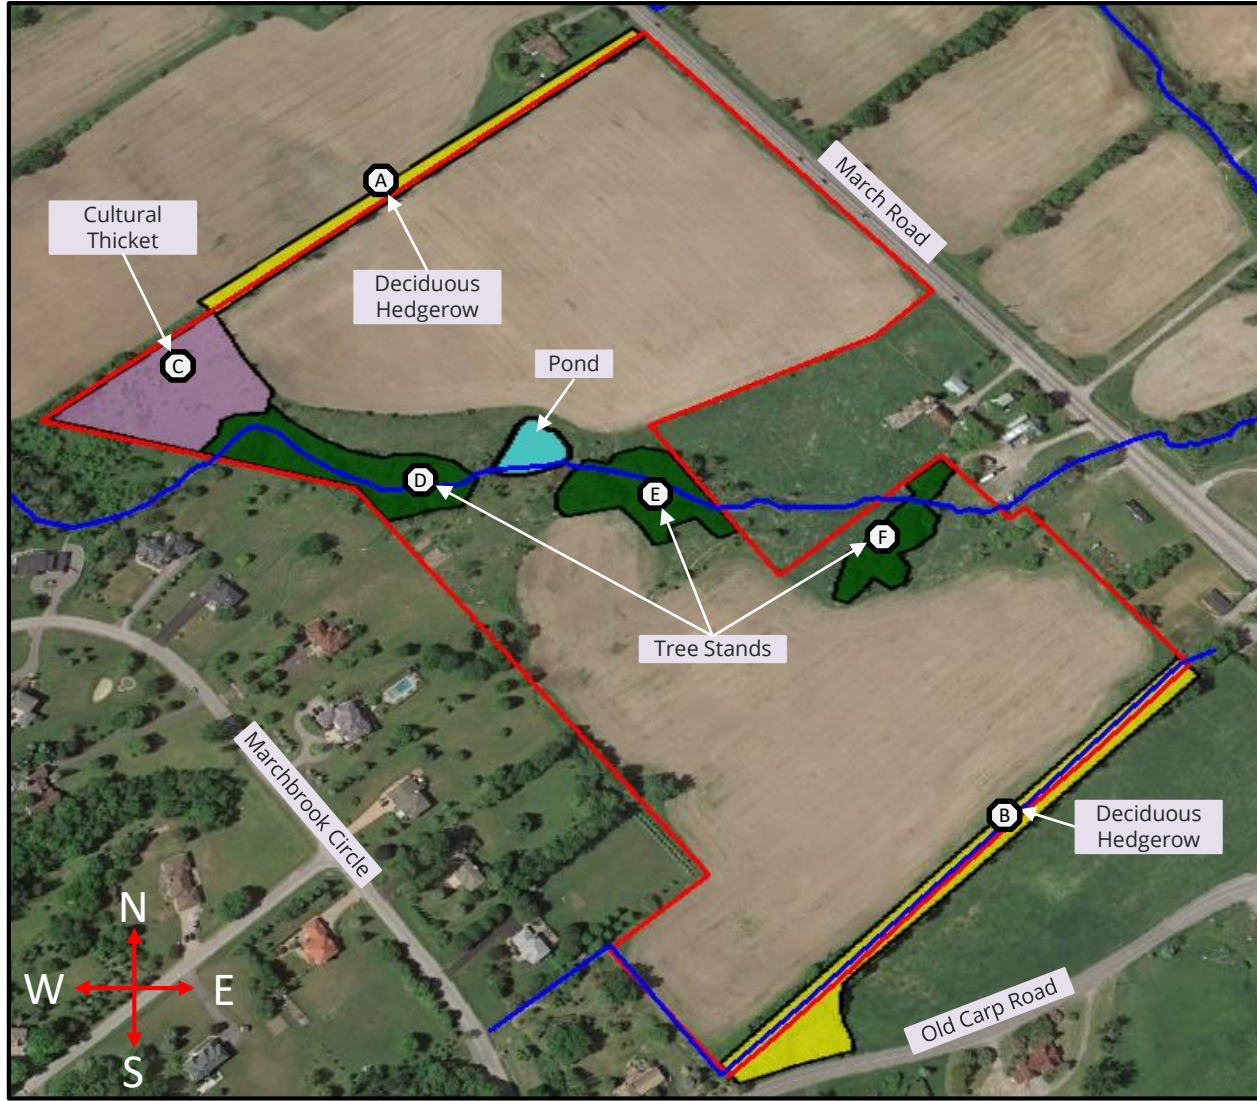
FIGURE 2: TREED HABITATS

The extent of these vegetation communities is shown in Figures 2 & 3. Appendix A includes a list of plant species noted during the vegetation surveys. Each of the vegetation communities is described in greater detail below.

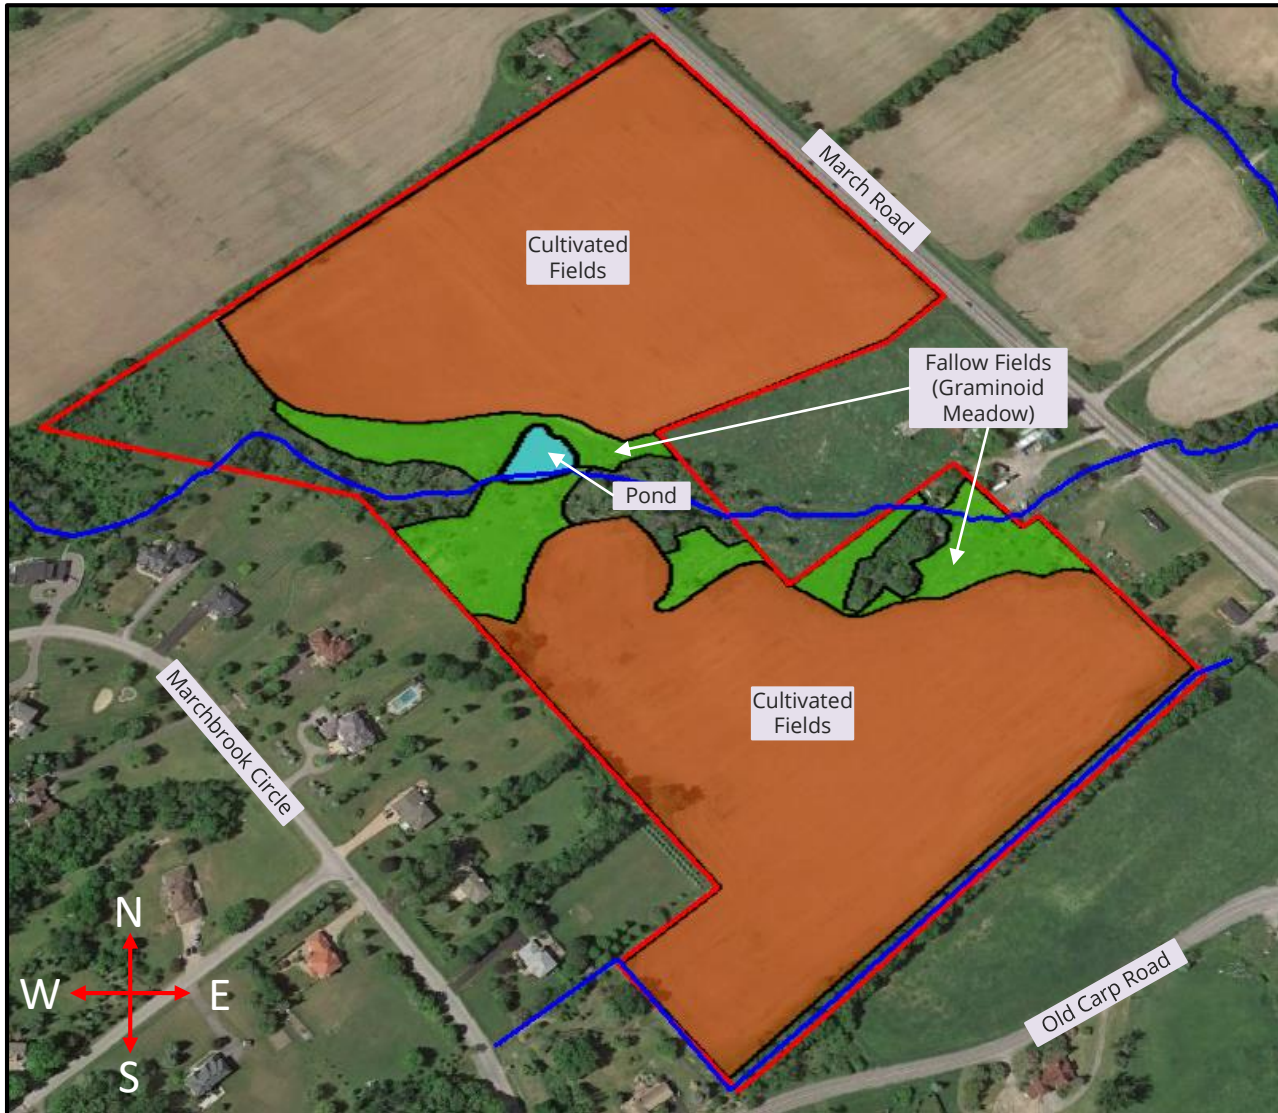
FIGURE 3: OPEN HABITATS

- **Cultivated Fields:** Areas under cultivation in 2018 are shown in Figure 3. The fields were observed to be cleared and planted with soybeans in the summer of 2018. The southern Cultivated Field has an isolated 114 cm diameter at breast height (dbh) Bur Oak growing near the western property line.

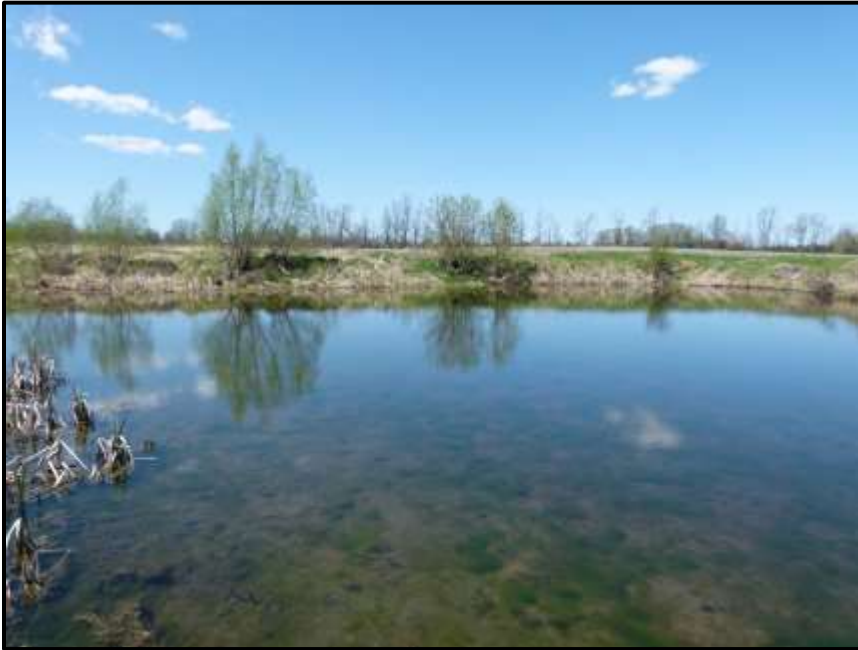
Photograph 12: Looking north at the inline pond. Note that the water level is relatively shallow (May 12th, 2018).

Three (3) concrete weirs occur along the North Branch, each of which creates pooling conditions. The largest weir has created an open water inline pond in the central part of the Site. The remaining two (2) weirs have created smaller pools, which are present at each weir. The inline pond is a relatively shallow feature, with much of its substrate consisting of bedrock. The presence of bedrock at the bottom of the inline pond likely limits its functionality as Blanding's Turtle habitat, as Blanding's Turtles require soft substrate that they can burrow into for overwintering (OMNRF 2014a). The inline pond has a generally flat profile with approximately 50 cm of water depth noted on May 12th, 2018. MEP (2016) noted that standing water depths in the inline pond reached 75 cm in

the spring of 2013. The inline pond was observed to contract significantly in the late summer, with the wetted area of the inline pond reduced by as much as 50% by July 2018. Notably, the northern approximately 50% of the inline pond was dry by July 2018, whereas the southern half of the inline pond remained hydrated. The southern half of the inline pond is likely to remain hydrated throughout the summer in most years.

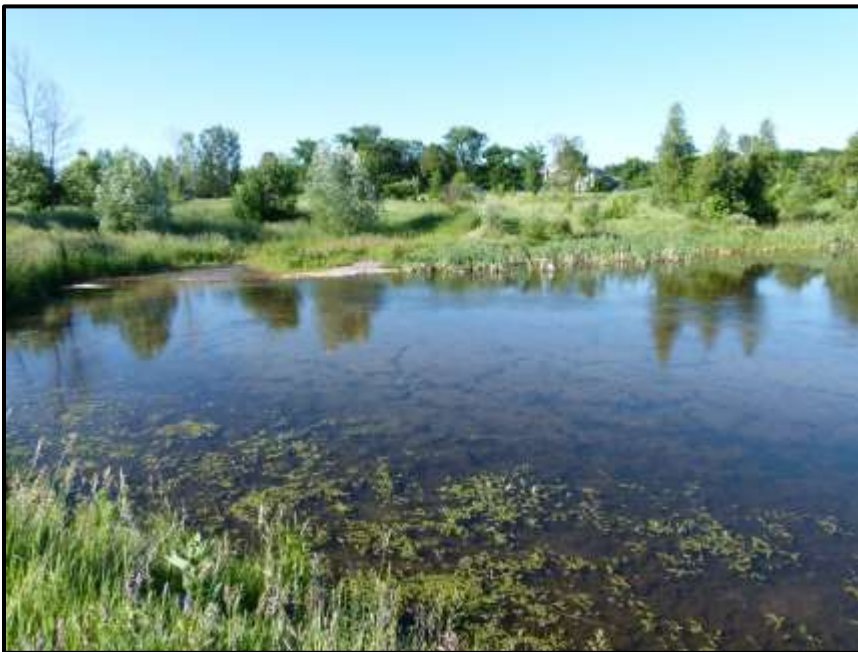
Photograph 13: Looking west at the inline pond. Note that the water level is relatively shallow (June 21st, 2018).

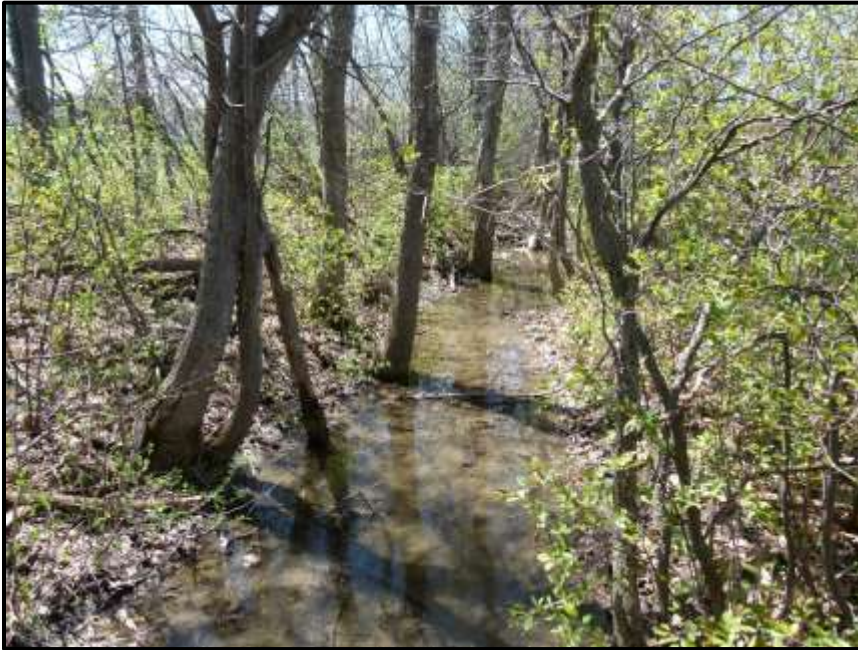
Photograph 18: Upstream (west) section of the Stormwater Swale (Tributary #4). The feature is found within Deciduous Hedgerow B (May 12th, 2018).
