Site Servicing and Stormwater
Management Brief – Mooney's Bay -
729 Ridgewood Avenue, Ottawa, ON

File: 160410536/83

June 9, 2021

Stantec Consulting Ltd.

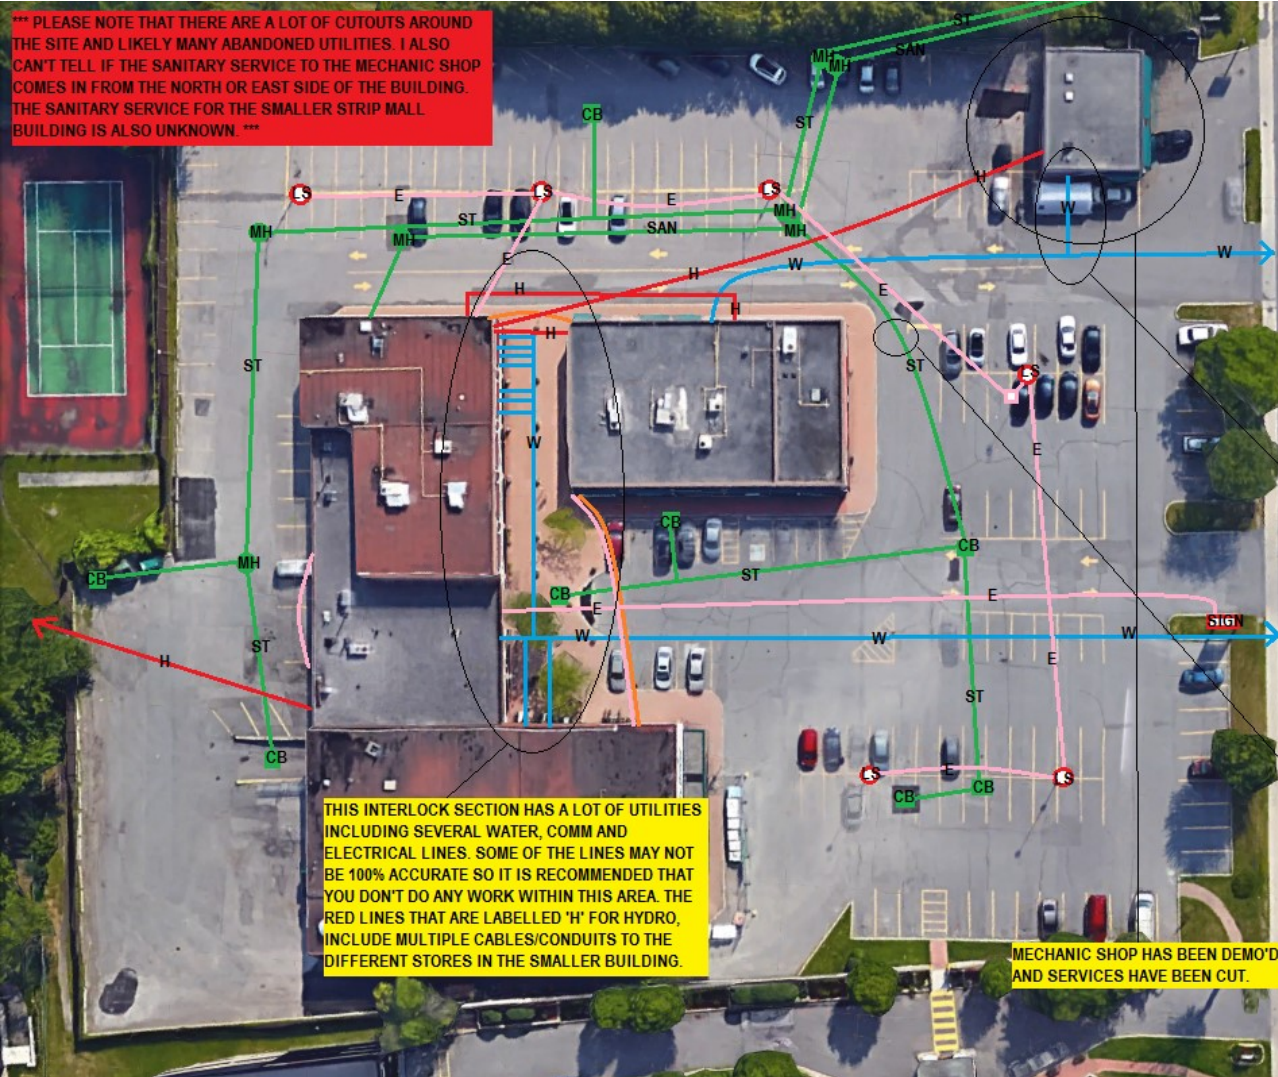
THIS INTERLOCK SECTION HAS A LOT OF UTILITIES INCLUDING SEVERAL WATER, COMM AND ELECTRICAL LINES. SOME OF THE LINES MAY NOT BE 100% ACCURATE SO IT IS RECOMMENDED THAT YOU DON'T DO ANY WORK WITHIN THIS AREA. THE RED LINES THAT ARE LABELLED 'H' FOR HYDRO, INCLUDE MULTIPLE CABLES/CONDUITS TO THE DIFFERENT STORES IN THE SMALLER BUILDING.

MECHANIC SHOP HAS BEEN DEMO'D AND SERVICES HAVE BEEN CUT.

THE CATCH BASIN CONNECTS TO THE STORM MANHOLE BUT THERE MAY BE AN ELBOW OR SLIGHT BEND IN THE PIPE AS A DIRECT LINE MAY BE TOO CLOSE TO THE BUILDING FOOTING. CAN'T TRACE IT EXACTLY UNLESS THE PIPE IS SONDED/FISHED. BEST NOT TO PUT A HOLE ALONG THAT LINE.
