Phase One Environmental Site Assessment

729 Ridgewood
Avenue
Ottawa, Ontario

Prepared for:
11684663 Canada Inc.

July 27, 2020

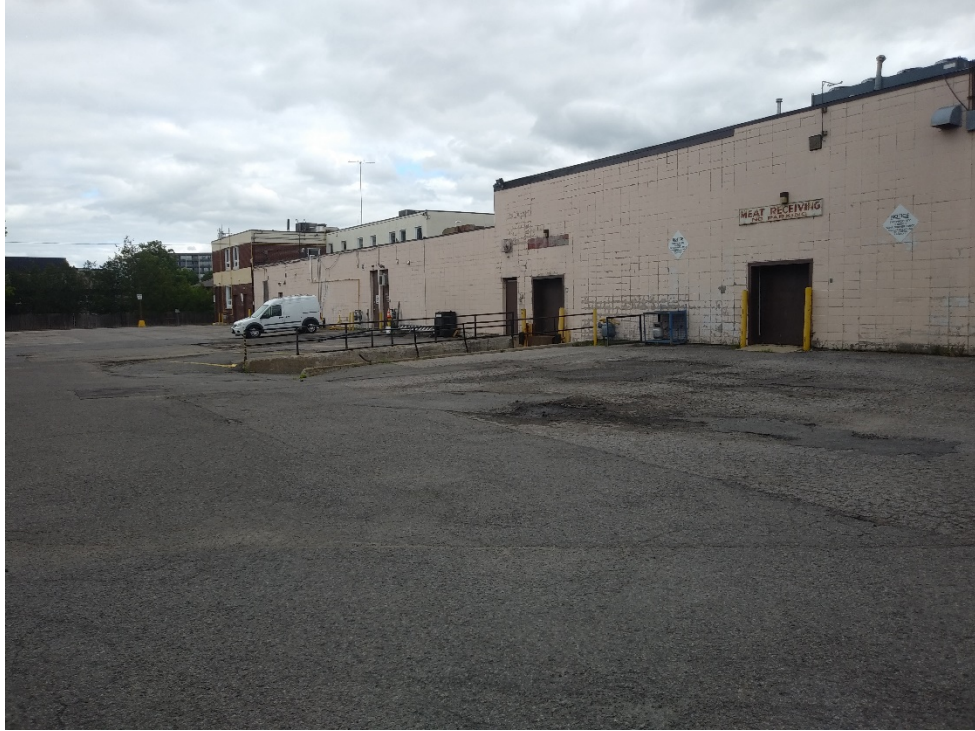
Photograph 3: View of the north side of the Phase One Property looking southeast. View shows the north side of the north commercial building, including the loading dock for the former grocery store and the natural gas meters for the commercial units.

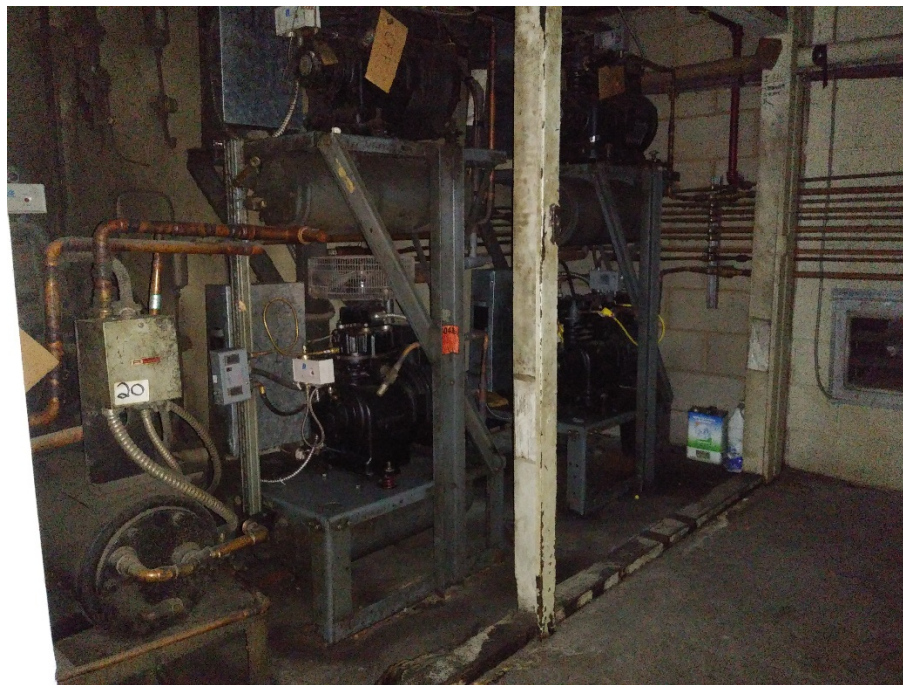
Photograph 10: View of the refrigeration equipment in the penthouse level of the former grocery store in the northwest portion of the north commercial plaza building.
