1194 WELLINGTON STREET W., OTTAWA, ON
**CULTURAL HERITAGE IMPACT
STATEMENT**

WELLDAL LIMITED PARTNERSHIP
JUNE 30, 2022

This Cultural Heritage Impact Statement (CHIS) was requested by the City of Ottawa to evaluate a redevelopment of the property located at 1186-1194 Wellington Street West in Ottawa’s Hintonburg neighbourhood.

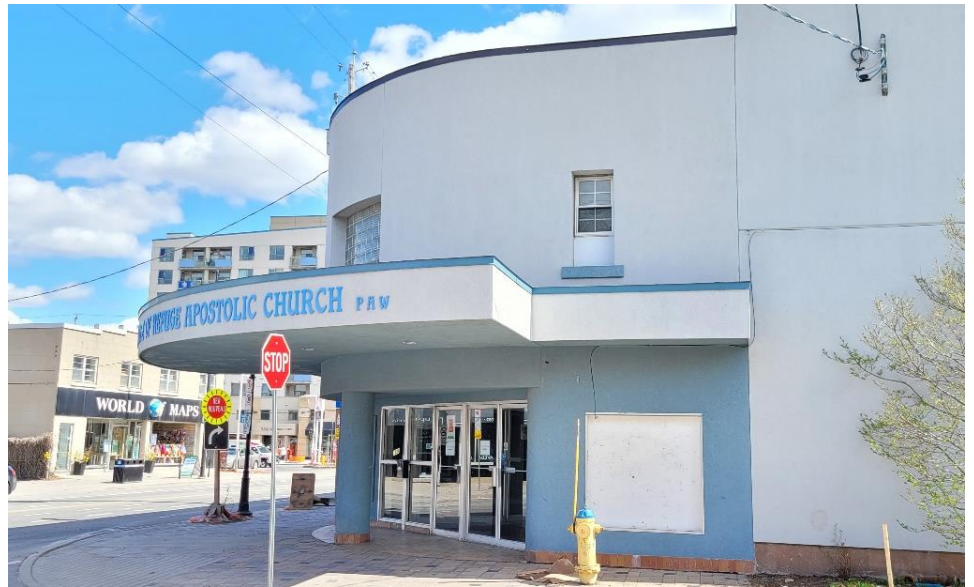
- 2 Cornerstone House of Refuge Apostolic Church, former Elmdale Theatre, corner of Wellington St W and Hamilton Avenue North. MTBA.
