# CONSERVATION PLAN

## 359 KENT STREET, 436 & 444 MACLAREN STREET, OTTAWA

July 2023    Revision 3

Application File Number: D02-02-21-0095 [ZBLA] & D01-01- 21-0015 [OPA]

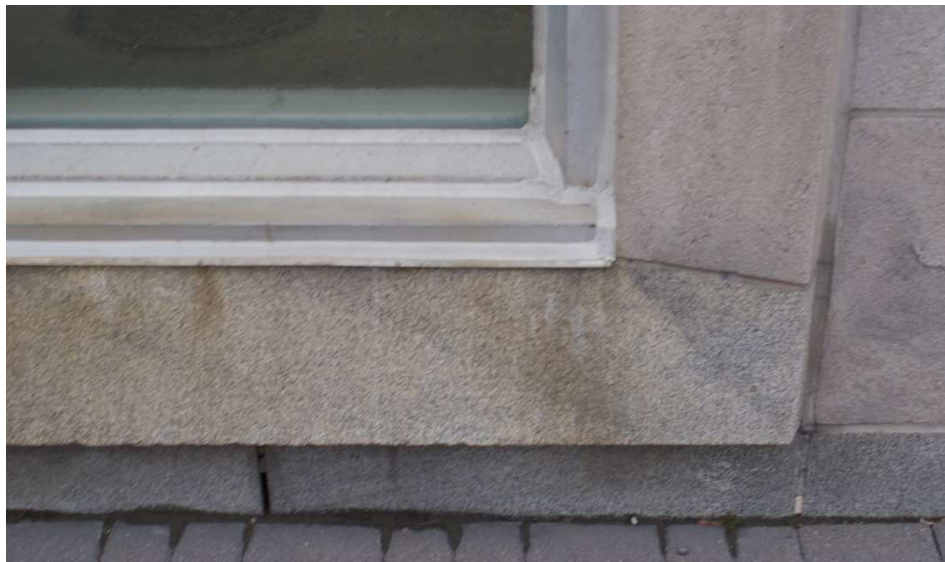
**Condition:** The granite sill on the Kent Street window is in good condition. The condition of the granite plinth course buried below grade has not been determined.

Figure 25: Detail of the granite plinth course and granite windowsill surround at the base of the three-storey Kent Street window. The colour of the granite sill is very close to the limestone cladding and window surrounds. Source: Commonwealth 2022.

**Preservation** of the intact granite sill and plinth course panels and reinstallation in the Kent and Gilmour Street façades forming an upstand wall supporting curtain wall glazing. The condition of the material buried below grade has not been determined.

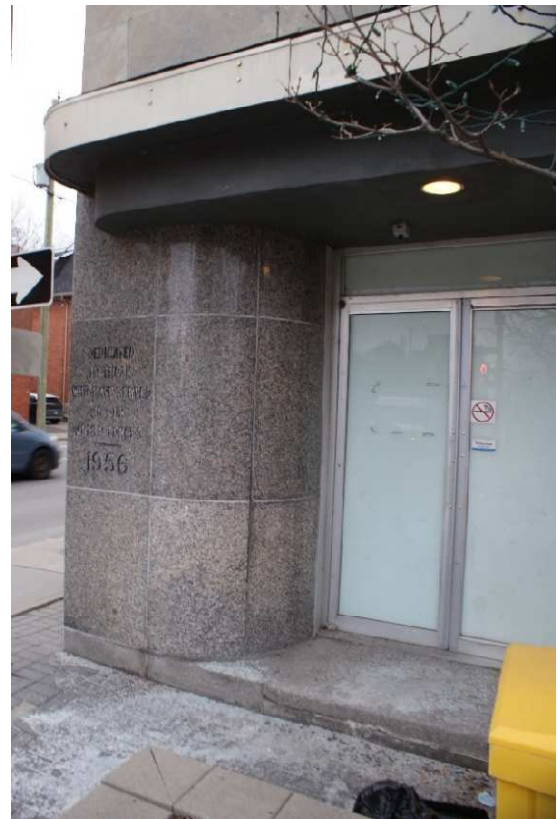
**Condition:** The canopy has been modified with a dropped modern enclosure with recessed lighting.

Figures 26 & 27: Detail section of the Gilmour Street Entrance illustrating the form and materials and the relationship to the entrance doors. Existing view of the canopy illustrating alterations to the canopy and entrance doors. Source: Original 1955 Drawing Set A5 & Commonwealth 2022.
