## Phase I - Environmental Site Assessment

1987 Robertson Road  
Ottawa, Ontario

Hadwen Properties Limited

Report: PE4378-1

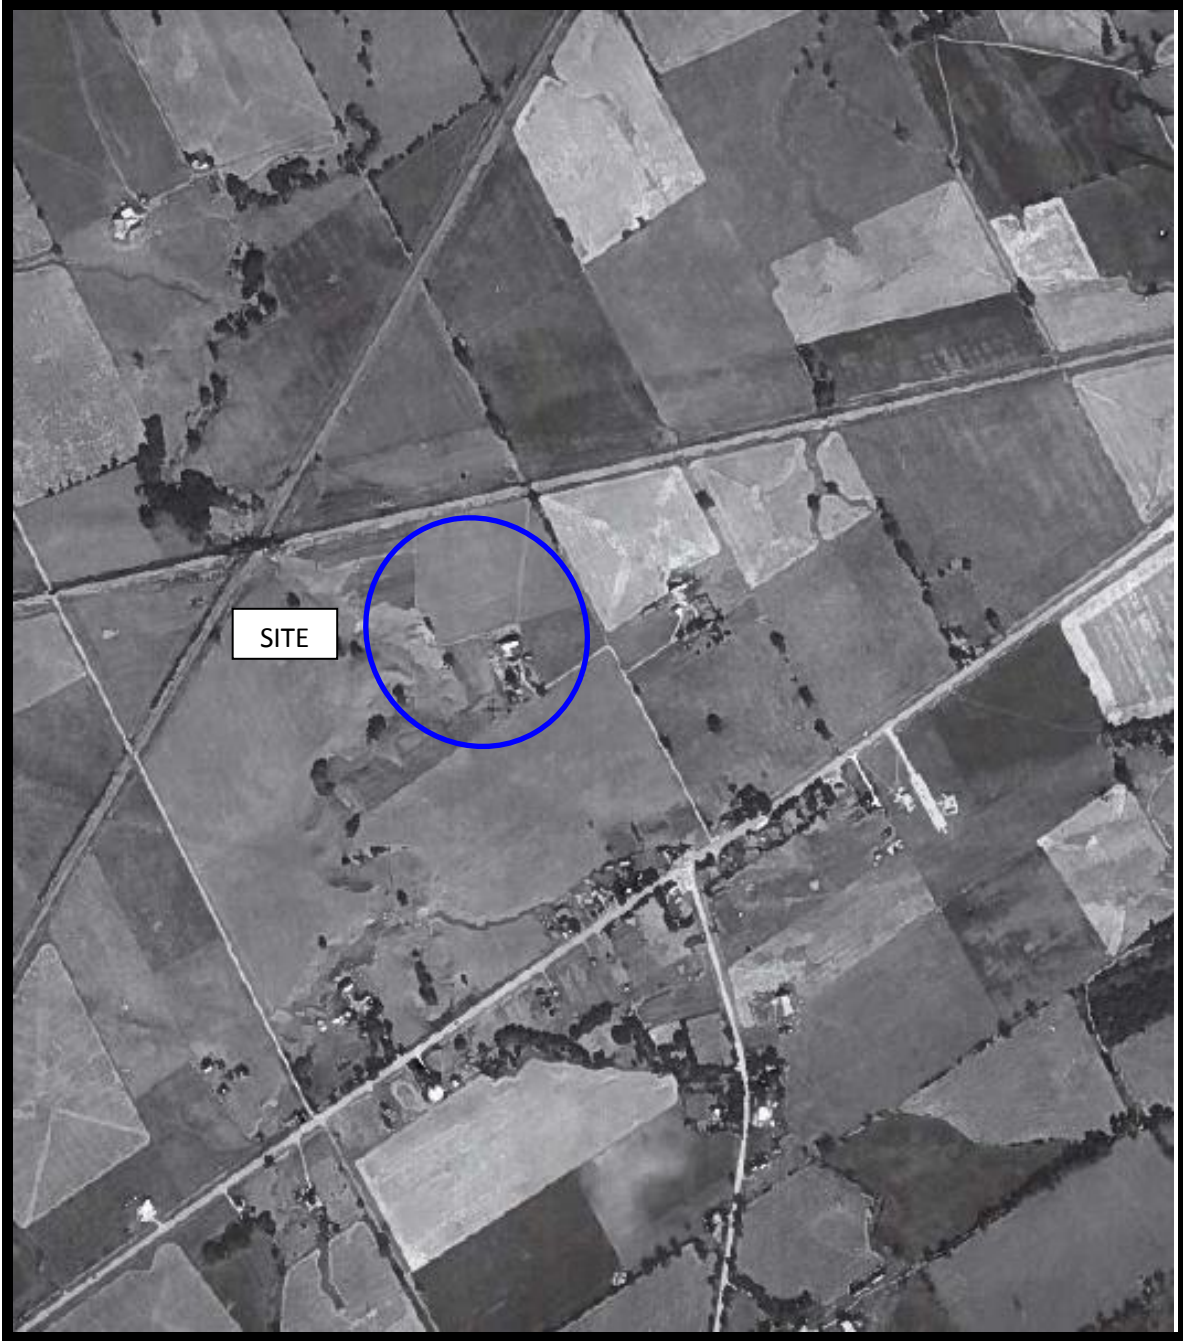
AERIAL PHOTOGRAPH  
1951

- 1951      The subject site is occupied by a farmstead and associated outbuildings at this time. Another farmstead can be seen to the east of the subject site while the remainder of the neighbouring properties are vacant and appear to be primarily used for agricultural purposes. A railway line can be seen to the north in this photo. Robertson Road is present to the south at this time.

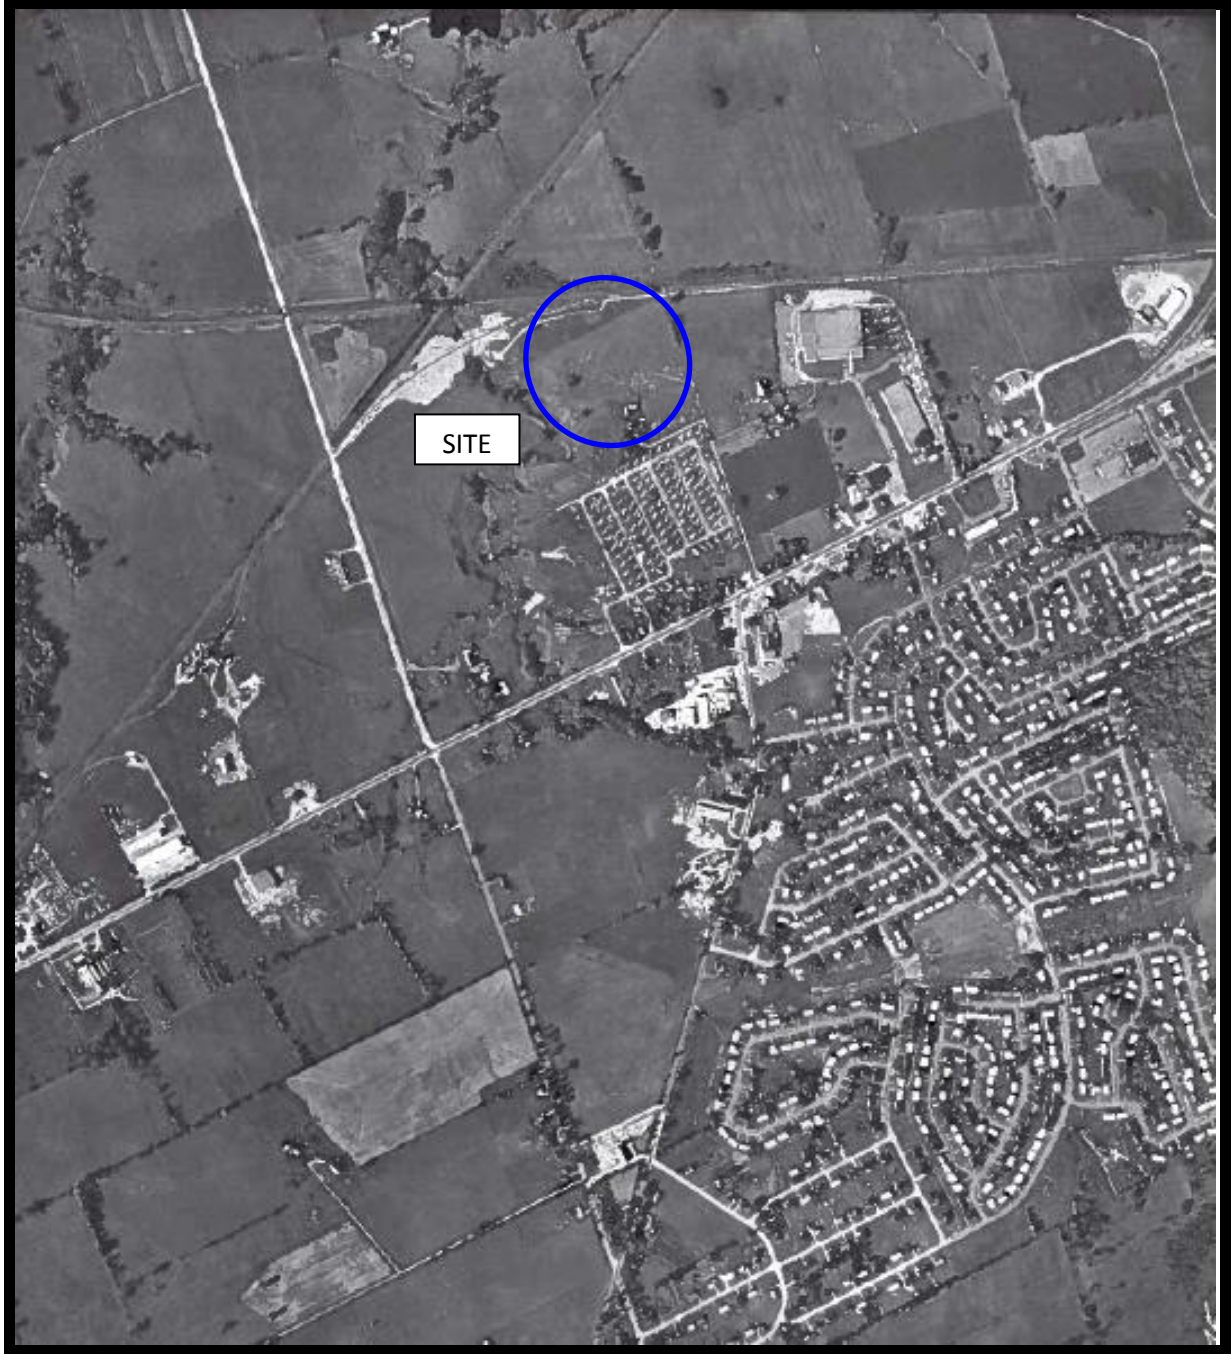
AERIAL PHOTOGRAPH  
1963

- 1963      The subject and neighbouring properties to the north and west are unchanged from the previous photo. The neighbouring property to the south is now occupied by a trailer park, while increased commercial development can be seen further to the east at this time.

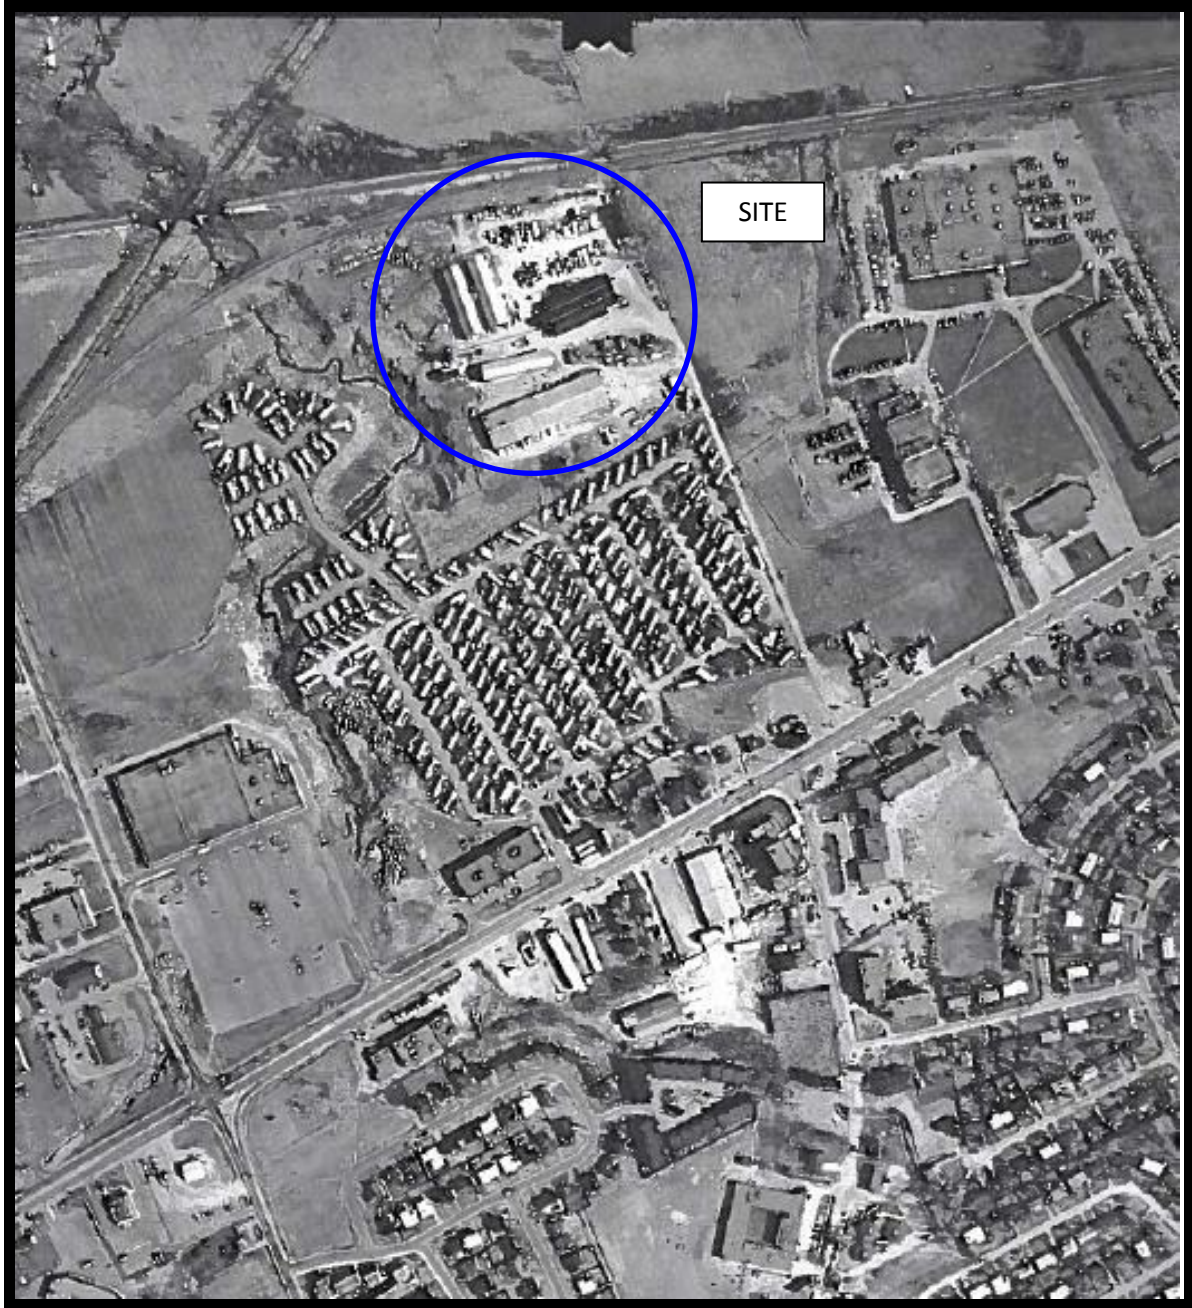
AERIAL PHOTOGRAPH  
1975

- 1975      The subject site has been re-developed with the farmstead and associated outbuildings having been removed in this photo. The site is utilized as a lumber yard at this time with approximately six large shed type structures visible in this photo. The trailer park on the neighbouring property to the south has expanded at this time and now occupies the neighbouring property to the west. The remaining neighbouring properties are unchanged from the previous photo.

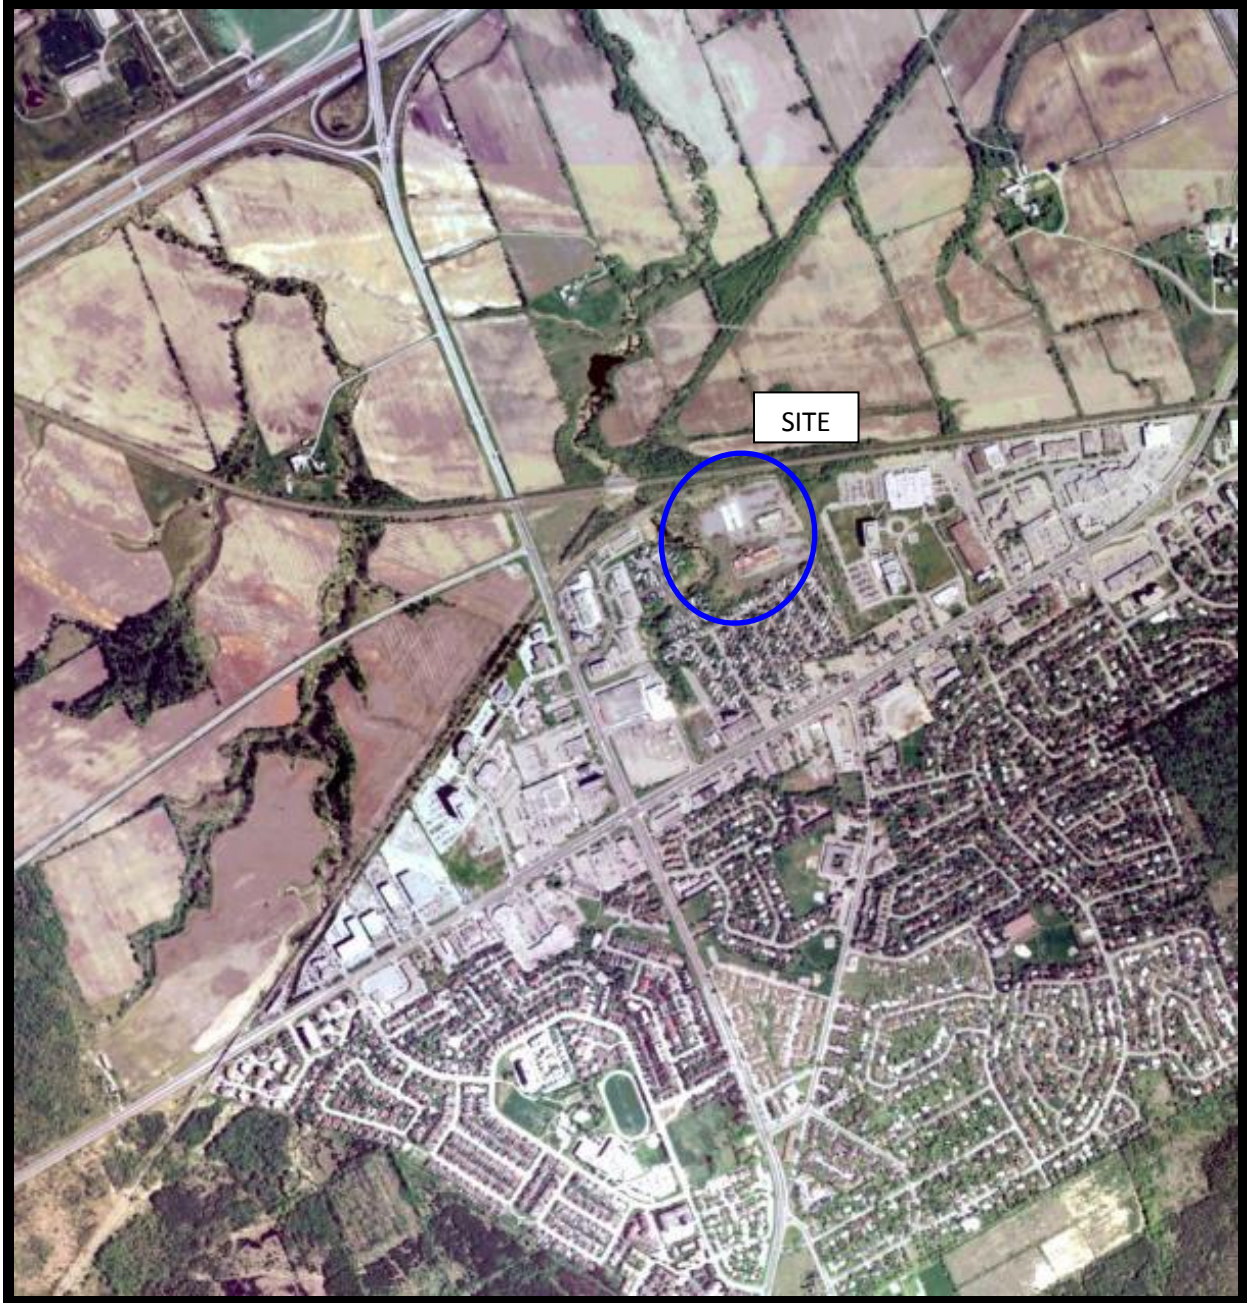
AERIAL PHOTOGRAPH  
1999

- 1999      The subject property appears to have gone through significant changes – three (3) warehouse structures no longer exist on the site as

they have been removed. The concrete pads where two (2) buildings existed are what is left of the buildings, an increase in residential density south and southwest of the subject property is noticeable.

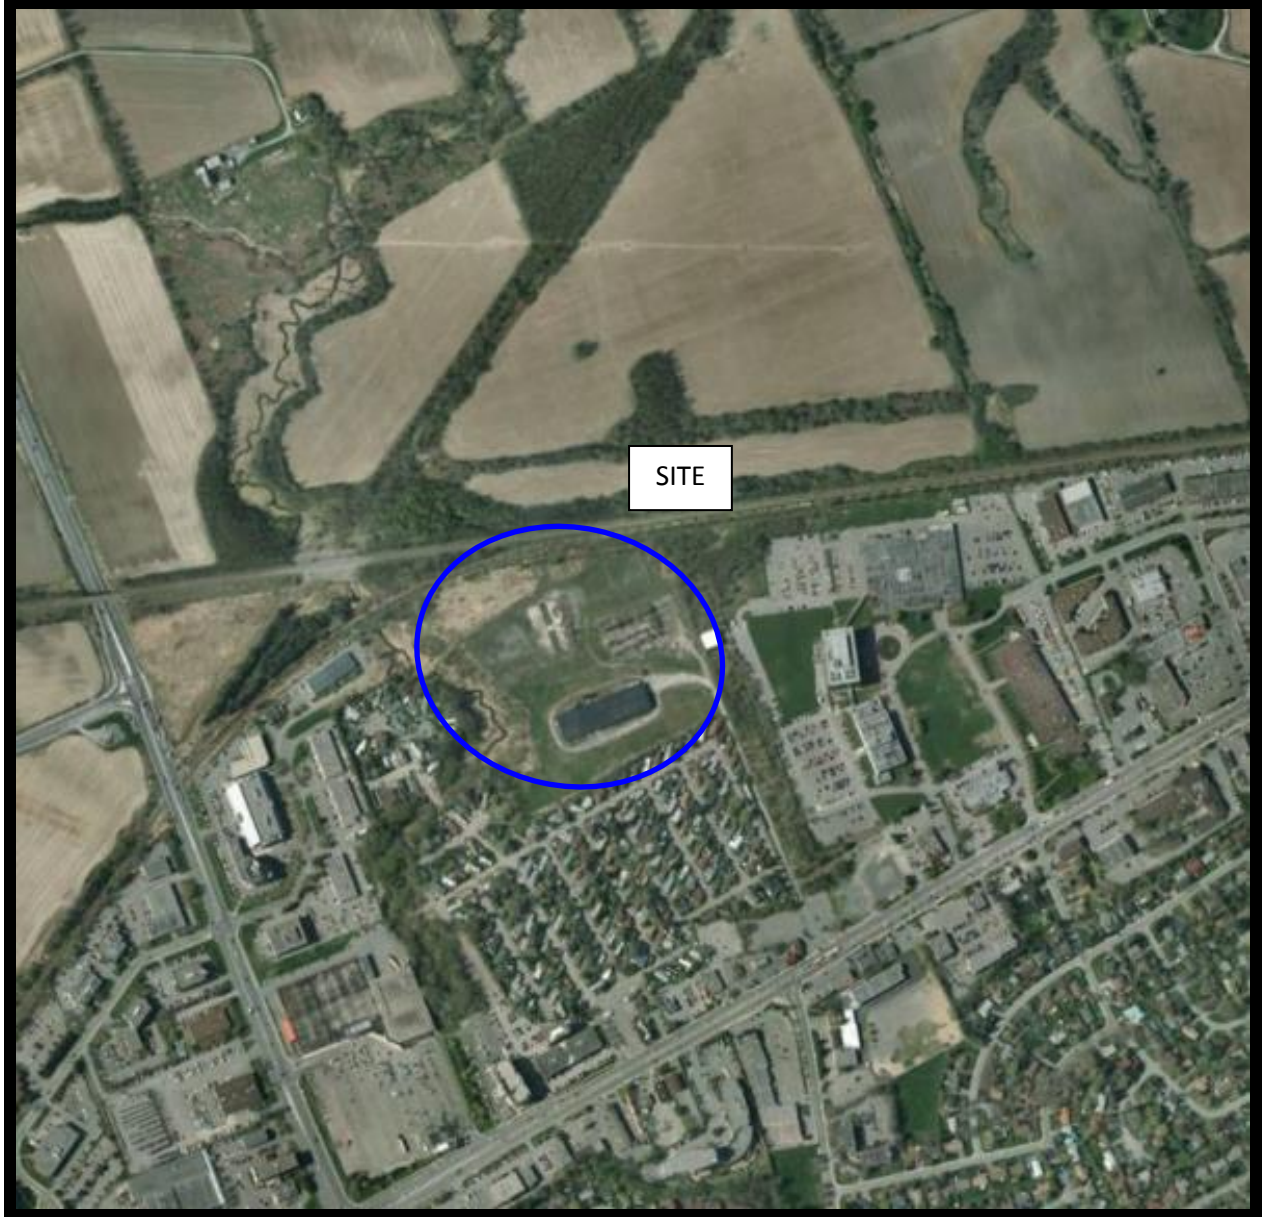
AERIAL PHOTOGRAPH  
2002

- 2002      The subject and neighbouring properties are unchanged from the previous photo.
- 2011      The subject and neighbouring properties are unchanged from the previous photo.
- 2017      A property east of the subject property has been developed, but otherwise, no significant changes have been made to the surrounding area or subject property. The subject and neighbouring properties are depicted as they appear today.
