URBAN FORESTRY & FOREST MANAGEMENT CONSULTING

RE: TREE CONSERVATION REPORT FOR 1987 ROBERTSON ROAD

PROJECT: 1987 ROBERTSON ROAD
CITY OF OTTAWA

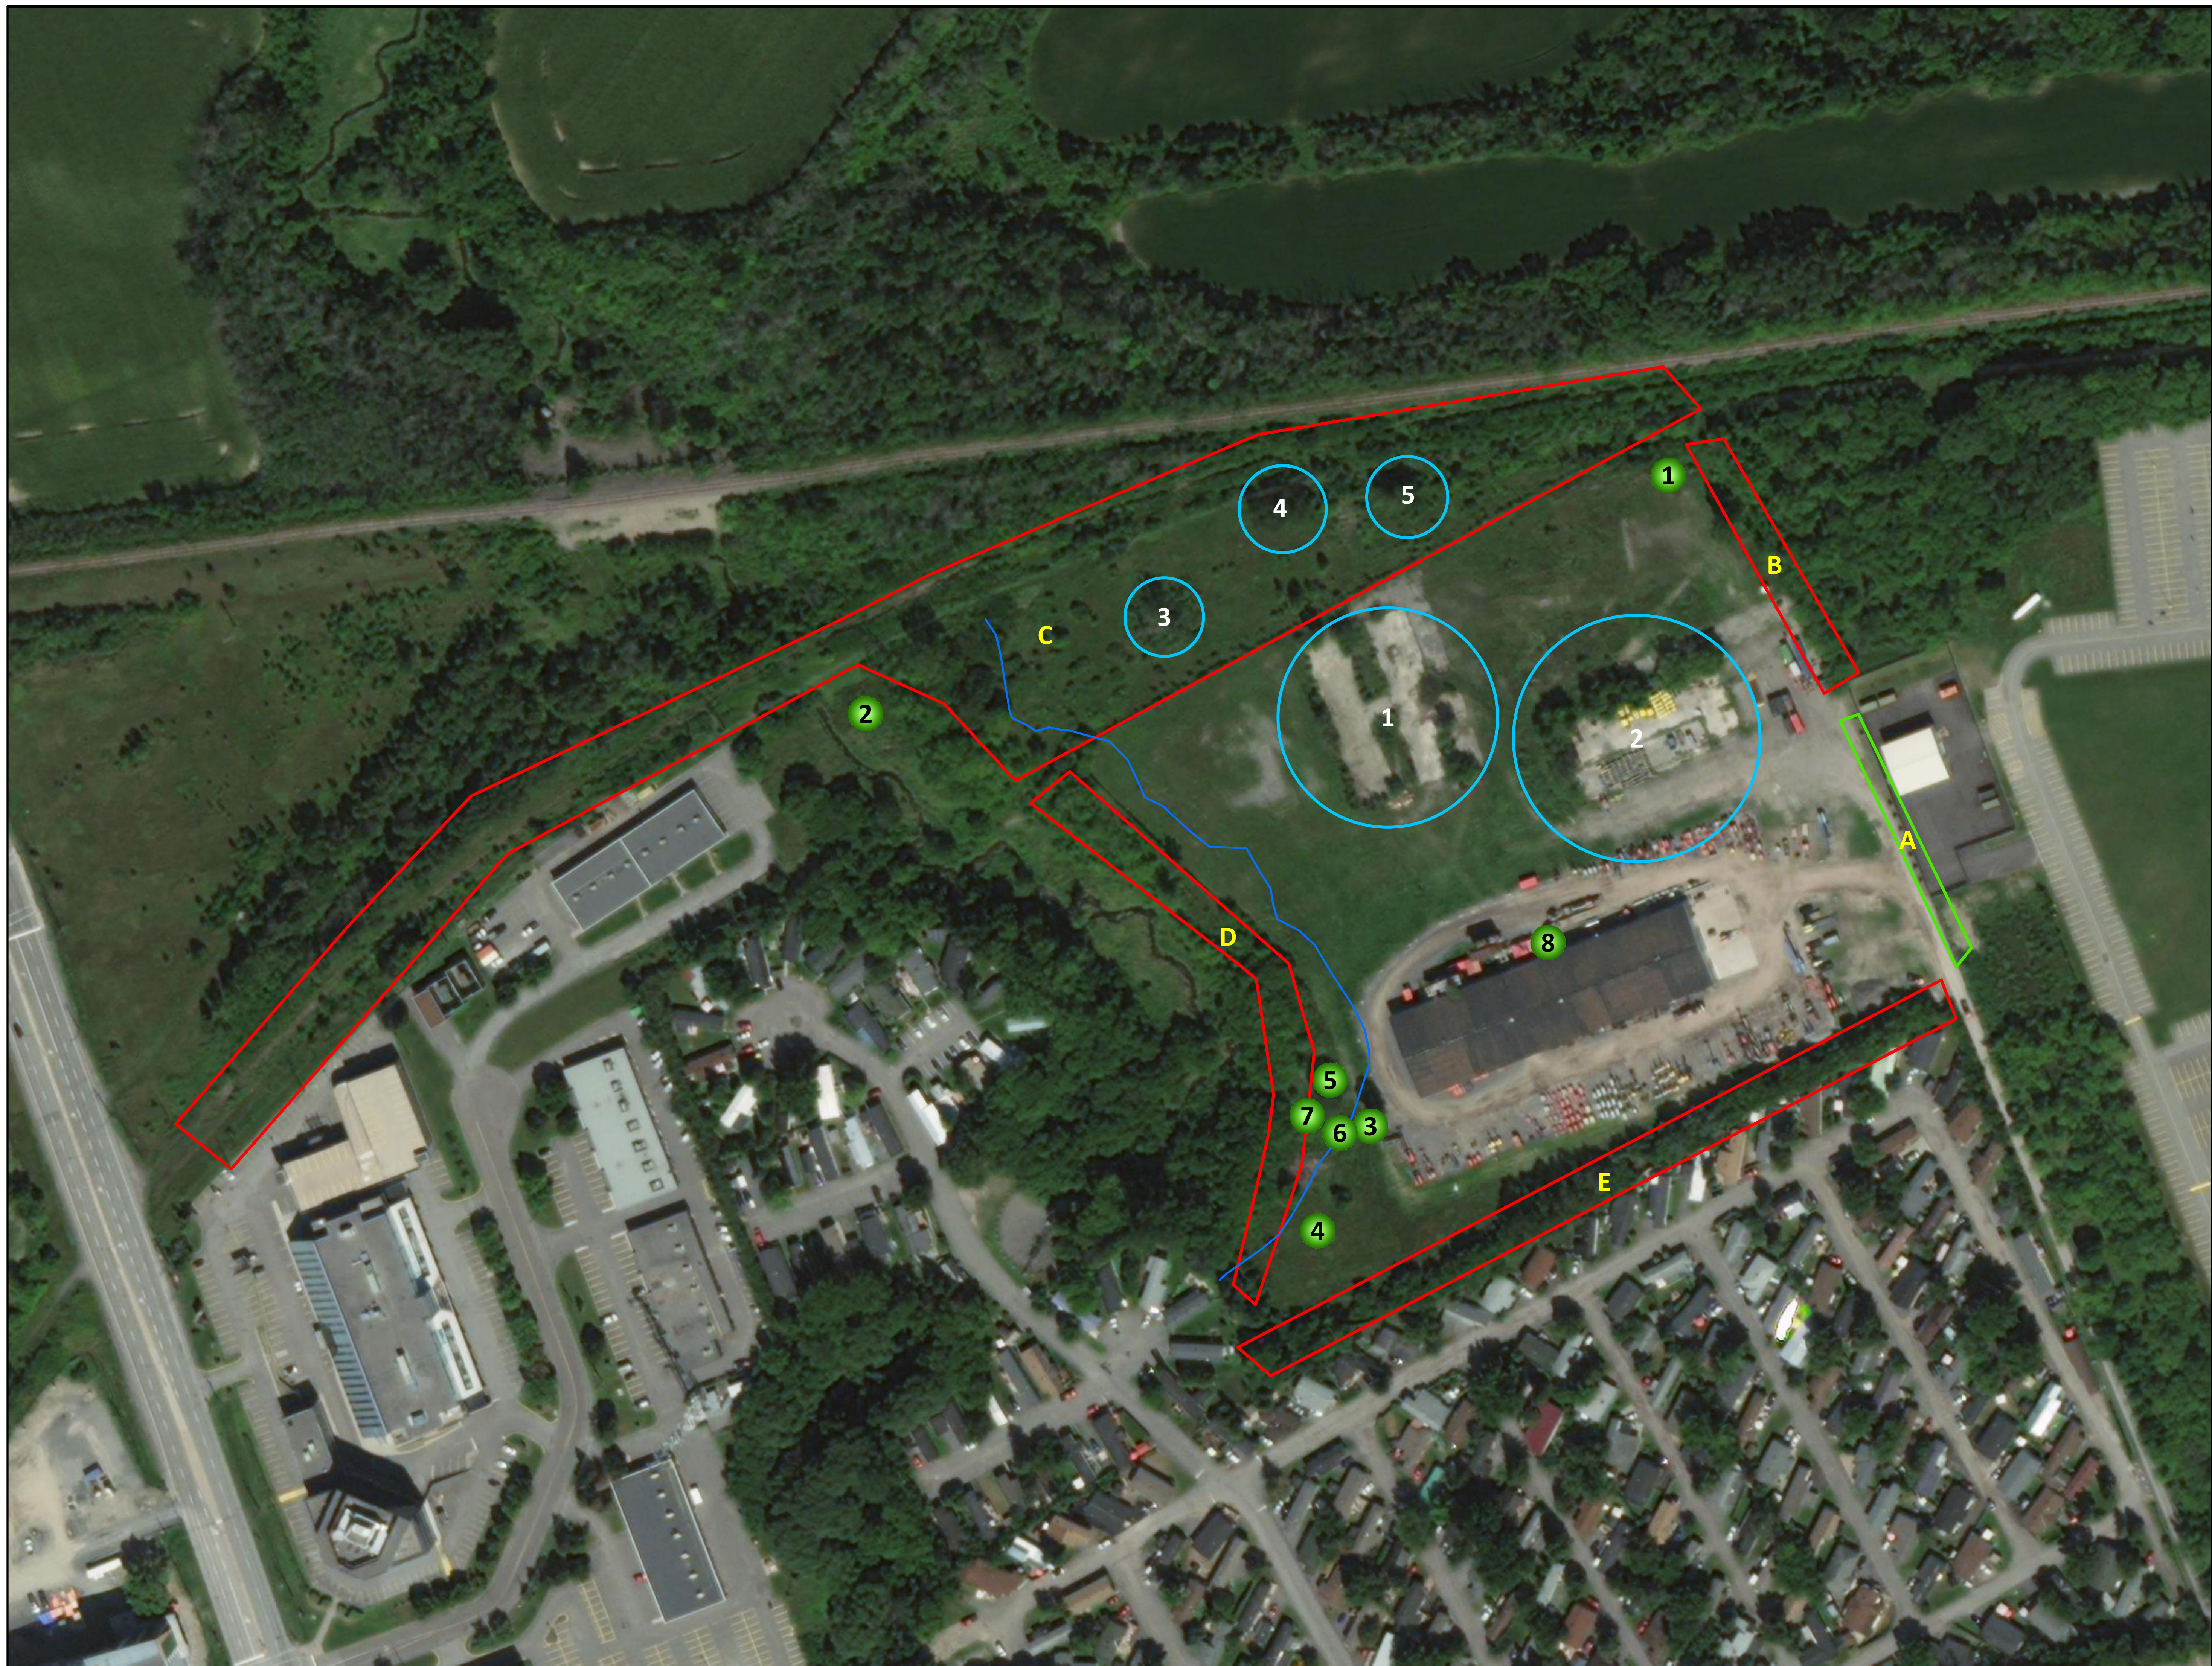
DRAWING: Tree Conservation Plan

All current vegetation is shown on the tree conservation plans included on page 5 and 6 of this report. By the numbers and letters indicated on the plans, each tree and grouping of trees is detailed below:

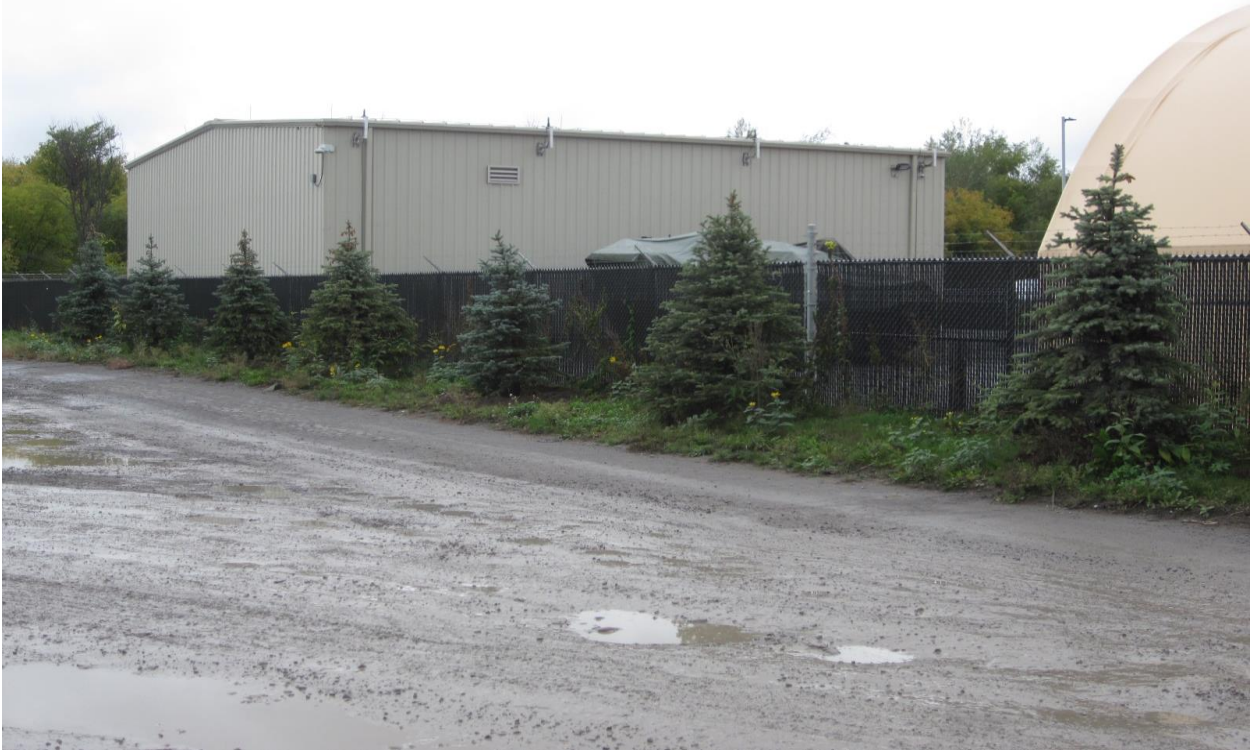
Tree grouping A: A line of nine planted Colorado spruce ranging in diameter from 5 to 9 cm which are in fair condition with the exception of one dead tree. Based on gaps in the line it appears other trees died and were removed in the past. This line of trees will be removed due to conflicts with construction. Transplanting elsewhere on the property may be an option for those trees in better health.

Picture 1. Tree grouping A at 1987 Robertson Road

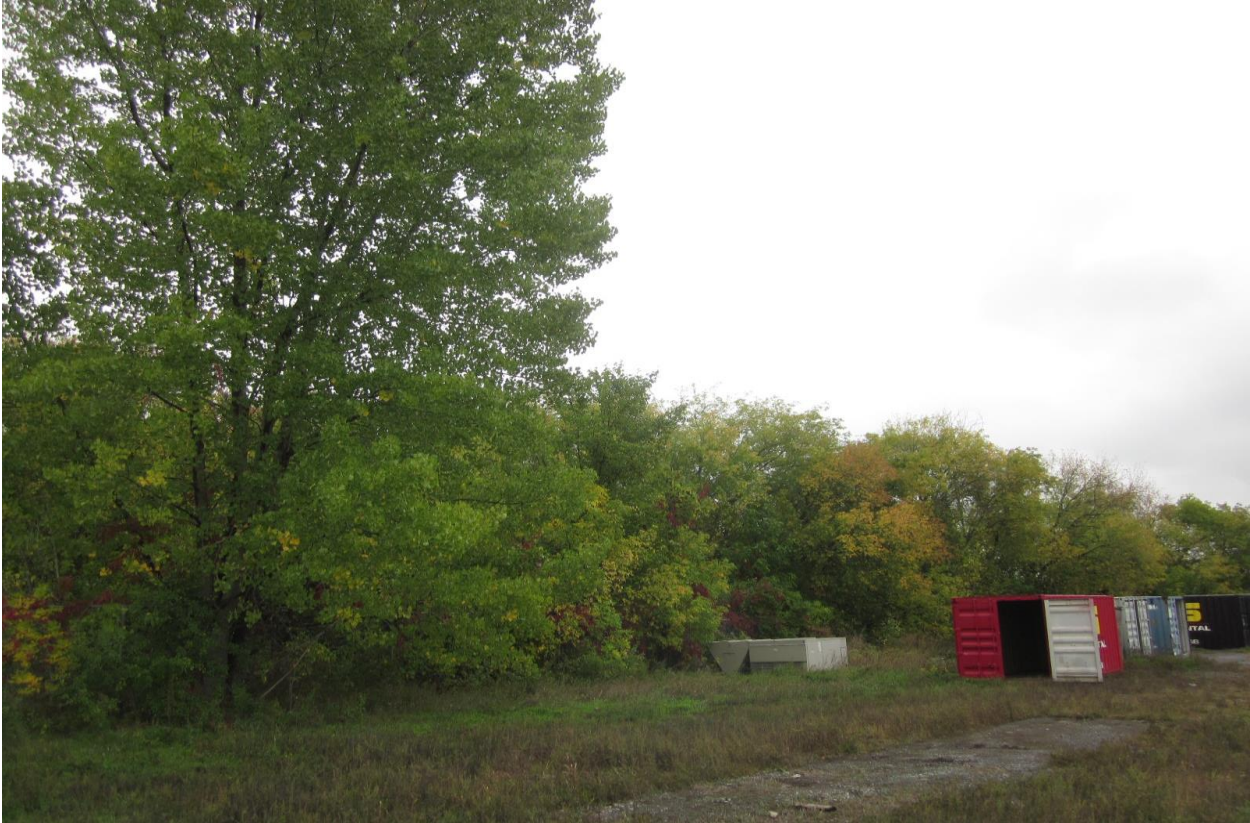
Tree grouping B: A group of Manitoba maples (*Acer negundo*) growing through the fence from the neighbouring property to the east. The largest tree is 19cm in diameter and in good condition. Being under the ownership of others these trees will be preserved and protected during construction (unless permission to remove is granted in writing by the adjacent landowner). However, the overhanging branches can be cut back to the property line.

Tree No.	Tree Species	Diameter (cm)	Tree Condition, Condition Notes and Age
1	Eastern cottonwood	27.5 avg.	Good; multi-stemmed (6) at grade; growing through chain link fence; mature
2	Eastern cottonwood	60	Good; basal wound; located on edge of hill, near train tracks; mature
3	Eastern cottonwood	30 avg.	Good; multi-stemmed (3) at grade; maturing
4	Crab apple (<i>Malus</i> spp.)	12.5 avg.	Good; multi-stemmed (7) at grade; maturing
5	Eastern cottonwood	55	Good; multiple leaders at 1m from grade; mature
6	Manitoba maple	27 avg.	Good; double leader at 0.2m from grade with inclusion ridge at union; maturing
7	Manitoba maple	21	Good condition; maturing
8	Balsam poplar	20	Fair; growing against building; maturing

Picture 2. Tree #1 (left) and grouping B at 1987 Robertson Road

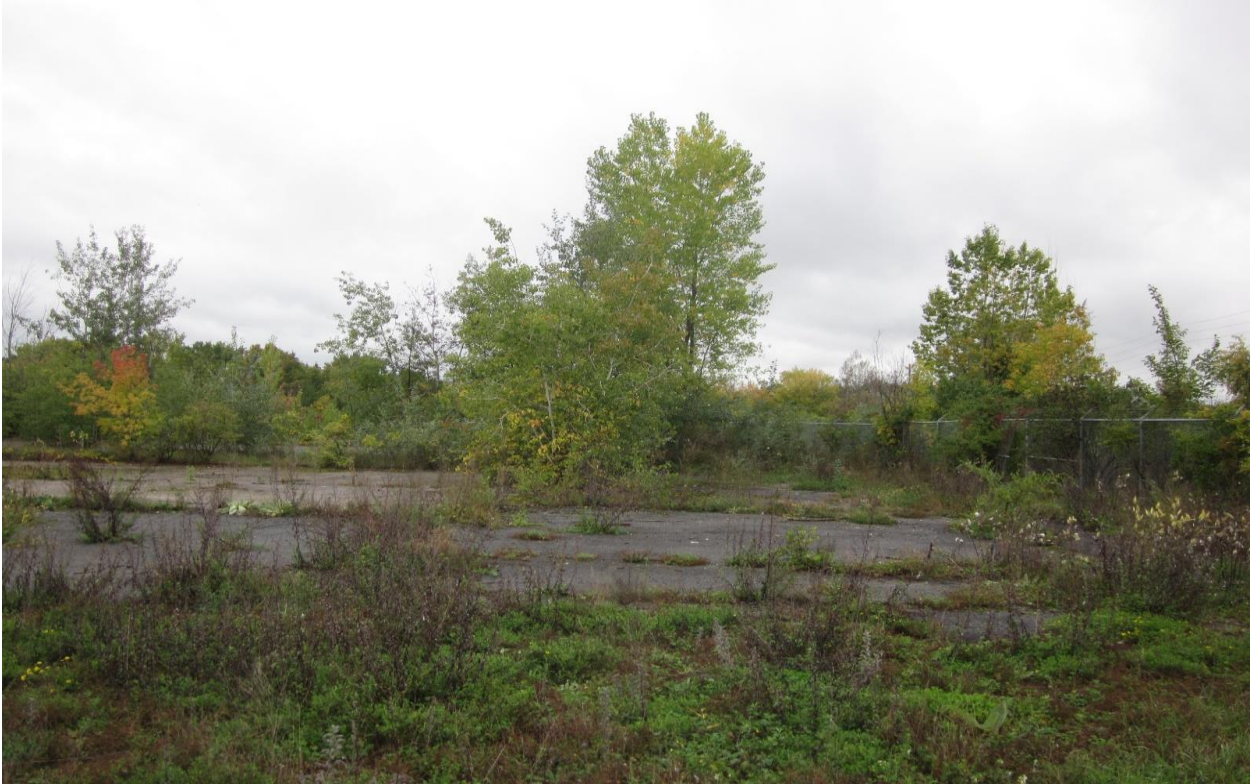
Tree stand #1: This stand is centered on a compacted area of stone, possibly a former parking lot. As with other areas on the property, all these trees arose from seed spread from elsewhere.

Tree Species	Average diameter (cm)	Percent occupancy
American elm	12	6
Ash species	12.5	2
Eastern cottonwood	15.1	28
Manitoba maple	12.1	28
Siberian elm (<i>Ulmus pumila</i>) ³	19.7	2
White poplar	16	2
Trembling aspen (<i>Populus tremuloides</i>)	15.1	32

Picture 3. Tree stand #1 at 1987 Robertson Road

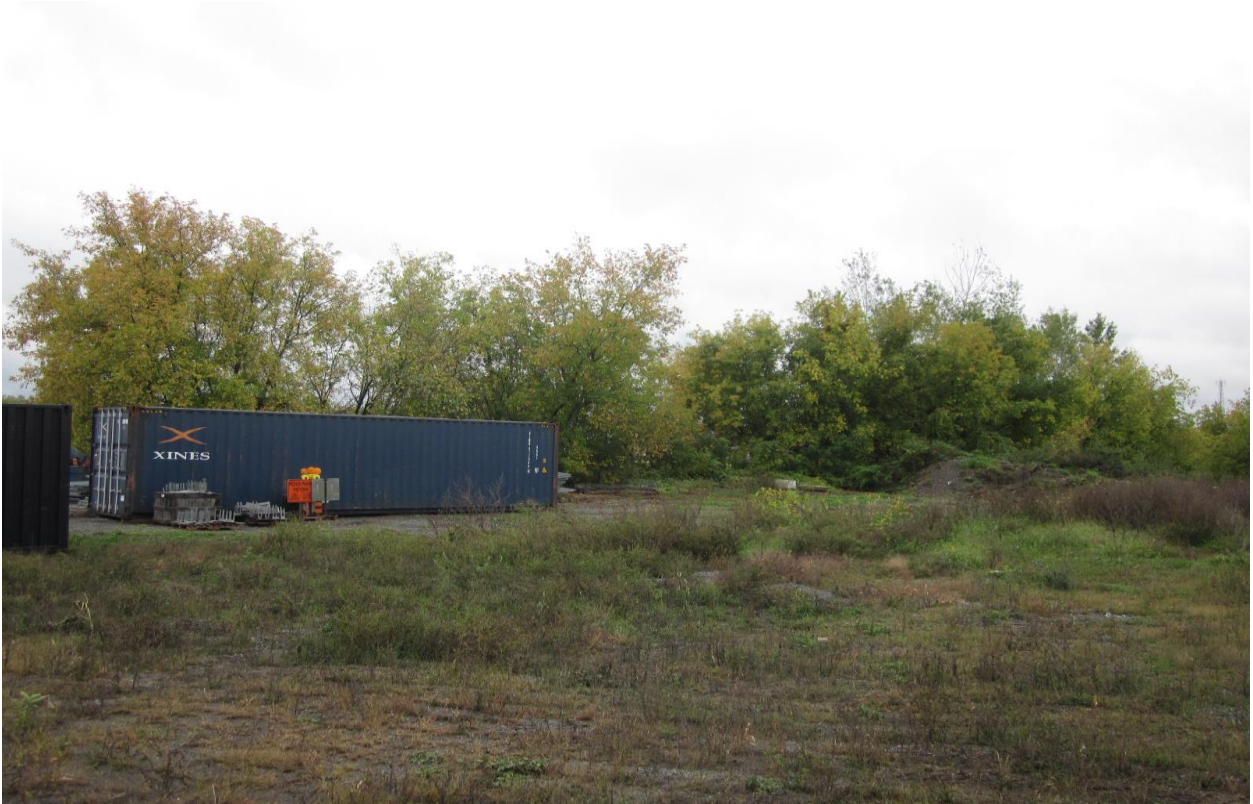
Tree stand #2: As with stand #1, this stand is centred on a heavily disturbed and compacted area.

Tree Species	Average diameter (cm)	Percent occupancy
Manitoba maple	16.3	43
White poplar	24.6	35
Trembling aspen	17.3	22

Picture 4. Tree stand #2 at 1987 Robertson Road

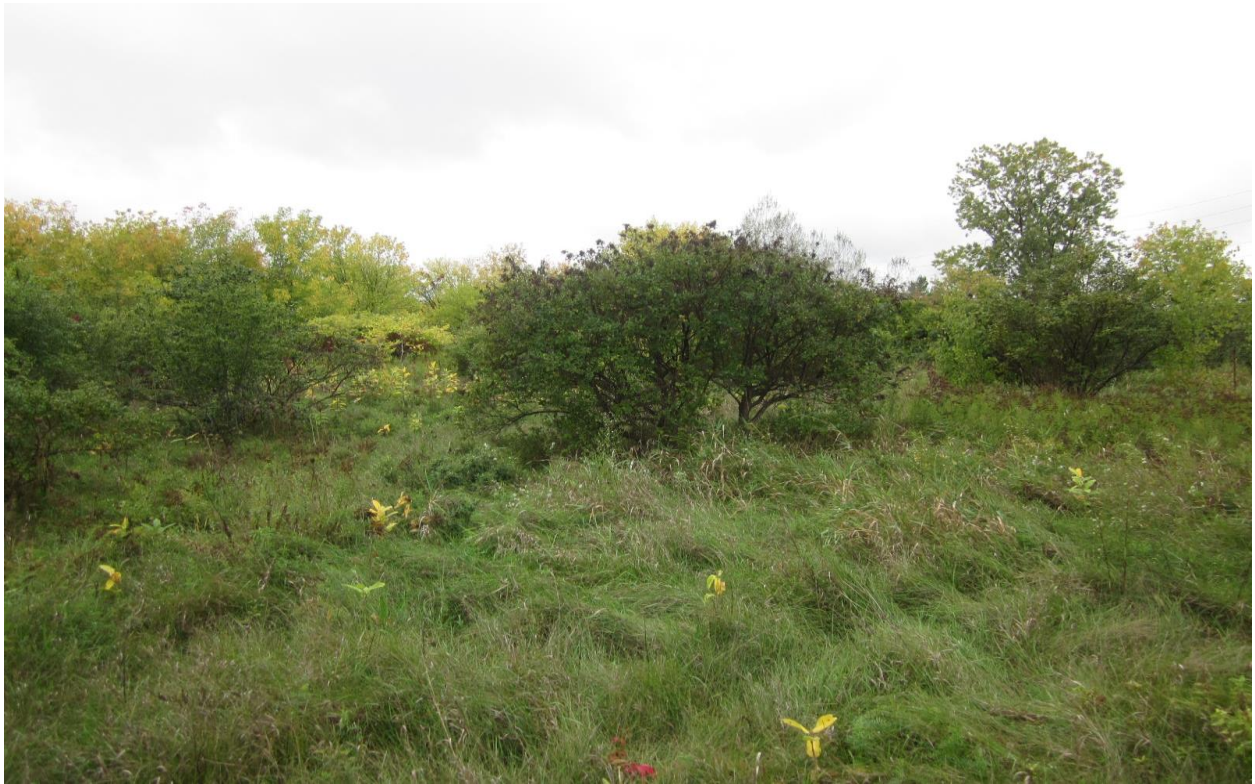
Tree grouping C: A series of sample plots were taken in this area to determine general tree composition – species, average diameters and percent occupancy by stem count:

Tree Species	Average diameter (cm)	Percent occupancy
American elm (<i>Ulmus americana</i>)	15.4	21
Ash species (<i>Fraxinus spp.</i>) ¹	15.2	13
Balsam poplar (<i>Populus balsamifera</i>)	14.6	18
Crab apple (<i>Malus spp.</i>)	17	2
Green ash (<i>Fraxinus pennsylvanica</i> var. <i>subintegerrima</i>) ¹	13	5
Manitoba maple (<i>Acer negundo</i>)	14.1	39
Willow species (<i>Salix spp.</i>)	19	2

¹ all ash on the property are either dead or heavily infested with emerald ash borer (*Agrilus planipennis*)

Picture 5. Tree grouping C at 1987 Robertson Road

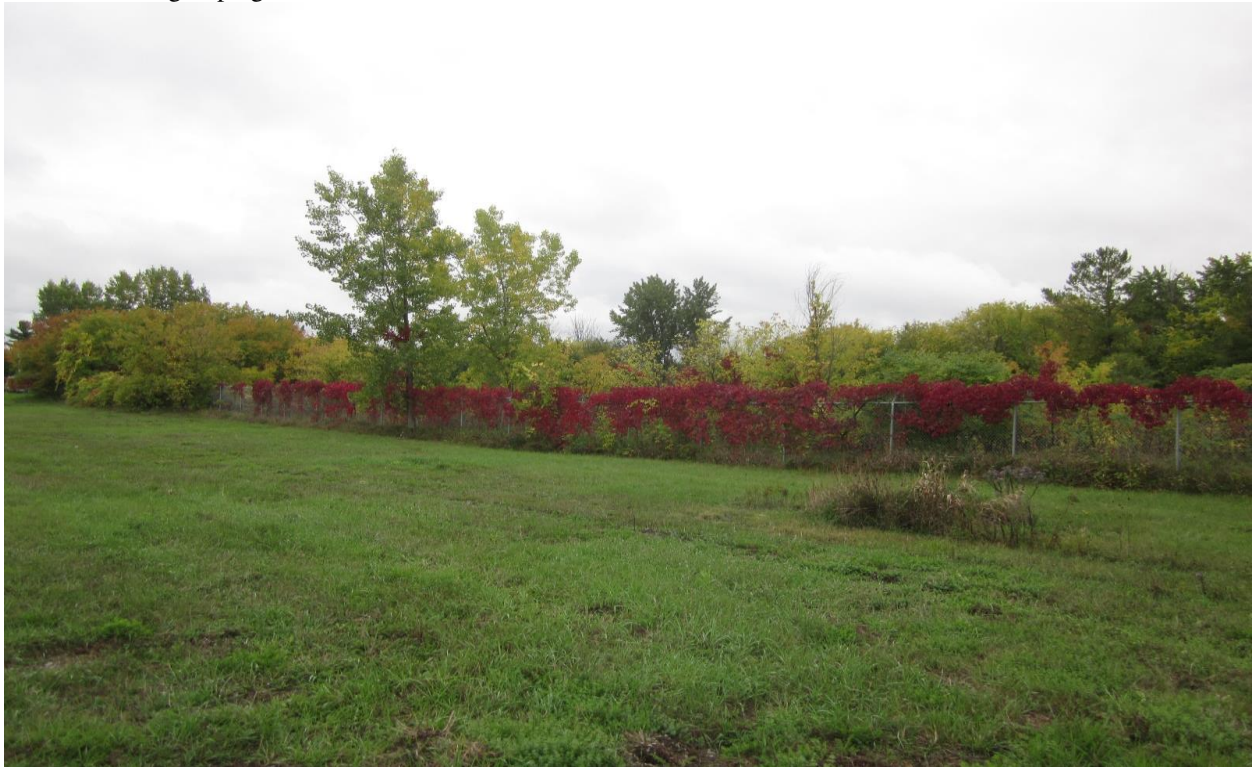
Tree grouping D: A series of sample plots were taken in this area to determine tree composition:

Tree Species	Average diameter (cm)	Percent occupancy
American elm	15	6
Eastern cottonwood (<i>Populus deltoides</i>)	27	6
Manitoba maple	15.8	82
Eastern redcedar (<i>Juniperus virginiana</i>)	6	6

Picture 6. Tree grouping D at 1987 Robertson Road

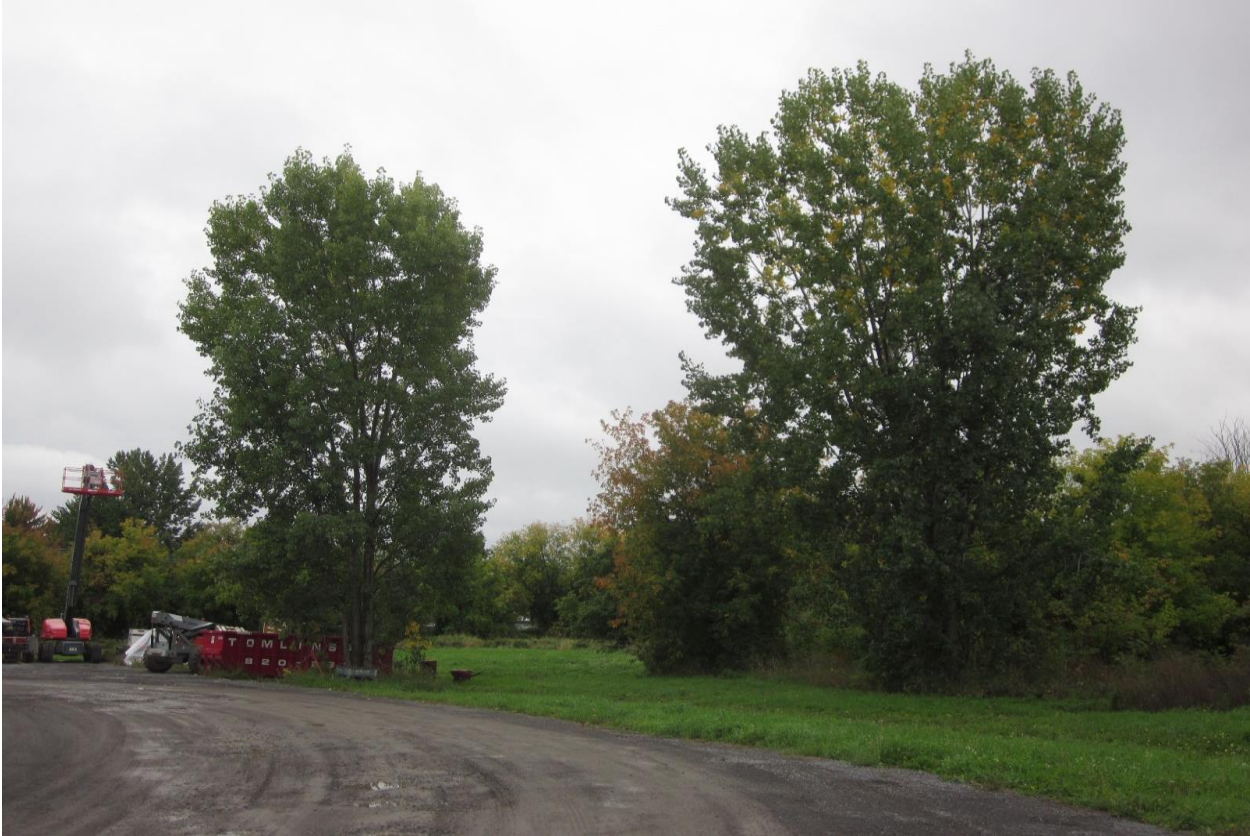
Picture 7. Trees #3 and 5 at 1987 Robertson Road

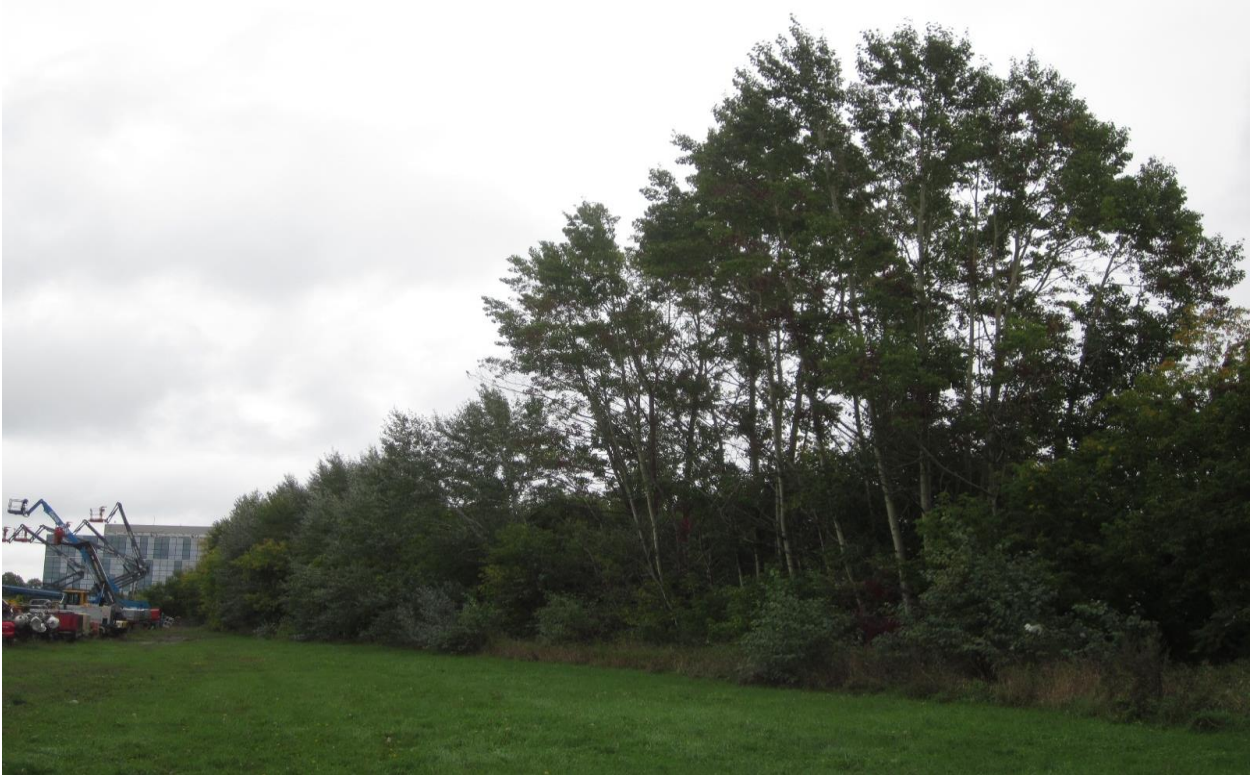
Tree grouping E: A series of sample plots were taken in this area to determine tree composition:

Tree Species	Average diameter (cm)	Percent occupancy
American elm	16	1
Manitoba maple	14	57
White poplar (<i>Populus alba</i>) ²	17.1	42

² white poplar is an introduced and invasive species in Ontario

Picture 8. Tree grouping E at 1987 Robertson Road
