**Stillwater Station Functional
Site Servicing and Stormwater
Management Report**

Job #160401686

Prepared for:
The Properties Group
Management Ltd.

Prepared by:
Stantec Consulting Ltd.
1331 Clyde Avenue
Ottawa, Ontario
K2C 3G4

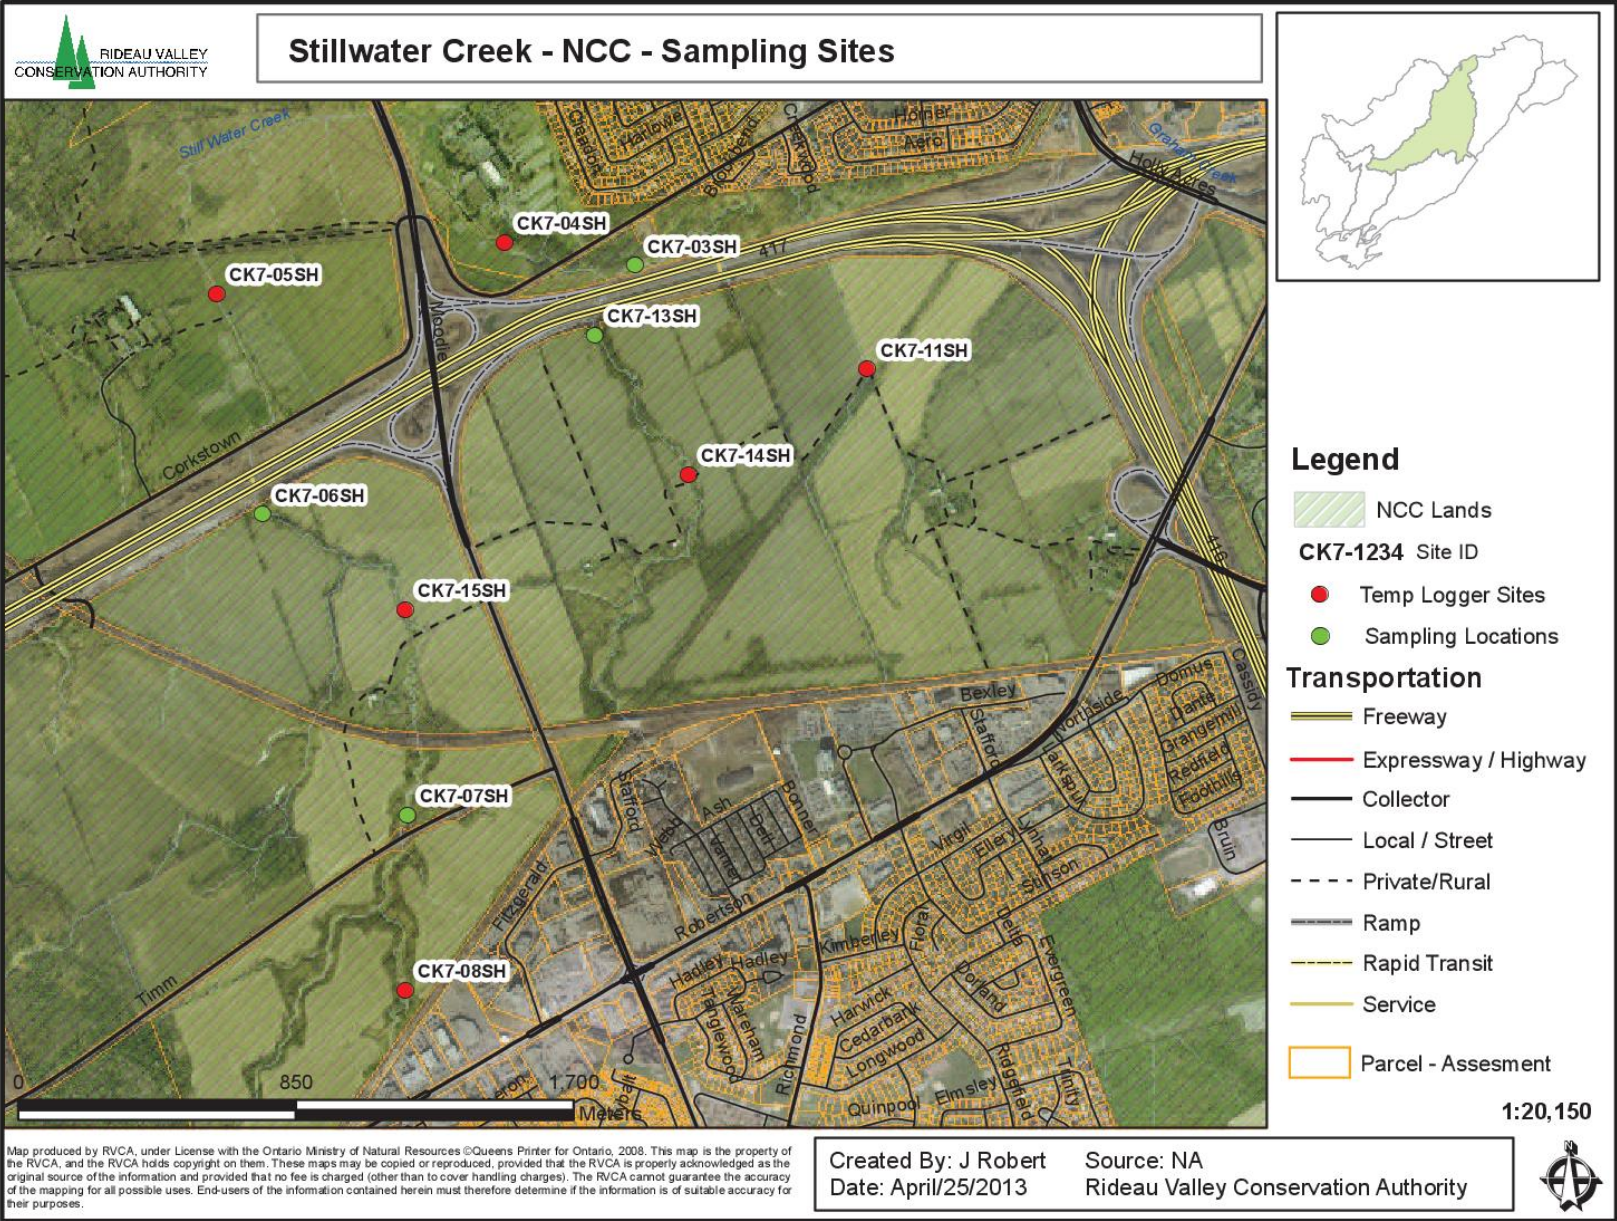
Figure 1. Stillwater Creek OSAP sampling and thermal classification sites.

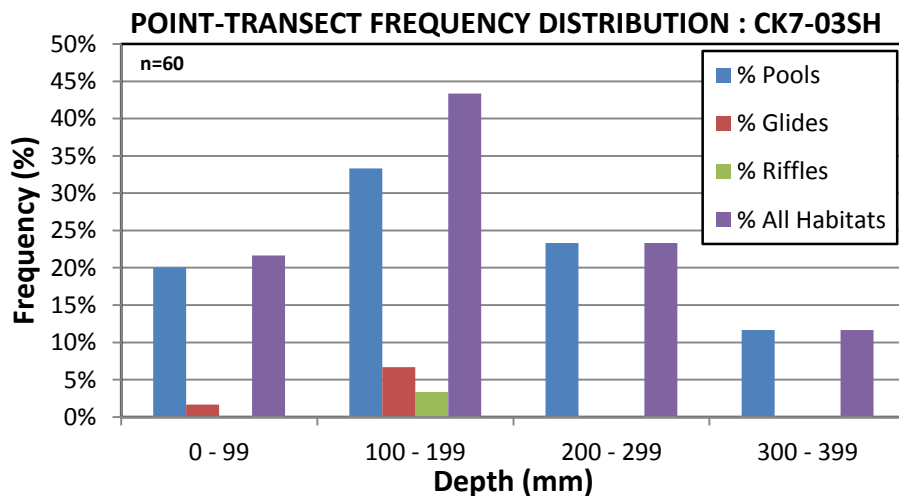
The results of the habitat assessment for site CK7-03SH are summarized in Figure 6. The analysis revealed a total habitat area of approximately 170.3m², consisting of 89% pool habitat, 8% glides and 3% riffles. Embedded cover was observed over approximately 30% of the site, and consisted primarily of rocks and macrophytes. Unembedded cover included rocks, macrophytes and wood, and was observed over approximately 70% of the site (Appendix IV).

Figure 6. Frequency distribution of habitat types/stream velocities at 100mm intervals for site CK7-03SH

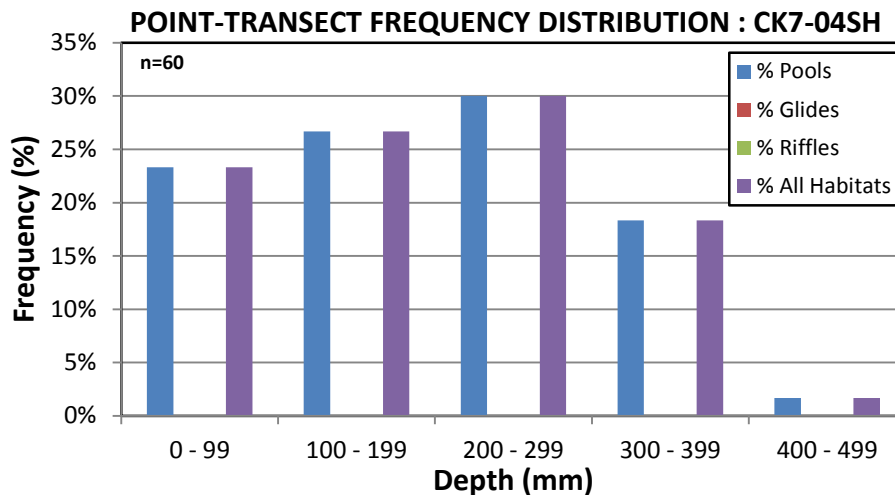
The results of the habitat assessment for site CK7-04SH are summarized in Figure 7. The analysis revealed a total habitat area of approximately 298.6m², consisting of 100% pool habitat. Embedded cover was observed over approximately 13% of the site, and consisted primarily of rocks, wood and macrophytes. Unembedded cover included rocks and wood, with the majority being macrophytes (66%); and was observed over approximately 86% of the site (Appendix IV).

Figure 7. Frequency distribution of habitat types/stream velocities at 100mm intervals for site CK7-04SH

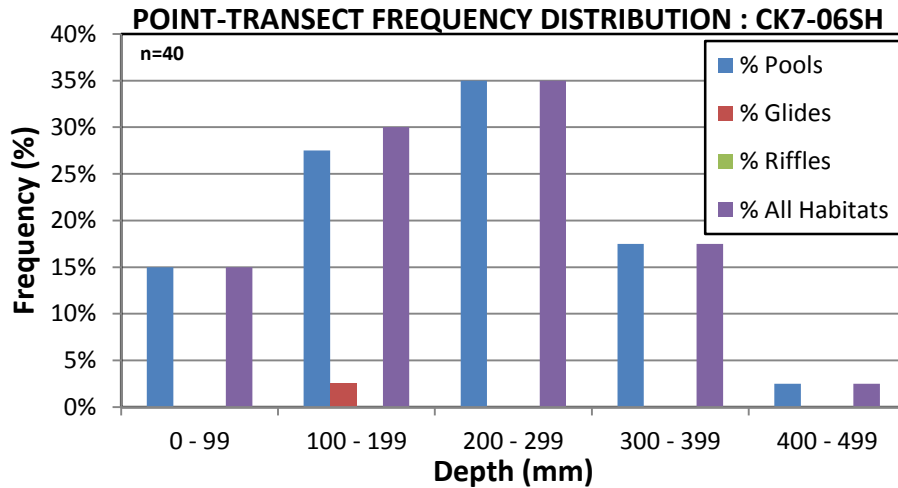
The results of the habitat assessment for site CK7-06SH are summarized in Figure 9. The analysis revealed a total habitat area of approximately 56.9m², consisting of 97% pool habitat, and 3% glides. Embedded cover was observed over approximately 5% of the site, and consisted solely of macrophytes. Unembedded cover included primarily macrophytes and wood, and was observed over approximately 68% of the site (Appendix IV).

Figure 9. Frequency distribution of habitat types/stream velocities at 100mm intervals for site CK7-06SH

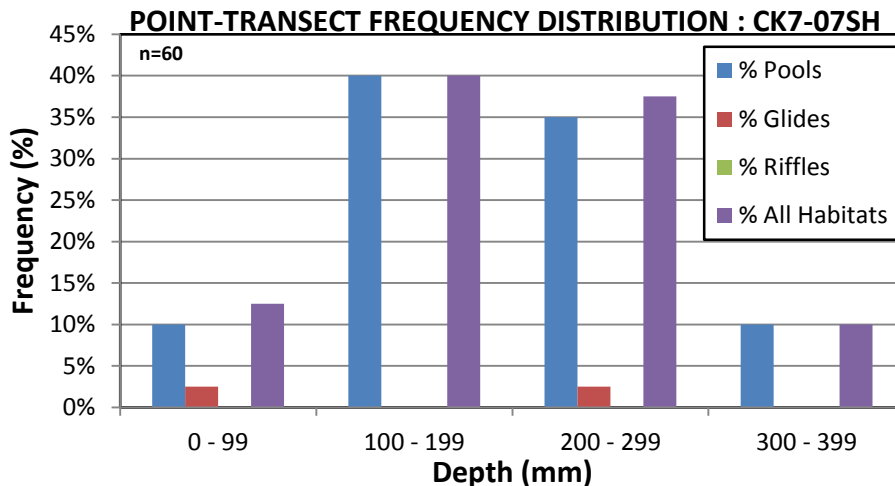
The results of the habitat assessment for site CK7-07SH are summarized in Figure 10.

Figure 10. Frequency distribution of habitat types/stream velocities at 100mm intervals for site CK7-07SH

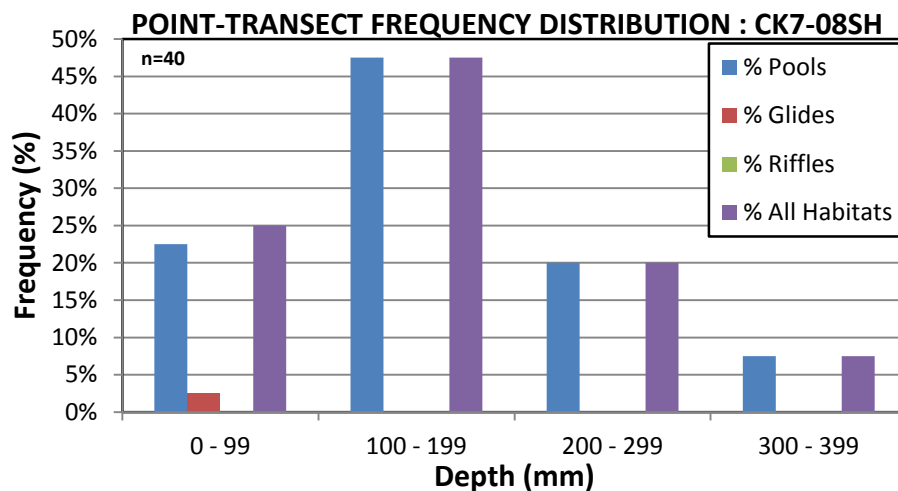
The results of the habitat assessment for site CK7-08SH are summarized in Figure 11. The analysis revealed a total habitat area of approximately 48.2m², consisting of 97% pool habitat, and 3% glides. Embedded cover was observed over approximately 15% of the site, and consisted primarily of rocks and macrophytes. Unembedded cover included rock, macrophytes and wood, and was observed over approximately 10% of the site (Appendix IV).

Figure 11. Frequency distribution of habitat types/stream velocities at 100mm intervals for site CK7-08SH

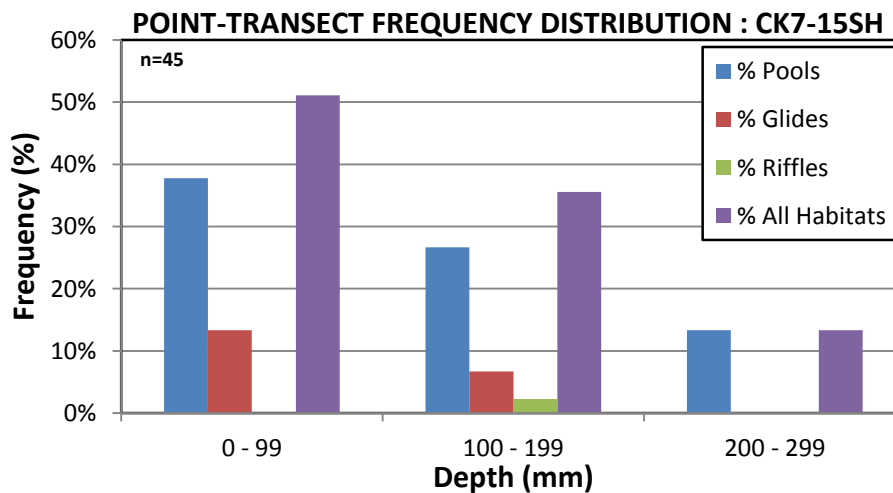
The results of the habitat assessment for site CK7-15SH are summarized in Figure 15. The analysis revealed a total habitat area of approximately 84.3m², consisting of 78% pool habitat, 20% glides and 2% riffles. Embedded cover was observed over approximately 9% of the site, and consisted solely of rock materials.

Figure 15. Frequency distribution of habitat types/stream velocities at 100mm intervals for site CK7-15SH

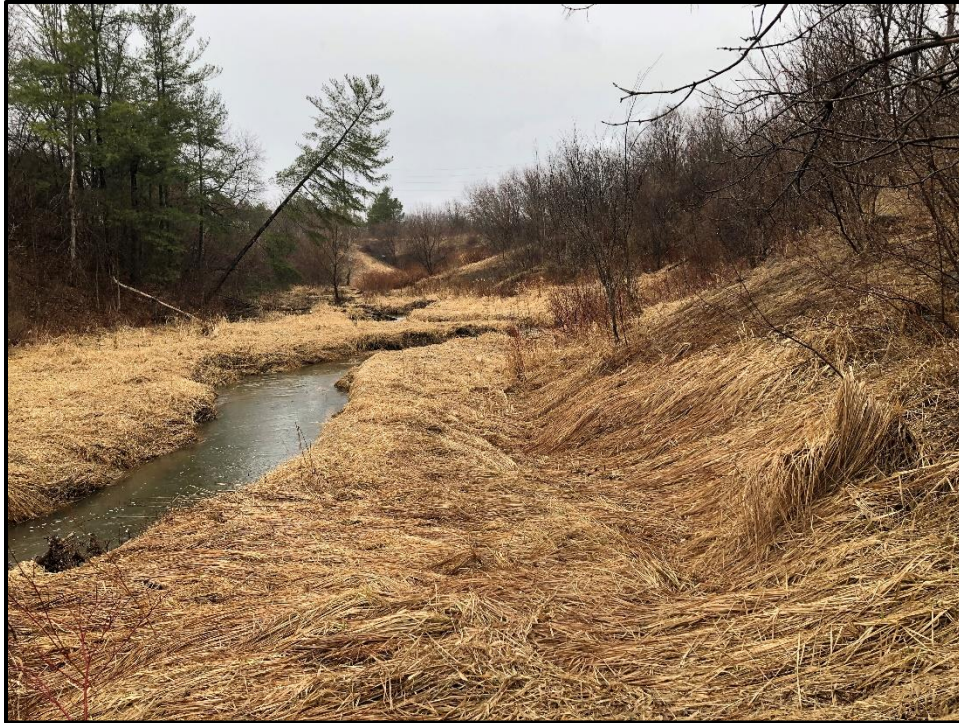
Photo 2: Photograph of Stillwater Creek and toe of slope taken at the west portion of the site towards the north illustrating grass covered side slopes, minor toe erosion was observed.
