Phase I - Environmental Site Assessment

1452-1470 Hunt Club Road &
1525-1545 Sieveright Avenue
Ottawa, Ontario

DCR Phoenix Group

Report: PE5015-1

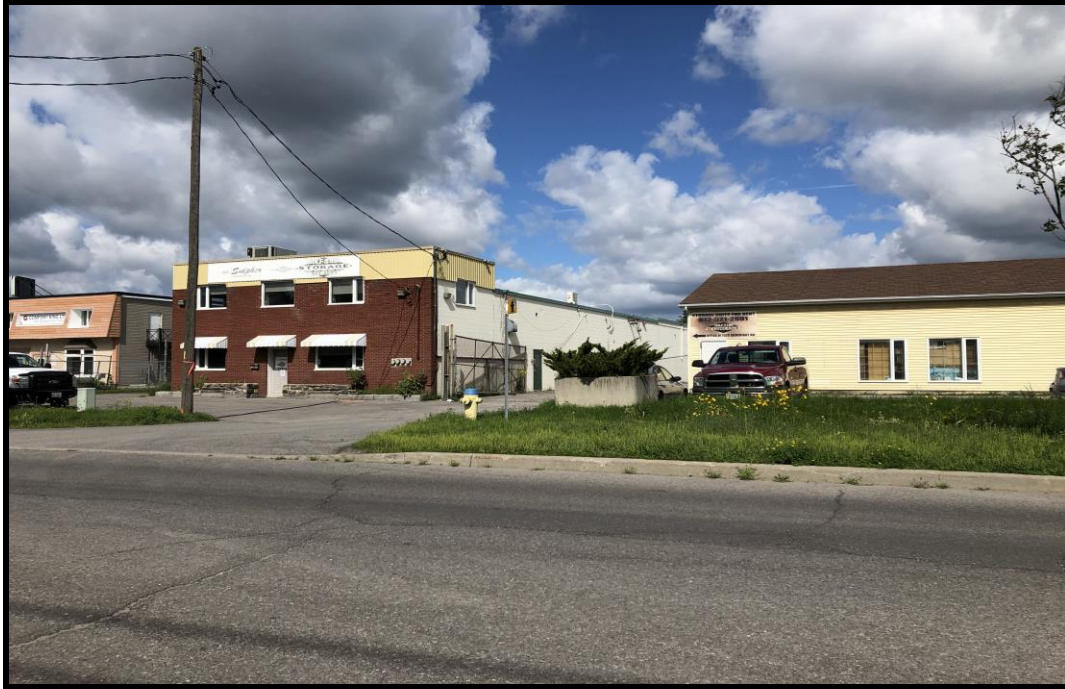
Photograph 1: View of the southern portion of the subject site, facing north from Sieveright Avenue.

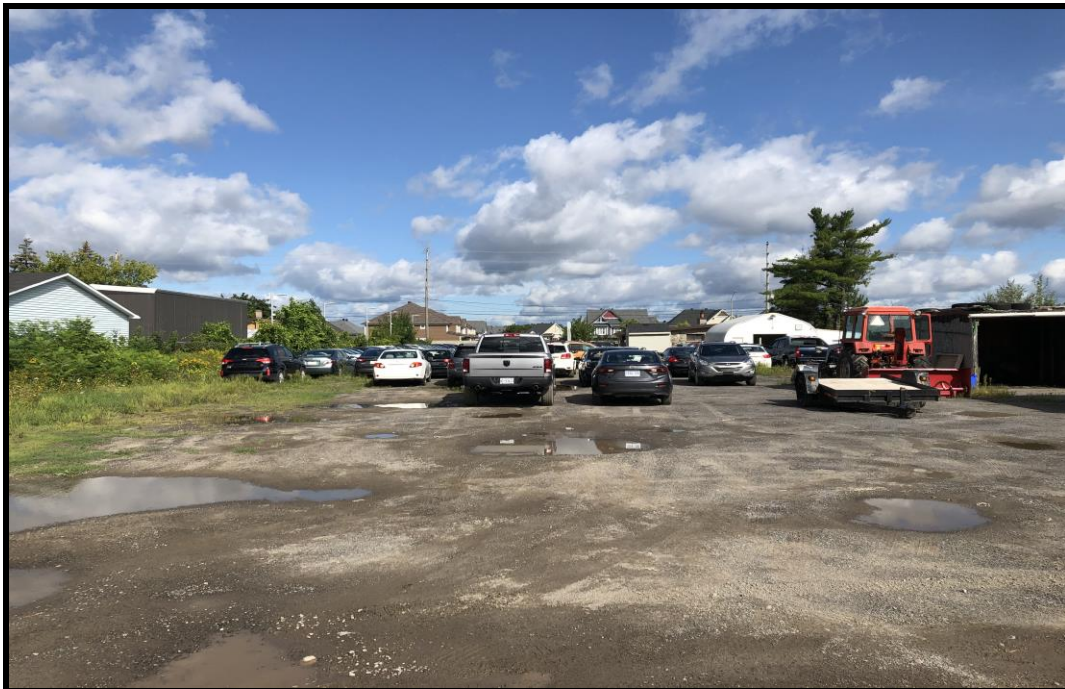
Photograph 2: View of the northern portion of the subject site, facing north from the central yard of 1470 Hunt Club Road.

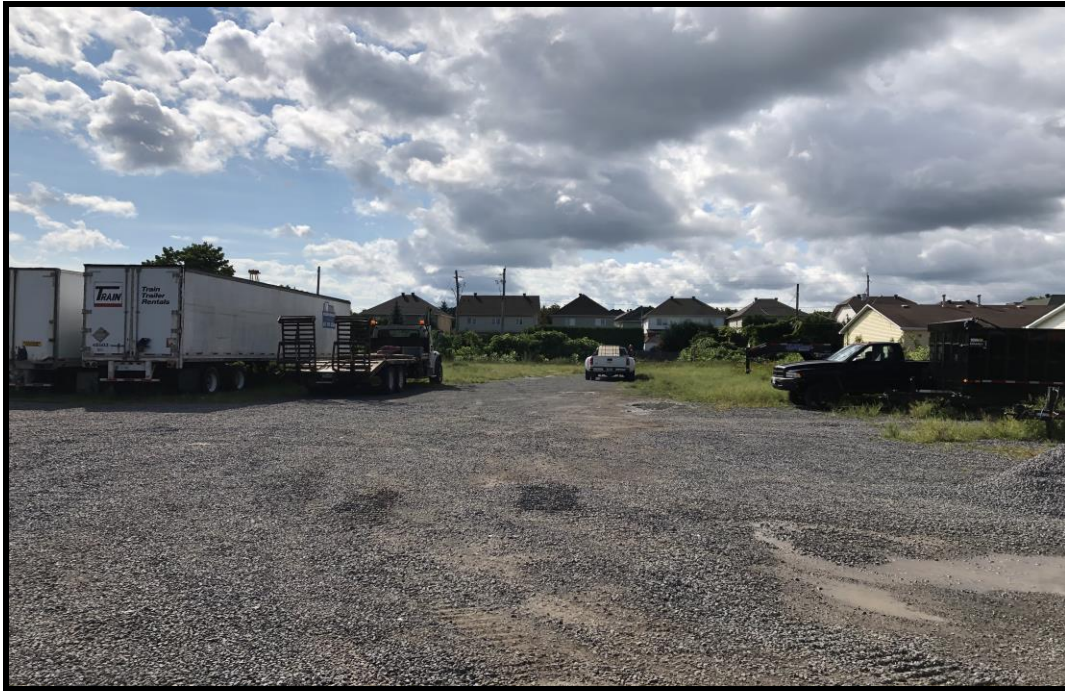
Photograph 3: View of the southern portion of the subject site, facing south from the central yard of 1470 Hunt Club Road.

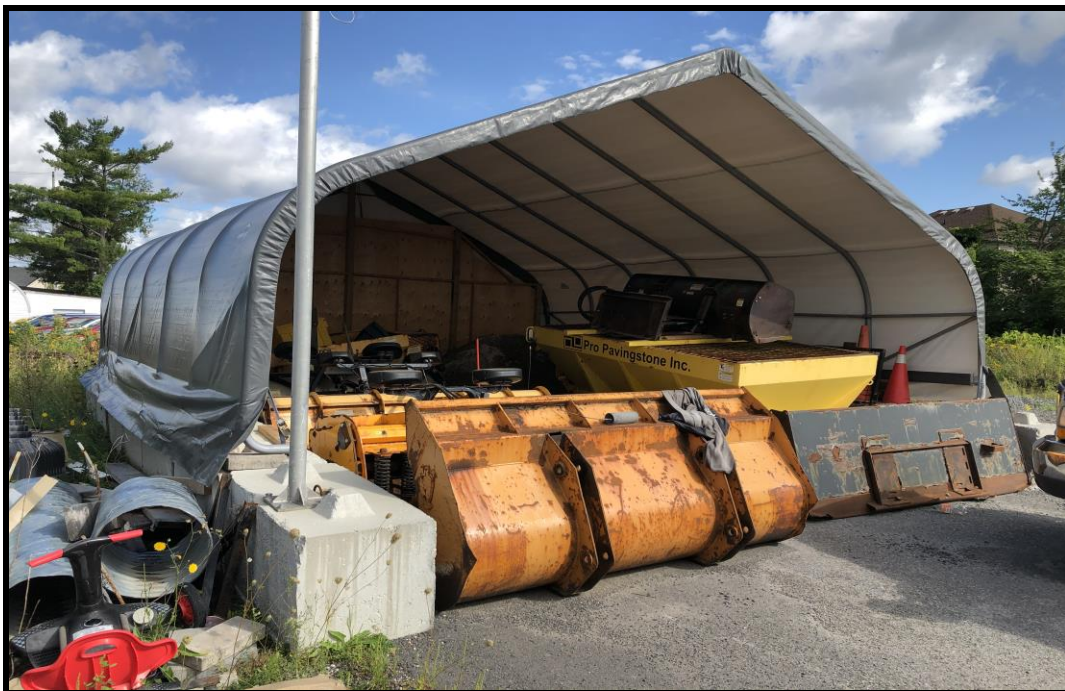
A small temporary storage tent, used for storing road salt and related equipment, was observed in the rear storage yard of the property addressed 1470 Hunt Club Road. A pile of salt was observed to be stored on the gravel ground surface within the storage tent. The use of this storage tent for the storage of road salt is considered to result in an area of potential environmental concern with respect to the subject site.

Photograph 4: View of a road salt storage tent, located within the central yard of 1470 Hunt Club Road.

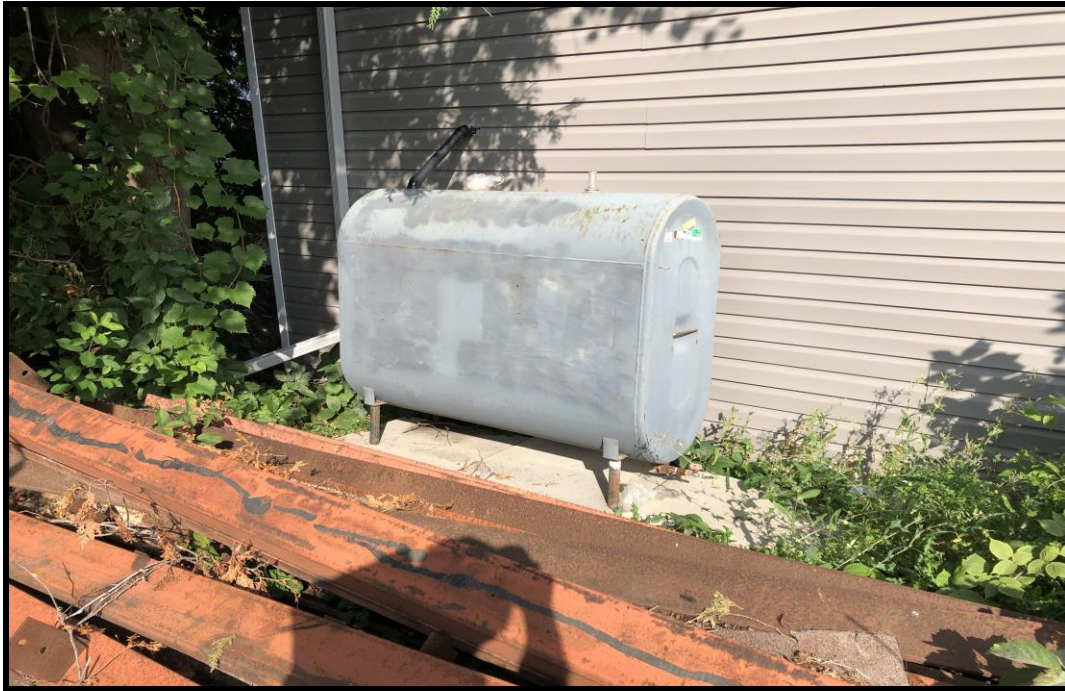
One (1) aboveground fuel oil storage tank was observed at the rear of the auto service garage at the property addressed 1452 Hunt Club Road. The tank was noted to contain a capacity of 900-1,000 L of fuel oil and was situated on a concrete pad base. The tank was observed to be in good condition, with no signs of leaks or stains observed at the time of the site inspection. The presence of this AST is considered to represent an area of potential environmental concern with respect to the subject site.

Photograph 5: View of a fuel oil AST, located at the rear of the auto service garage at 1452 Hunt Club Road.

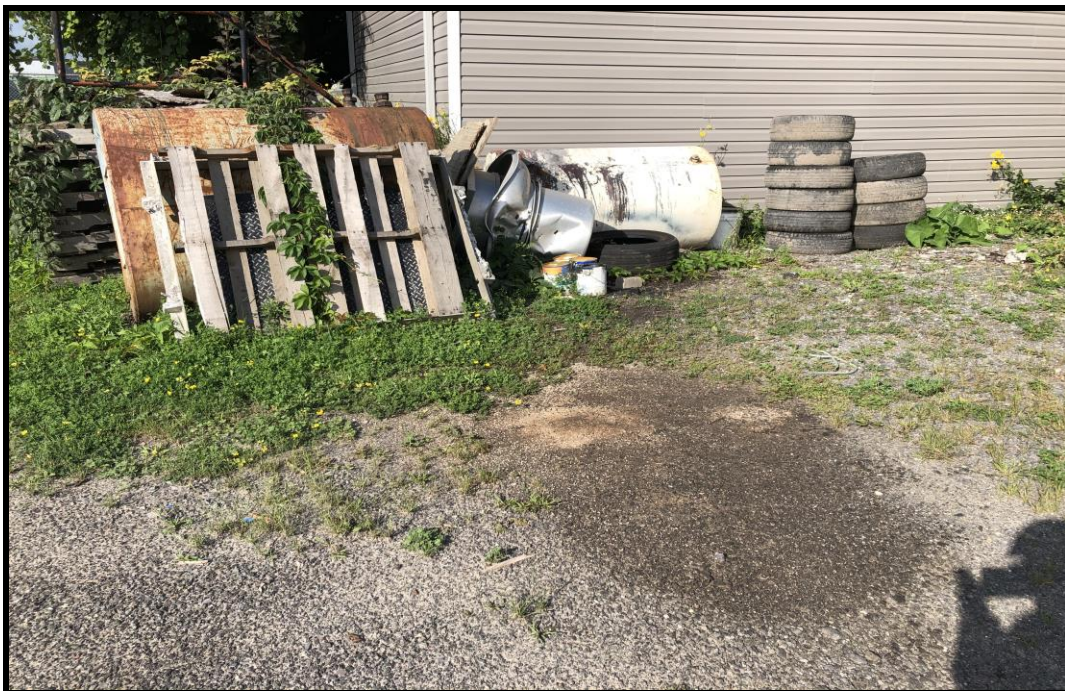
A small patch of dark surficial staining was observed in the vicinity of an empty decommissioned aboveground fuel storage tank, located at the rear of 1460 Hunt Club Road, adjacent to a storage warehouse building. This surficial staining is considered to represent an area of potential environmental concern with respect to the subject site.

Photograph 6: View of an area of surficial staining, located at the rear of 1460 Hunt Club Road.

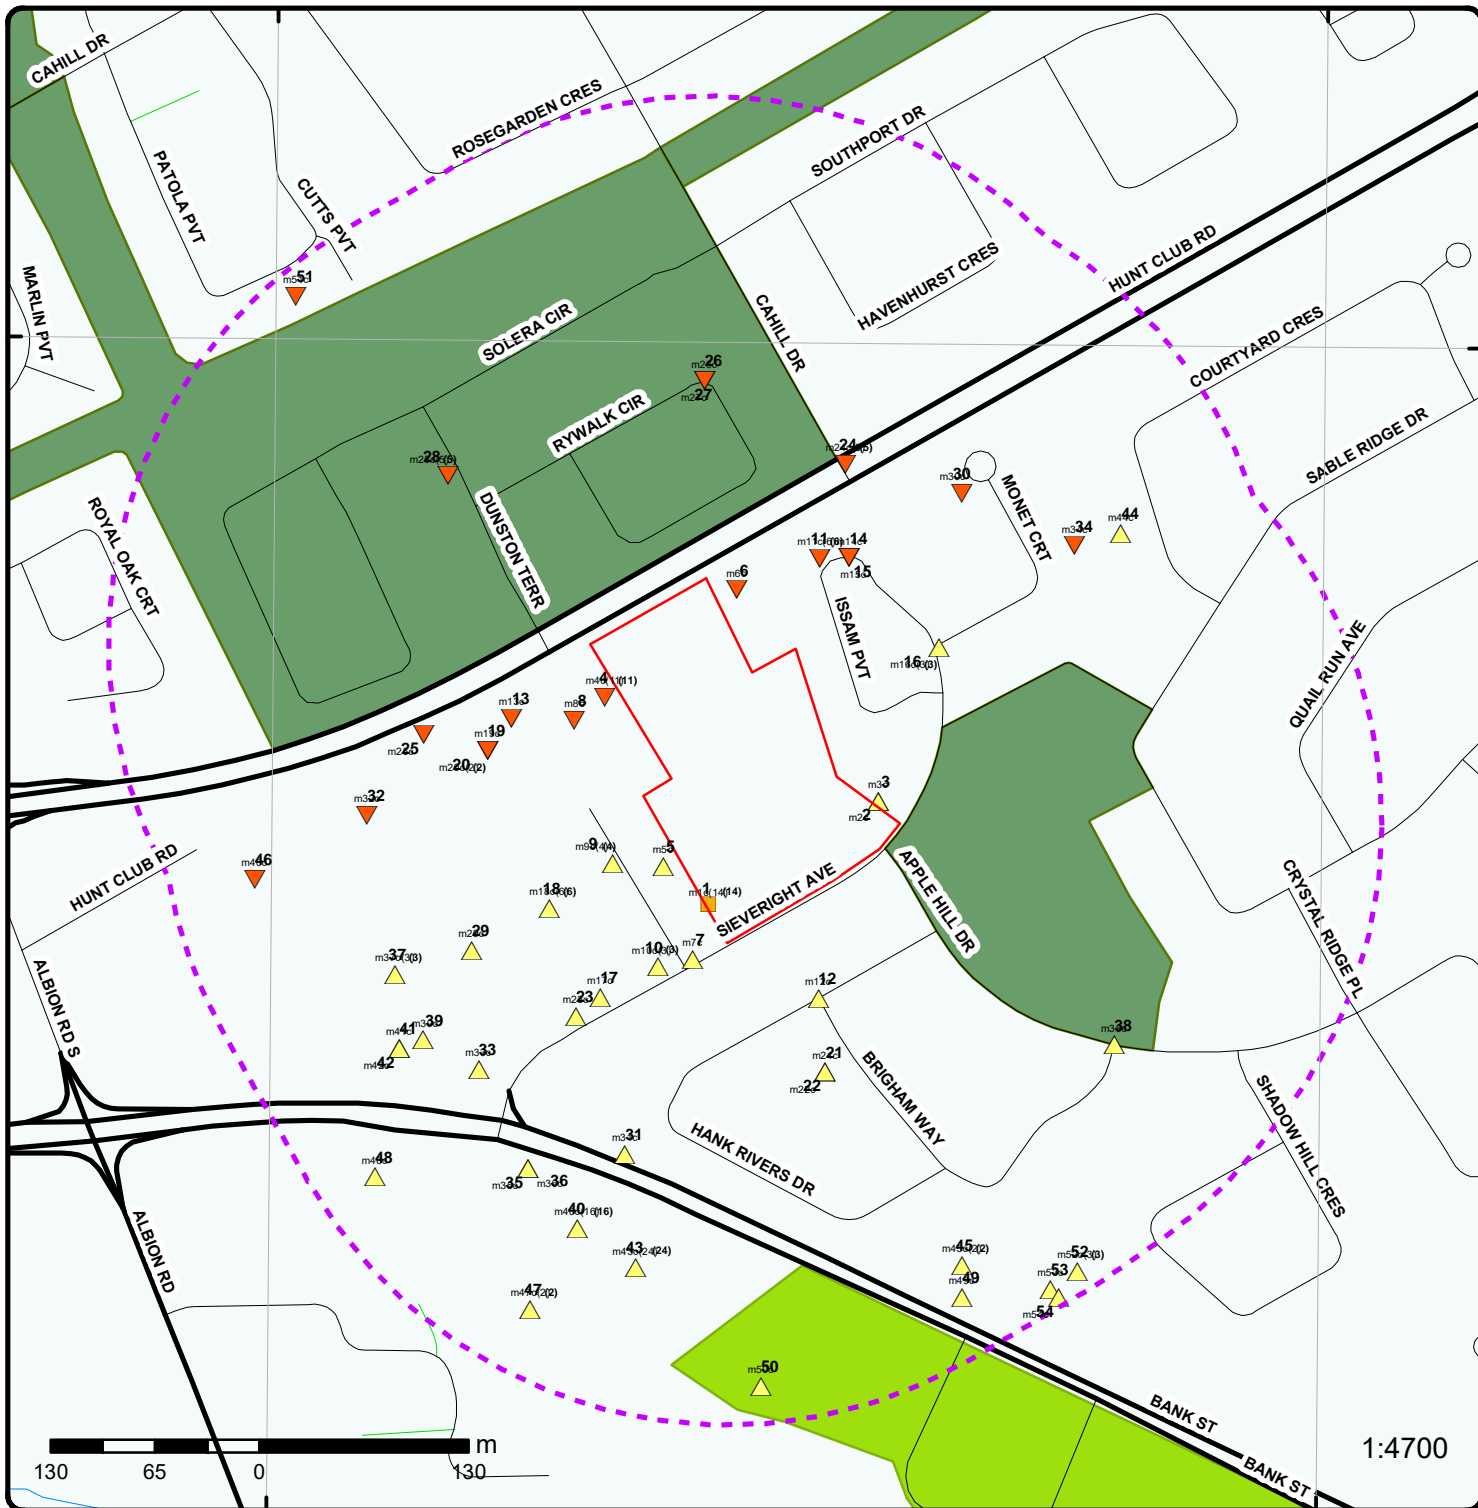
Map : 0.3 Kilometer Radius

<u>Site</u>	<u>Address</u>	<u>Distance (m)</u>	<u>Map Key</u>
	<i>Well ID:</i> 1508333		
	lot 6 con 4 ON	32.9	<u>8</u>
	<i>Well ID:</i> 1513721		
	ON	65.7	<u>13</u>
	<i>Well ID:</i> 1508323		
	ON	65.7	<u>14</u>
	<i>Well ID:</i> 1508334		
	ON	88.9	<u>20</u>
	<i>Well ID:</i> 1508318		
	ON	88.9	<u>20</u>
	<i>Well ID:</i> 1508325		
	lot 6 con 4 ON	100.1	<u>22</u>
	<i>Well ID:</i> 1501846		
	lot 6 con 4 ON	104.1	<u>23</u>
	<i>Well ID:</i> 1501853		
	ON	122.6	<u>26</u>
	<i>Well ID:</i> 1508331		
	lot 6 con 4 ON	140.3	<u>29</u>
	<i>Well ID:</i> 1513849		
	ON	141.5	<u>30</u>
	<i>Well ID:</i> 1508319		
	OTTAWA ON	145.9	<u>31</u>
	<i>Well ID:</i> 7292894

<u>Site</u>	<u>Address</u>	<u>Distance (m)</u>	<u>Map Key</u>
	ON <i>Well ID:</i> 1508329	172.2	<u>32</u>
	lot 6 con 4 ON <i>Well ID:</i> 1501848	187.2	<u>36</u>
	lot 6 con 4 ON <i>Well ID:</i> 1501852	194.1	<u>39</u>
	lot 6 con 4 ON <i>Well ID:</i> 1501847	209.6	<u>42</u>
	lot 7 con 4 ON <i>Well ID:</i> 1501864	246.7	<u>45</u>
	ON <i>Well ID:</i> 1508321	247.3	<u>46</u>
	lot 6 con 4 ON <i>Well ID:</i> 1501849	262.8	<u>48</u>
	lot 7 con 4 ON <i>Well ID:</i> 1513272	263.9	<u>49</u>
	lot 7 con 4 ON <i>Well ID:</i> 1501890	276.1	<u>50</u>
	lot 7 con 4 ON <i>Well ID:</i> 1501855	287.5	<u>53</u>
	lot 7 con 4 ON <i>Well ID:</i> 1513269	294.4	<u>54</u>
