Phase One Environmental Site Assessment 90 Woodridge Crescent, Ottawa, Ontario

Phase One Environmental Site Assessment

OTT-00201554-G0

2022-02-25

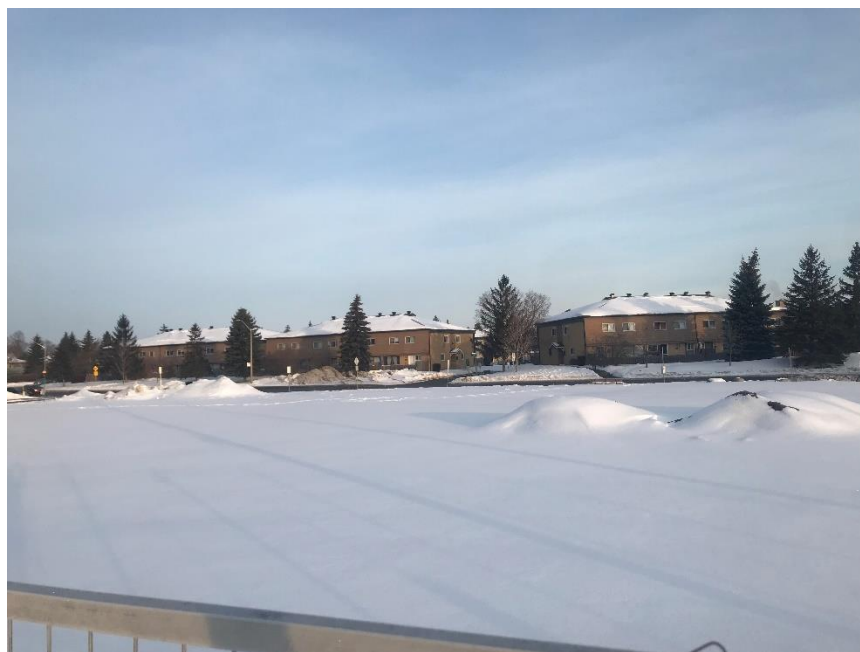
Photograph No. 6

North part of the Phase One property which remains vacant.
