Phase Two Environmental Site Assessment

265 Catherine Street
Ottawa, Ontario

Prepared for:
11034936 Canada Inc.

LOP21-018B

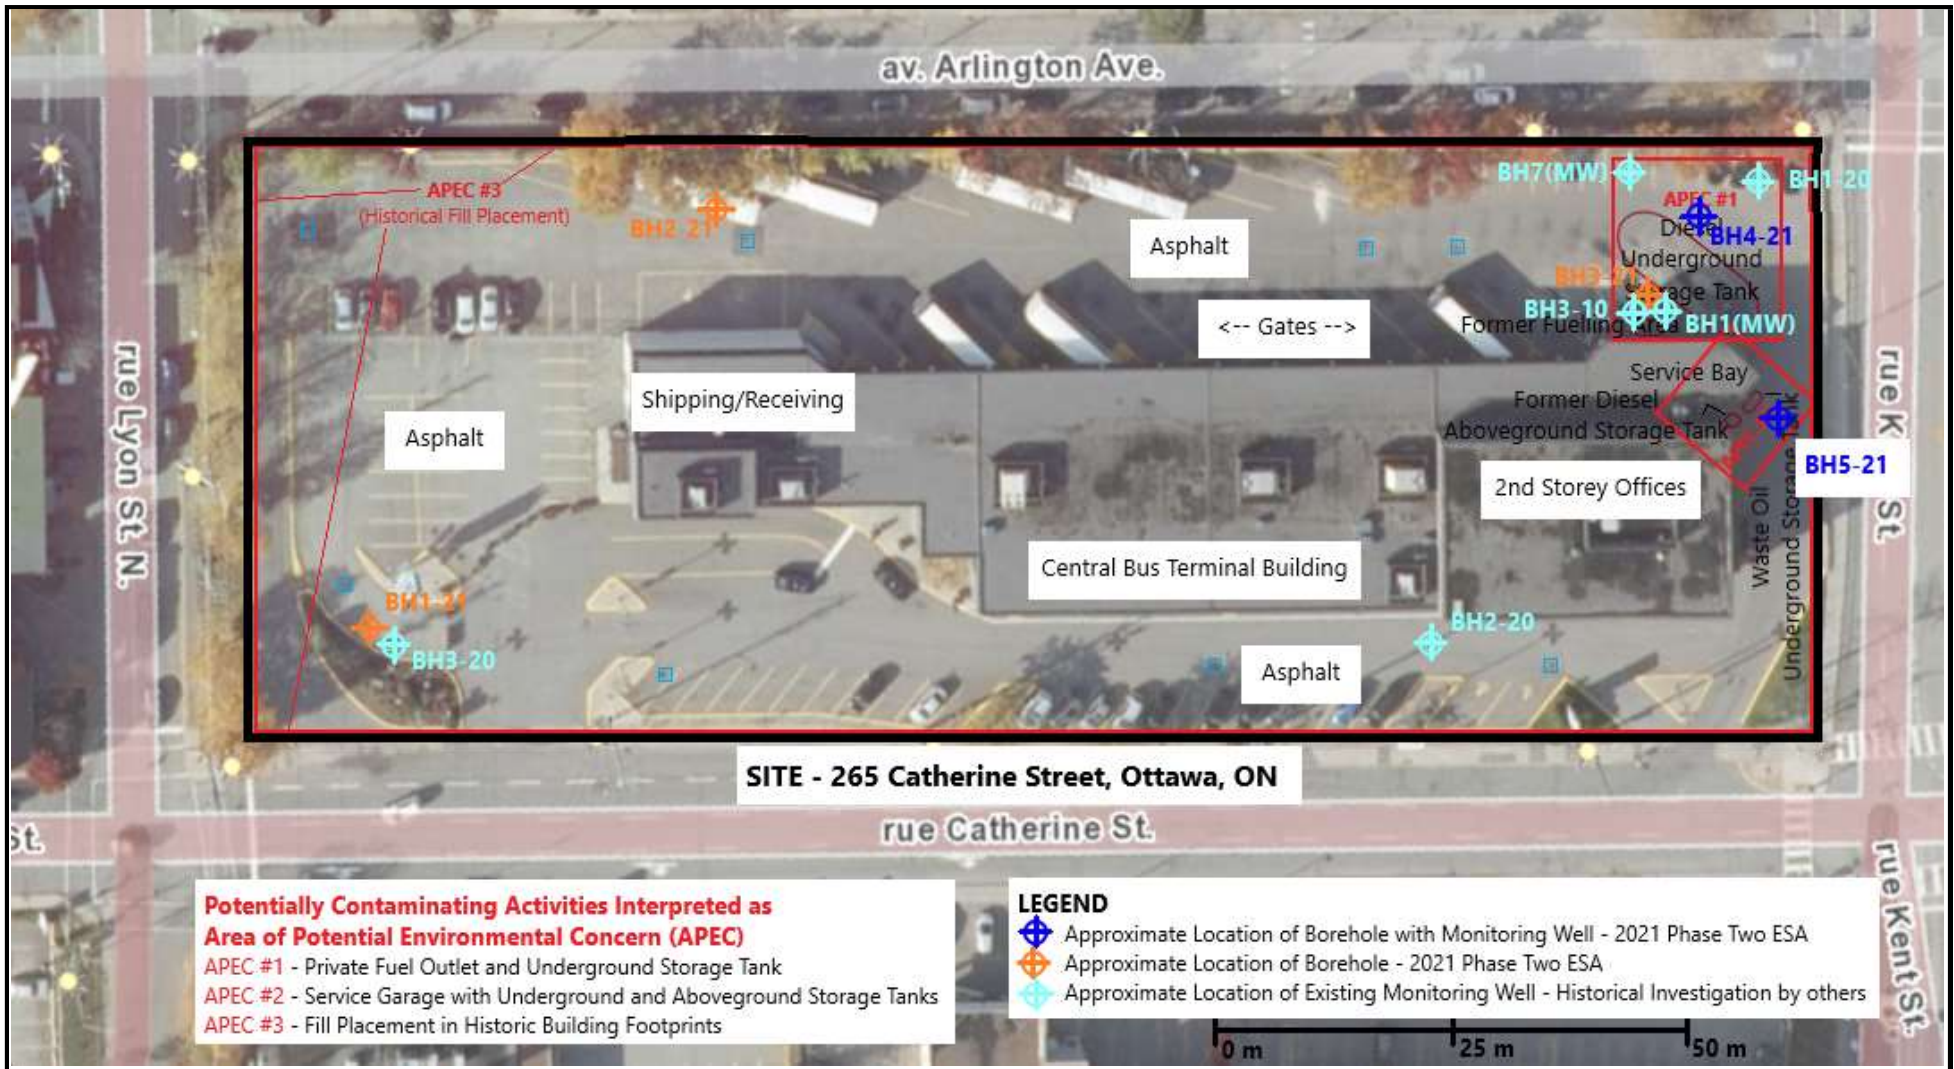
Figure 2: Site Plan
 Phase Two Environmental Site Assessment
 265 Catherine Street, Ottawa, Ontario
 11034936 Canada Inc.

On June 18, 2021, a total of five boreholes (BH1-21 through BH5-21) were drilled at the Phase Two Property. The boreholes were drilled using a truck mounted CME 55 drill rig operated by George Downing Estate Drilling. Soil samples were collected using stainless steel split spoons. Soil samples recovered during the sampling program were screened in the field for volatile vapour concentrations, as well as visual and olfactory observations.

- BH4-21 was drilled in the northeast portion of the Phase Two Property. This borehole was placed in a location to assess potential soil and groundwater contamination from the diesel underground storage tank (APEC #1). This borehole was instrumented with a groundwater monitoring well, with its screen installed within soil which was observed to be wet during the drilling/soil sample collection in an attempt to straddle the shallow groundwater table.

- BH5-21 was drilled in the east portion of the Phase Two Property, near the suspected location of a waste oil underground storage tank. This borehole was placed in a location to assess potential soil and groundwater contamination from the associated on-Site service garage (APEC #2). This borehole was instrumented with a groundwater monitoring well, with its screen installed within soil which was observed to be wet during the drilling/soil sample collection in an attempt to straddle the shallow groundwater table.
