Phase One Environmental Site Assessment

265 Catherine Street
Ottawa, Ontario

Prepared for:
11034936 Canada Inc.

LOP21-018A

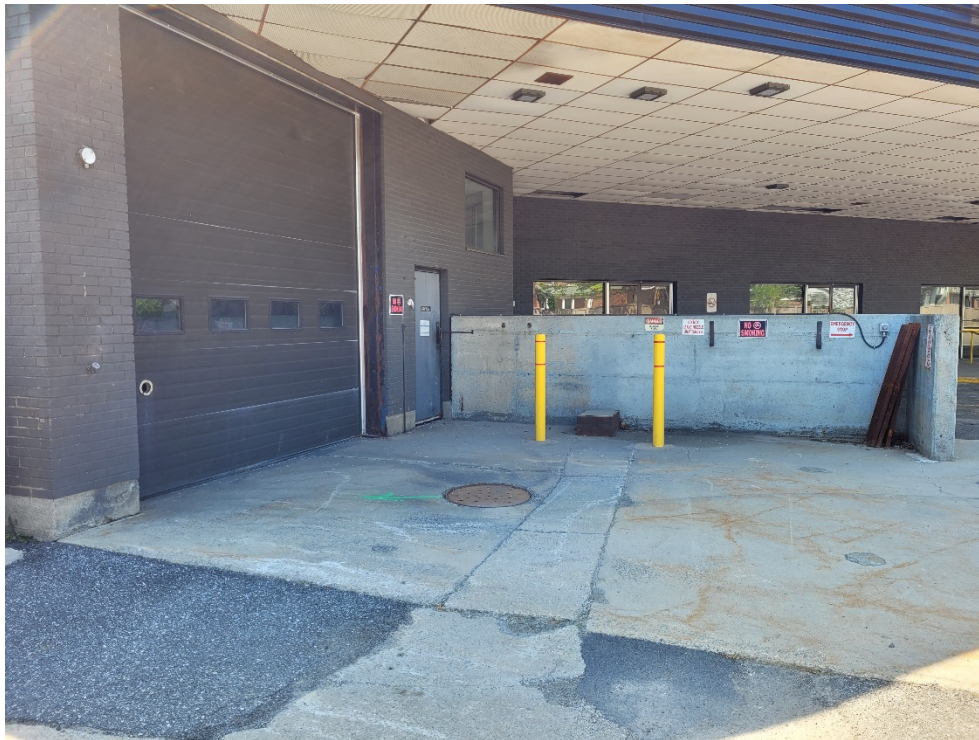
Photograph 4: View of the service garage entrance and former fueling area at the Property.
