Phase I Environmental Site Assessment

50 Bayswater Avenue and 1088 Somerset Street West
Ottawa, Ontario

Prepared for Manor Park Management

Report: PE5971-1
Date: July 6, 2023

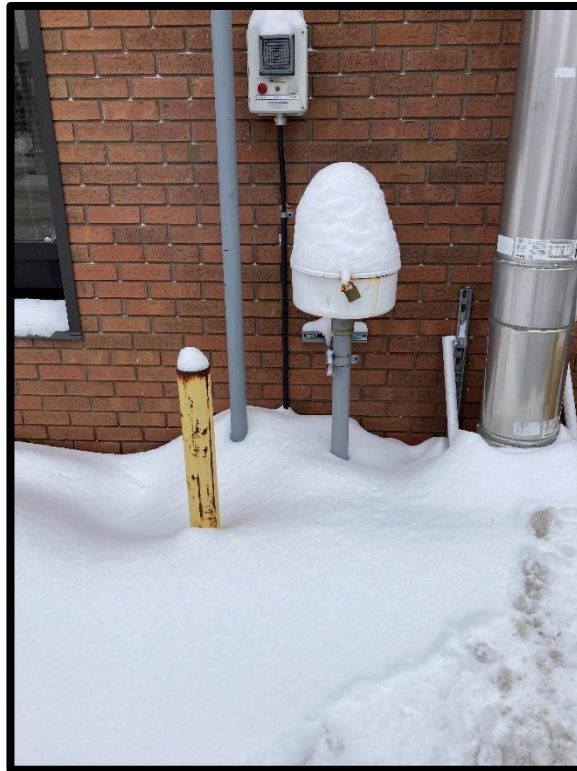
Photograph 3: View of the vent and fill pipes along the back wall of the 50 Bayswater Avenue office building, facing east.

Vent and fill pipes were observed on the exterior of the 50 Bayswater Avenue building (along the west face) at the time of the site visit. The vent and fill pipes and the ground beneath them were noted to be in good condition, with no visual or olfactory signs of contamination noted.

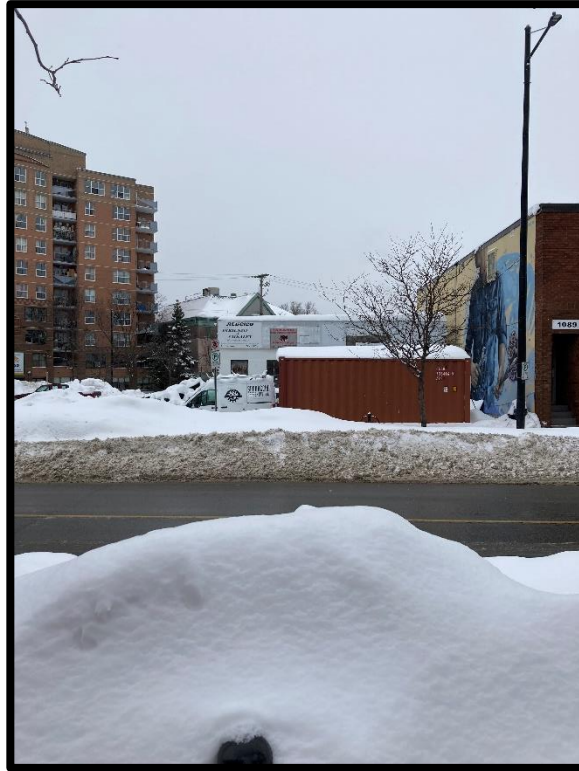
Photograph 7: View of the automotive service garage on the 1 Spadina Avenue property from the northwest corner of the Phase I Property, facing north.
