## **Phase II – Environmental Site Investigation**

1440 Blair Towers Place  
Ottawa, Ontario

**Report: PE6304-2R**

**Date: January 26, 2024**

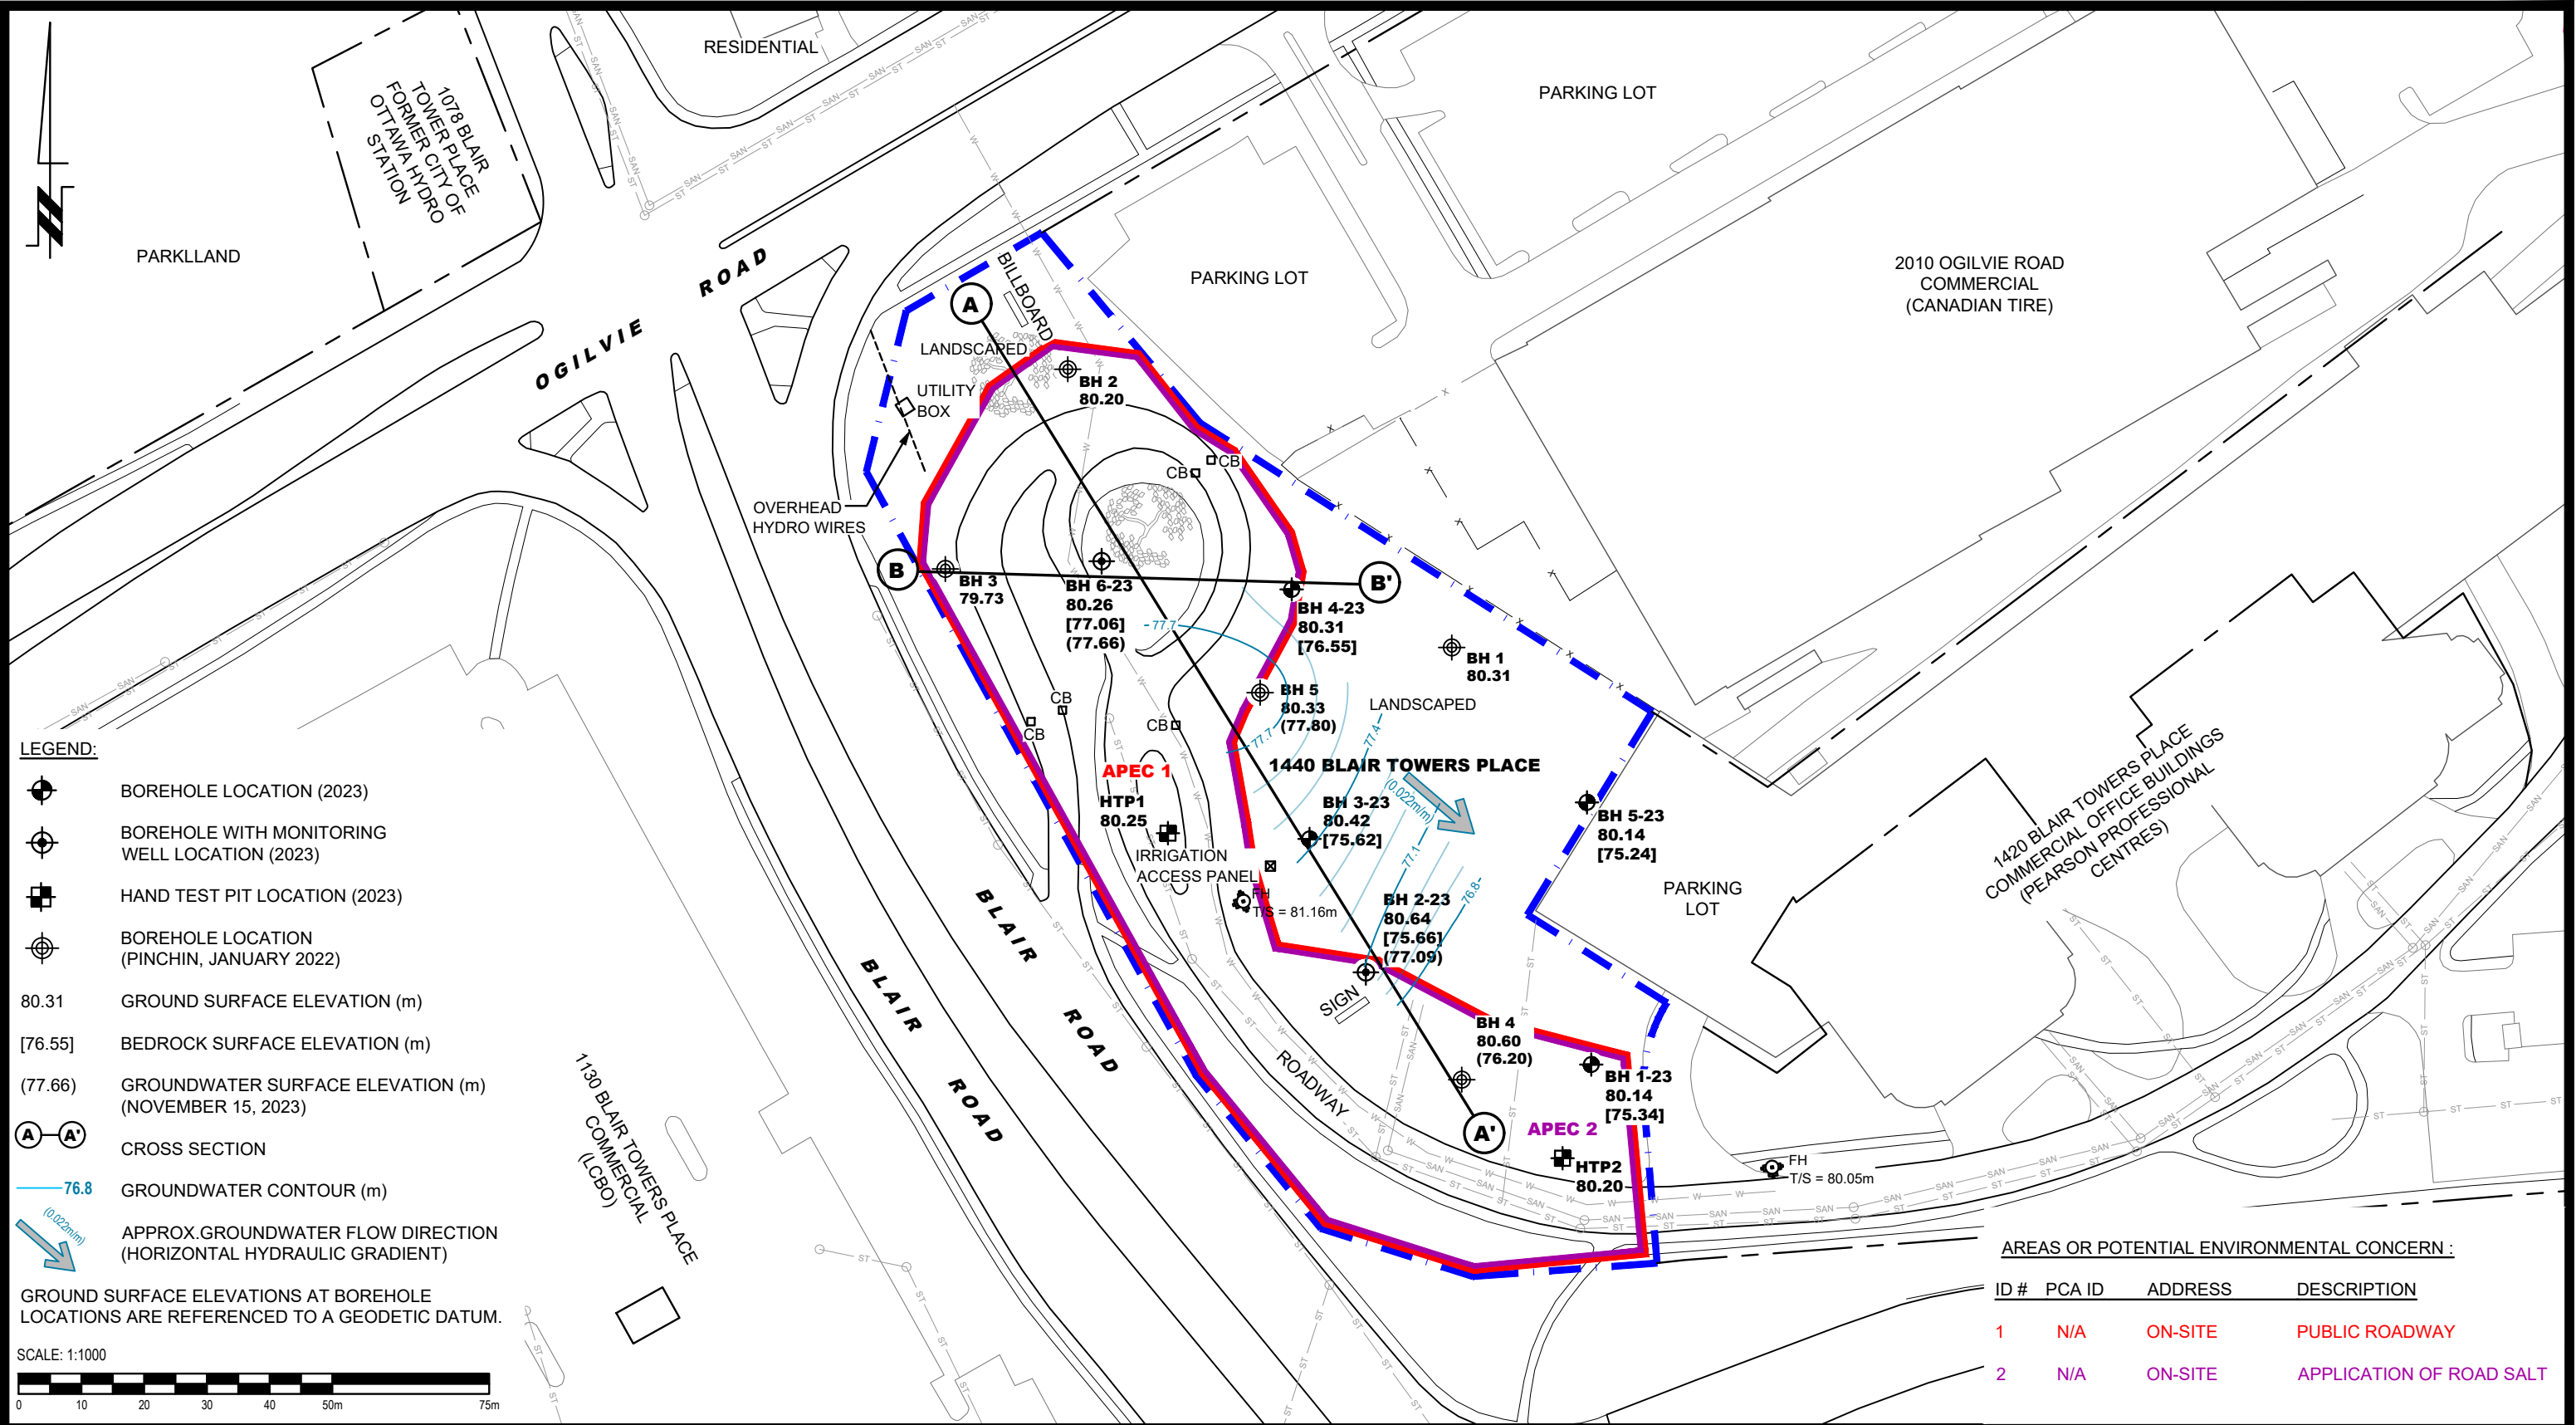
Date: 01/2024  
Report No.: PE6304-2  
Dwg. No.: PE6304-3  
Revision No.:

Based on the groundwater elevations measured during the sampling events, groundwater contour mapping was completed. Groundwater contours are shown on Drawing PE6304-3 – Test Hole Location Plan. Based on the contour mapping, groundwater flow at the subject site is in a southeasterly direction. It should be noted that groundwater levels are expected to fluctuate throughout the year with seasonal variations.

It should be noted that groundwater levels are expected to fluctuate throughout the year with seasonal variations. Groundwater contours are shown on Drawing PE6304-3 – Test Hole Location Plan.

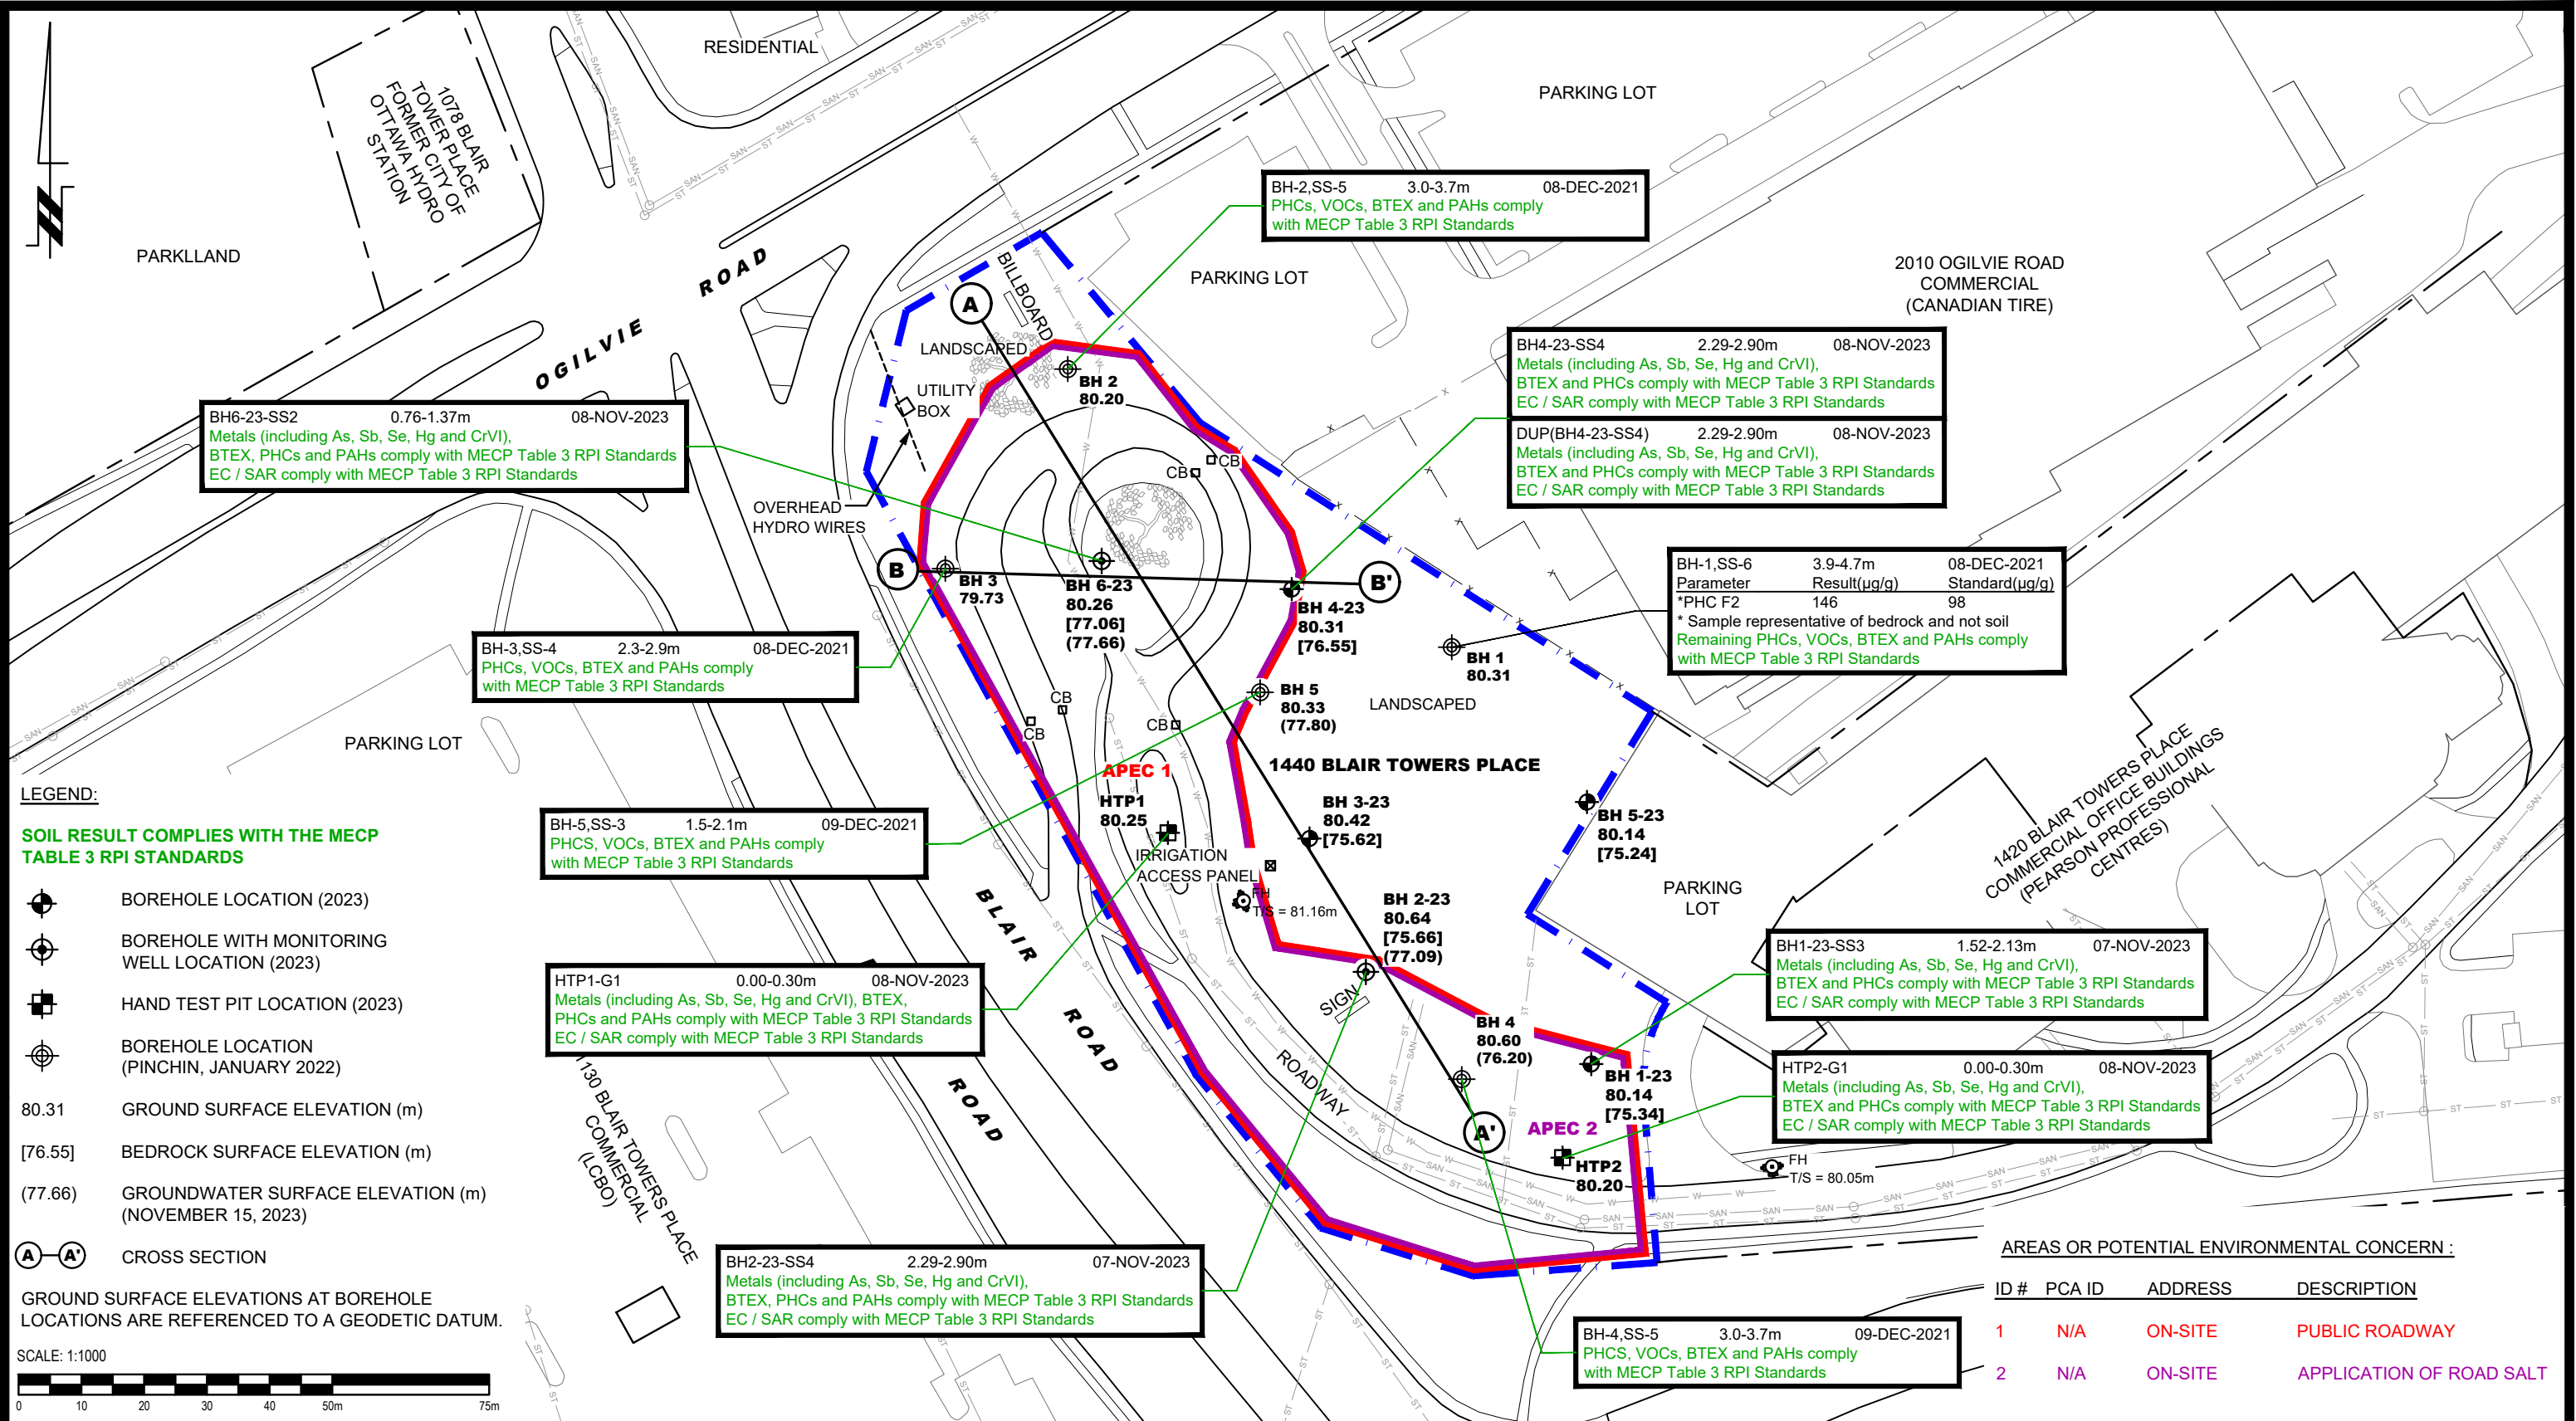
| Checked by: | JC | Dwg. No.: | PE6304-4 |

BH6-23-SS2      0.76-1.37m      08-NOV-2023  
Metals (including As, Sb, Se, Hg and CrVI),  
BTEX, PHCs and PAHs comply with MECP Table 3 RPI Standards  
EC / SAR comply with MECP Table 3 RPI Standards

BH4-23-SS4      2.29-2.90m      08-NOV-2023  
Metals (including As, Sb, Se, Hg and CrVI),  
BTEX and PHCs comply with MECP Table 3 RPI Standards  
EC / SAR comply with MECP Table 3 RPI Standards  
DUP(BH4-23-SS4)      2.29-2.90m      08-NOV-2023  
Metals (including As, Sb, Se, Hg and CrVI),  
BTEX and PHCs comply with MECP Table 3 RPI Standards  
EC / SAR comply with MECP Table 3 RPI Standards

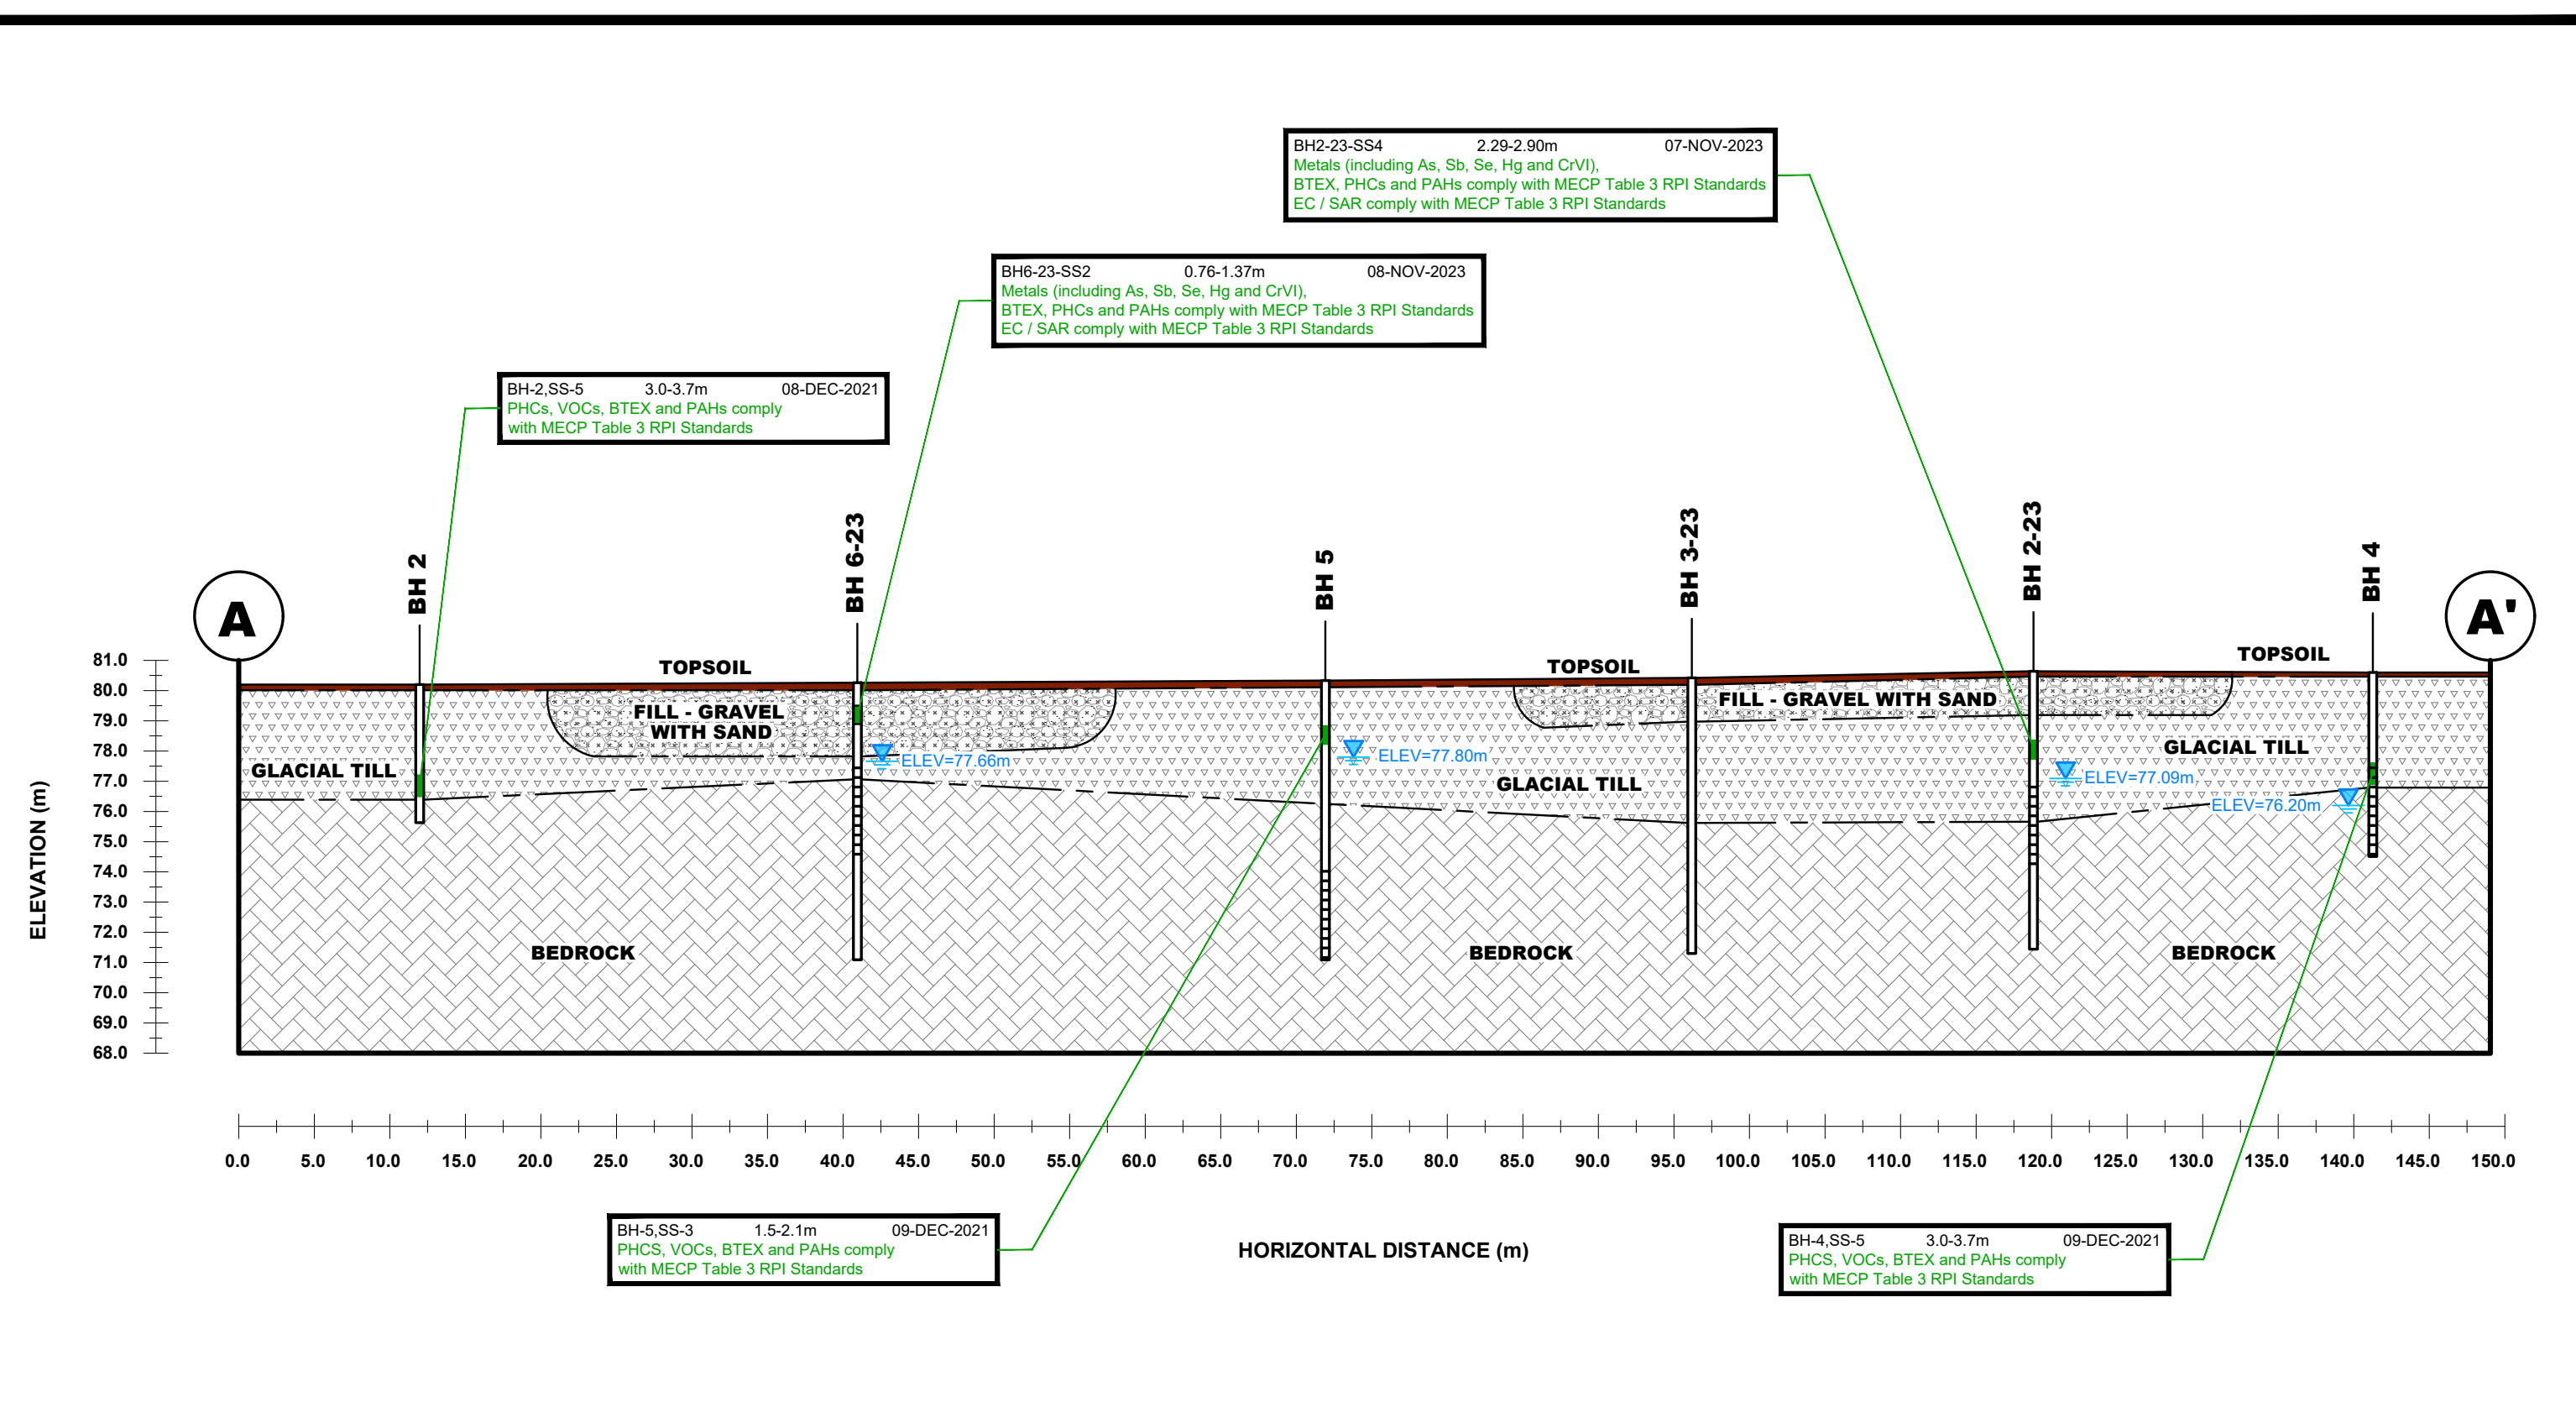
SOIL RESULT COMPLIES WITH THE MECP TABLE 3 RPI STANDARDS

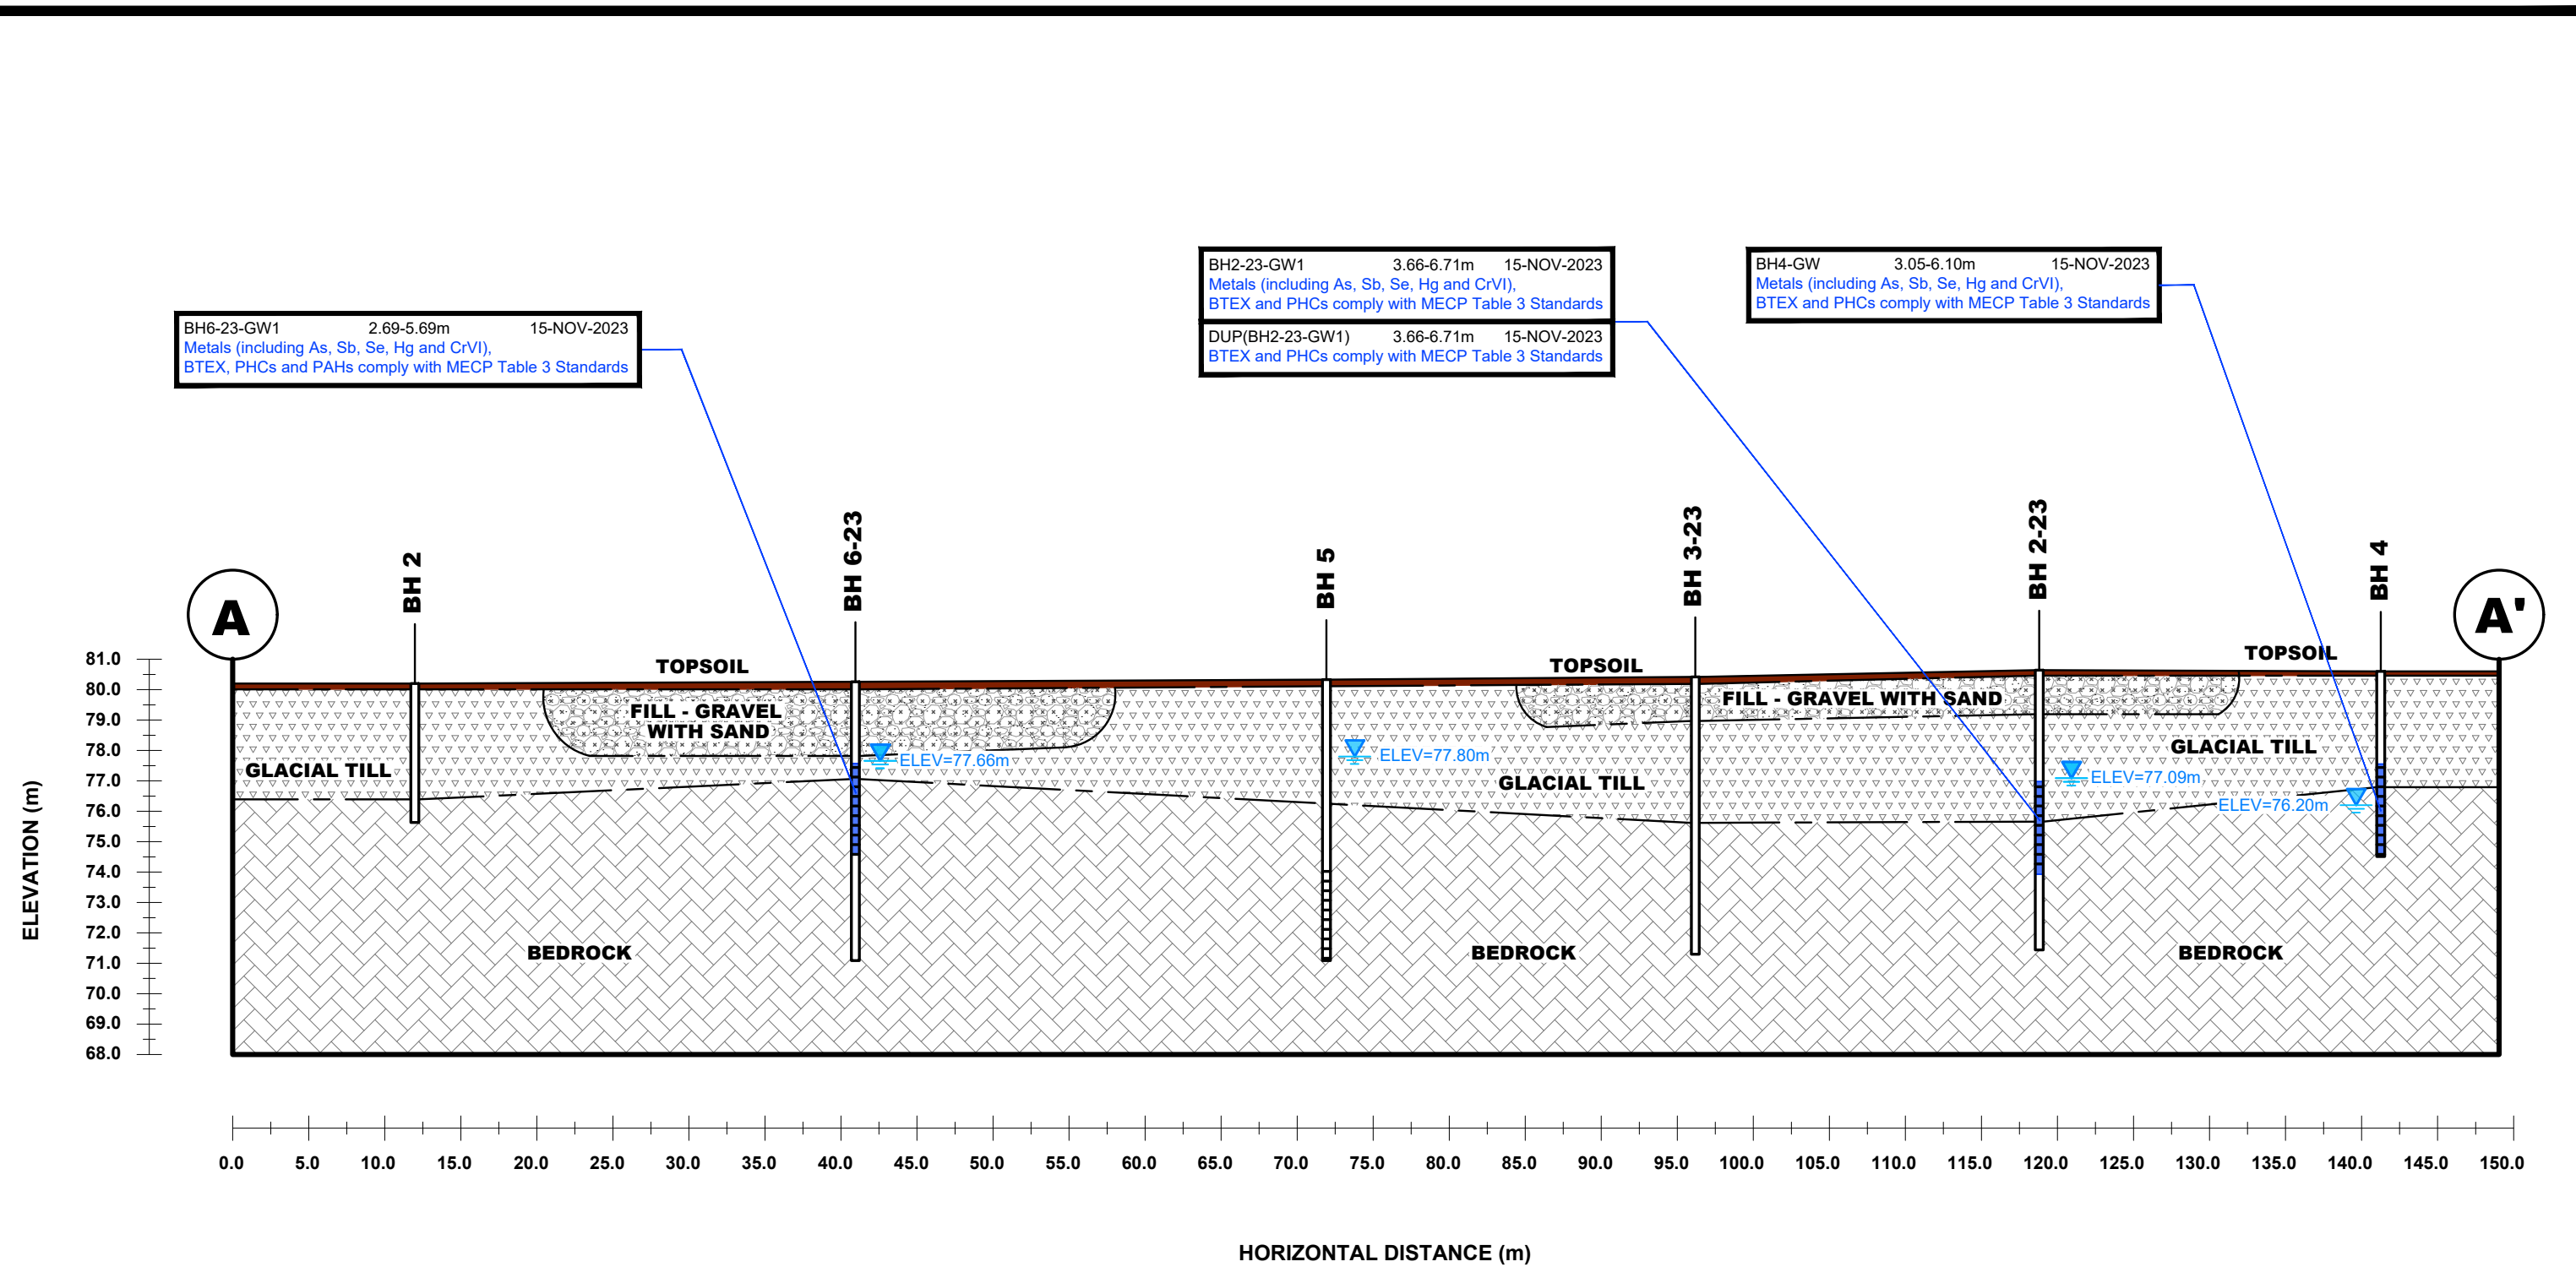
GROUNDWATER RESULT COMPLIES WITH THE MECP TABLE 3 RPI STANDARDS

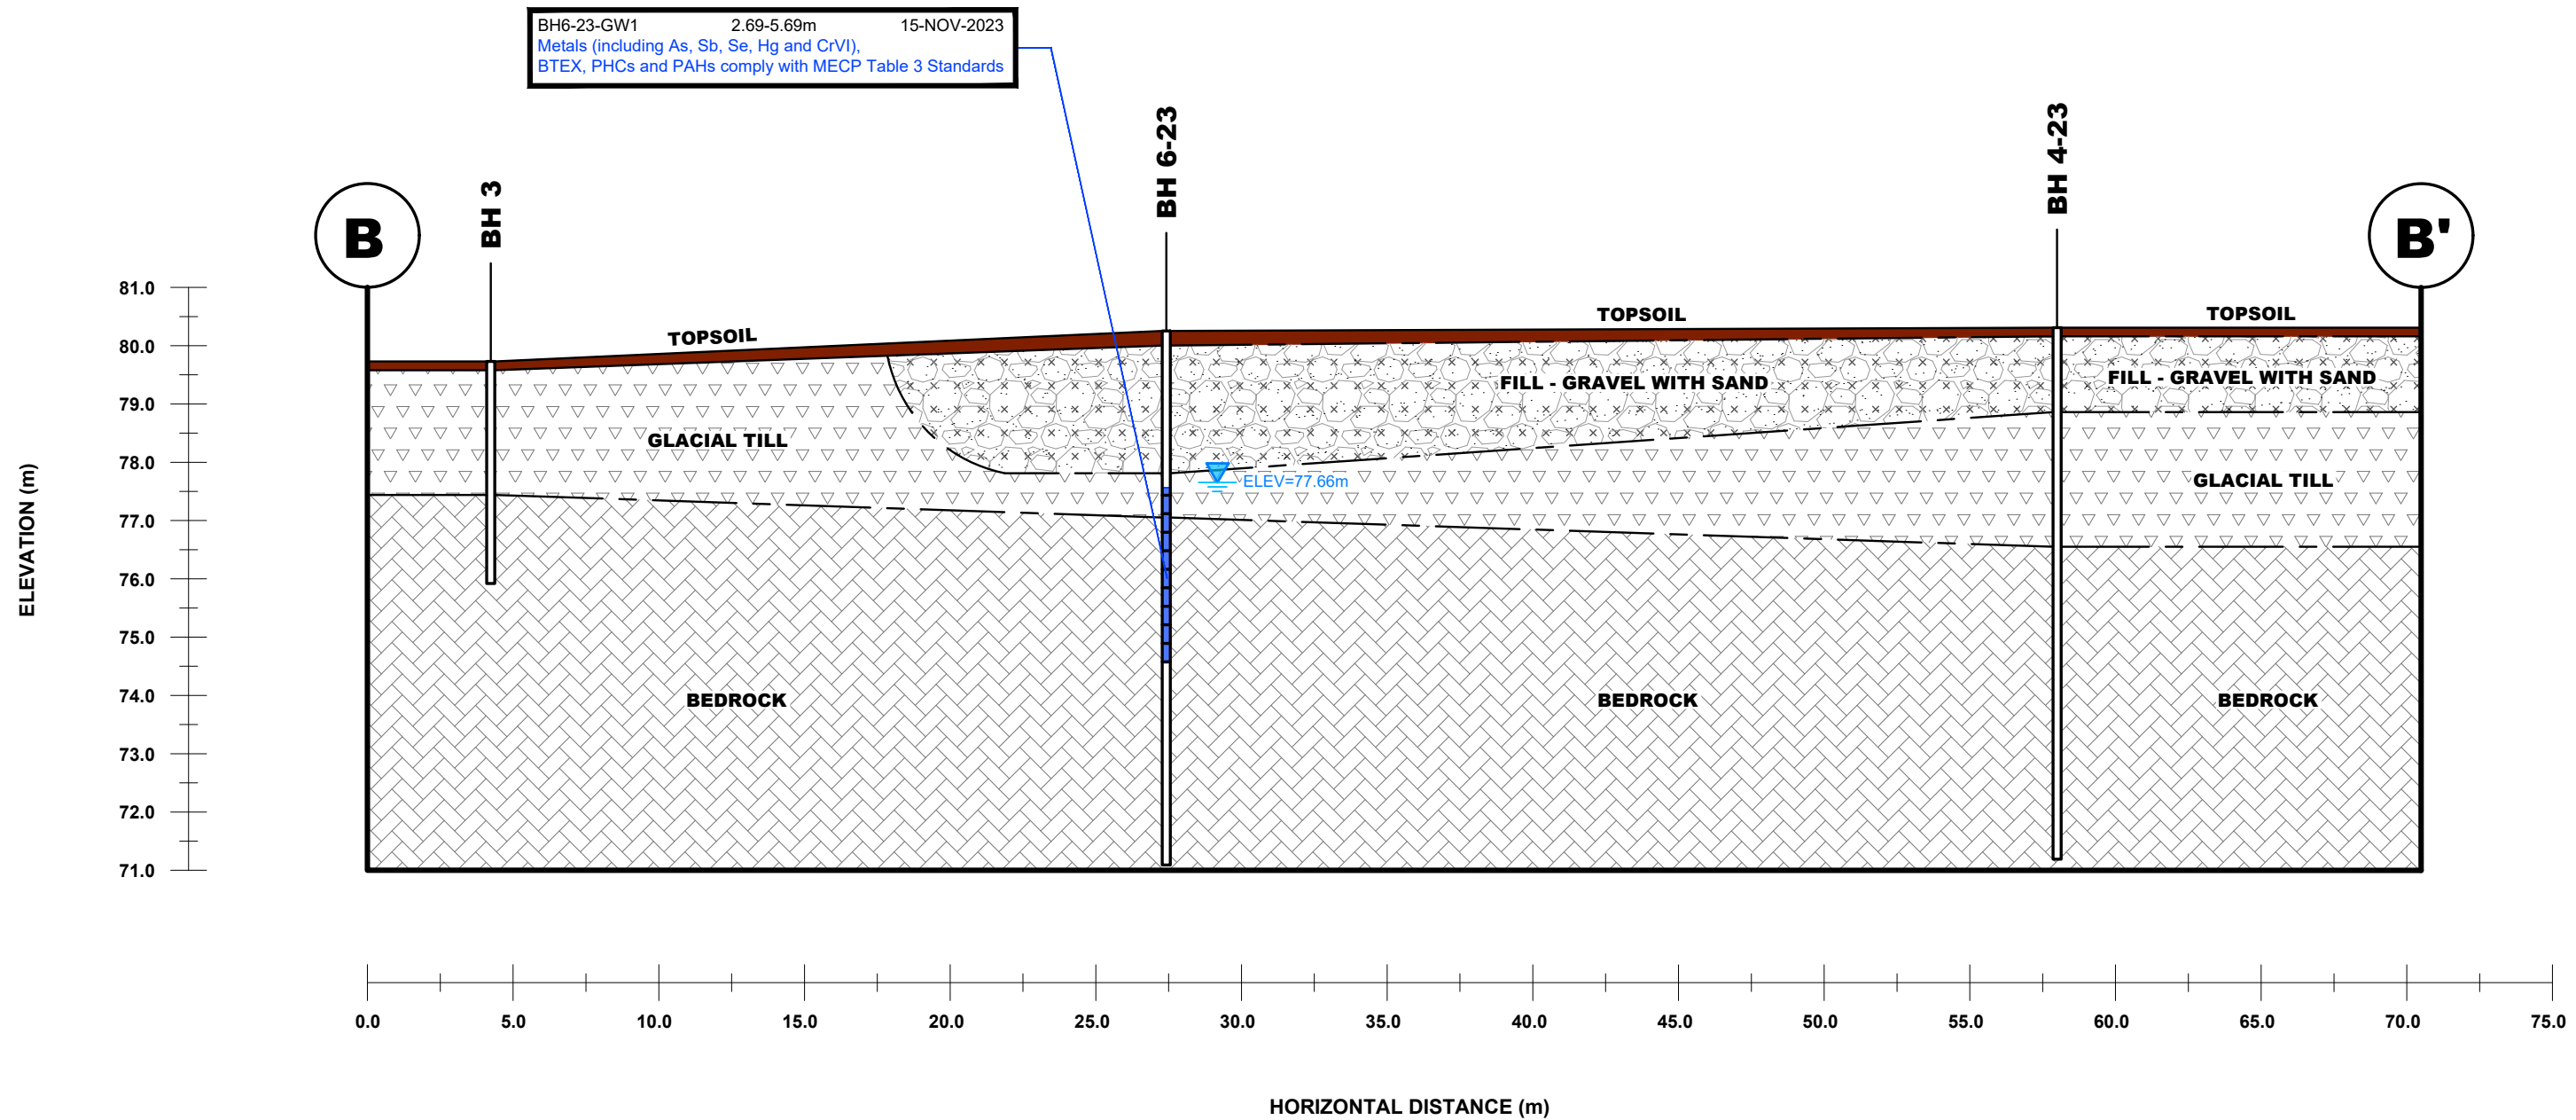
**DRAWING PE6304-5B – CROSS SECTION B-B' – GROUNDWATER**

GROUNDWATER RESULT COMPLIES WITH THE MECP TABLE 3 RPI STANDARDS
