CCOC 240 PRESLAND 240 PRESLAND, OTTAWA, ON

TREE CONSERVATION REPORT

Date 2025-01-02 Scale 1:150 TCR01 Drawn SW Checked PG Job No. 24-160 PLAN N° XXXXX

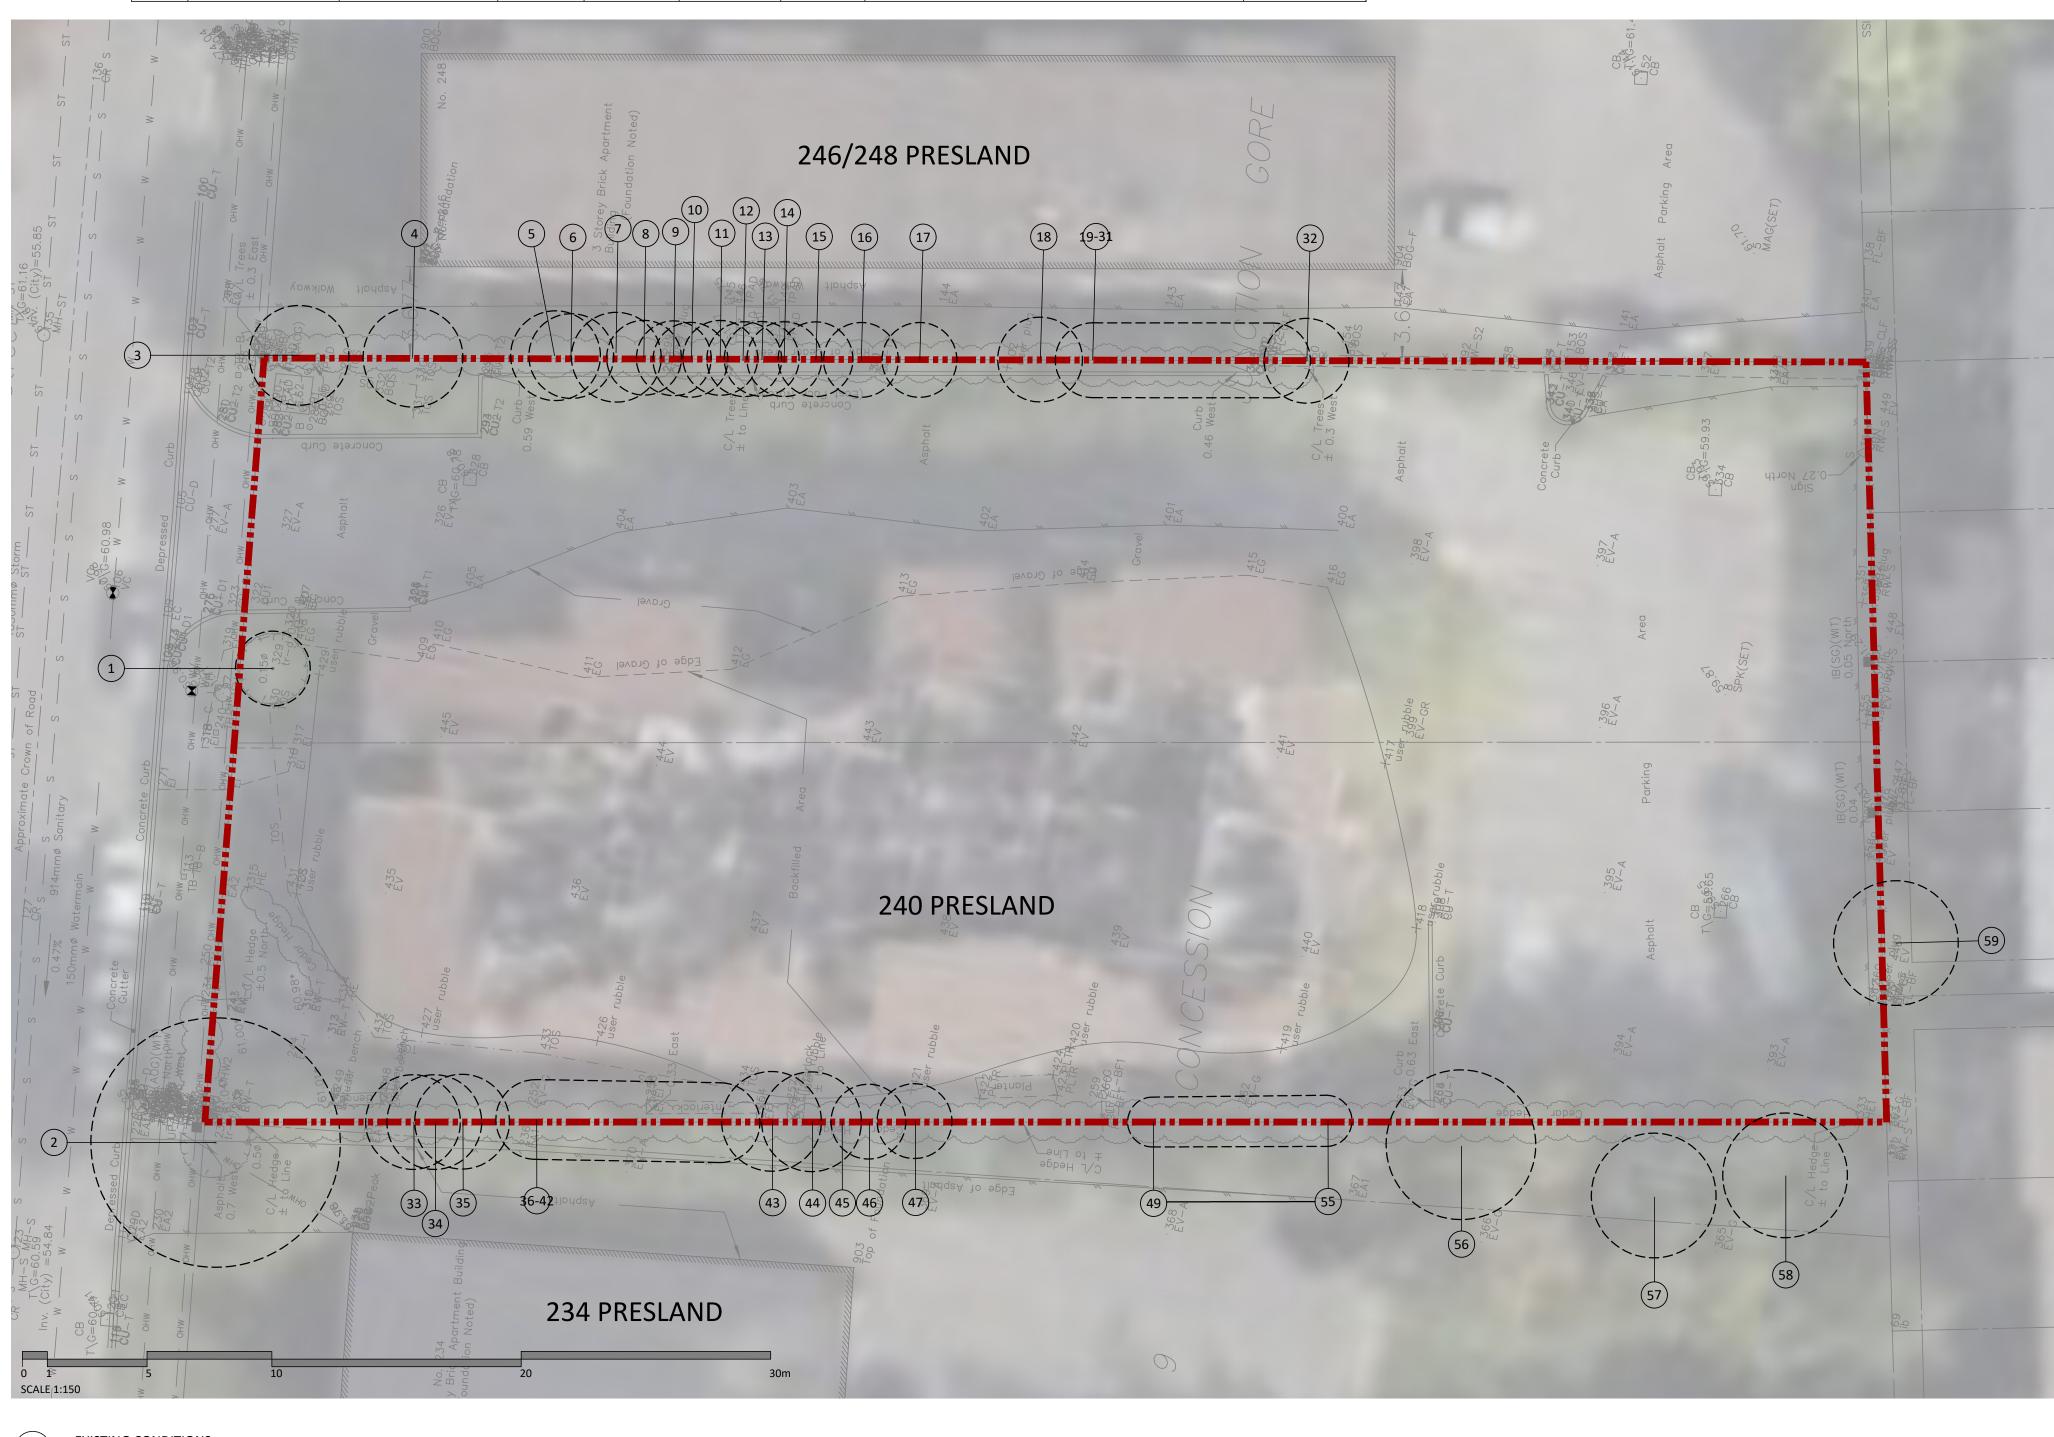
EXISTING CONDITIONS 1

Tree #	Botanical Name	Common Name	DBH (cm)	Own	ership	Condition	NOTES	To Be Preserved
1	Acer negundo	Manitoba Maple	15	Private	240 Presland	Moderate	Single stem, Girdled trunk (wire)	NO
2	Acer negundo	Manitoba Maple	50	Private	234 Presland	Moderate	Asymmetrical canopy, Pruned @ O.H., Poor branch union, Multi-stem w/ 2 co-dominant leaders @ 3m above grade. Bark rot @ cavities.	YES
3	Rhamnus Cathartica	European Buckthorn	20	Private	246/248 Presland	Moderate	Asymmetrical canopy, Single stem. Bark rot @ limbs. NHB.	YES
4	Rhamnus Cathartica	European Buckthorn	14	Boundary		Moderate	Asymmetrical canopy, Pruned limb, Single stem, Heart rot @ cavities.	YES
5	Thuja Occidentalis	Eastern White Cedar	18	Boundary		Moderate	Asymmetrical canopy, Poor branch union, Single stem w/ 2 co-dominant leaders @ 3m above grade.	YES
6	Thuja Occidentalis	Eastern White Cedar	17	Boundary		Good	Asymmetrical canopy, Pruned limbs, Single stem	YES

7	Thuja Occidentalis	Eastern White Cedar	2@ 18	Boundary		Moderate	Asymmetrical canopy, Pruned leader, Poor branch union. Multi-stem w/2 co-dominant leaders.	YES
8	Thuja Occidentalis	Eastern White Cedar	18	Boundary		Good	Asymmetrical canopy, Poor branch angle. Single stem. Included bark	YES
9	Thuja Occidentalis	Eastern White Cedar	14	Boundary		Poor	Dieback ~75% @ canopy, Pruned leader. Single stem	YES
10	Thuja Occidentalis	Eastern White Cedar	15	Boundary		Moderate	Asymmetrical canopy, Broken limbs, Pruned limbs, Single stem	YES
11	Thuja Occidentalis	Eastern White Cedar	15	Boundary		Moderate	Asymmetrical canopy, Broken limbs, Pruned limbs, Single stem	YES
12	Thuja Occidentalis	Eastern White Cedar	15	Boundary		Moderate	Asymmetrical canopy, Broken limbs, Pruned limbs, Single stem	YES
13	Thuja Occidentalis	Eastern White Cedar	15	Boundary		Moderate	Asymmetrical canopy, Broken limbs, Pruned limbs, Single stem	YES

14	Thuja Occidentalis	Eastern White Cedar	14	Boundary		Good	Asymmetrical canopy, Single stem. Included bark	YES
15	Thuja Occidentalis	Eastern White Cedar	12	Boundary		Poor	Asymmetrical canopy, Dieback ~75%, Bark, Damaged Bark on approx. 50% of trunk, Pruned leader, Single stem	NO
16	Thuja Occidentalis	Eastern White Cedar	12	Boundary		Moderate	Asymmetrical canopy, Pruned, Multi-stem 2, Dead leader	YES

Ι			1	1			
17	Thuja Occidentalis	Eastern White Cedar	15	Boundary		Moderate	Asymmetrical canopy, Pruned leaders, Multi-stem 2, Rot @ crotches.	YES
18	Thuja Occidentalis	Eastern White Cedar	17	Boundary		Moderate	Asymmetrical canopy, Pruned leaders, Single stem 2, Bark rot @ trunk.	YES
19-31	Thuja Occidentalis	Eastern White Cedar	15	Boundary		Moderate	Asymmetrical canopy, Single stem	YES
32	Thuja Occidentalis	Eastern White Cedar	25	Boundary		Good	Asymmetrical canopy, Multi-stem 2. Girdled by wire @ base.	YES
33-34	Thuja Occidentalis	Eastern White Cedar	19	Boundary		Moderate	Asymmetrical canopy, Single stem w/ 2 leaders @ 1m above grade.	YES
35	Thuja Occidentalis	Eastern White Cedar	20	Boundary		Moderate	Asymmetrical canopy, Pruned leader, Multi-stem 2	YES
36-42	Thuja Occidentalis	Eastern White Cedar	16	Boundary		Moderate	Asymmetrical canopy, Single stem	YES
43	Thuja Occidentalis	Eastern White Cedar	20	Boundary		Moderate	Asymmetrical canopy, Single stem w/ 2 leaders @ 1m above grade.	YES

44	Thuja Occidentalis	Eastern White Cedar	20	Boundary		Moderate	Asymmetrical canopy, Single stem w/ 2 leaders @ 1m above grade.	YES
45						Dead		NO
46	Thuja Occidentalis	Eastern White Cedar	15	Boundary		Moderate	Asymmetrical canopy, Poor branch angle. Single stem	YES
47	Thuja Occidentalis	Eastern White Cedar	15	Boundary		Poor	Asymmetrical canopy, Broken limbs. Single stem. Broken leader	YES
48	Acer negundo	Manitoba Maple	20	Boundary		Good	Asymmetrical canopy, Broken limbs. Single stem	YES
49-55	Thuja Occidentalis	Eastern White Cedar	10	Boundary		Moderate	Asymmetrical canopy, Broken limbs, Pruned. Single stem	YES
56	Acer negundo	Manitoba Maple	30	Private	234 Presland	Moderate	Asymmetrical canopy, Single stem, Leaning. NHB	YES
57	Acer negundo	Manitoba Maple	25	Private	234 Presland	Moderate	Asymmetrical canopy, Single stem, Leaning. NHB	YES
58	Acer negundo	Manitoba Maple	15	Private	234 Presland	Moderate	Asymmetrical canopy, Single stem, Leaning. NHB	YES

59	Acer spp.	Maple	20	Private	191 Arcola	Good	Symmetrical canopy, Multi-stem. NHB, overhang	YES

THE EXISTING SITE IS A VACANT LOT WITH AN ABANDONED ASPHALT PARKING LOT AND GRANULAR PILE.
 THERE ARE A TOTAL OF FIFTY-NINE TREES INCLUDED IN THE TREE

- CONSERVATION REPORT, IN VARYING CONDITIONS.
 THE DEVELOPMENT SITE IS NOT CONSIDERED OF PRIMARY, SUPPORTING OR CONTRIBUTING SIGNIFICANCE AS NATURAL LANDS IN THE GREENSPACE
- 4. THERE ARE NO OTHER APPLICATIONS AFFECTING THE LAND UPON WHICH TREES ARE TO BE PROTECTED, INJURED OR DESTROYED.

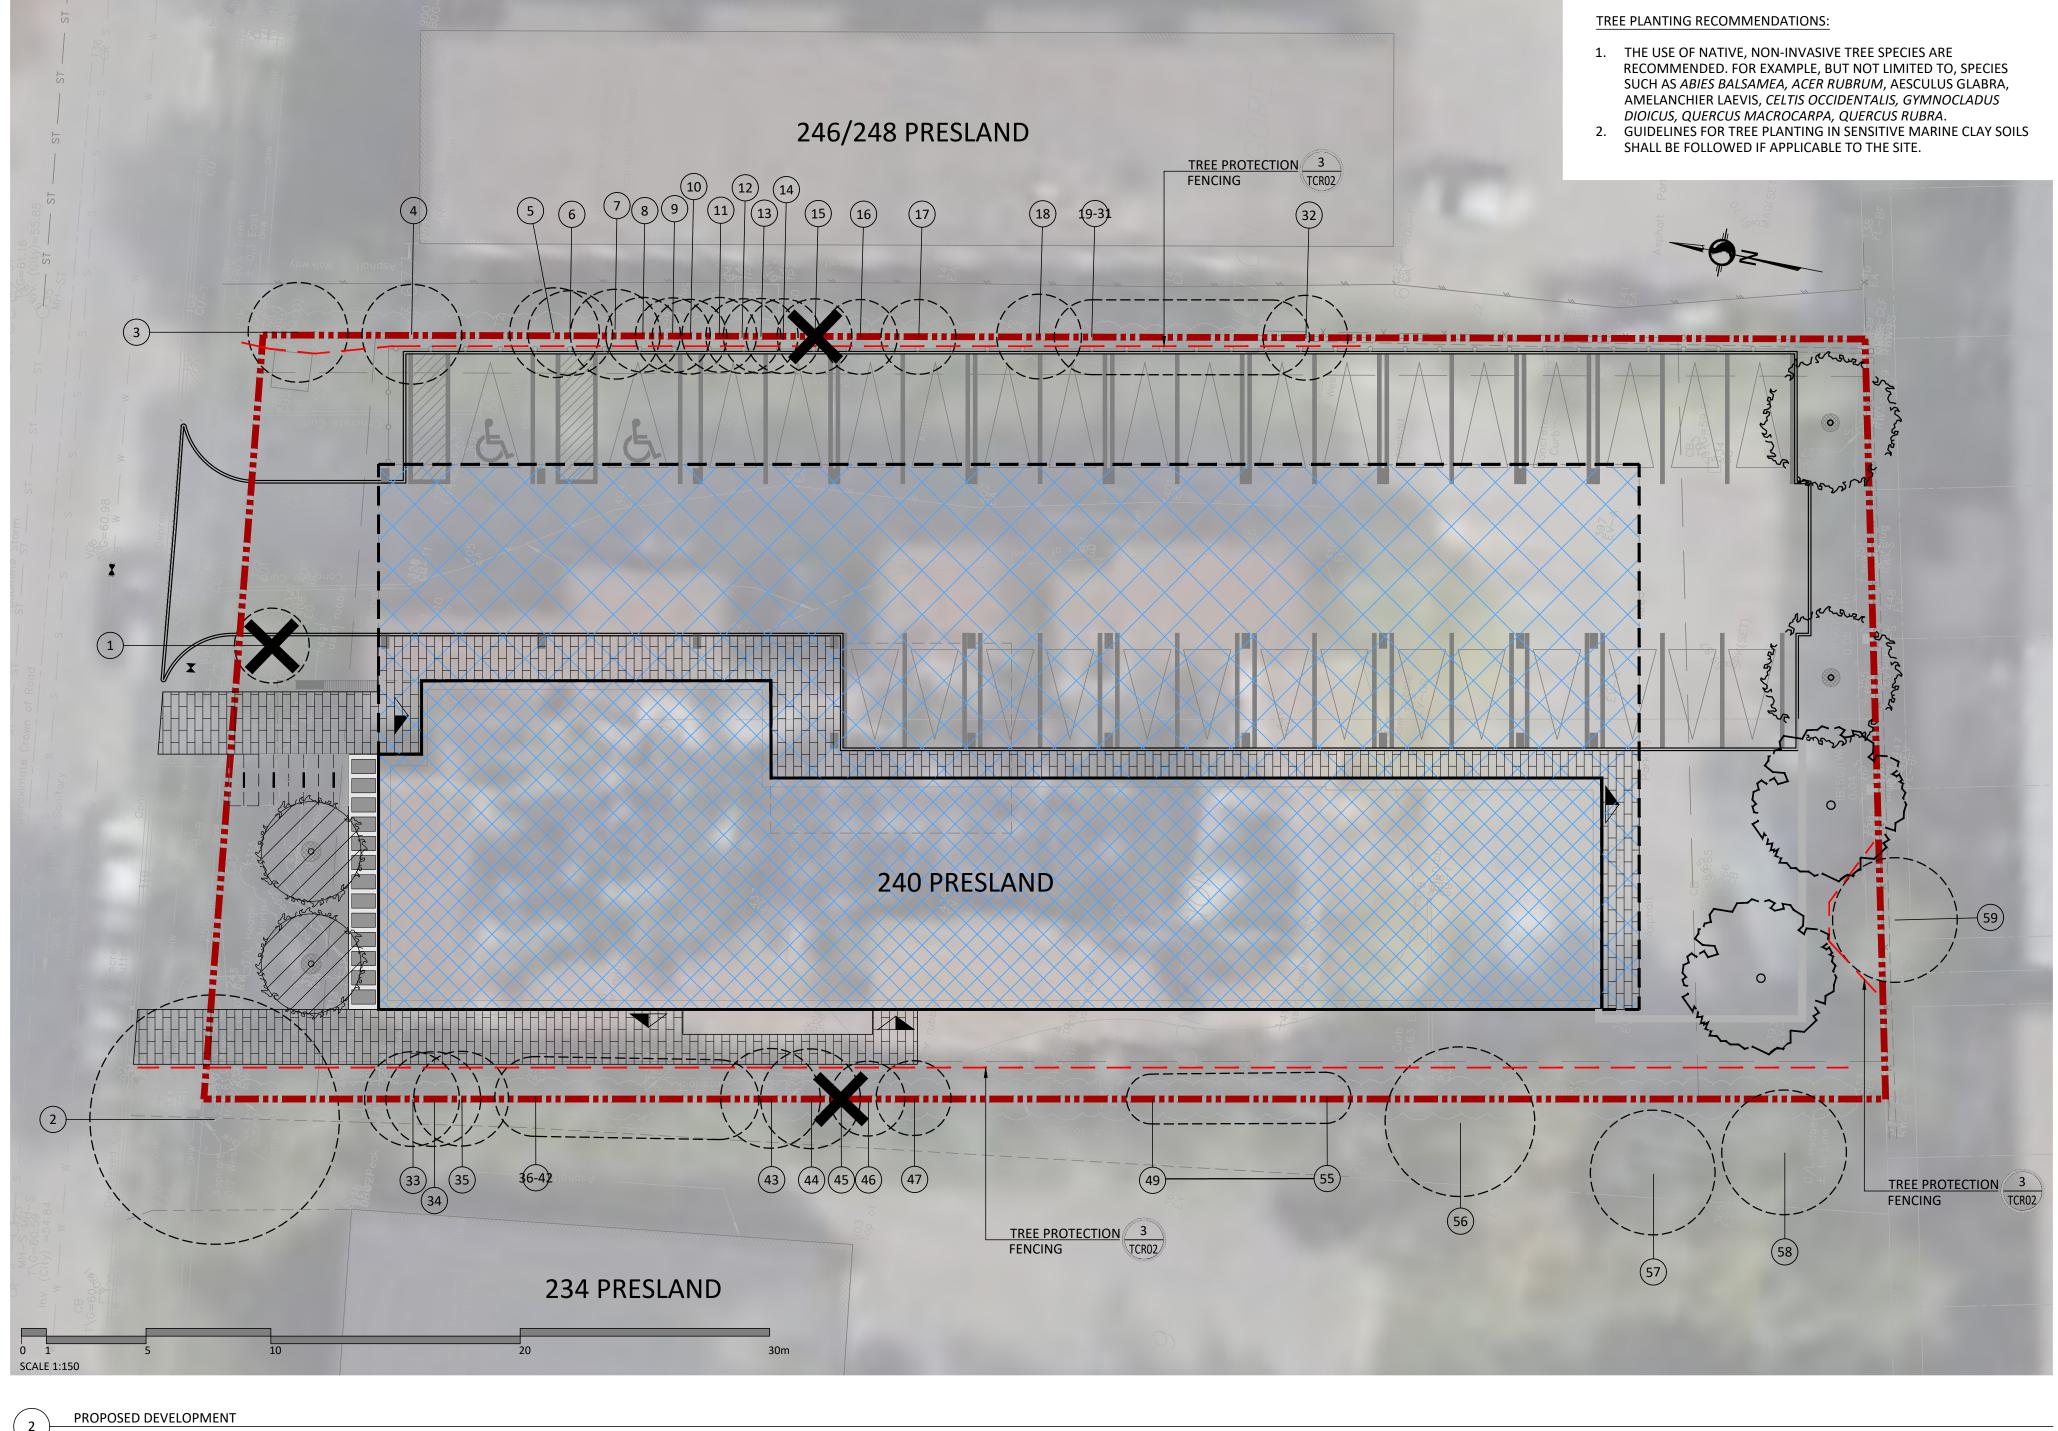
Date	2025-01-02	Sheet
Scale	1:150	
Drawn	SW	TCR02
Checked	PG	
Job No.	24-160

Tree #	Botanical Name	Common Name	DBH (cm)	Owr	ership	Condition	NOTES	To Be Preserved	Reason for Removal
1	Acer negundo	Manitoba Maple	15	Private	240 Presland	Moderate	Single stem, Girdled trunk (wire)	NO	Construction activities
2	Acer negundo	Manitoba Maple	50	Private	234 Presland	Moderate	Asymmetrical canopy, Pruned @ O.H., Poor branch union, Multi-stem w/ 2 co-dominant leaders @ 3m above grade. Bark rot @ cavities.	YES	& conflict with propose hard surface layout
3	Rhamnus Cathartica	European Buckthorn	20	Private	246/248 Presland	Moderate	Asymmetrical canopy, Single stem. Bark rot @ limbs. NHB.	YES	
4	Rhamnus Cathartica	European Buckthorn	14	Boundary		Moderate	Asymmetrical canopy, Pruned limb, Single stem, Heart rot @ cavities.	YES	
5	Thuja Occidentalis	Eastern White Cedar	18	Boundary		Moderate	Asymmetrical canopy, Poor branch union, Single stem w/ 2 co-dominant leaders @ 3m above grade.	YES

6	Thuja Occidentalis	Eastern White Cedar	17	Boundary		Good	Asymmetrical canopy, Pruned limbs, Single stem	YES	
7	Thuja Occidentalis	Eastern White Cedar	2@ 18	Boundary		Moderate	Asymmetrical canopy, Pruned leader, Poor branch union. Multi-stem w/2 co-dominant leaders.	YES	
8	Thuja Occidentalis	Eastern White Cedar	18	Boundary		Good	Asymmetrical canopy, Poor branch angle. Single stem. Included bark	YES	
9	Thuja Occidentalis	Eastern White Cedar	14	Boundary		Poor	Dieback ~75% @ canopy, Pruned leader. Single stem	YES	
10	Thuja Occidentalis	Eastern White Cedar	15	Boundary		Moderate	Asymmetrical canopy, Broken limbs, Pruned limbs, Single stem	YES	
11	Thuja Occidentalis	Eastern White Cedar	15	Boundary		Moderate	Asymmetrical canopy, Broken limbs, Pruned limbs, Single stem	YES	
12	Thuja Occidentalis	Eastern White Cedar	15	Boundary		Moderate	Asymmetrical canopy, Broken limbs, Pruned limbs, Single stem	YES

13	Thuja Occidentalis	Eastern White Cedar	15	Boundary		Moderate	Asymmetrical canopy, Broken limbs, Pruned limbs, Single stem	YES	
14	Thuja Occidentalis	Eastern White Cedar	14	Boundary		Good	Asymmetrical canopy, Single stem. Included bark	YES	Poor condition and ir
15	Thuja Occidentalis	Eastern White Cedar	12	Boundary		Poor	Asymmetrical canopy, Dieback ~75%, Bark, Damaged Bark on approx. 50% of trunk, Pruned leader, Single stem	NO	state of decline. Highl likely to be sensitive t
16	Thuja Occidentalis	Eastern White Cedar	12	Boundary		Moderate	Asymmetrical canopy, Pruned, Multi-stem 2, Dead leader	YES	construction impacts

1							
17	Thuja Occidentalis	Eastern White Cedar	15	Boundary		Moderate	Asymmetrical canopy, Pruned leaders, Multi-stem 2, Rot @ crotches.	YES
18	Thuja Occidentalis	Eastern White Cedar	17	Boundary		Moderate	Asymmetrical canopy, Pruned leaders, Single stem 2, Bark rot @ trunk.	YES
19-31	Thuja Occidentalis	Eastern White Cedar	15	Boundary		Moderate	Asymmetrical canopy, Single stem	YES
32	Thuja Occidentalis	Eastern White Cedar	25	Boundary		Good	Asymmetrical canopy, Multi-stem 2. Girdled by wire @ base.	YES
33-34	Thuja Occidentalis	Eastern White Cedar	19	Boundary		Moderate	Asymmetrical canopy, Single stem w/ 2 leaders @ 1m above grade.	YES
35	Thuja Occidentalis	Eastern White Cedar	20	Boundary		Moderate	Asymmetrical canopy, Pruned leader, Multi-stem 2	YES
36-42	Thuja Occidentalis	Eastern White Cedar	16	Boundary		Moderate	Asymmetrical canopy, Single stem	YES
43	Thuja Occidentalis	Eastern White Cedar	20	Boundary		Moderate	Asymmetrical canopy, Single stem w/ 2 leaders @ 1m above grade.	YES

44	Thuja Occidentalis	Eastern White Cedar	20	Boundary		Moderate	Asymmetrical canopy, Single stem w/ 2 leaders @ 1m above grade.	YES
45						Dead		NO
46	Thuja Occidentalis	Eastern White Cedar	15	Boundary		Moderate	Asymmetrical canopy, Poor branch angle. Single stem	YES
47	Thuja Occidentalis	Eastern White Cedar	15	Boundary		Poor	Asymmetrical canopy, Broken limbs. Single stem. Broken leader	YES
48	Acer negundo	Manitoba Maple	20	Boundary		Good	Asymmetrical canopy, Broken limbs. Single stem	YES
49-55	Thuja Occidentalis	Eastern White Cedar	10	Boundary		Moderate	Asymmetrical canopy, Broken limbs, Pruned. Single stem	YES
56	Acer negundo	Manitoba Maple	30	Private	234 Presland	Moderate	Asymmetrical canopy, Single stem, Leaning. NHB	YES
57	Acer negundo	Manitoba Maple	25	Private	234 Presland	Moderate	Asymmetrical canopy, Single stem, Leaning. NHB	YES
58	Acer negundo	Manitoba Maple	15	Private	234 Presland	Moderate	Asymmetrical canopy, Single stem, Leaning. NHB	YES

59	Acer spp.	Maple	20	Private	191 Arcola	Good	Symmetrical canopy, Multi-stem. NHB, overhang	YES

1. TREES IDENTIFIED FOR RETENTION ARE IN MODERATE TO GOOD CONDITION AND CAN BE REASONABLY PROTECTED FROM CONSTRUCTION ACTIVITIES, GIVEN ADEQUATE TREE PROTECTION MEASURES AS DESCRIBED ARE TAKEN. 2. USE OF HYDRO VAC TECHNOLOGIES AND HAND PRUNING SHALL BE USED TO ENSURE A CLEAN INTERFACE FOR PROPER ROOT PRUNING BY A QUALIFIED ARBORIST (ISA CERTIFIED)

3. A QUALIFIED ARBORIST (ISA CERTIFIED) OR OTHER TREE PROFESSIONAL AS APPROVED BY THE CITY OF OTTAWA MUST PRUNE ROOTS OR BRANCHES THAT EXTEND BEYOND PRESCRIBED TREE PROTECTION ZONE AS REQUIRED. ALL PRUNING OF TREE ROOTS AND BRANCHES MUST BE IN ACCORDANCE WITH GOOD ARBORICULTURAL STANDARDS.

4. TREES SHALL BE INSPECTED BY THE LANDSCAPE ARCHITECT OR CITY FORESTER REGULARLY FOR DAMAGE INCURRED DURING CONSTRUCTION TO ENSURE APPROPRIATE PRUNING OR OTHER MEASURES ARE IMPLEMENTED.

5. THE AREAS WITHIN THE TREE PROTECTION ZONE MUST REMAIN UNDISTURBED AT ALL TIMES. NO WORK OR MATERIAL STORAGE IS PERMITTED WITHIN THE TREE PROTECTION ZONE.

13.a. EQUIPMENT SHALL NOT BE ALLOWED TO OPERATE, PARK, BE REPAIRED OR REFUELLED; NOR SHALL CONSTRUCTION MATERIALS BE STORED OR ANY EARTH MATERIALS BE STOCKPILED; WITHIN THE TREE PROTECTION FENCE OR WITHIN THE CRITICAL ROOT ZONE OF ANY TREE. WASTE OR VOLATILE MATERIALS, SUCH AS MINERAL SPIRITS, OIL OR PAINT THINNER SHALL NOT BE DISPOSED OF ON SITE. 13.b. WHEN EXCAVATION MUST TAKE PLACE WITHIN THE CRITICAL ROOT ZONE OF A TREE, A TRENCH SHALL BE DUG CAREFULLY BY HAND OR WITH A ROOT-CUTTING (STUMP GRINDER) OR STONE CUTTING (CUT-OFF) MACHINE ALONG THE FURTHEST REACH OF THE CUT.
