**Claridge Homes
Wurtemberg Street Condominium Development
Ottawa, Ontario**

April 19, 2010

Project Number: GP 10106

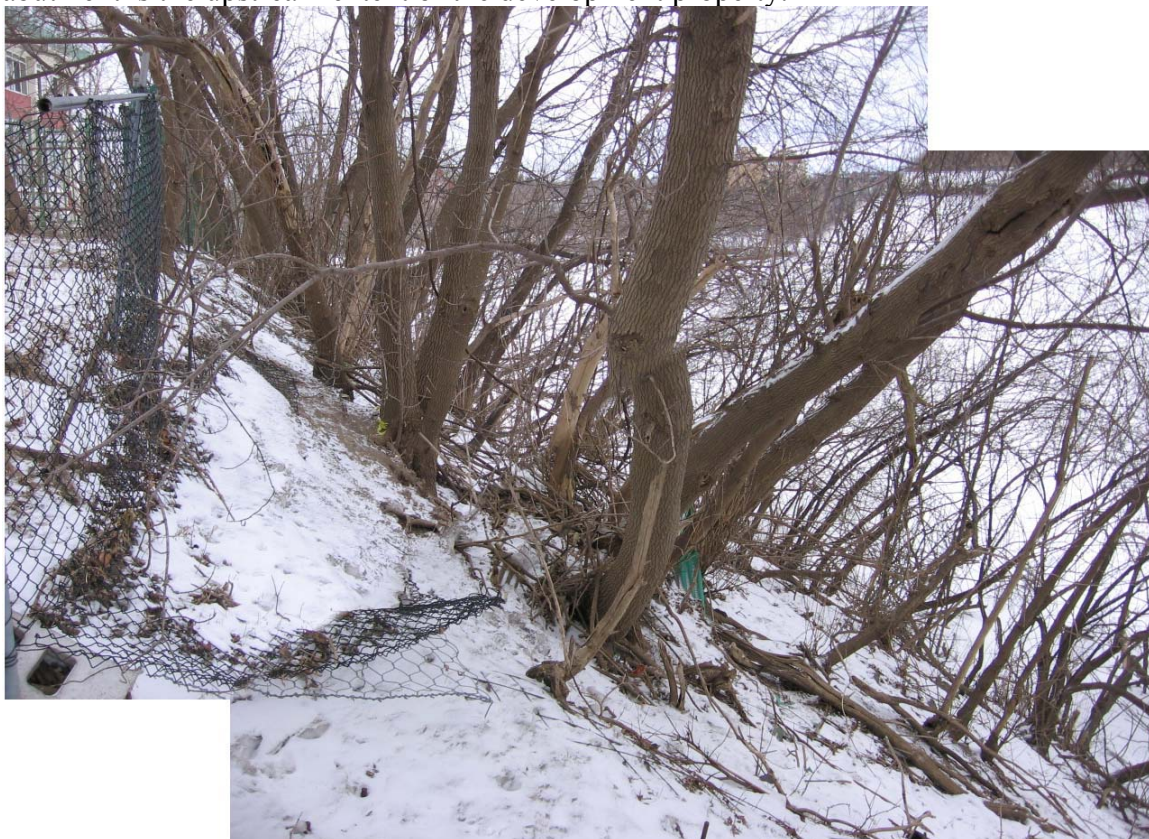
Photos 1, 2 and 3 in Appendix 1 depict the slope of the property and foreshore along the Rideau River on February 21, 2010. On the side adjacent to the Rideau River, the property slopes steeply toward the river as indicated in Photos 1 and 2. The slope is vegetated with trees and shrubs. Although it did not appear as though there was extensive ground cover, the ground was covered with snow on February 21, 2010 and this was difficult to confirm.

Photo 2. View across the slope on February 21, 2010. The fence represents the top of the slope on the development property.

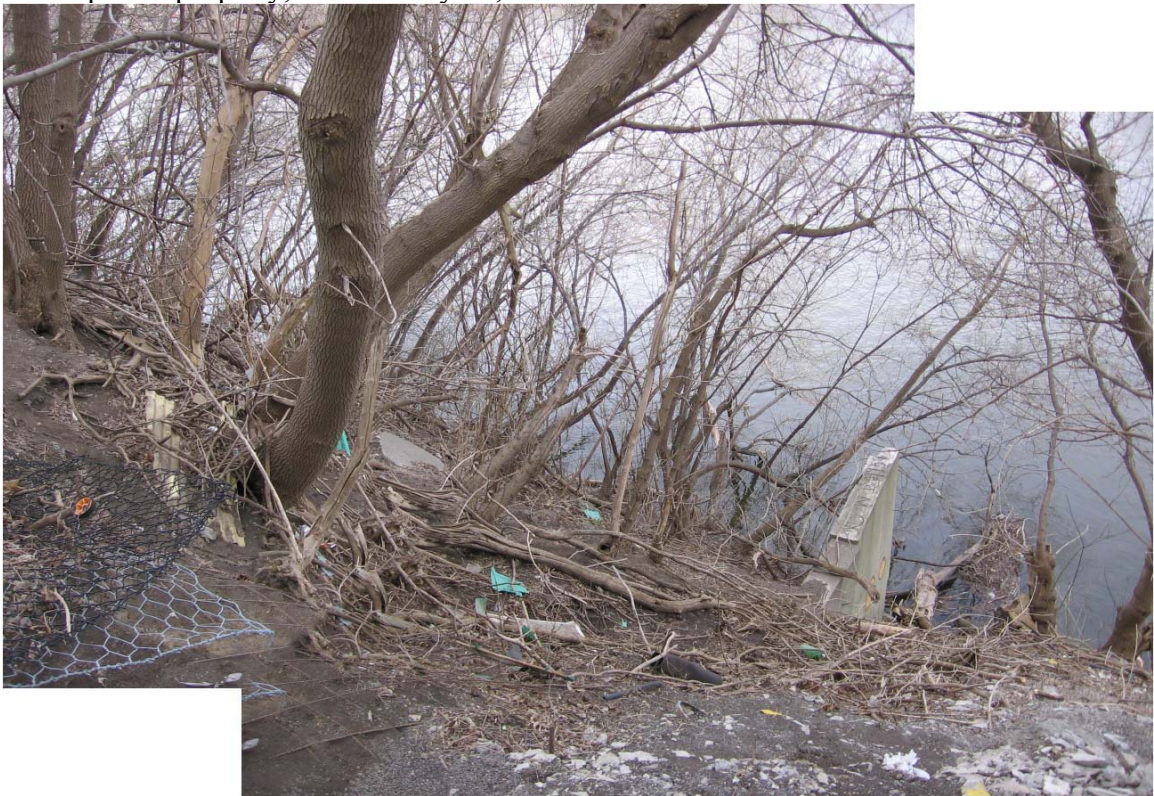
On the side adjacent to the Rideau River, the property slopes steeply toward the river. Photos 4 through 9 in Appendix 1 depict the slope of the property and foreshore along the Rideau River on March 25, 2010. Photos 9 and 10 provide overviews of the property and adjacent foreshore from the opposite bank of the Rideau River.

Photo 4. View down slope to the Rideau River on March 25, 2010. The concrete abutment is the upstream extent of the development property.

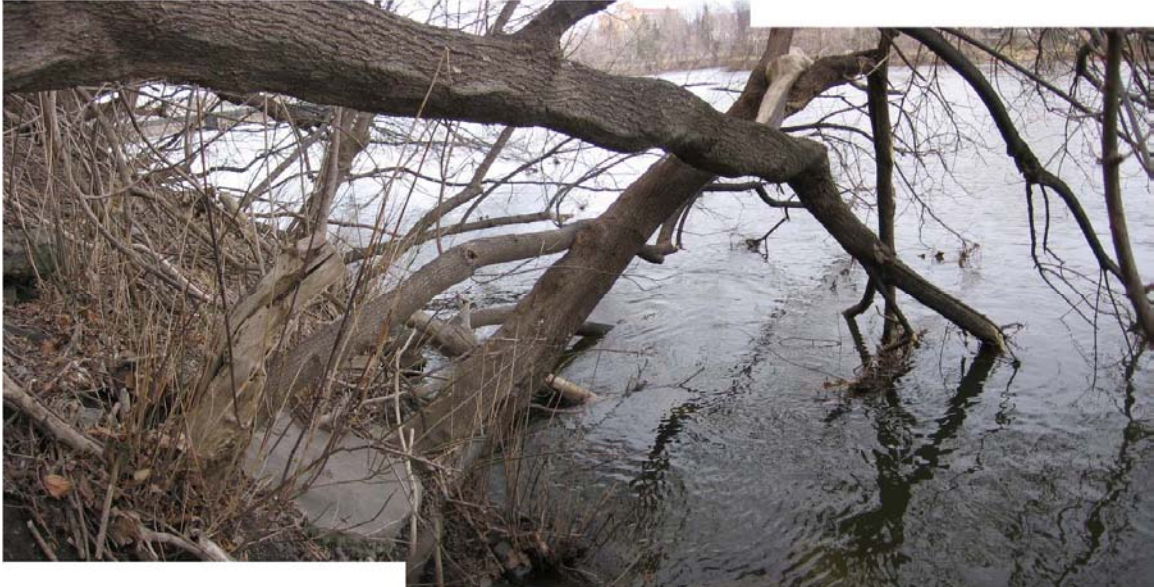
Photo 5. View along the foreshore of the Rideau River, looking downstream from the upstream side, on March 25, 2010.

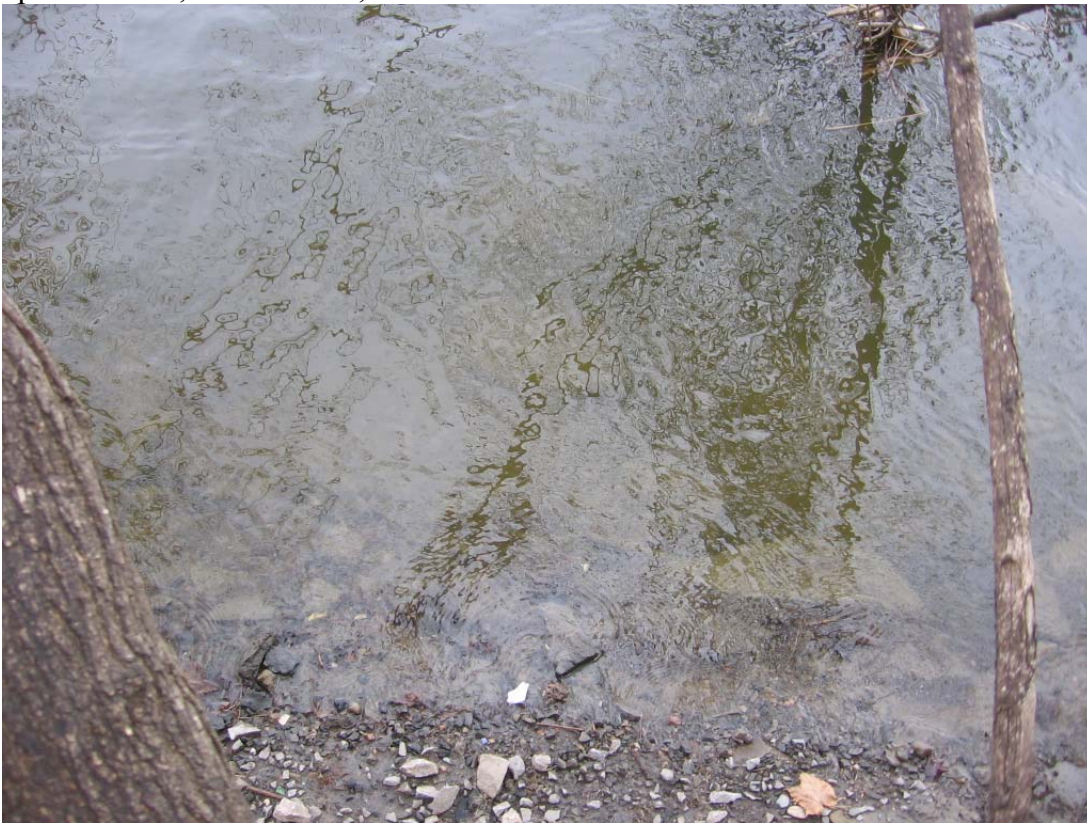
Habitat Resiliency	<ul style="list-style-type: none"> • The shoreline habitat currently present at the site is a mix of broken concrete and related granular material, along with a mix of fine particle substrate and gravel, as indicated in Photos 6, 7 8, 12, 13 and 16 in Appendix 1. It can be seen from the photos that the gravel is fairly embedded. • The shallow littoral habitat is comprised of a sloping silty substrate (Photos 14 and 15), with some large woody debris present. • The Manitoba maples overhang the shoreline providing shade. There is virtually no understory. • Generally, along this section of river, the littoral habitat (Photos 10 and 11) is similar to that depicted in Photos 6, 7 and 8 in Appendix 1. The property immediately downstream has a concrete retaining wall however (Photo 10). • Golder Associates (2010) indicates that the existing bank is erosional and the slope is unstable. This was also noted in the site visits reported upon in this report. Placement of rip-rap is intended to correct this ongoing source of habitat alteration. • Structure provided by large woody debris can be replaced by rip-rap. If necessary, large woody debris could be placed with the rip-rap. • Overhanging vegetation can be replaced with appropriate species of shrubs.

Photo 6. Close-up of the littoral zone along the front of the property showing substrate and degree of embeddedness - March 25, 2010

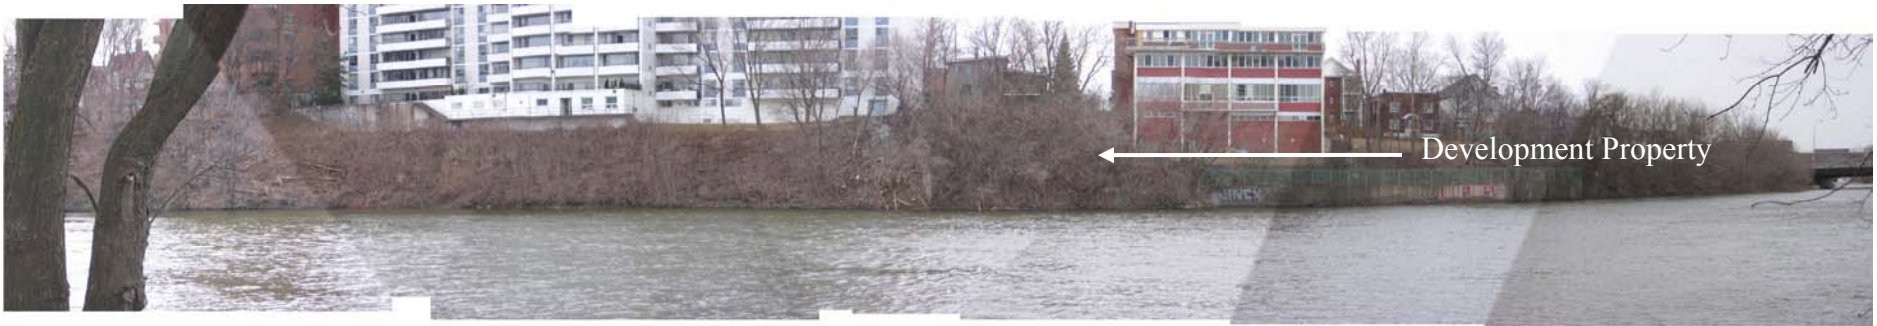
Photo 10. View of the property and adjacent shoreline from across the Rideau River - March 25, 2010.

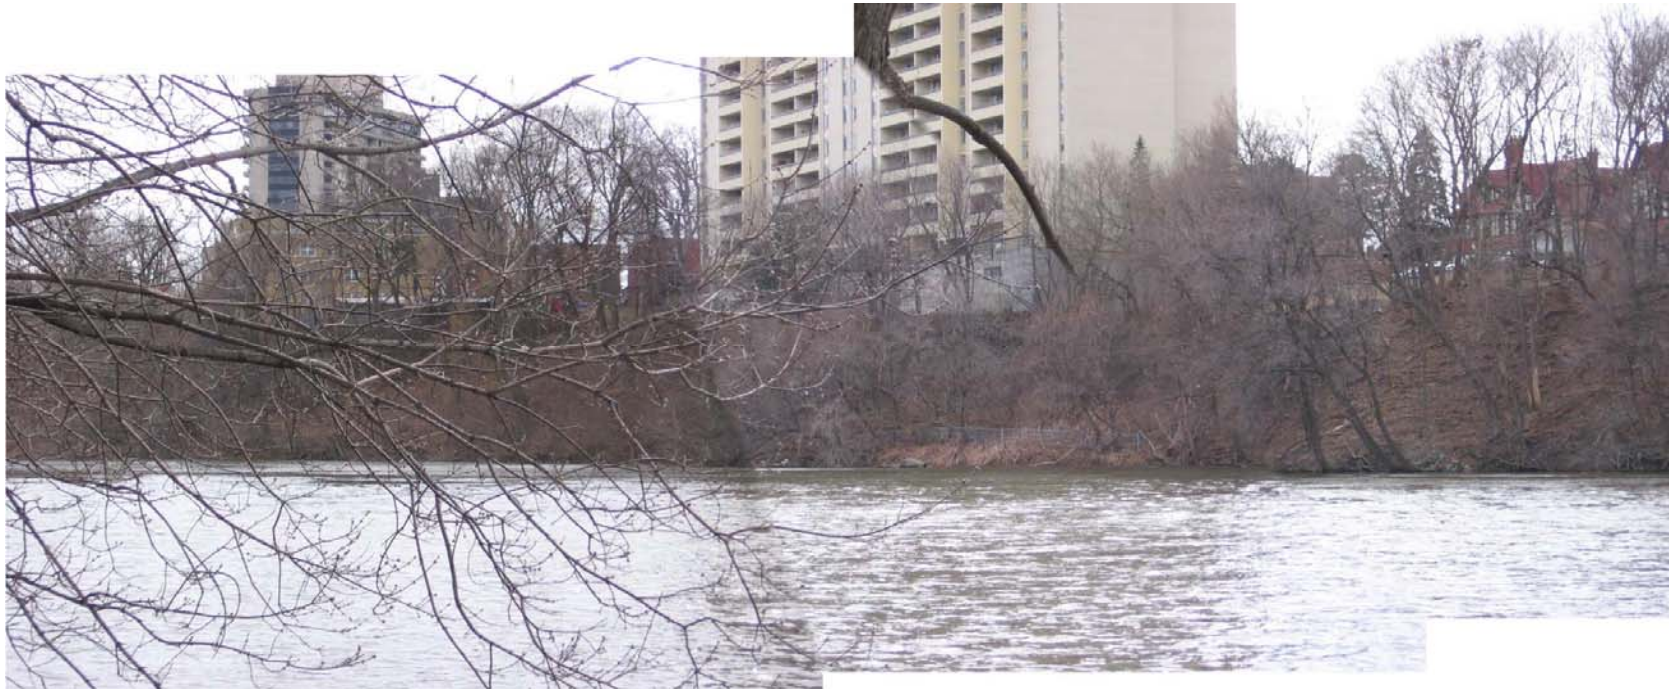
Photo 11. View of the upstream shoreline from across the Rideau River - March 25, 2010.

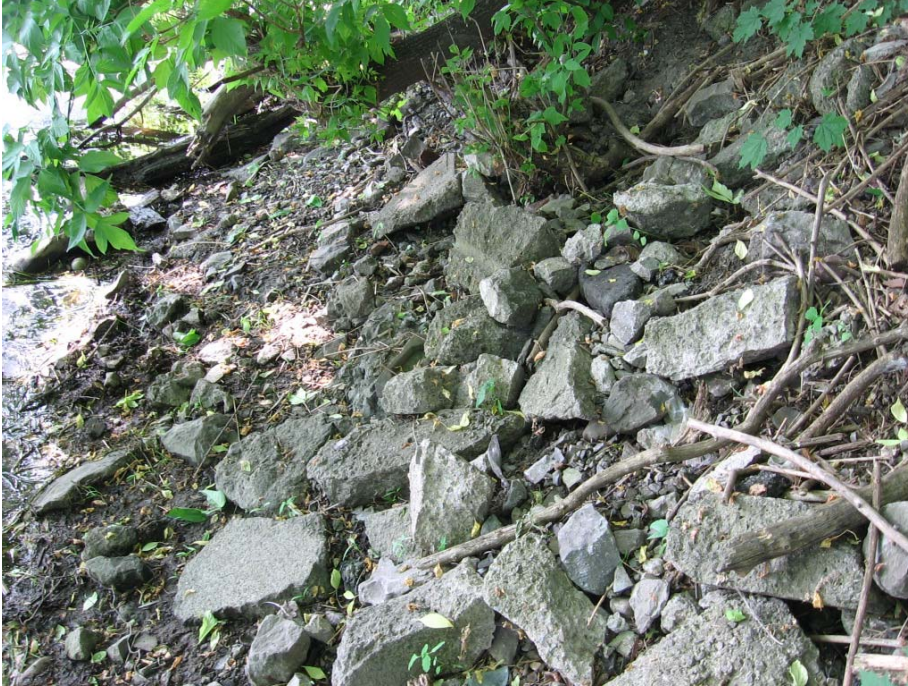
Photos 12 through 16 in Appendix 1 depict the Rideau River shoreline and shallow littoral zone along the property on May 25, 2010. From Photos 12, 13 and 16 it is apparent that the shoreline has a substantial component that is comprised of broken concrete and granular material. Photos 14 and 15 show the shallow littoral zone where the substrate is comprised of silty material. Some submergent aquatic vegetation and a minor amount of large woody debris were present.

Photo 12. Shoreline showing broken concrete that has been moving downslope toward the river – May 25, 2010.

Rip-rap at the toe of the slope would extend approximately 2 meters into the littoral areas of the adjacent Rideau River for a distance of 17.3 meters. Approximately 35 square meters of fish habitat would be altered by the placement of rip-rap at the toe of the slope. Rip-rap would also be placed on the slope itself, meaning that existing vegetation would be removed. Trees would be planted along the toe of the slope, through spaces between the rip-rap.

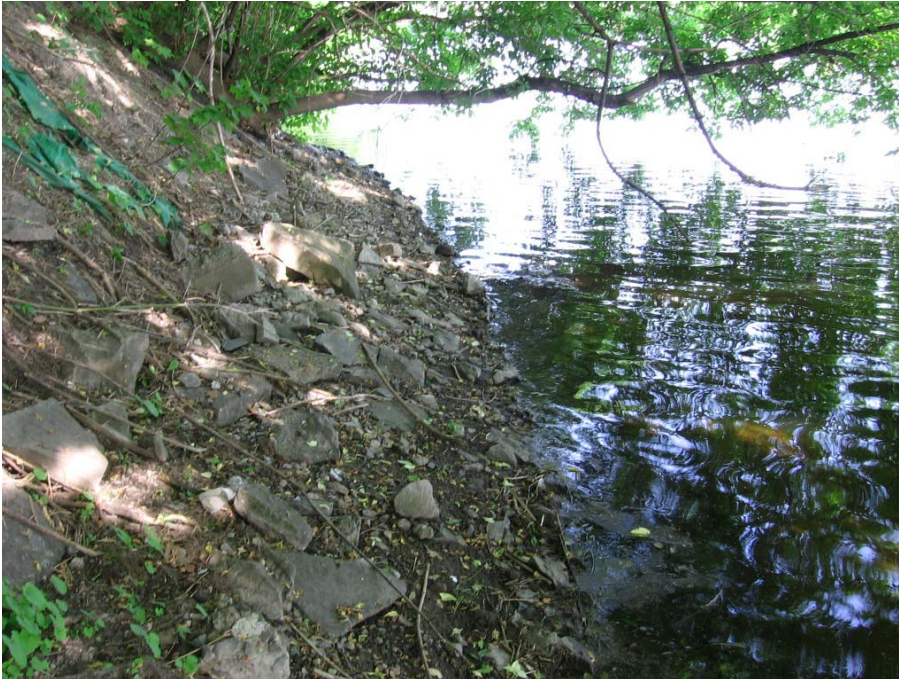
Photo 13. Shoreline showing broken concrete and unconsolidated material that has been moving downslope toward the river. While the Manitoba maples provide overhead shade, the shoreline itself lacked riparian vegetation – May 25, 2010.

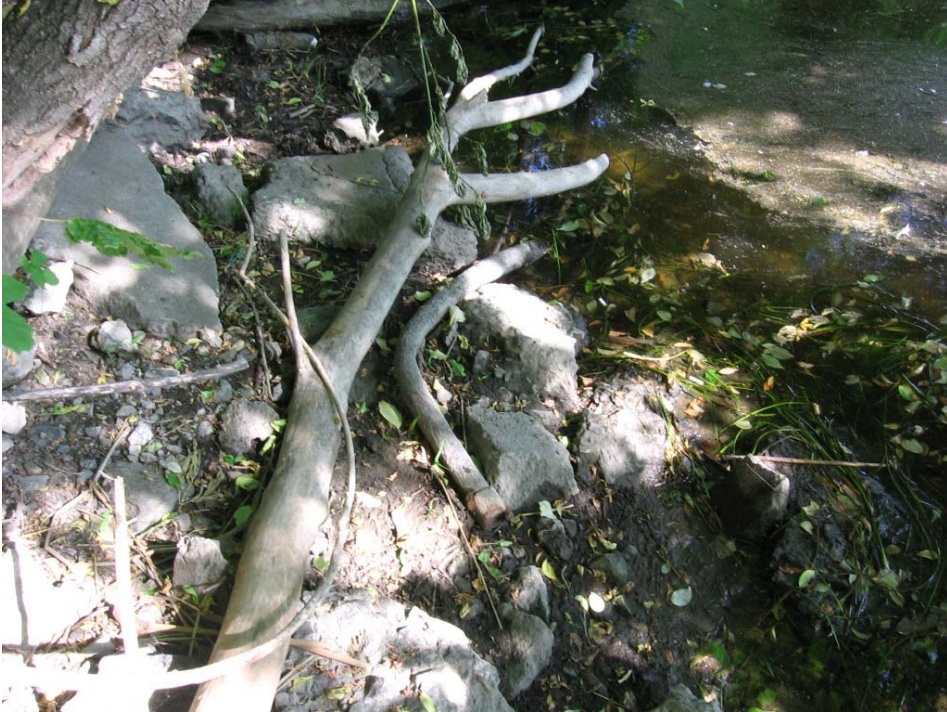
Photo 16. Riparian zone – May 25, 2010.

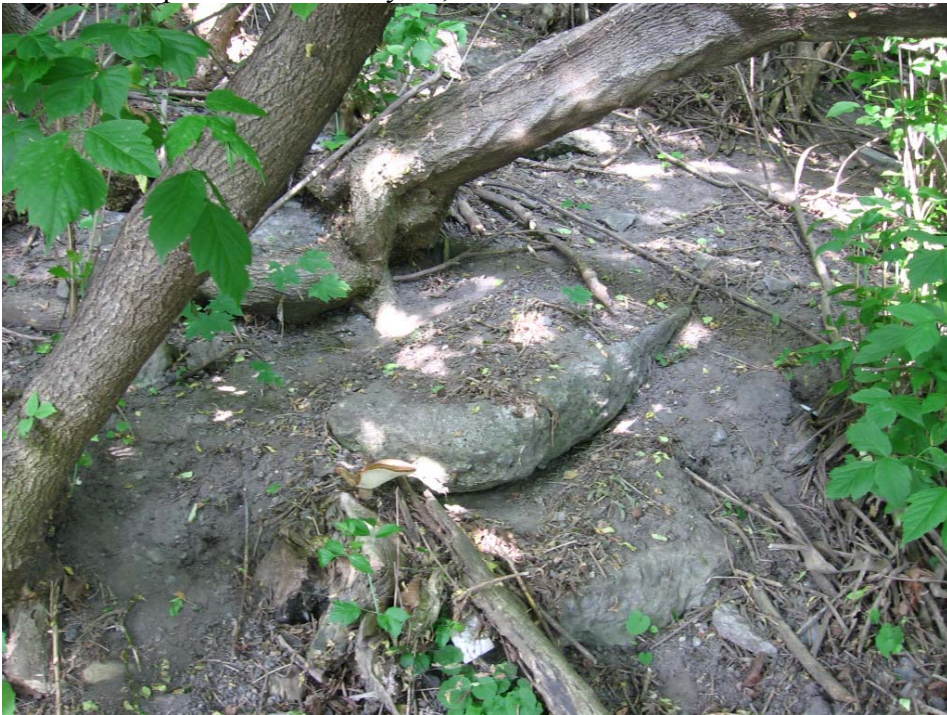
The habitat currently present at the site is a granular mix of fine particle substrate and gravel, and the gravel is fairly embedded. The existing bank is considered erosional and the slope is unstable. Placement of rip-rap is intended to correct this ongoing source of habitat alteration. The habitat change resulting from the project represents a very small proportion of habitat along this section of the Rideau River. It is not apparent that the relevant habitat contributes in any unique or critical manner to the productive capacity of species found in this section of the Rideau River. The habitat changed by the project represents a very small proportion of similar habitat along this section of the Rideau River. The relevant habitat is not considered rare. Species at risk were not identified in this section of the Rideau River.

Photo 17. Eroding slope above the shoreline – May 25, 2010.

- Grading the slope to the angle required to ensure stability;
- Stabilizing the slope with rip-rap; and
- Stabilizing the toe of the slope at the Rideau River with rip-rap.
