BIOLOGICAL INVESTIGATION OF DEVELOPMENTAL SETBACK FOR ARCADIA LANDS DEVELOPMENT, FEEDMILL CREEK, KANATA, ONTARIO

Report Number: 11-1126-0054

Subject: **Geotechnical Limit of Hazard Lands
Arcadia Lands - Kanata West
Huntmar Drive - Ottawa**

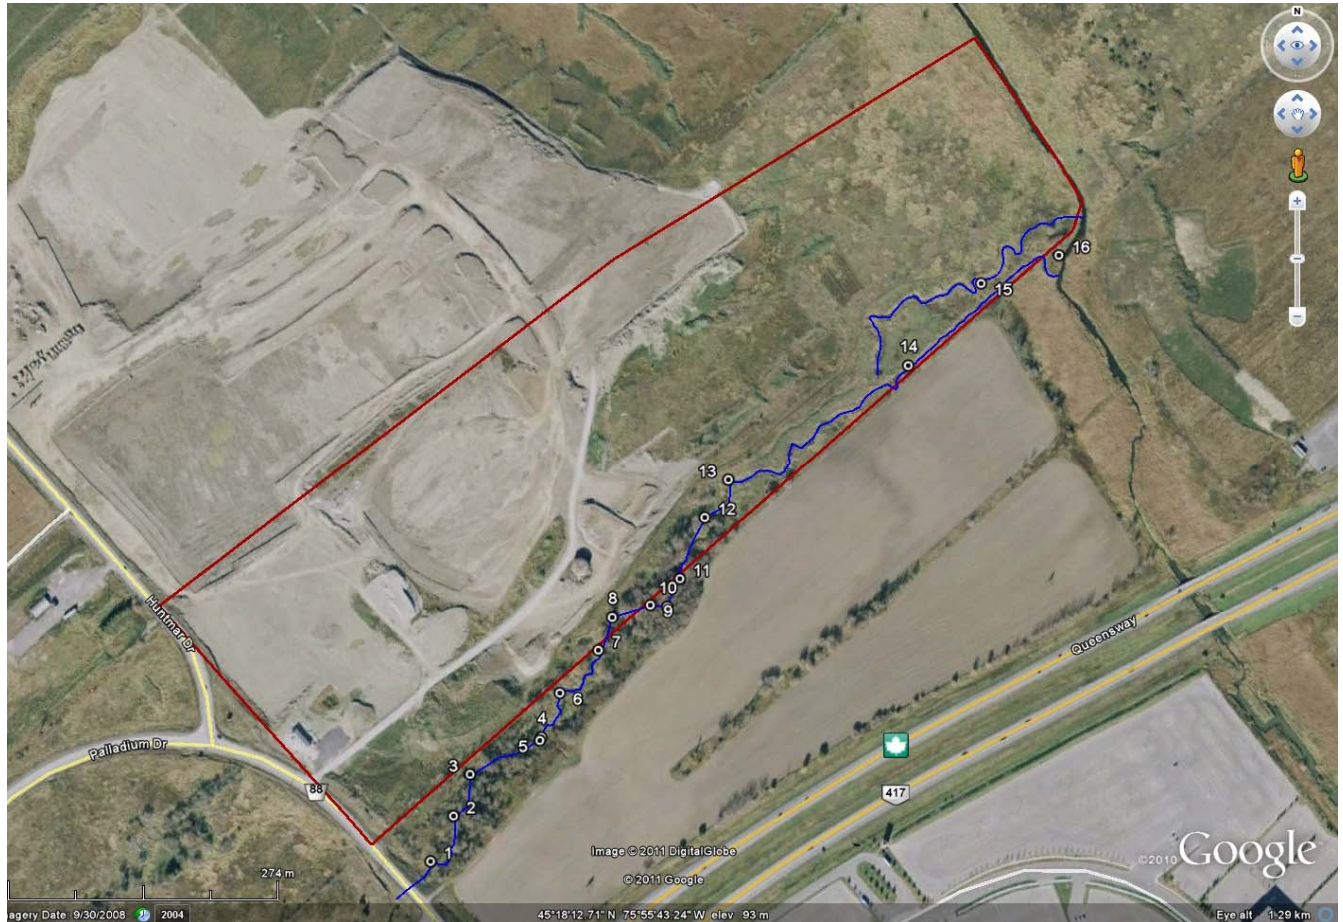
Figure 1: Waypoint Locations

The Site is located at Part Lot 3, Con 1 City of Ottawa. It is situated on Huntmar Drive. The Site is approximately 14.65 hectares in size. The Site is west of the Carp River. The adjacent land uses include inactive agricultural lands and riparian forests along portions of Feedmill Creek (Figure 1).

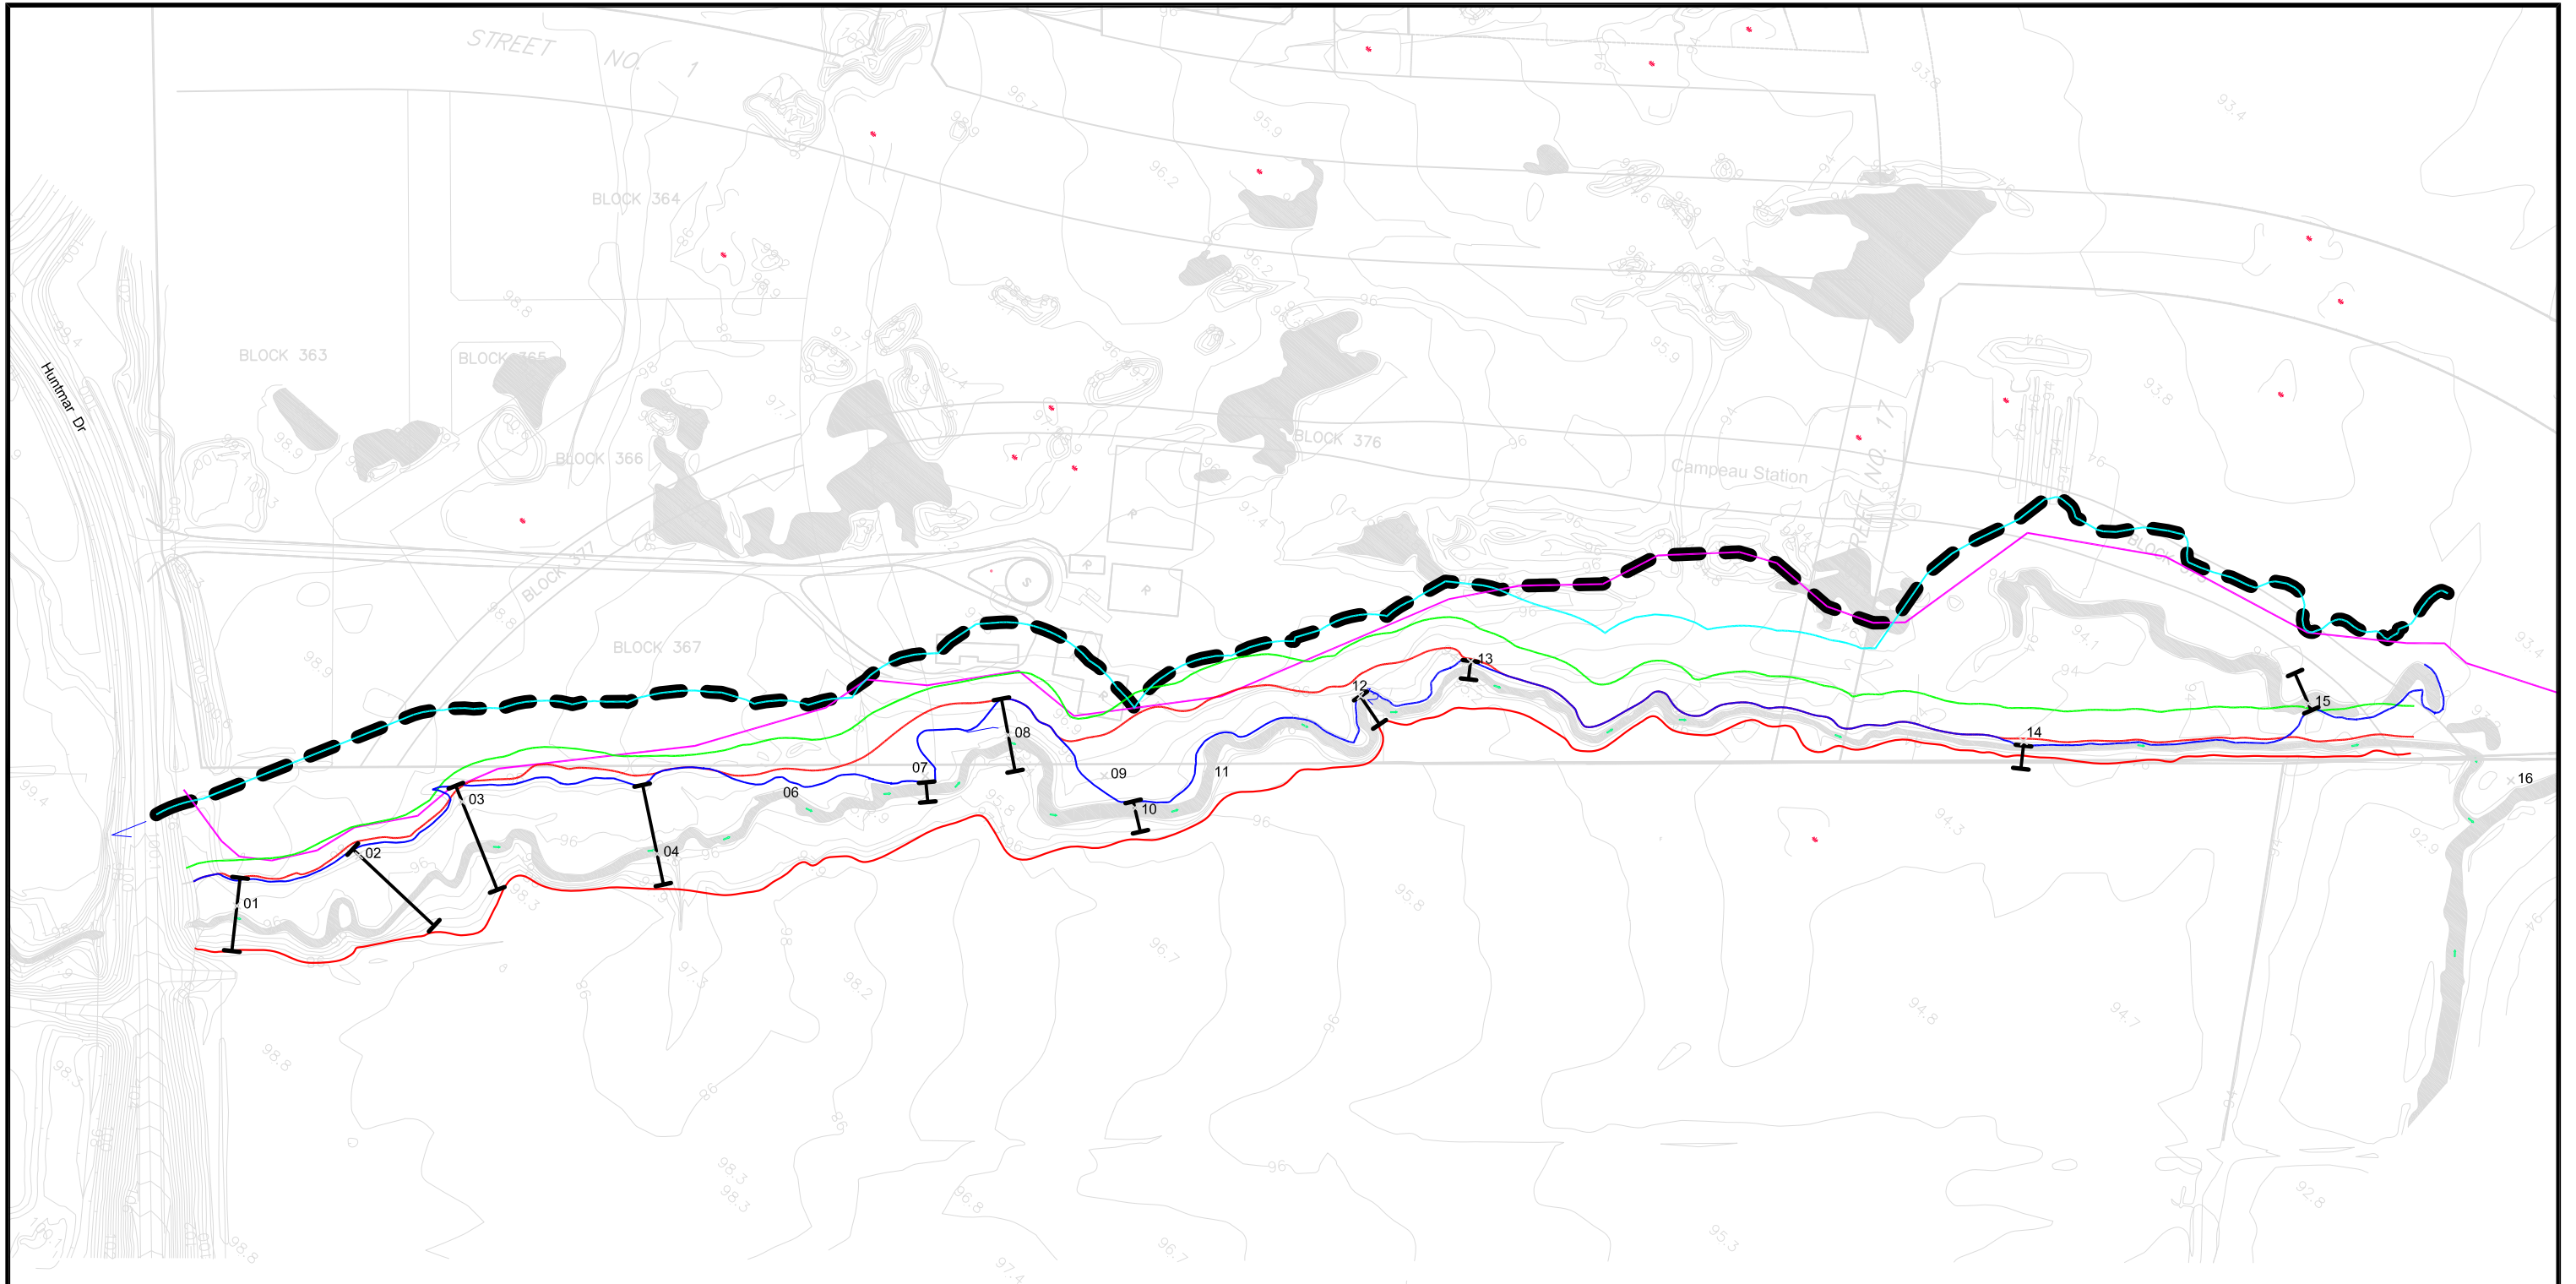
Figure 2 summarizes the Feedmill Creek setback recommendations. Based on the current biological conditions of the creek in both reaches and hazard land determination provided by Paterson, it is recommended that a 30 metre set back from the normal high water mark on either side of the watercourse for the 400 metre riparian fringed section be established (waypoints 1 through 12). This setback will ensure protection and continued functioning of the riparian vegetation as well as conform to the 30 metre setbacks necessary to support the target of a Type I fish community per the Carp River Watershed/Stubwatershed Study (Robinson Consultants Inc. 2004). A setback of 30 metres also conforms to the Schedule K requirements of the City of Ottawa Official Plan. From waypoint 13 to approximately 30 metres west of the secondary channel of Feedmill creek the greatest setback limit is that of the existing floodplain line scaled from flood plain maps and it is suggested that this be the minimum corridor limit. From this point forward, it is recommended that a corridor limit of 30 metres from the secondary channel of Feedmill Creek be maintained. This will ensure the natural dynamic behaviour of the creek is maintained and complies with the recommendation that this secondary channel be preserved (TSH 2006). This will also allow for the prescribed riparian planting that is to cover 75% of the corridor lands (Robinson Consultants Inc. 2004).

Due to the history of the restoration projects in the area, the corridor setbacks for Feedmill Creek have been recommended previously. The 2006 EA and 2004 Watershed study recommended a 70 metre corridor setback based on a 40-80 metre meander belt calculation. The Kanata West Implementation Plan, Appendix B provided rationale for a 100 metre wide corridor based on meander belt allowance and 30 metre setback within the reach of Feedmill Creek within the grassy fields. For the section of the creek exhibiting riparian cover, a 70-80 metre corridor was defined based on the meander belt width plus pathway requirements.

Since previous corridor limits were completed some years back, up-to-date corridor limits based on existing conditions are needed to finalize the Minto Arcadia Design plans for the blocks 368, 371 and 374. To assist in the determination of corridor limits, pictorial representation of the creek at each waypoint as observed during the site visit on July 6th, 2011 was completed (Appendix B). The measurements in these images are estimates only. An official survey must be completed to confirm these widths in order to properly incorporate the requirements in the final design drawings.
