Subject: **Phase I - Environmental Site Assessment**
175 Richmond Road
Ottawa, Ontario

Phase I - Environmental Site Assessment

175 Richmond Road
Ottawa, Ontario

Report: PE2357-1

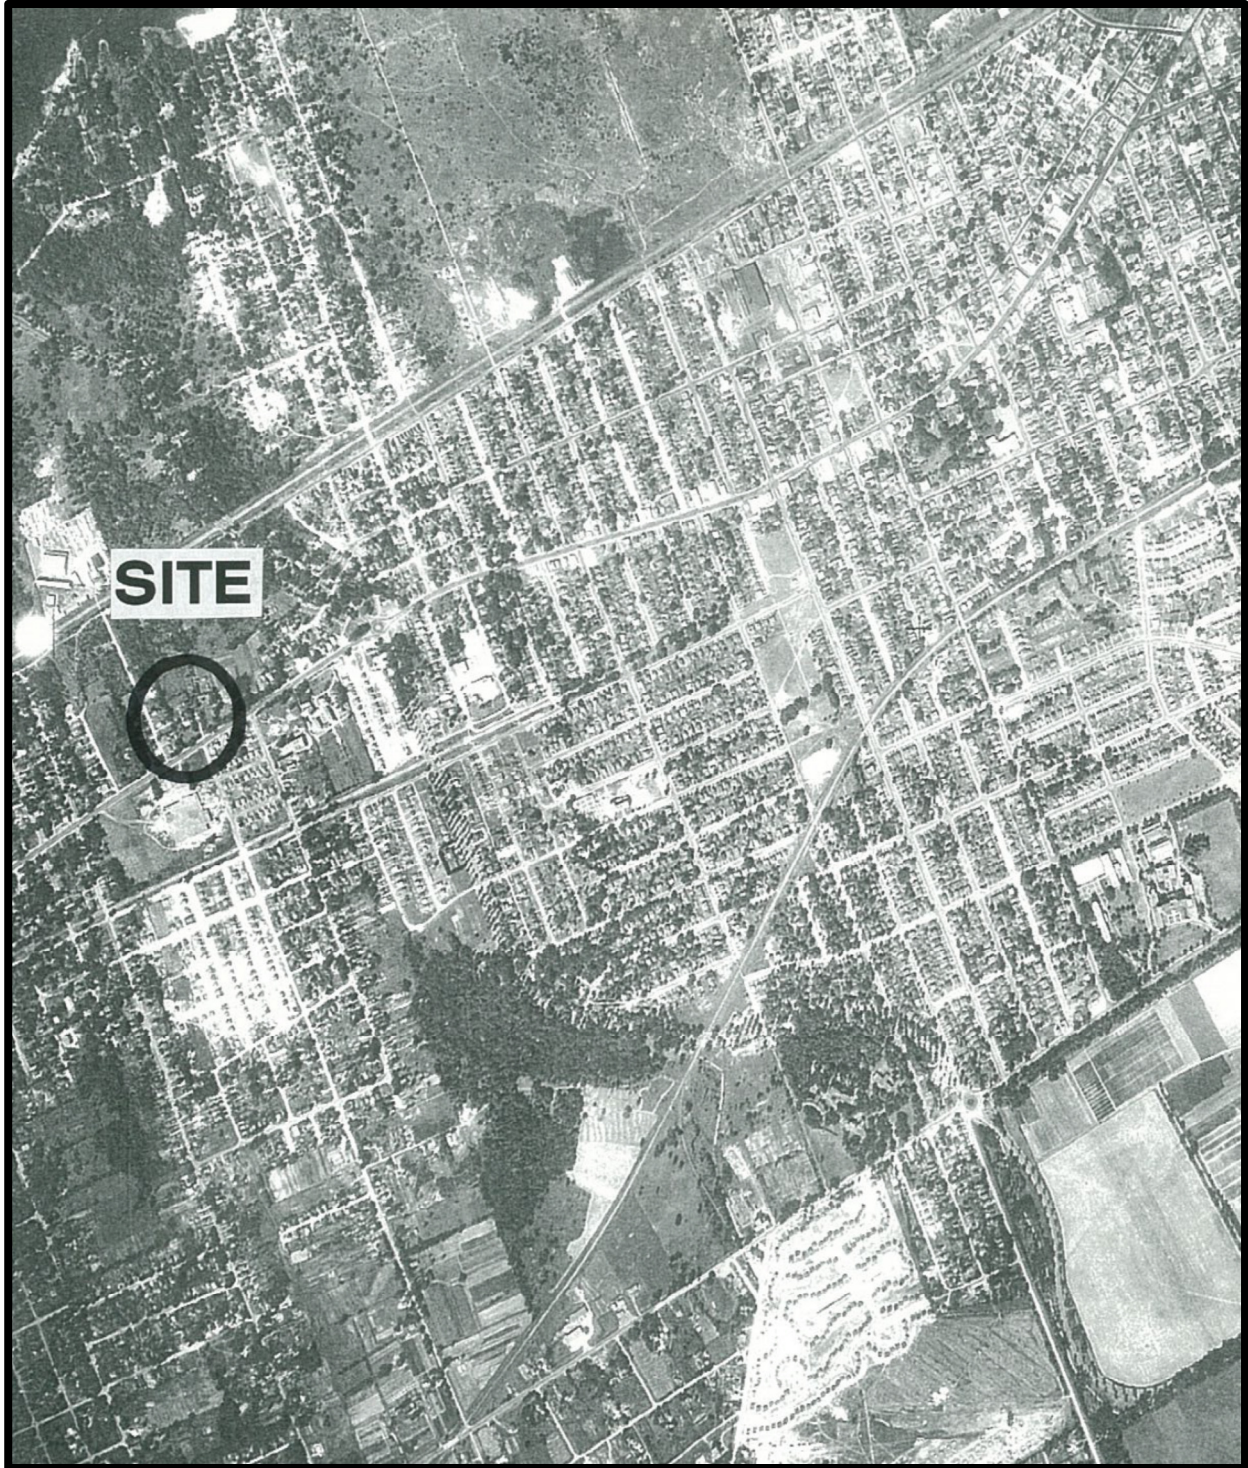
AERIAL PHOTOGRAPH
1946

An aerial photograph from 1946 show the presence of what appears to be at least one (1) residential structure on the central portion of the subject site. It should be noted that the photograph is too poor in scale to show any significant details. Aerial photographs from 1953 through 2008, clearly show the subject structure. City directories, which were reviewed at the National Archives as part of this assessment, indicate that the subject property was first listed with the existing structure in 1952, at which time it was occupied by Canadian General Electric Company. According to the directories, the subject site remained occupied by Canadian General Electric until 1978. The property was subsequently listed as vacant in 1979, and has been listed as various commercial businesses (retail and offices) since 1980. For the purposes of this report, the subject property was first developed for residential purposes in the early 1900's until developed with the existing structure circa 1950.
