**PHASE ONE
ENVIRONMENTAL SITE ASSESSMENT
PROPOSED COSTCO FUEL OUTLET
KANATA COSTCO
OTTAWA, ONTARIO**

Prepared For: Costco Wholesale
45940 Horseshoe Drive, Suite 150
Sterling, VA, USA
2016620

File No. 13-11-6171
December 12, 2011

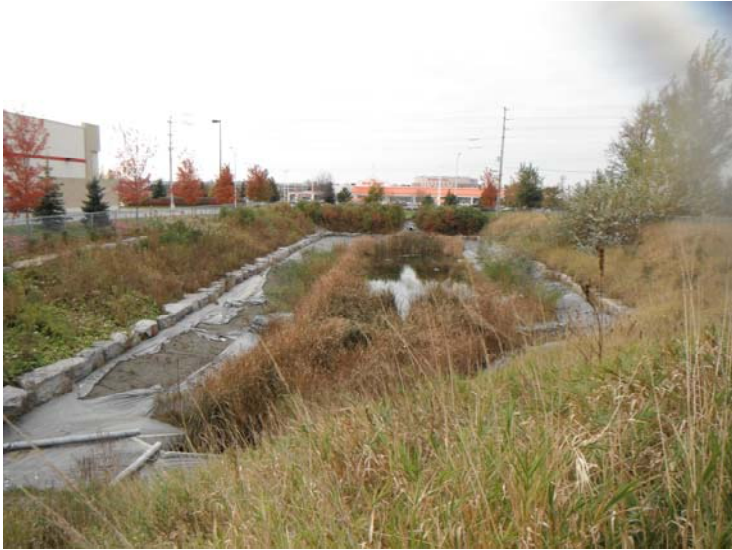
Photograph #1

The majority of the property is occupied by a storm water management pond with an inlet on the eastern property boundary and an outlet on the western property boundary. No other waste water or sewage works were noted on the Phase One Property at the time of inspection.

View looking west from the eastern property boundary at the storm water management pond (SWMP).

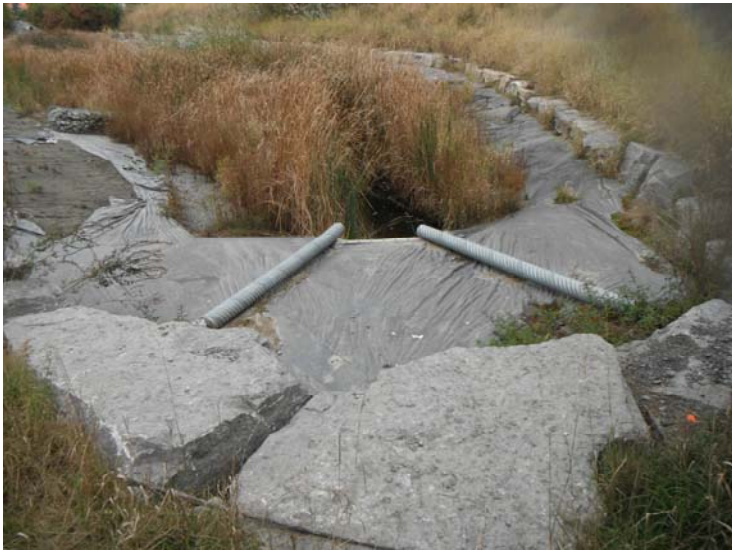
Photograph #2

View of inlet to SWMP on the eastern portion of the subject property.

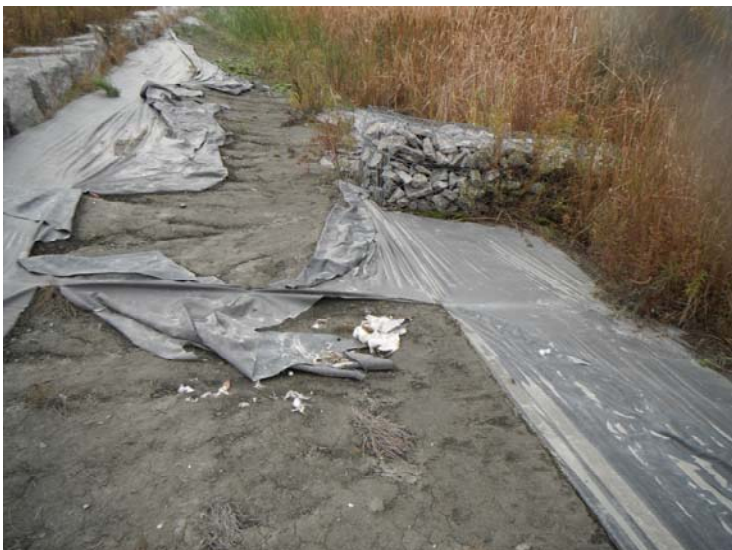
Photograph #3

The Phase One Property consisted of a storm water management pond and landscaped area at the time of inspection. Quarried rock and rock-filled gabions were part of the erosion control for the storm water management pond. Details of the ground surfaces observed during the site inspection are shown in the Site Plan, Figure 2.

View of the gabion and erosion control on measures along the perimeter of the SWMP.

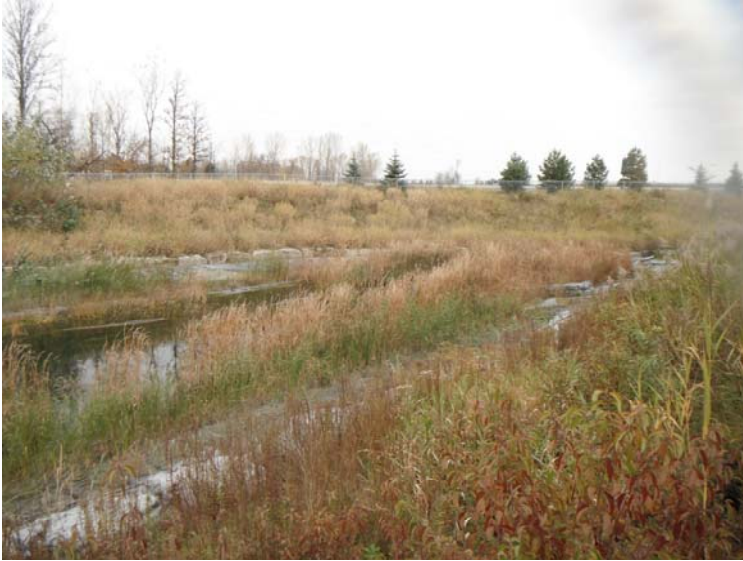
Photograph #4

View looking east across the SWMP from the southwest property boundary.

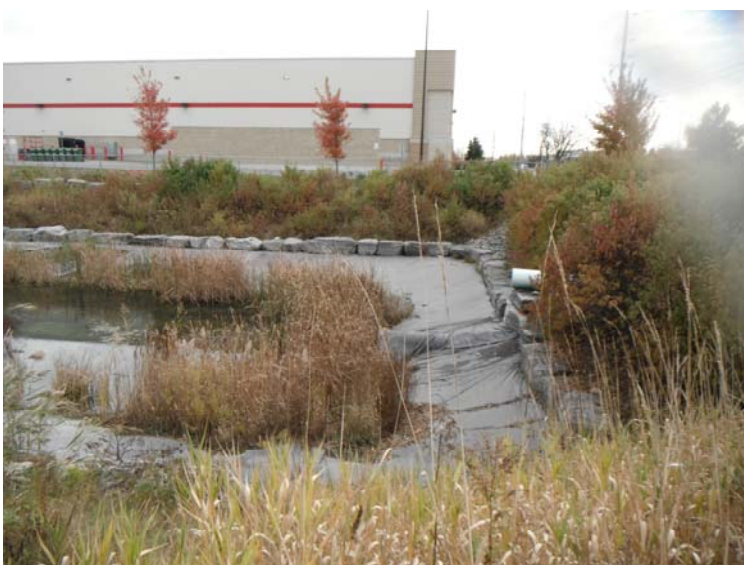
Photograph #9

View of a storm sewer outlet to the storm water management ponds located on the western portion of the property.
