## **Phase II Environmental Site Assessment**

Residential and Commercial Properties  
250, 252, 254, 266, 268, 272, and 274 Parkdale  
Avenue, 9, 11, and 13 Bullman Street,  
And 1518 Scott Street, Ottawa, Ontario

April 16, 2014

Report: PE2967-5

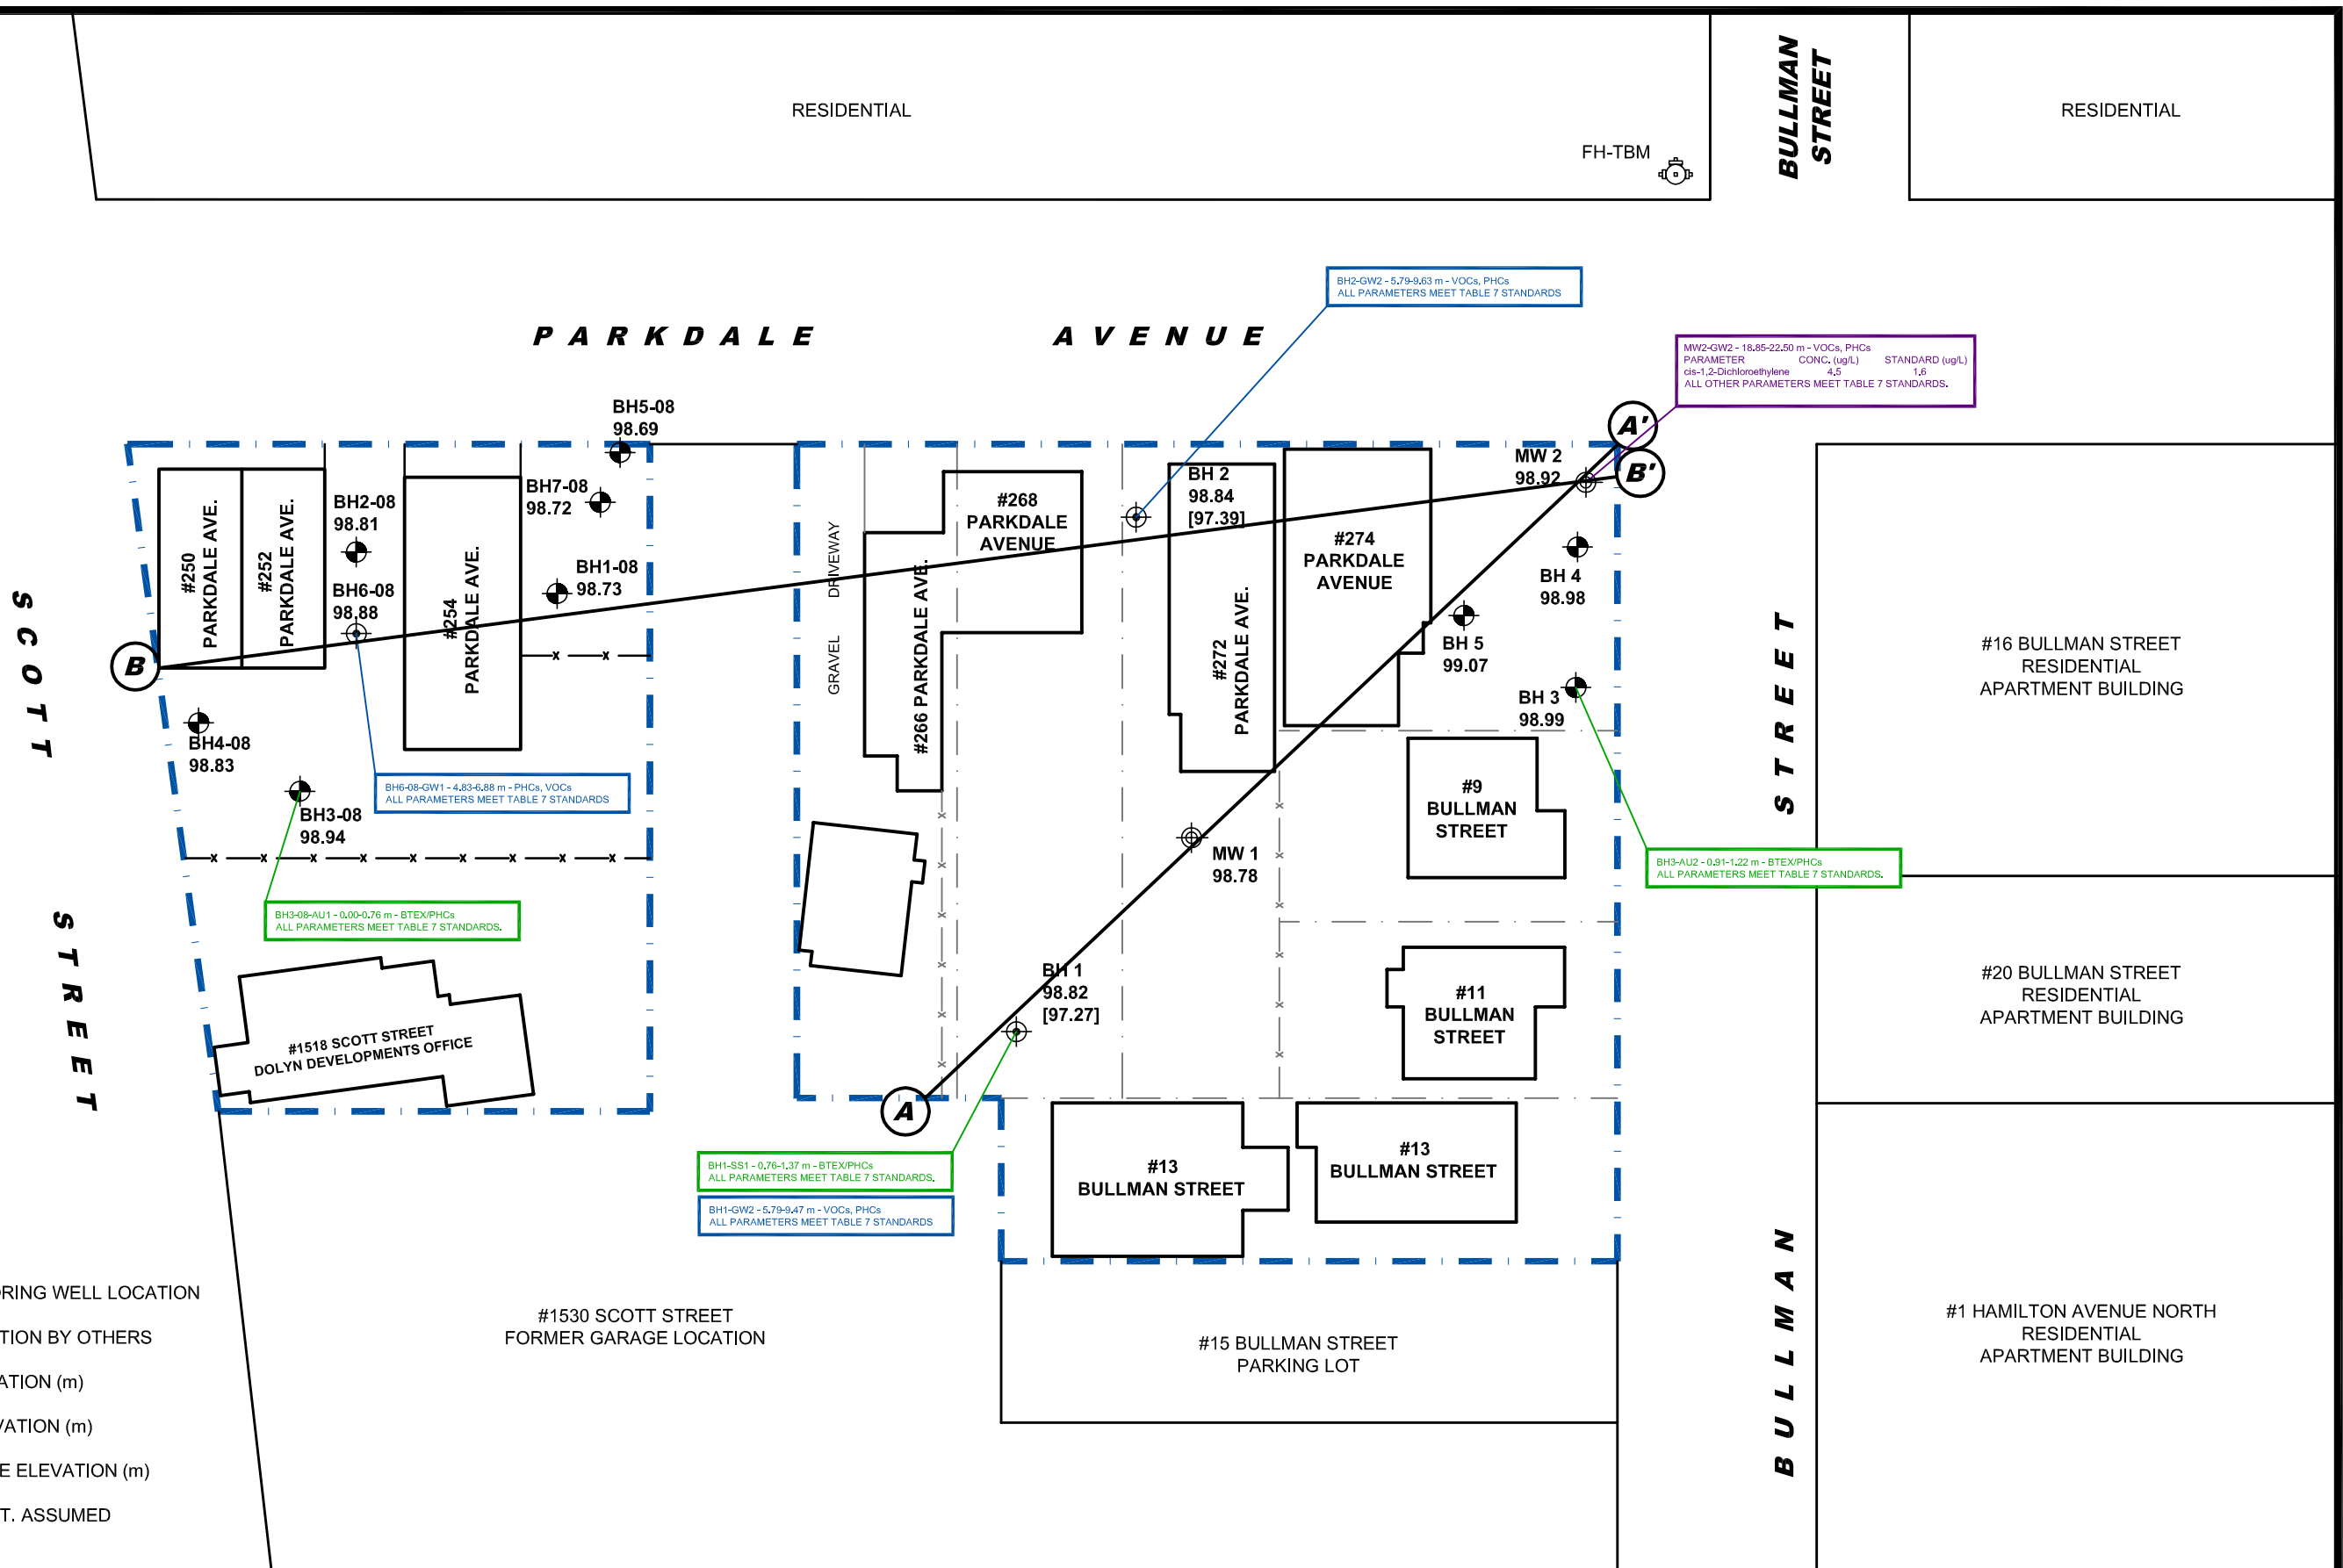
**TEST HOLE LOCATION PLAN**

- LEGEND:**
- BOREHOLE LOCATION
  - BOREHOLE WITH MONITORING WELL LOCATION
  - MONITORING WELL LOCATION BY OTHERS
  - 98.82 GROUND SURFACE ELEVATION (m)
  - [97.27] BEDROCK SURFACE ELEVATION (m)
  - (97.0) GROUNDWATER SURFACE ELEVATION (m)
  - TBM - TOP SPINDLE OF FIRE HYDRANT. ASSUMED ELEVATION = 100.00m

Paterson has completed a Phase I ESA for the subject site, provided under separate cover. This report also incorporates the findings of a subsurface investigation completed by Paterson for 250, 252, and 254 Parkdale Avenue in 2008. Additionally, two (2) monitoring wells were present on the southern portion of the subject site from a previous geotechnical investigation by Stantec, discussed in the Phase I ESA. The existing borehole locations are shown on Drawing PE2967-8 - Test Hole Location Plan.

The subsurface investigation on the northern portion of the subject site was conducted on November 28, 2008, and consisted of the drilling of seven (7) boreholes on the subject site. The subsurface investigation on the southern portion of the subject site was conducted on June 10, 2013, and consisted of the drilling of five (5) boreholes on the subject site. The boreholes were placed to provide general coverage of the property and to address the aforementioned areas of potential environmental concern. The boreholes were advanced using a truck-mounted CME 75 power auger drill rig (2008 investigation) and a truck-mounted CME 55 power auger drill rig (2013 investigation). The drilling contractor was George Downing Estate Drilling of Hawkesbury, Ontario. Drilling occurred under full-time supervision of Paterson personnel. Borehole locations are shown on Drawing No. PE2967-8 – Test Hole Location Plan, appended to this report.

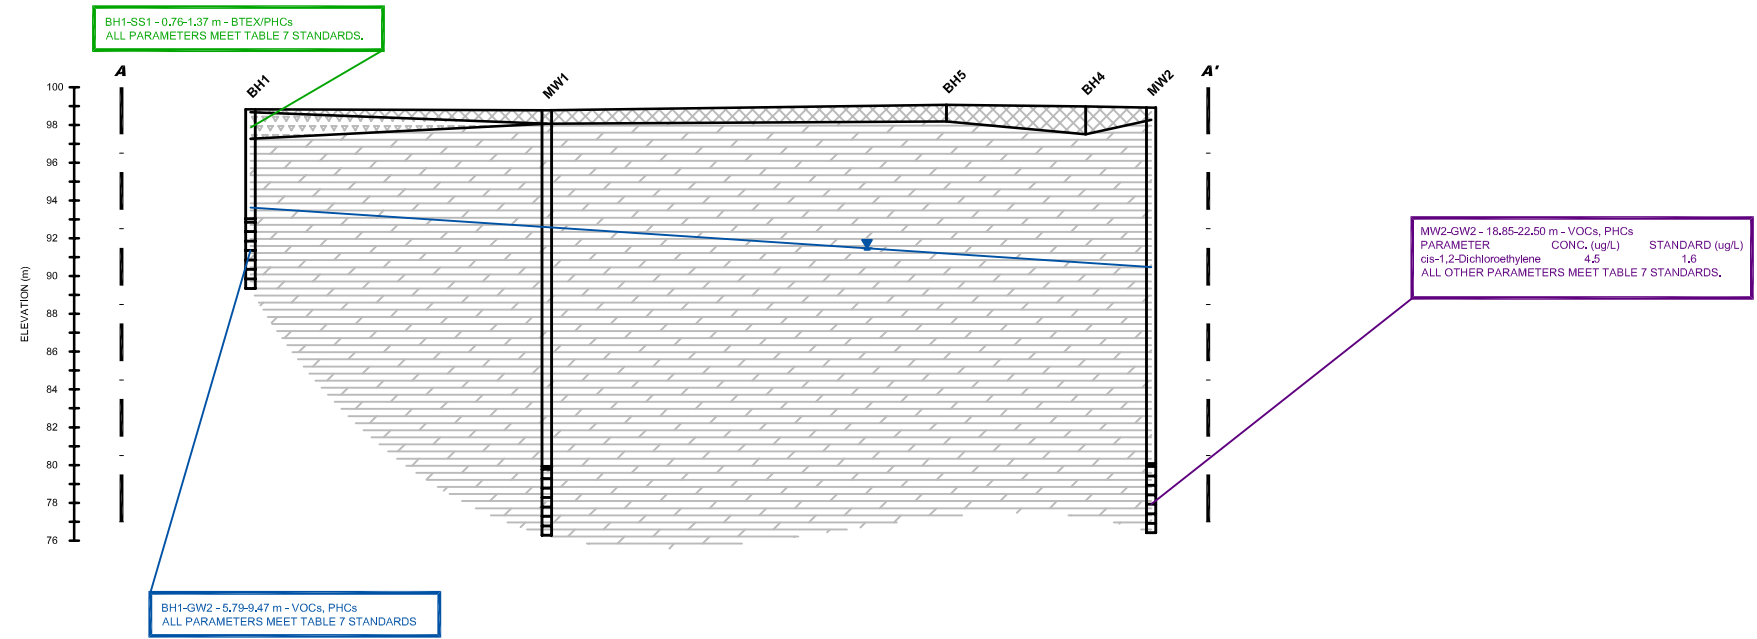
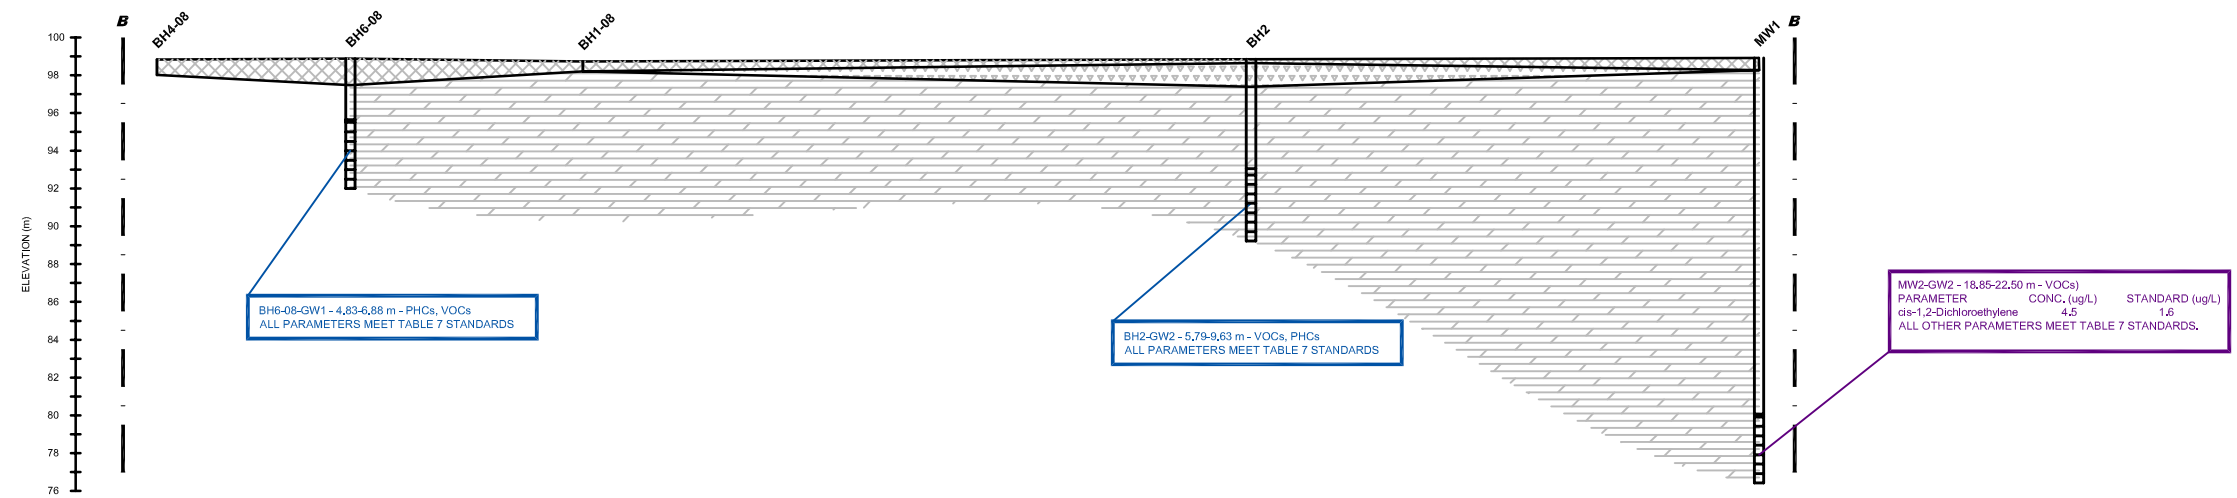
**DRAWING PE2967-9 - CROSS-SECTIONS**

- LEGEND**
- FILL: SILTY SAND AND GRAVEL
  - GLACIAL TILL: SILTY SAND MATRIX WITH CLAY, GRAVEL, COBBLES
  - LIMESTONE BEDROCK
  - GROUNDWATER LEVEL, JULY 2013

- Fill, consisting of silty sand and gravel, varying in thickness from 0.15 to 1.8 m. Groundwater was not observed in this stratigraphic unit. The fill material was observed to extend to bedrock at BH3, BH4, and BH5.
- An intermittent layer of glacial till, not observed in BH3, BH4, and BH5. The glacial till material consists of a silty sand matrix with clay, gravel and cobbles. This layer varied in thickness from 1.3 to 1.4 m. Groundwater was not observed in this stratigraphic unit.
- Limestone bedrock of the Bobcaygeon Formation, encountered at depths ranging from 0.2 to 1.8 m. Groundwater was encountered in the bedrock unit, and the monitoring wells at BH6-08, BH1, BH2, and Stantec's MW1 and MW2 were screened in the bedrock unit. The upper fractured bedrock is considered to function as an aquifer at the subject site. This is the deepest unit investigated.

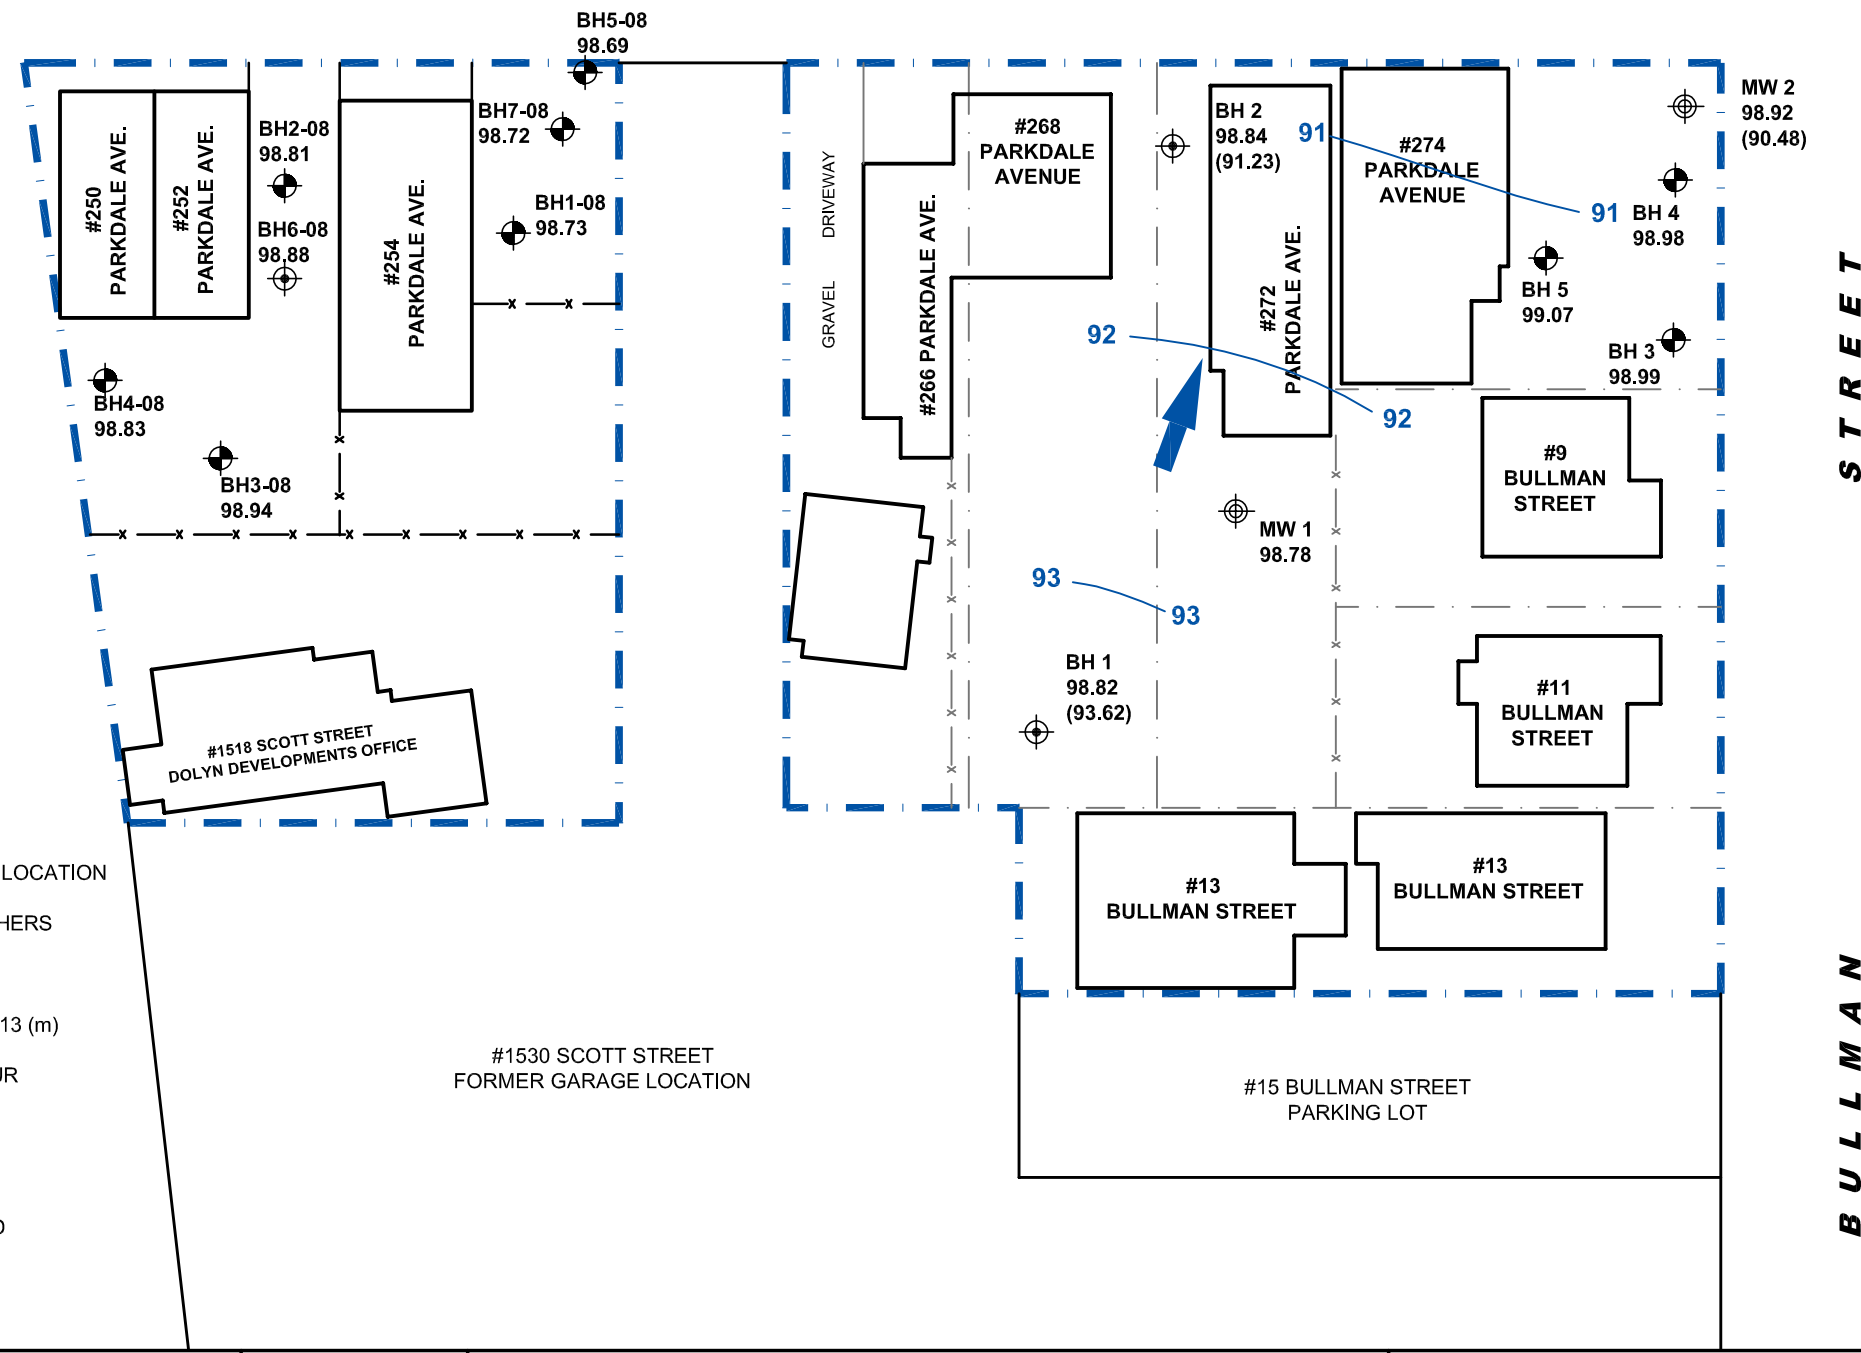
**DRAWING PE2967-10 - GROUNDWATER CONTOUR PLAN**

- LEGEND:**
- BOREHOLE LOCATION
  - BOREHOLE WITH MONITORING WELL LOCATION
  - MONITORING WELL LOCATION BY OTHERS
  - 98.82 GROUND SURFACE ELEVATION (m)
  - (97.0) GROUNDWATER ELEVATION, JULY 2013 (m)
  - 93 GROUNDWATER ELEVATION CONTOUR
  - GROUNDWATER FLOW DIRECTION
  - $i = 0.07 \text{ m/m}$  HYDRAULIC GRADIENT (m/m)
- TBM - TOP SPINDLE OF FIRE HYDRANT. ASSUMED ELEVATION = 100.00m

The migration of contaminants within the site groundwater is considered to be controlled by the hydraulic gradient within the bedrock aquifer. Given the observed hydraulic gradient, contaminants are interpreted to be migrating in a southeasterly direction.

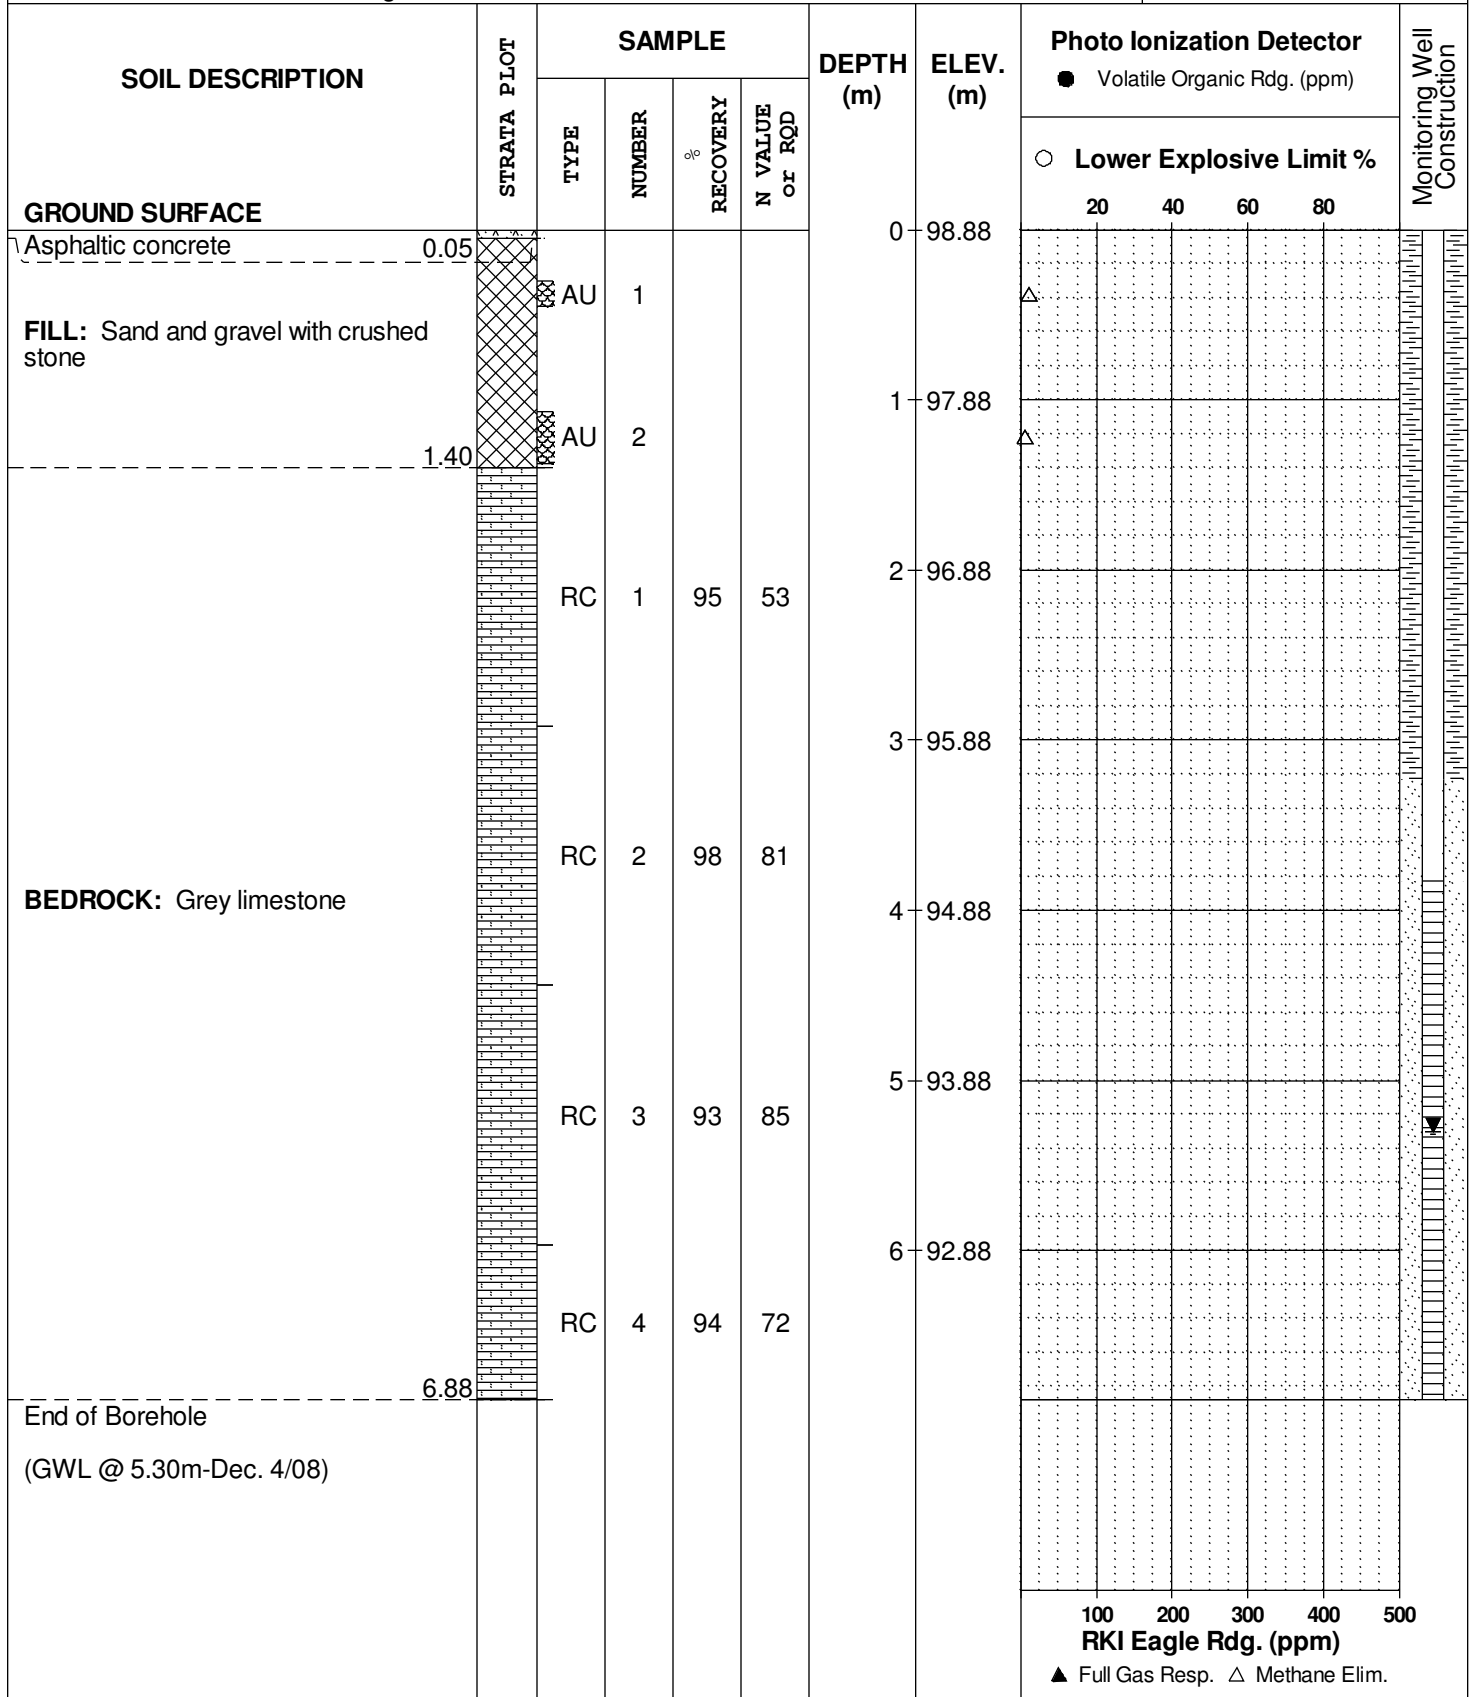
**HOLE NO.** BH 1

**BORINGS BY** CME 75 Power Auger

**DATE** November 28, 2008

**DATUM** TBM - Top spindle of fire hydrant, corner of Bullman Street and Parkdale Avenue.  
Assumed elevation = 100.00m.

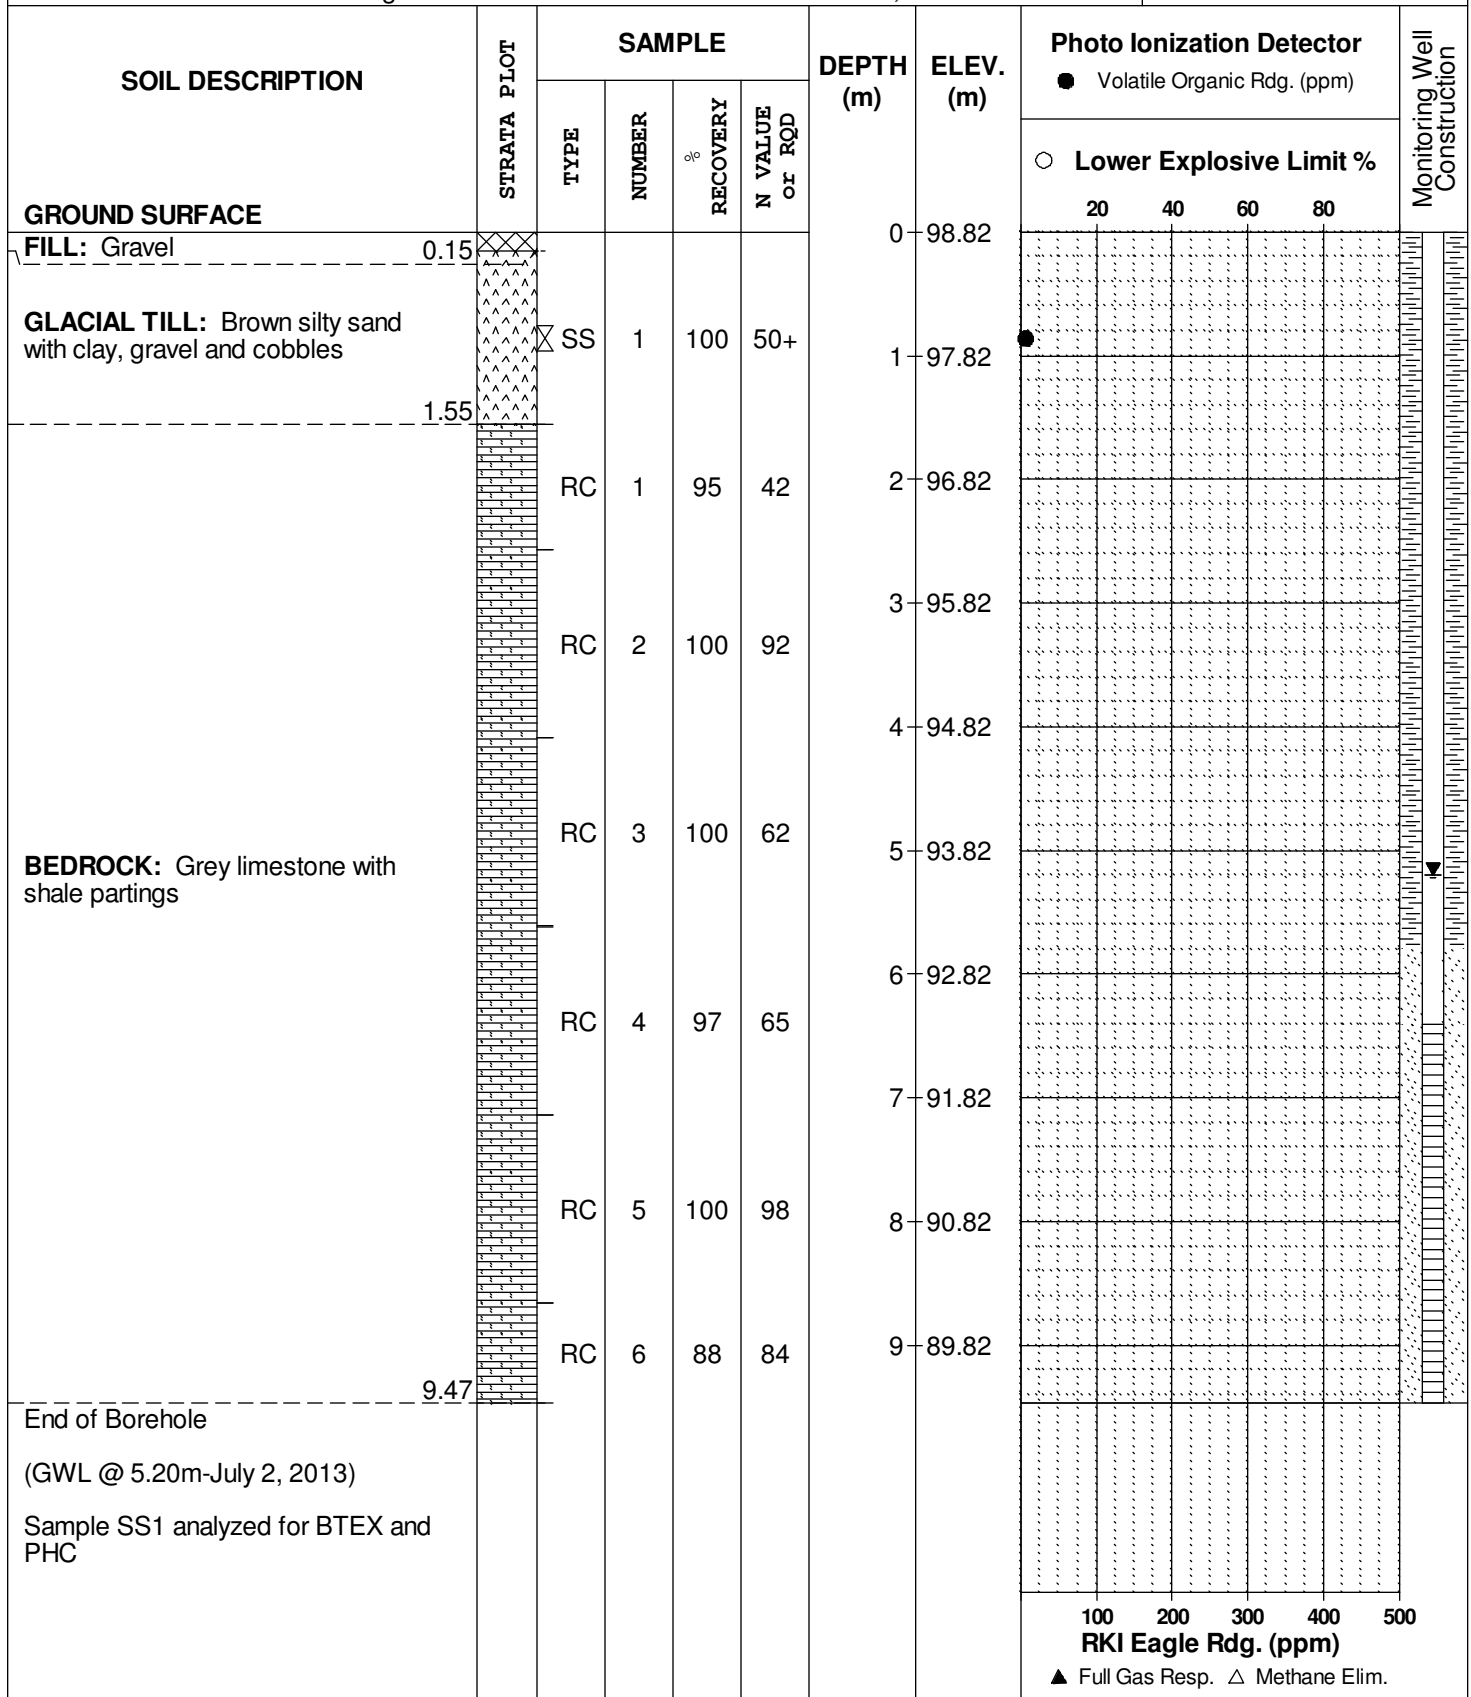
## SOIL PROFILE AND TEST DATA

Phase II Environmental Site Assessment  
266, 268, 272, 274 Parkdale Ave.; 9, 11, 13 Bullman St.  
Ottawa, Ontario

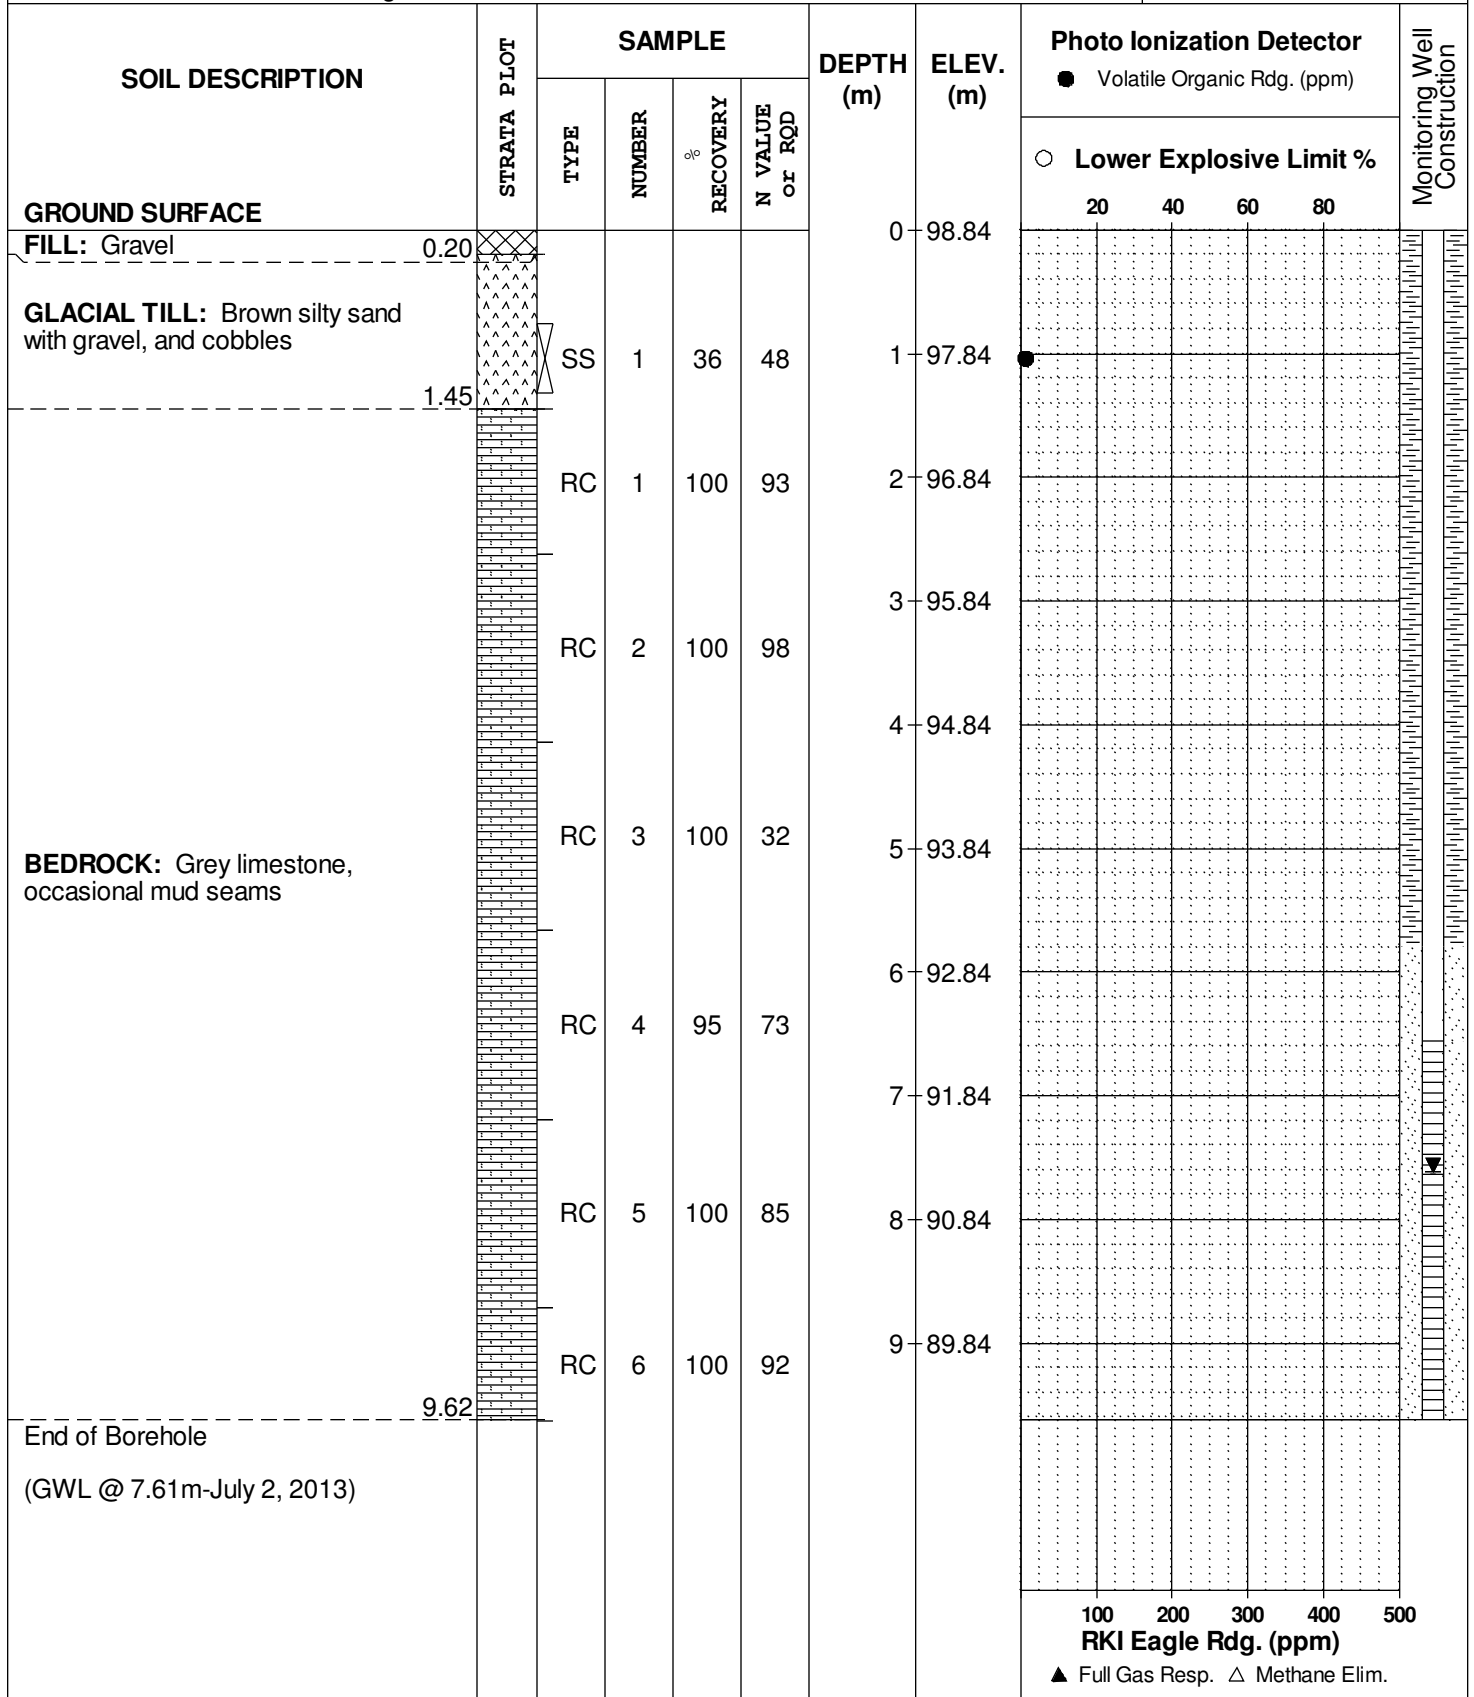
## SOIL PROFILE AND TEST DATA

Phase II Environmental Site Assessment  
266, 268, 272, 274 Parkdale Ave.; 9, 11, 13 Bullman St.  
Ottawa, Ontario
