## **Phase I Environmental Site Assessment**

Residential and Commercial Properties  
250, 252, 254, 266, 268, 272, and 274 Parkdale  
Avenue, 9, 11, and 13 Bullman Street,  
And 1518 Scott Street, Ottawa, Ontario

April 10, 2014

Report: PE2967-4

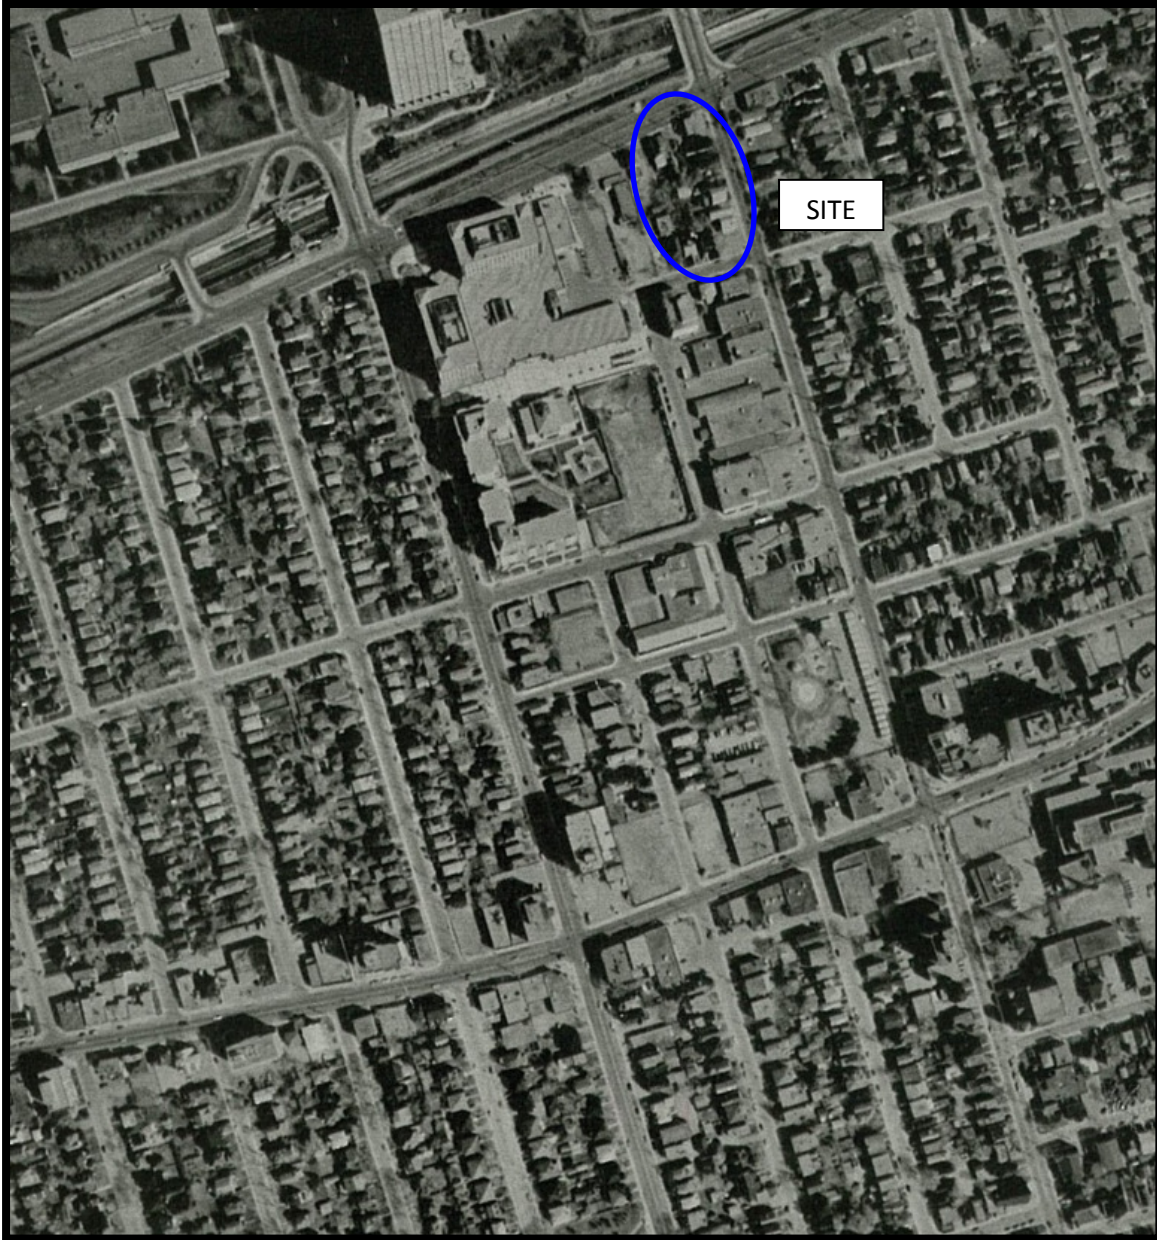
AERIAL PHOTOGRAPH  
1993

- 1993      No significant changes have been made to the subject site. The former Beach Foundry site has been redeveloped with a commercial building. No other significant changes have been made to the neighbouring properties.

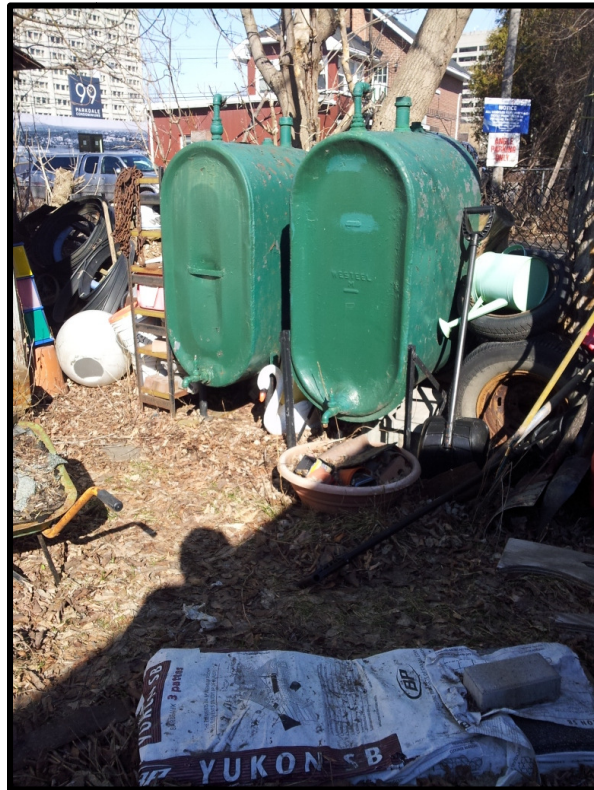
Two (2) single-walled steel aboveground storage tanks (ASTs) were observed along the north boundary of 266 Parkdale at the time of the site inspection. These tanks did not appear to be in use, but both contained a quantity of fuel oil. No apparent leaks, spills, or staining were observed in the vicinity of the ASTs.

Photograph 1: ASTs on the exterior of the subject site (266 Parkdale).

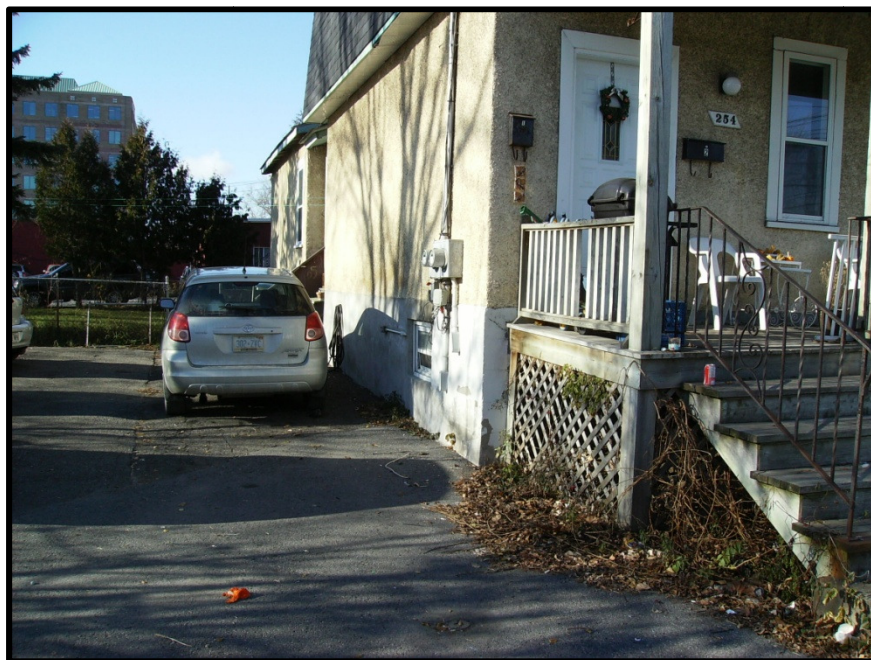
- 254 Parkdale Avenue: Residential dwelling containing two apartment units. The building is a two-storey wood frame structure with a sloped shingled roof, one basement level and a poured concrete foundation. The building is currently heated by a natural gas fired furnace and is finished with a combination of metal siding and stucco.

Photograph 2: 254 Parkdale Avenue, facing west.

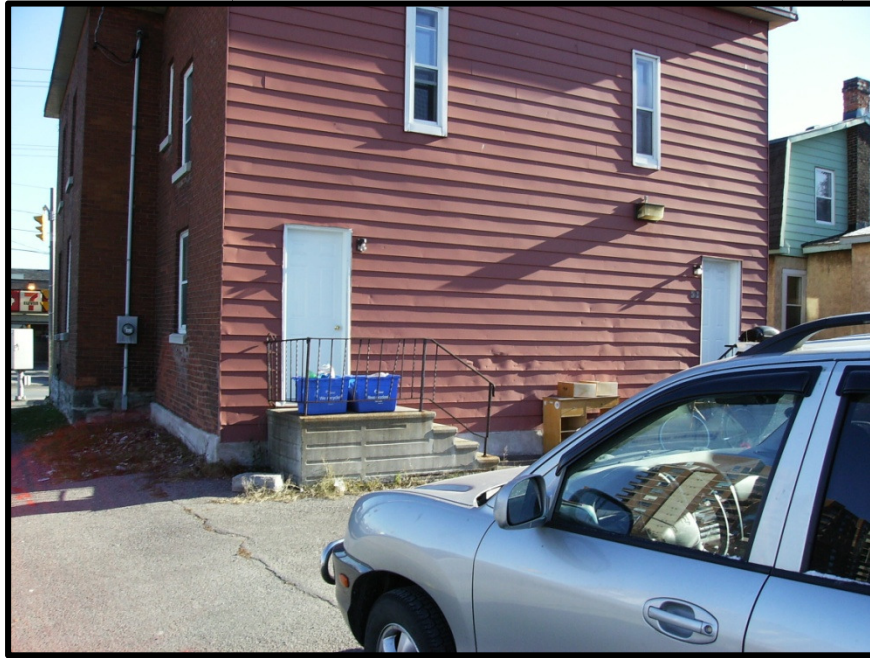
- 250/252 Parkdale Avenue: Semi-detached residential dwelling. The dwelling is a wood-frame structure with one basement level with a flat tar-and-gravel roof and a stone and mortar foundation. The building is currently heated with a natural gas fired furnace (250 Parkdale) and an electric furnace (252 Parkdale).

Photograph 3: 250-252 Parkdale Avenue, facing east.

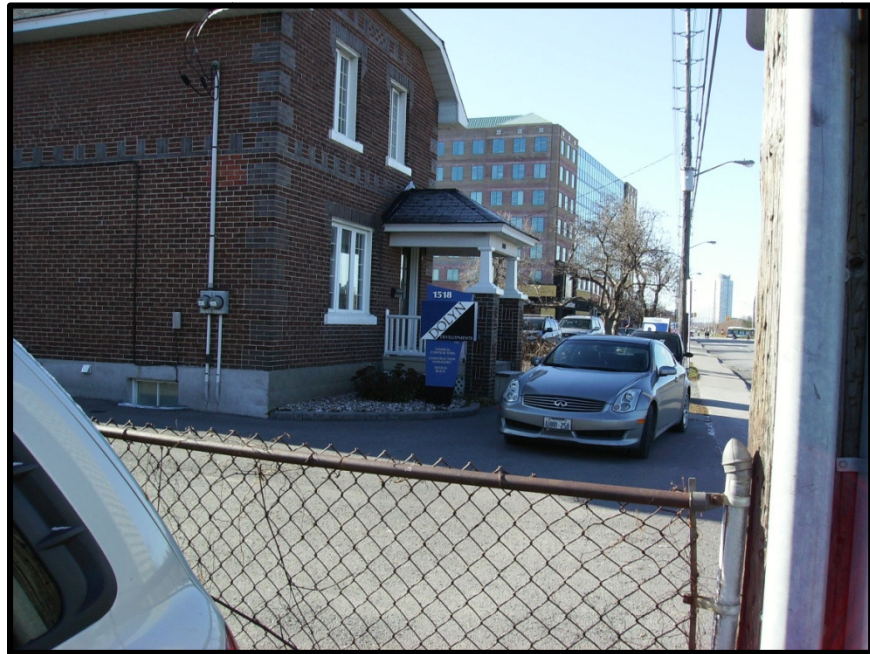
- 1518 Scott Street: Former residential building, used as the offices of Dolyn Developments Inc. at the time of the site visit. The building is a two-storey wood-frame building with an asphalt shingle and flat tar-and-gravel roof, and a full basement with a poured concrete foundation. The building is finished with brick and wood siding and is heated by an oil-fired hot water/radiator heating system.

Vent and fill pipes were observed on the east side of the building at 1518 Scott Street. No apparent leaks, spills, or staining were observed in the vicinity of the vent and fill pipes.

Photograph 4: 1518 Scott Street, facing west.
