RE: 373 Princeton Avenue – Chimney Swift Assessment

## 1.0 BACKGROUND AND SITE DESCRIPTION

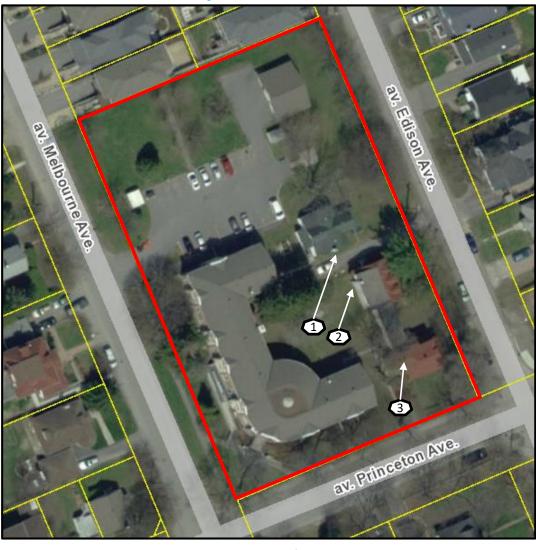
## FIGURE 1: SITE OVERVIEW

McKinley Environmental Solutions was retained by Uniform Urban Developments (Uniform) to evaluate the potential for Chimney Swifts (*Chaetura pelagica*) to be found nesting within three (3) residential homes that are scheduled to be demolished as part of the redevelopment of the 373 Princeton Avenue parcel. The three (3) residential homes are located within the 373 Princeton Avenue parcel, at municipal addresses marked 530, 534 and 540 Edison Avenue. Each of these residential homes has a single chimney. Figure 1 (below) shows the position of the chimneys within the Site.

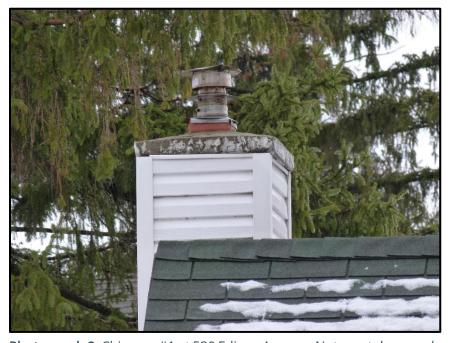
- **530 Edison Avenue (Chimney #1):** The chimney includes a ceramic liner and a metal cap that would prevent Chimney Swift nesting;
- **534 Edison Avenue (Chimney #2):** The chimney includes a ceramic liner and a wire mesh cap that would prevent Chimney Swift nesting.
- **540 Edison Avenue (Chimney #3):** The chimney includes a ceramic liner and a wire mesh cap that would prevent Chimney Swift nesting.

Photograph 2: Chimney #1 at 530 Edison Avenue. Note metal cap and ceramic liner (March 28<sup>th</sup>, 2017).

Due to the presence of ceramic liners and caps on all three (3) chimneys, Chimney Swifts would not be able to utilize any of the chimneys found within the Site for nesting. A follow-up Chimney Swift survey is therefore not required, and Chimney Swifts are not considered a significant concern for the proposed demolition of the residential buildings at 530, 534, and 540 Edison Avenue.

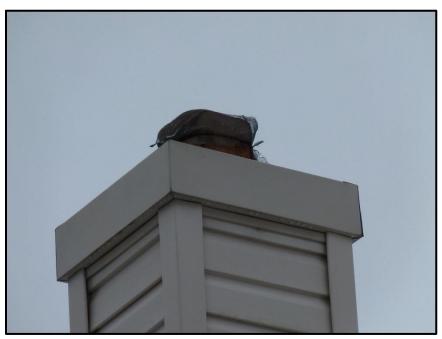
It should be noted that even if the wire mesh caps were removed from the chimneys at 534 and 540 Edison Avenue, these chimneys would likely remain unsuitable for Chimney Swift nesting, as Chimney Swifts will not typically nest in un-capped chimneys with ceramic liners (Bird Studies Canada 2009).

**Photograph 4**: Chimney #2 at 534 Edison Avenue. Note ceramic liner with wire mesh cap (March 28<sup>th</sup>, 2017).

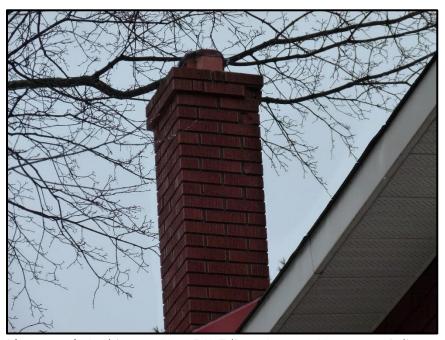
**Photograph 6**: Chimney #3 at 540 Edison Avenue. Note ceramic liner with wire mesh cap (March 28<sup>th</sup>, 2017).
