## Phase One Environmental Site Assessment 1154, 1176, 1180, and 1208 Old Montreal Road, Ottawa, Ontario

Phase One Environmental Site Assessment

OTT-00234493-A0

2021-02-11

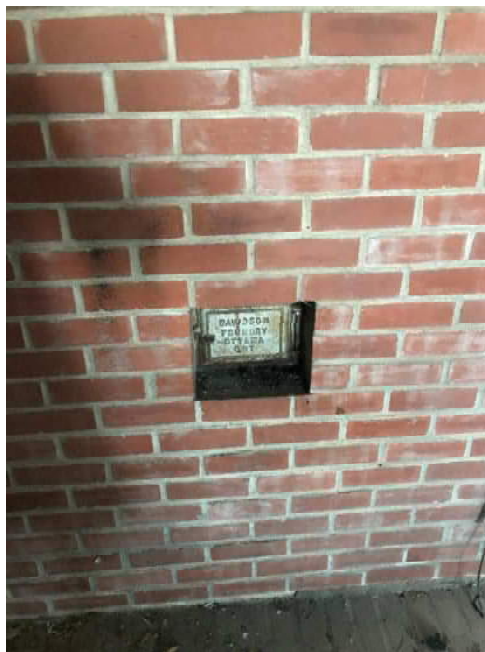
**Photograph No. 2**

View of former coal chute at 1154 Old Montreal Road.

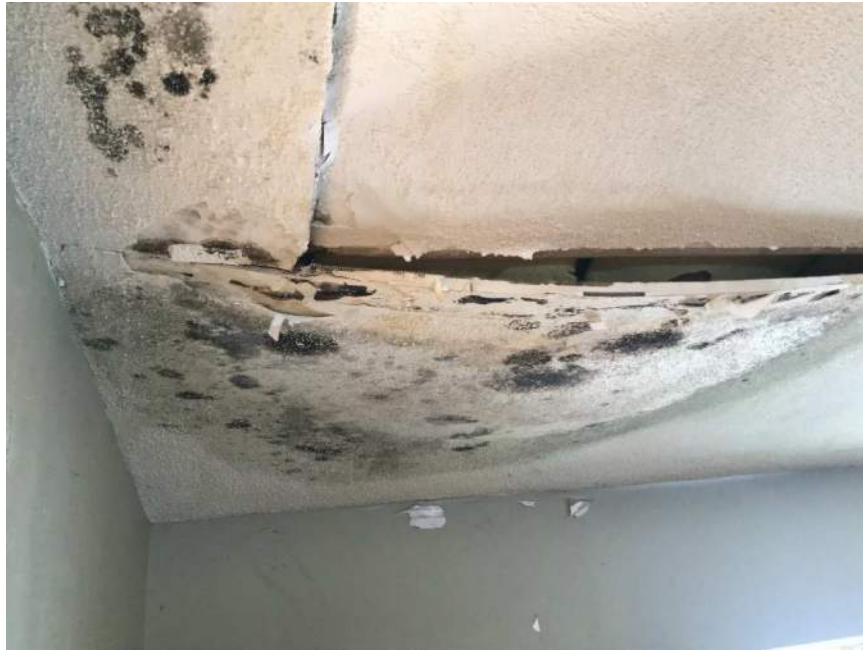
**Photograph No. 5**

Significant black mould growth and water damage was observed during the site visit in all of the residences.

View of mould and water damage on ceiling of main floor in 1174 Old Montreal Road.

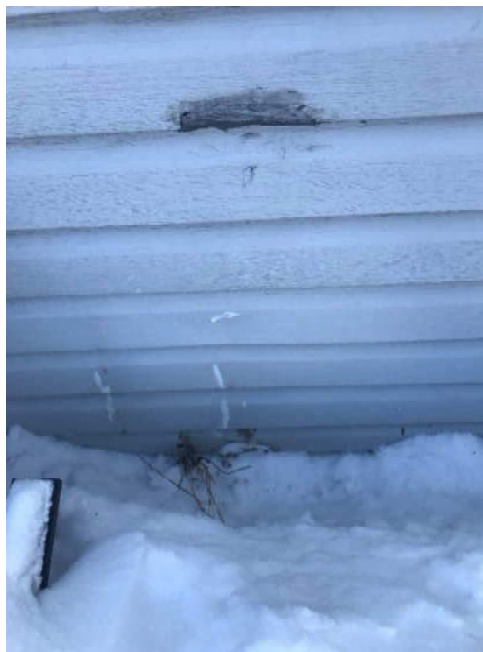
**Photograph No. 6**

- A former heating oil tank was located in the basement of 1176 Old Montreal Road, which was replaced with propane a few years ago. No staining was observed on the concrete floor in the former tank location. This represents an APEC (**PCA 4**).

View of location of former fill and vent pipes at 1174 Old Montreal Road.

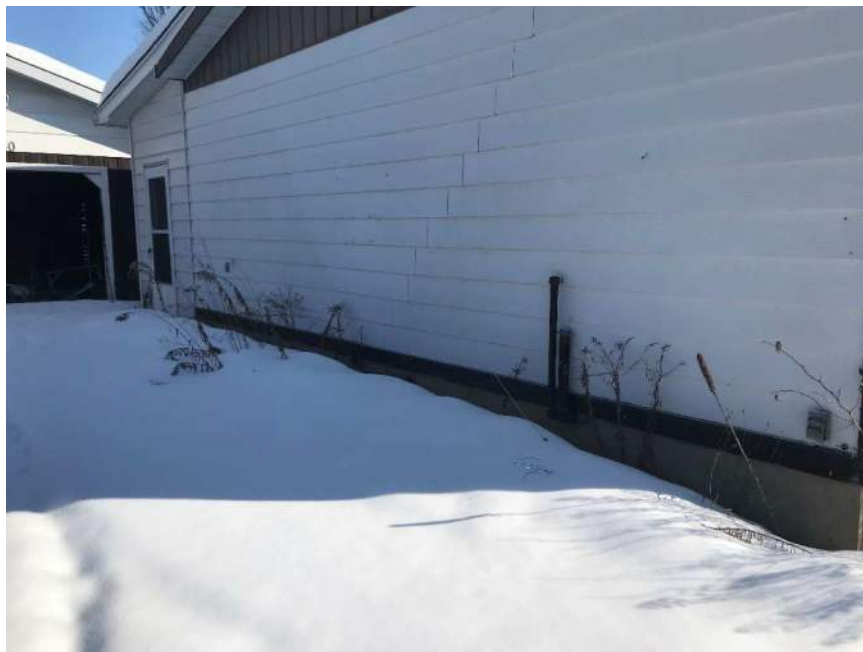
**Photograph No. 8**

View of fill/vent pipes on the north side of the residence at 1180 Old Montreal Road.

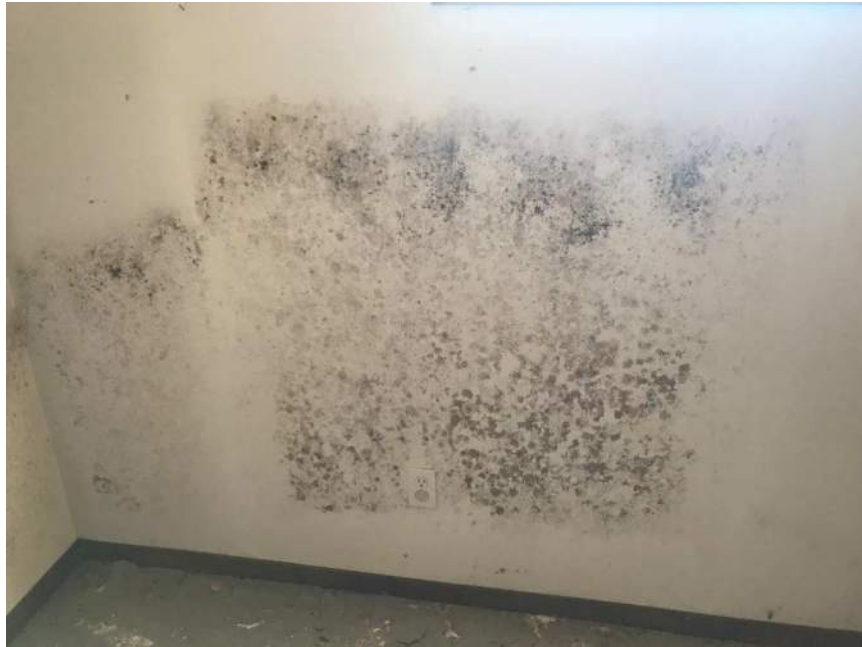
**Photograph No. 9**

View of black mould on the walls of 1180 Old Montreal Road.

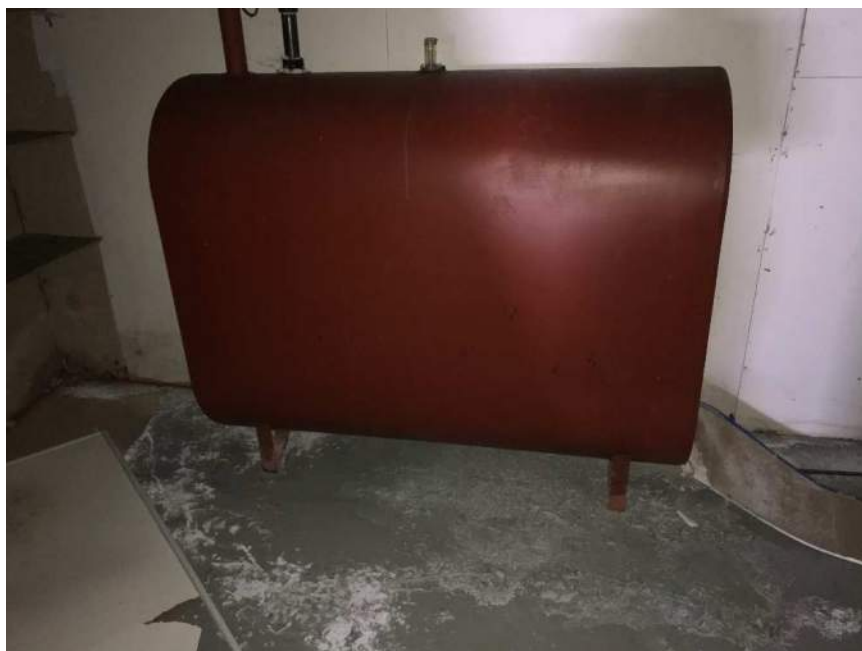
**Photograph No. 10**

- A heating oil tank in the basement of 1180 Old Montreal Road. The tank was installed above a concrete floor in good condition, and there was no staining in the vicinity of the tank. This represents an APEC (**PCA 3**).

View of the fuel oil AST in the basement of 1180 Old Montreal Road.

The Qualified Person who oversaw this work, Mark McCalla, M.Sc., P.Geo., recommends that a Phase Two ESA be conducted to address the PCA that may have adversely affected the APEC on the Phase One property. A Phase Two ESA is recommended for the property to assess the identified APECS.

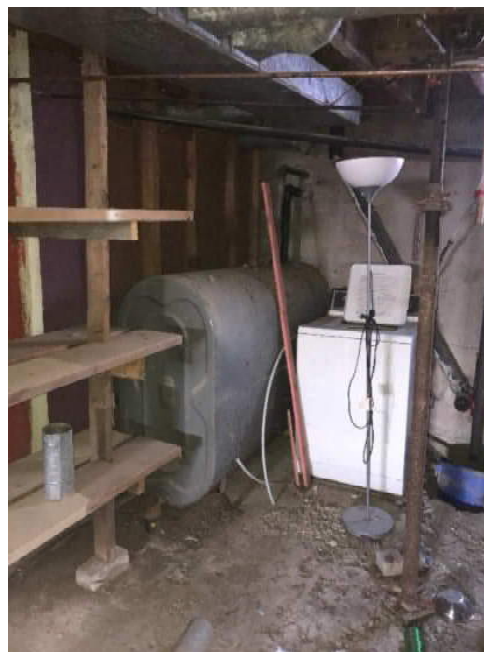
**Photograph No. 14**

- A heating oil tank in the basement of 1208 Old Montreal Road. The tank was installed above a concrete floor in fair condition. There was some staining observed on the concrete floor below the tank, although the staining appeared to be contained within the building footprint. This represents an APEC (**PCA 2**).

View of the fuel oil AST at 1208 Old Montreal Road.

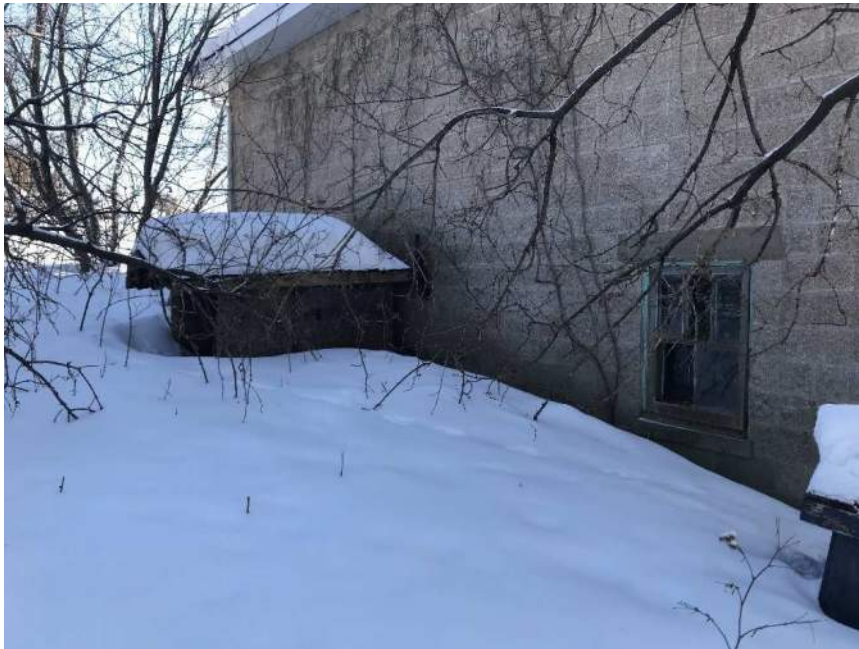
**Photograph No. 15**

View of vent/fill pipes on the east side of the residence at 1208 Old Montreal Road.
