Phase I - Environmental Site Assessment

Proposed Mixed Use Development
321-325 Dalhousie Street and
137-141 George Street
Ottawa, Ontario

April 19, 2013

Report: PE2709-1

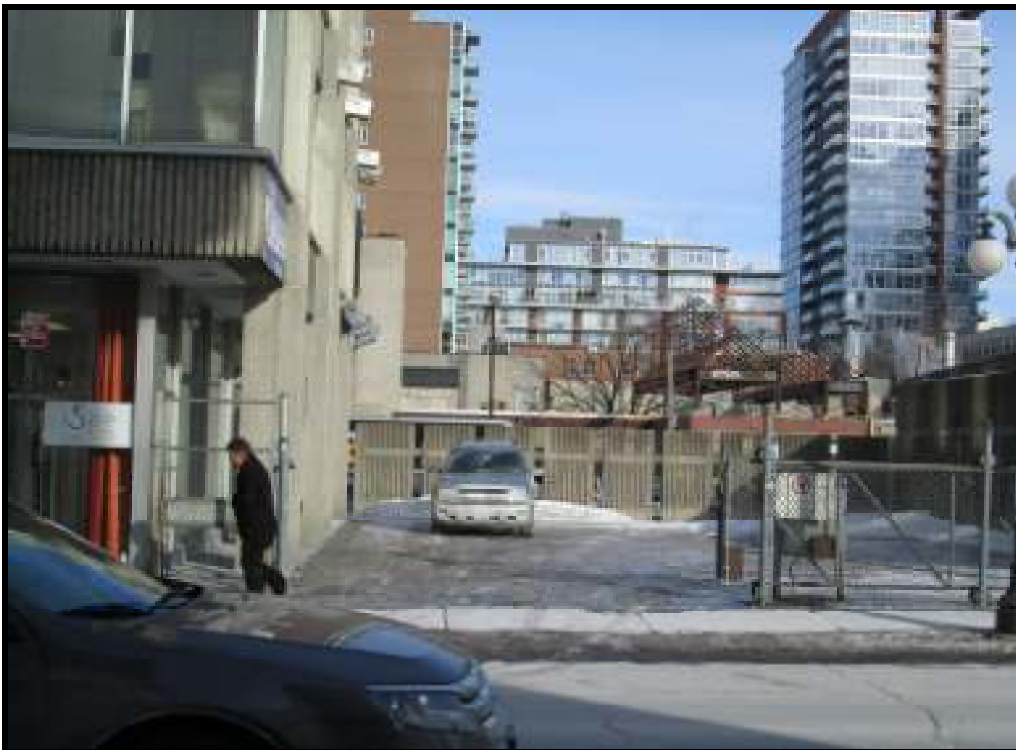
- ❑ a former service station located at 337 Dalhousie Street, in the portion of the subject property currently addressed as 321 Dalhousie Street;
- ❑ a former service station at 351 Dalhousie Street (currently addressed as 353 Dalhousie Street), immediately to the west of 137 George Street;
- ❑ a printing business formerly located at 125-127 George Street (currently the parking lot addressed as 137 George Street);
- ❑ a former dry cleaning business at 343 Dalhousie Street, immediately to the west of 137 George Street; and
- ❑ fill material associated with historical uses of the site.

Photograph 2: Southern portion of 321 to 325 Dalhousie Street (location of former retail fuel outlet), facing east.

Based on the results of this assessment, it is our recommendation that a soil and groundwater remediation program be carried out for the subject property, in order to meet the 2011 MOE Table 3 standards.

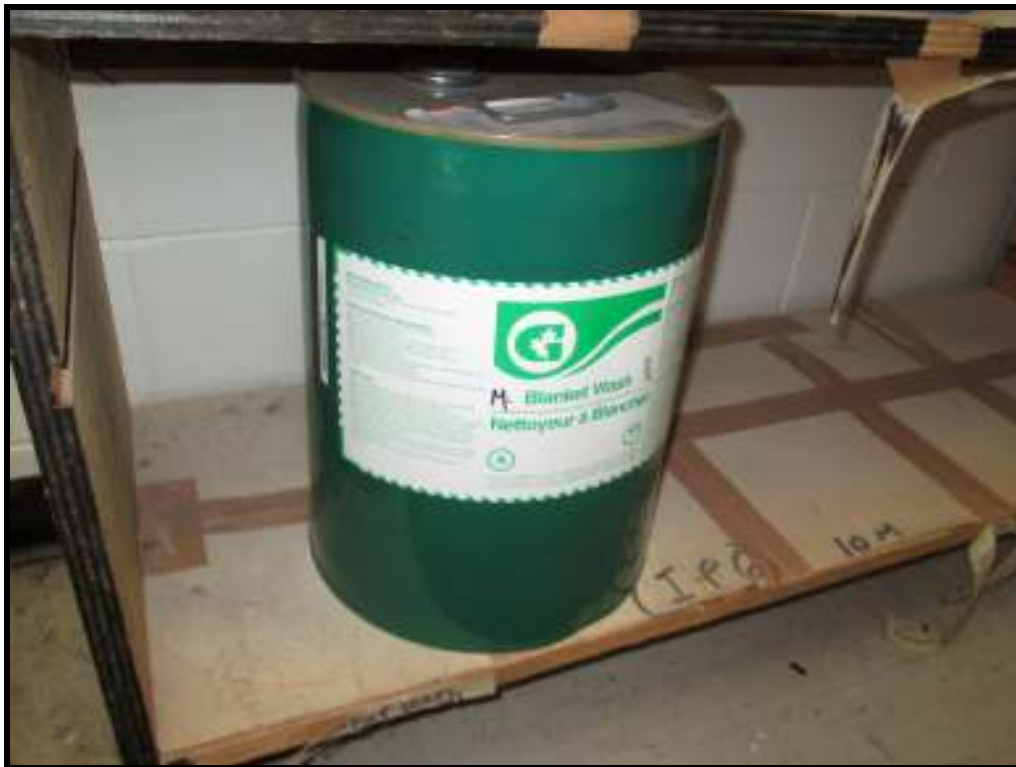
Other chemicals observed onsite at the time of the assessment include one (1) 50 L container of blanket wash, one (1) 50 L container of ink and seven (7) 5 L containers of Activator Working Solution. Small quantities of general cleaning and maintenance chemicals including paint and water treatment chemicals were also observed.

No signs of leakage or staining were observed on the floor surface in the vicinity of the stored chemicals. As noted previously, the floor surface was in good condition with no cracks and no floor drains or other potential discharge points located nearby.

Photograph 4: Chemical storage in the basement of 321 to 325 Dalhousie Street.

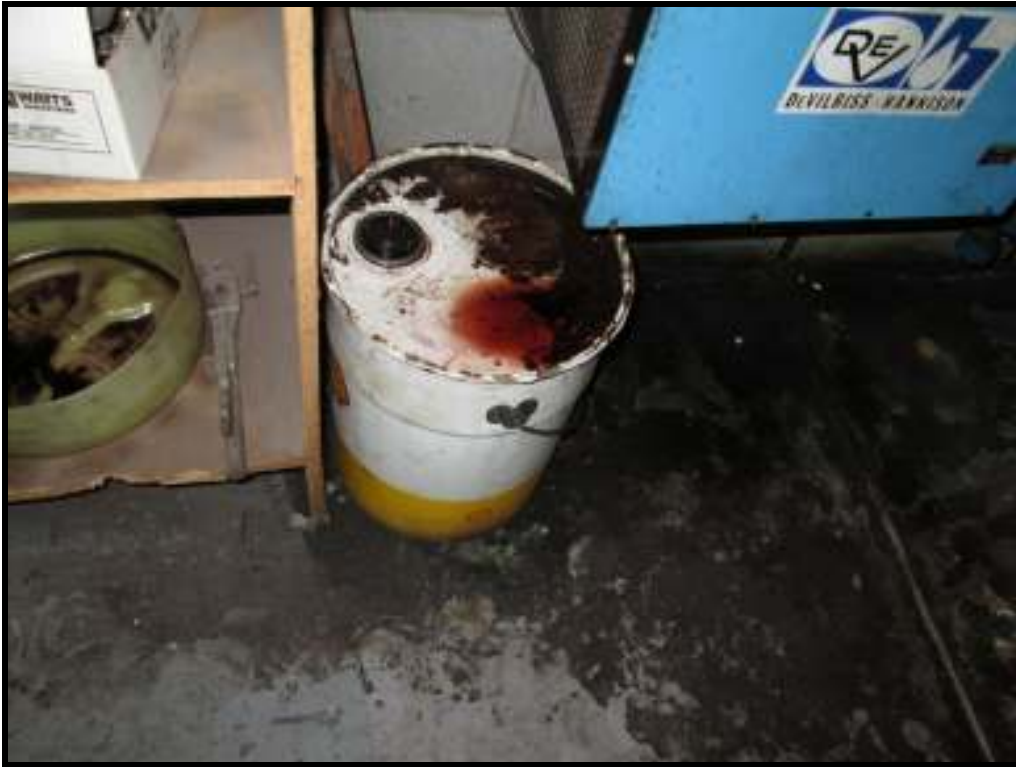
The floor surfaces in the building consisted of poured concrete, ceramic tile, vinyl tile, terrazzo and carpet. All floor surfaces were in good condition at the time of the site assessment, with no significant signs of leaks or stains. Minor staining was observed on the floor of the electrical room (11th floor) in the vicinity of a transformer and 20 L pail of waste hydraulic oil. No cracks or drains or other discharge routes were noted in the vicinity of the staining.

Photograph 5: Hydraulic oil and minor staining on floor slab in penthouse mechanical room.

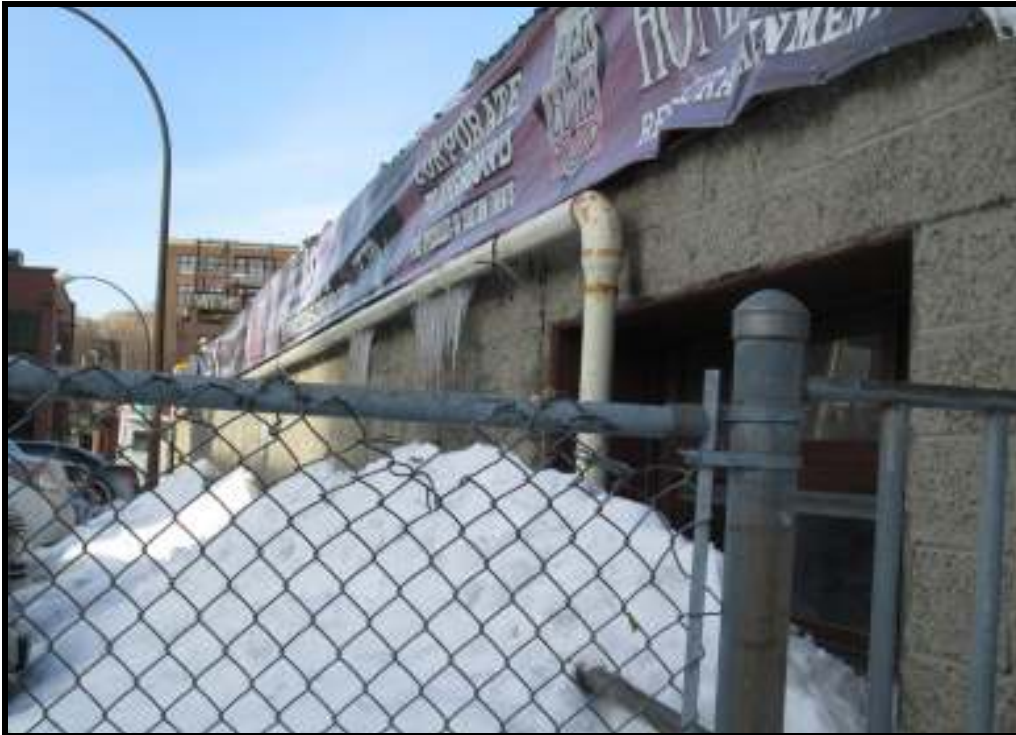
Photograph 7: West wall of 141 George Street and eastern portion of parking lot at 137 George Street (former printers), facing north.

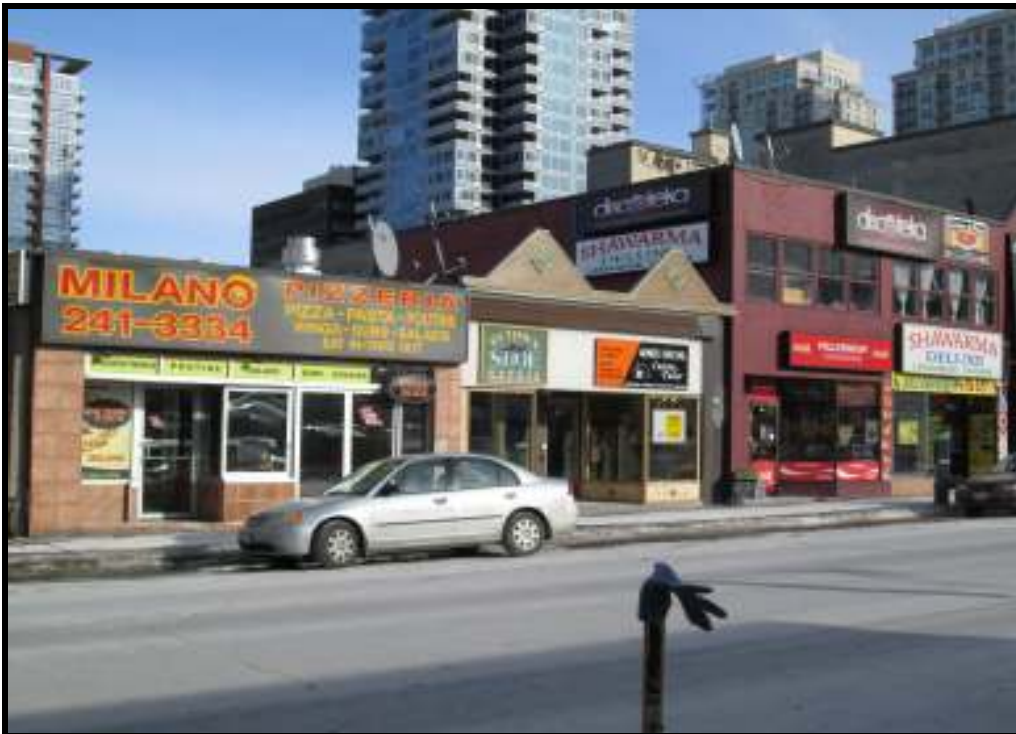
Photograph 10: Commercial properties to the south and west (location of former cleaners and former retail fuel outlet), facing southeast.
