REPORT ON

Phase One Environmental Site Assessment 100 New Orchard Avenue Ottawa, Ontario

Report Number: 1658362-2000

PHASE ONE ESA – 100 NEW ORCHARD AVENUE OTTAWA, ONTARIO

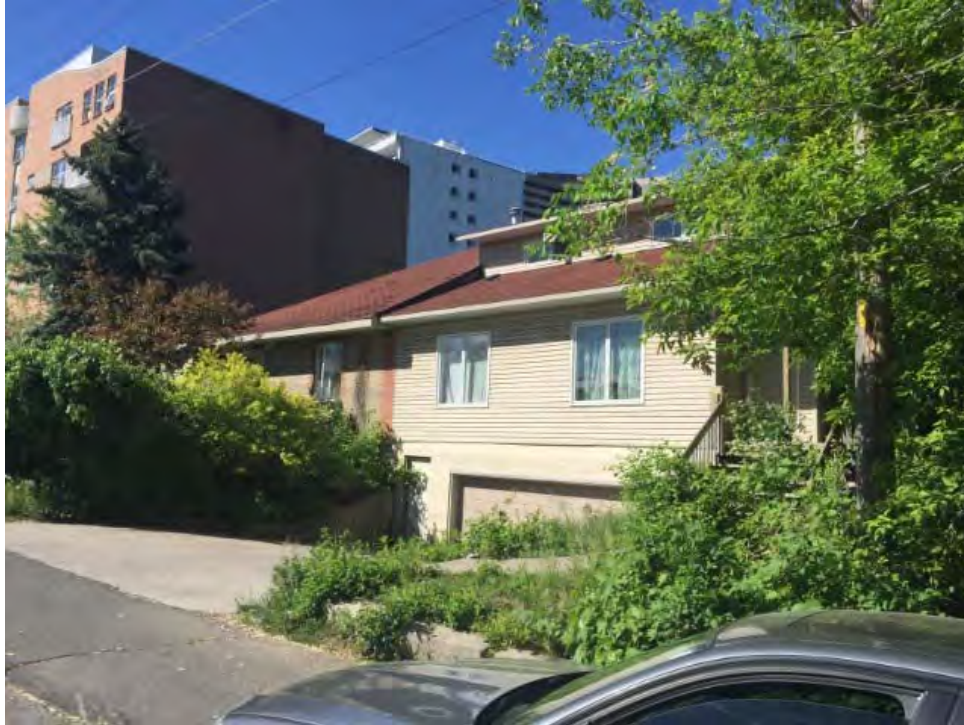
Photo 1: Looking southwest at the residential house located on the Site.

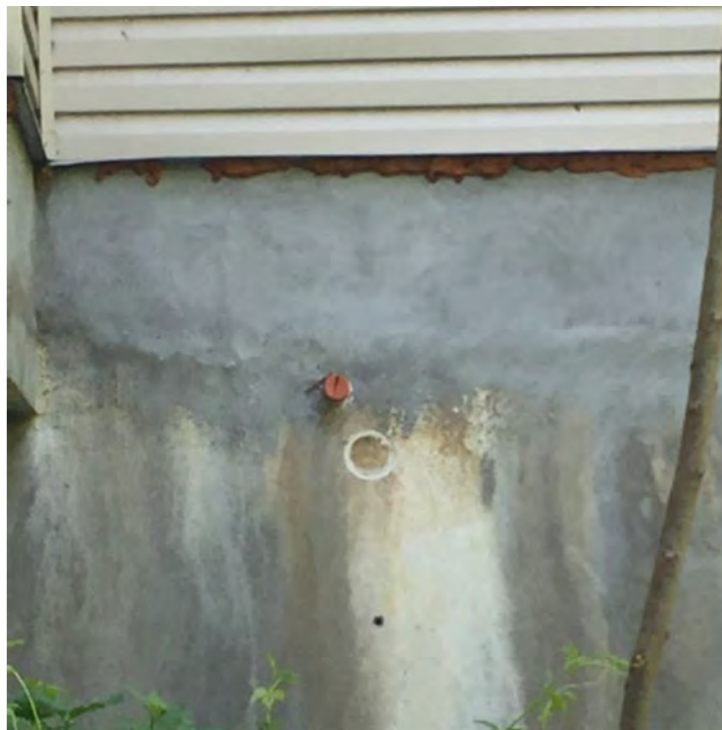
Photo 2: Photo of the pipe and filled in hole of a former pipe located in the basement foundation on the on-Site residential building. They are likely former fill and vent pipes for a former heating oil AST.

During the Site visit, a pipe and a filled in hole of a former pipe were observed in the exterior portion of the basement foundation on the north side of the building. They are likely former fill and vent pipes for a heating oil AST that was located in the below grade parking garage. Given that the AST is no longer being used, it may have been removed from the Site; however, this could not be confirmed as access into the parking garage was not provided during the Site visit. The former and/or current presence of this heating oil AST is an on-Site PCA.

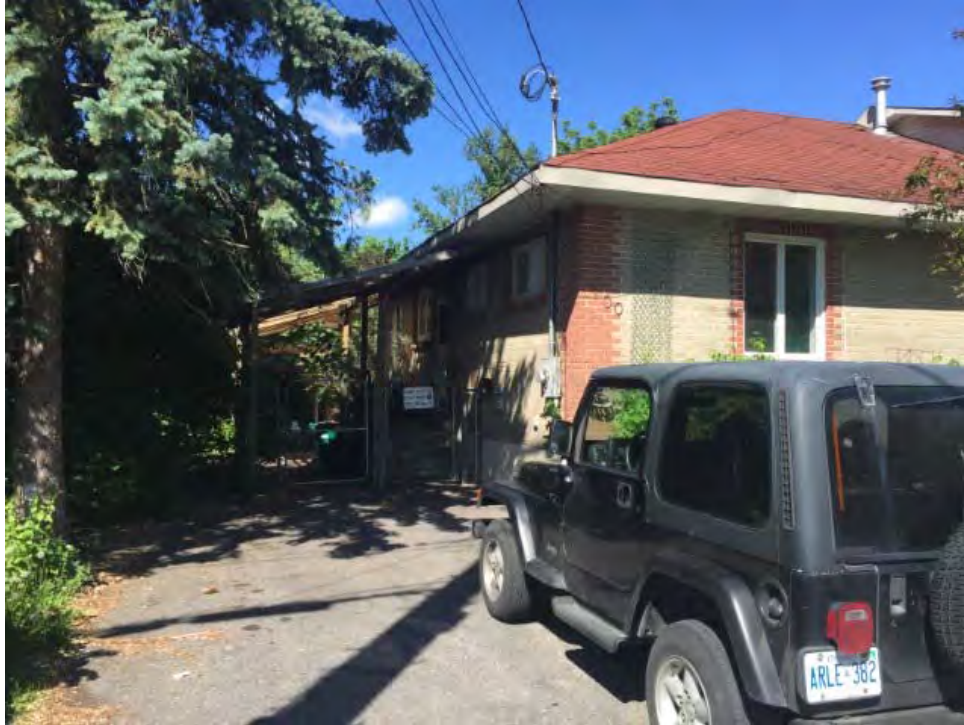
Photo 3: Looking west at the southeast corner of the on-Site residential building and the driveway located on the southeast corner of the Site.

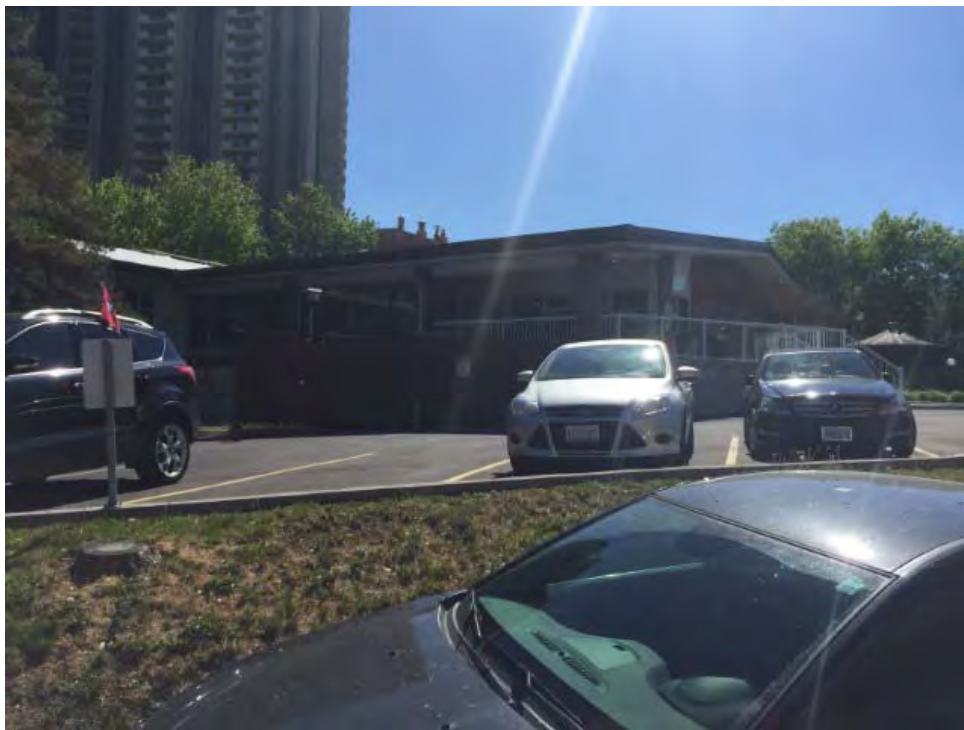
Photo 4: Looking east at the nursing home located on the adjacent property east of the Site (99 New Orchard Avenue).

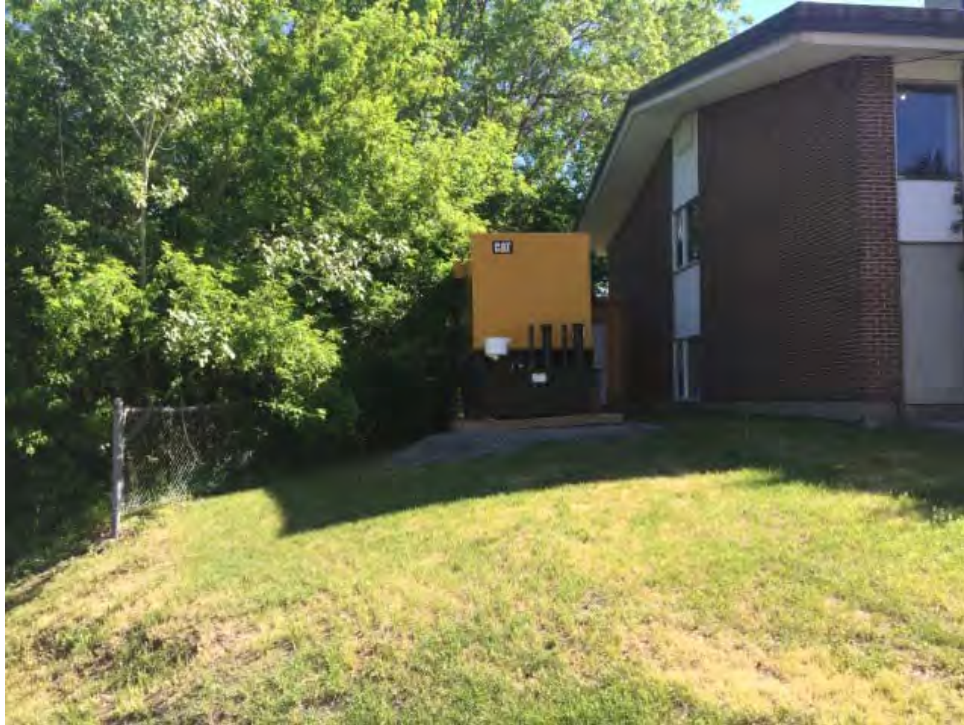
Photo 5: Diesel generator with an associated AST located on the north side of the nursing home at 99 New Orchard Avenue.

East: New Orchard Avenue followed by a mix of residential (a nursing home, high-rise apartment building and single residential houses) and commercial development. A diesel generator with an associated diesel AST was located on the north side of the nursing home at 99 New Orchard Avenue, approximately 20 m northeast of the Site. It appeared to be in good condition and was located on a concrete pad. No evidence of spills or staining was observed in the vicinity of generator/AST. In addition, a car dealership (Metro Chrysler Dodge Jeep and Ram) with an associated automotive garage was located approximately 55 m east/southeast of the Site at the 1047 Richmond Road.

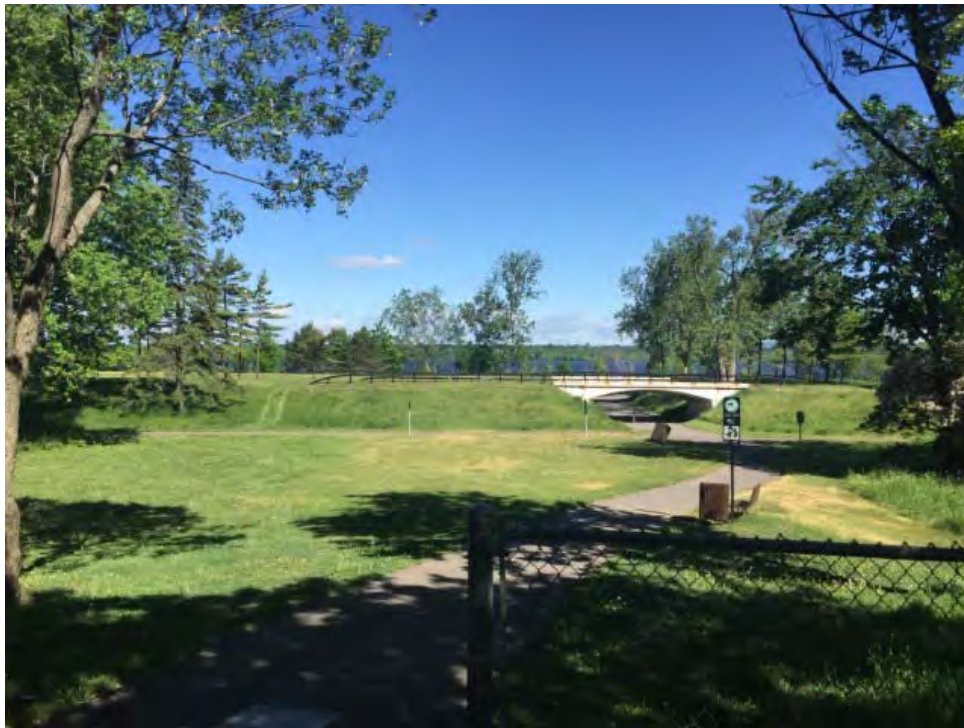
Photo 6: Looking north at the vacant land, gravel pathways, the Sir John A. Macdonald Parkway and the Ottawa River located on the adjacent lands north of the Site.

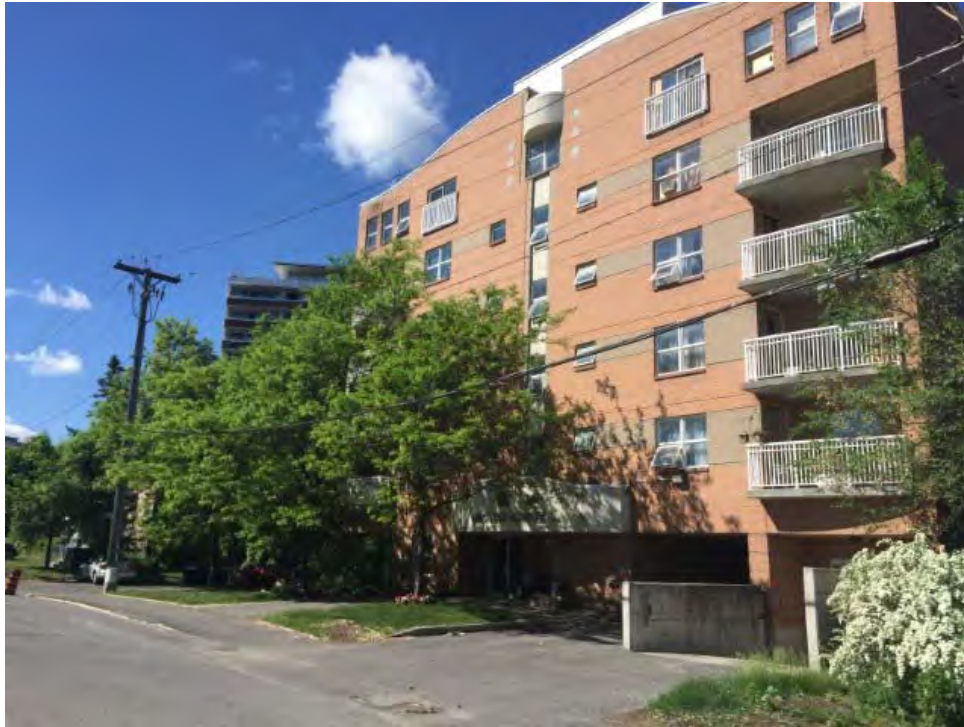
Photo 7: View of the residential apartment building located on the adjacent property immediately south of the Site (108 New Orchard Avenue).

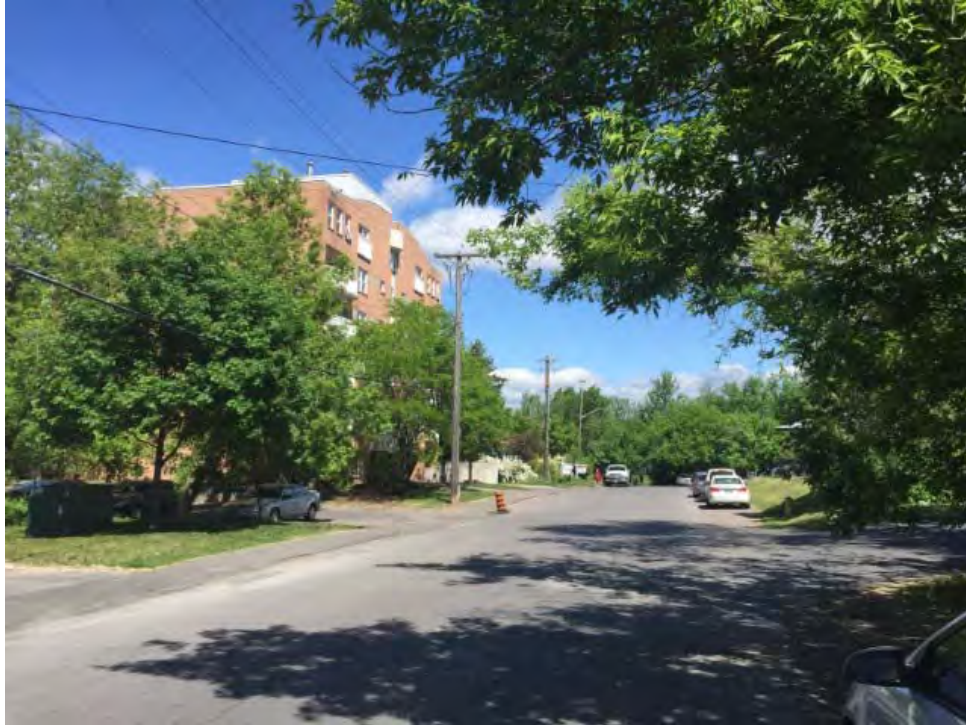
Photo 9: Looking north at New Orchard Avenue located east of the Site.

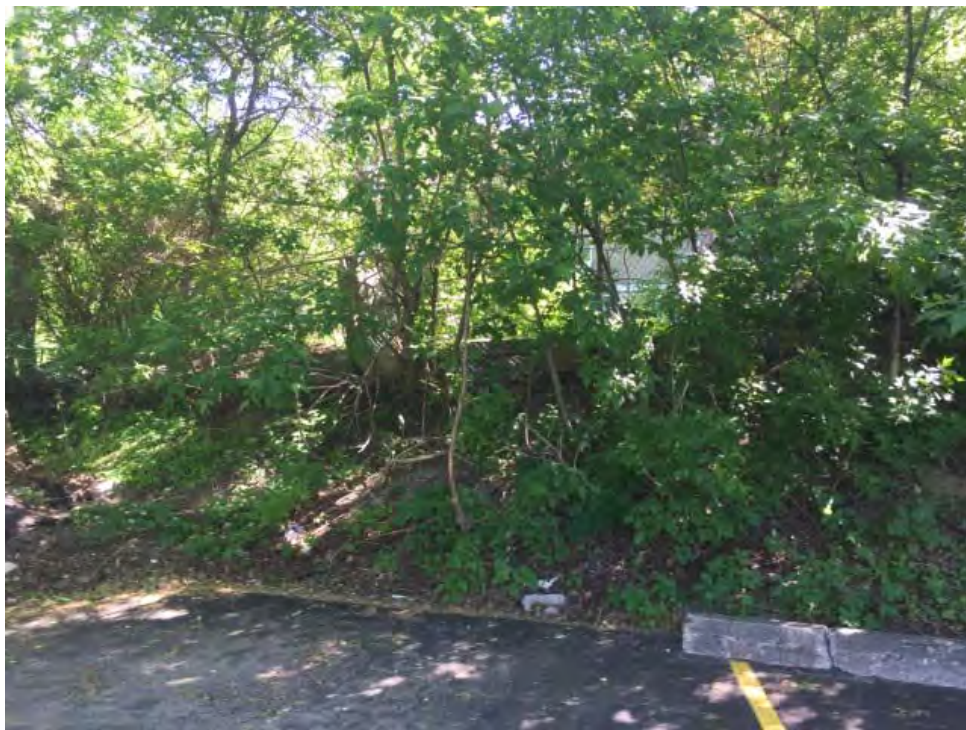
Photo 10: Photo of the west side of the Site taken from the parking lot on the adjacent property immediately west of the Site.

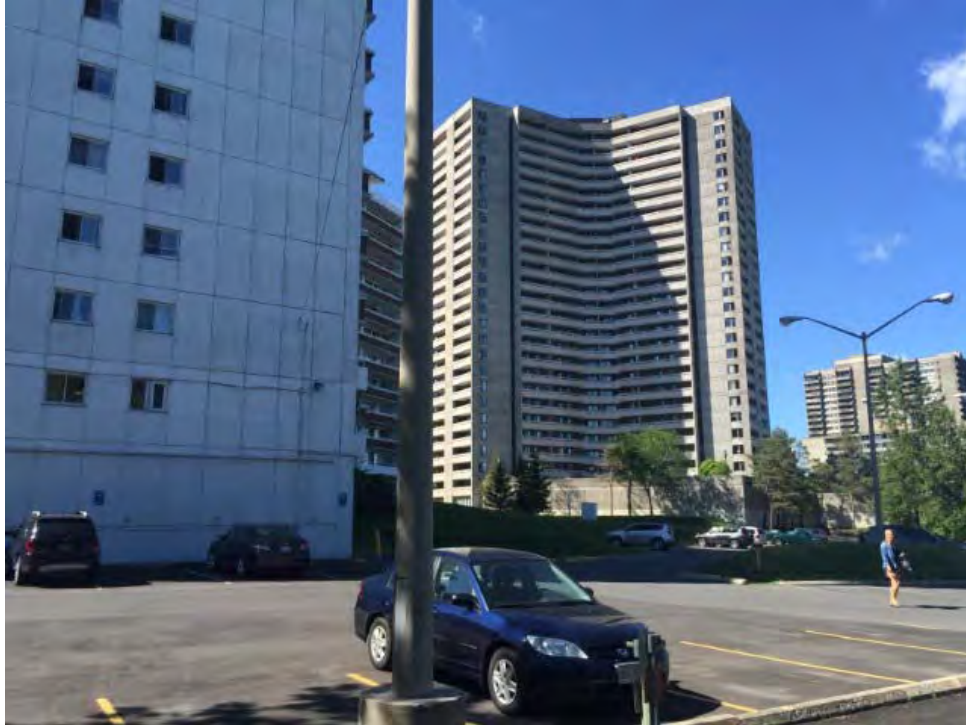
Photo 11: Looking southwest at the high-rise residential apartment buildings located on the surrounding properties southwest of the Site.
