1053/1075/1145 March Road
Headwaters Drainage Assessment (HDA) (Revised)

November 2019
Prepared for CU Developments Inc.

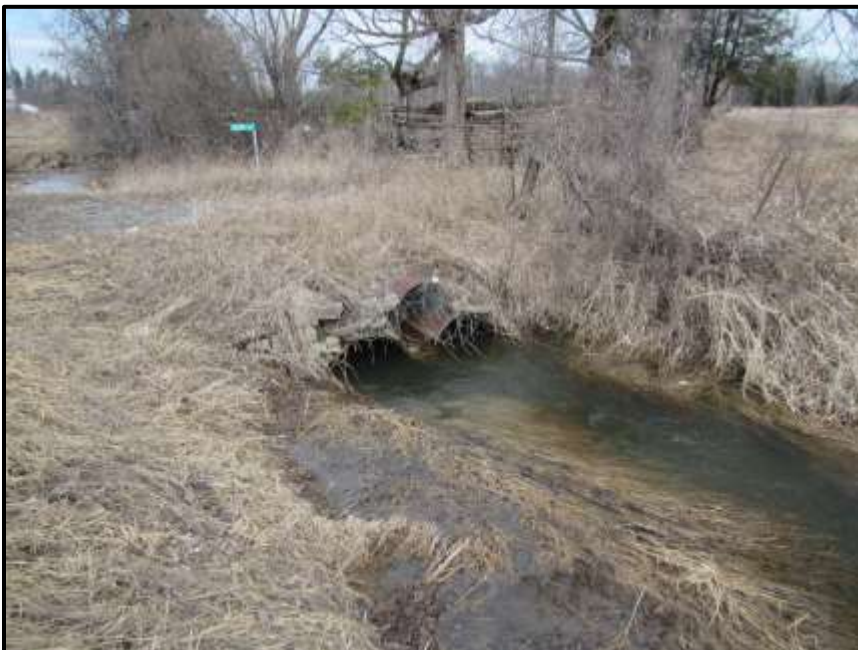
Photograph 2: Survey Site #1 - Three (3) stacked 60 cm CSP culverts under the old farm driveway, east of March Road (facing upstream) (March 30th, 2018).

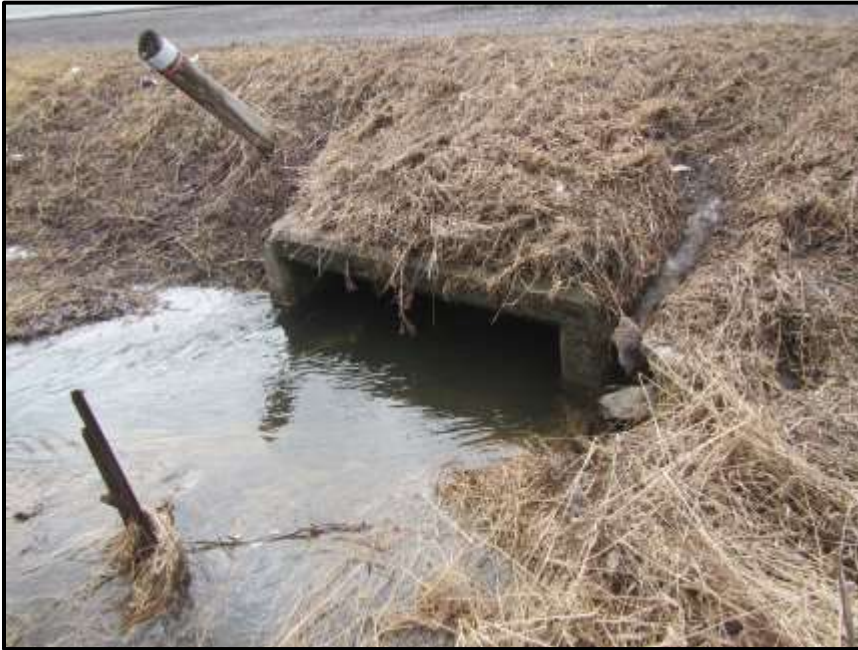
Photograph 3: Survey Site #1 - 2 m concrete box culvert under March Road (facing upstream) (March 30th, 2018).

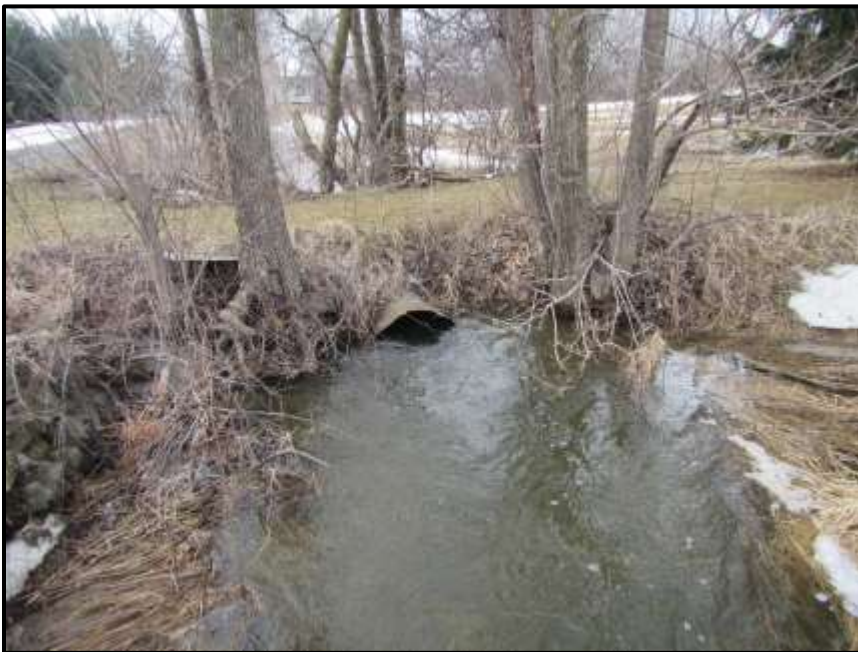
Photograph 4: Survey Site #1 - 60 cm CSP culvert under the driveway west of March Road (facing upstream) (March 30th, 2018).

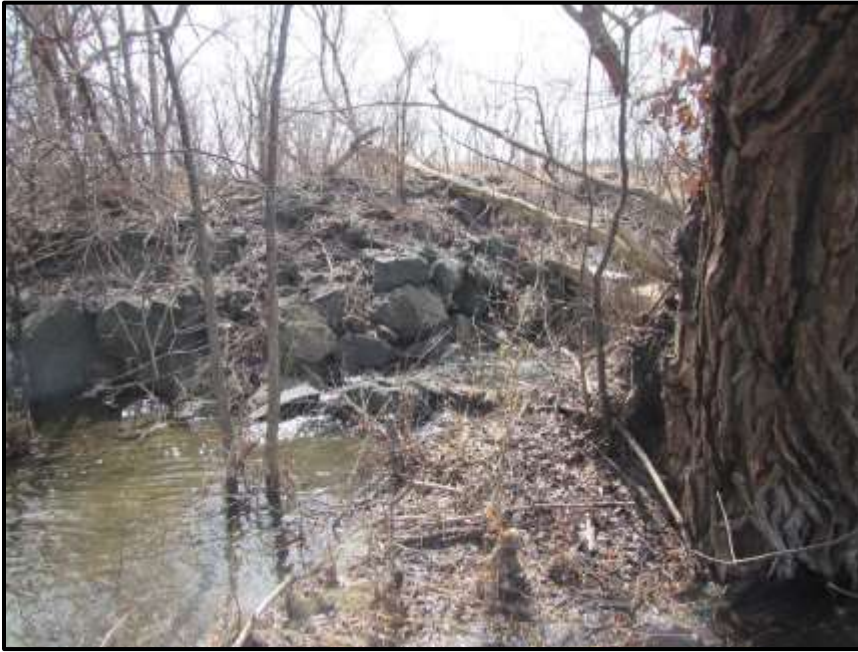
Photograph 7: Old Stone Weir downstream of pond in Survey Site #2 (March 30th, 2018).

As noted above, west of 1035 March Road water flow is held back by a crushed stone weir, which creates a 0.08 ha inline pond. The pond includes a deep pool that reaches standing water depths of greater than 1 m (MEP 2016). The substrate of the pond consists primarily of muck. Aquatic plant species grow around the margins of the pond, however, the majority of the feature consists of open water throughout the summer.

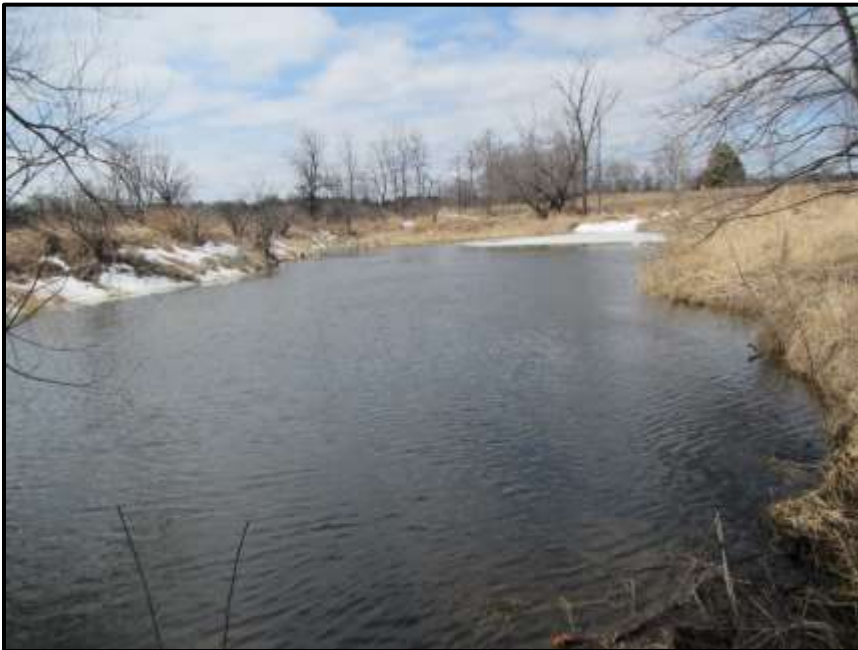
Photograph 8: Pond within Survey Site #2 (facing upstream) (March 30th, 2018).

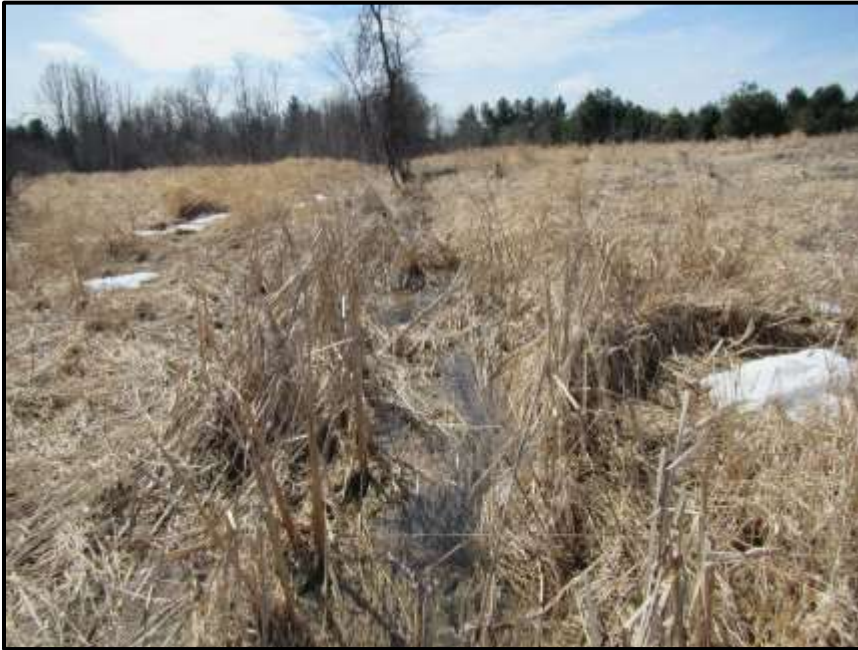
Photograph 11: Survey Site #3 (Channel F), facing upstream (March 30th, 2018).

As described above, Drainage Channel F is a stormwater swale that receives intermittent flow and is dry throughout the majority of the growing season. No evidence of amphibian breeding or direct fish habitat was documented for Drainage Channel F. Within the Kanata North Urban Expansion Area (KNUEA) Environmental Management Plan (EMP), Drainage Channel F was identified to be decommissioned (Novatech 2016b). Given the lack of habitat functionality observed within Drainage Channel F, removal of the feature is not considered a significant negative impact.

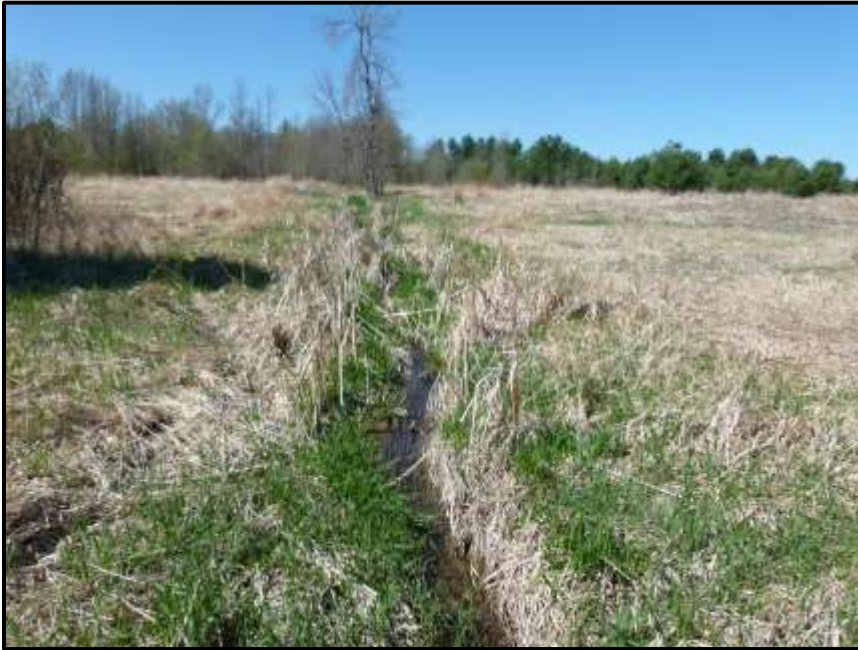
Photograph 21: Survey Site #3 (Channel F), facing upstream (May 12th, 2018).

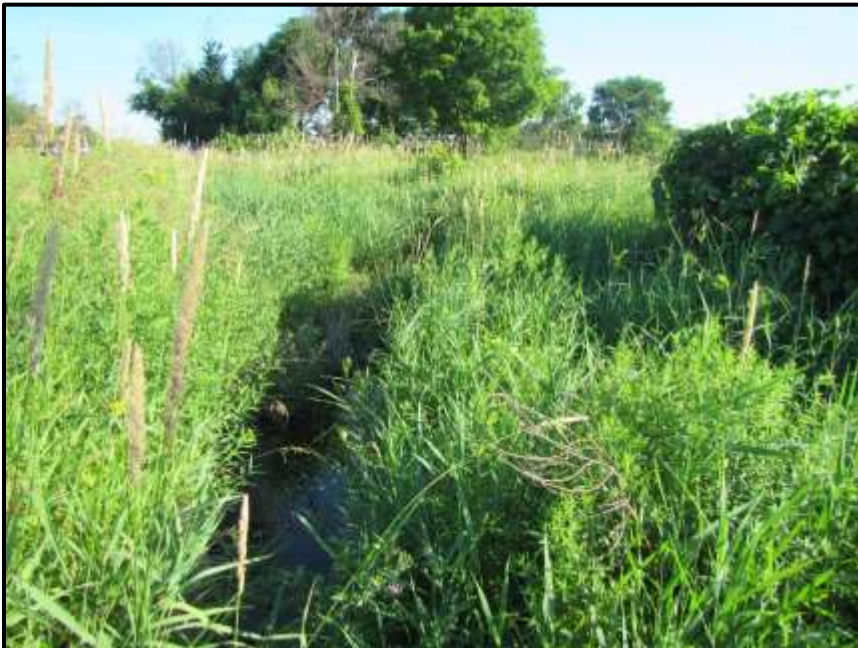
Photograph 26: Survey Site #1 downstream, facing upstream (July 4th, 2018).

By mid-summer (July), wetted width, standing water depth, and flow volumes decreased substantially. All segments were observed to have comparatively minimal flow volume, with the exception of Survey Site #4 (upstream – north fork) which had standing water depths of 43 mm but no flow (standing water only). By July, no standing water was observed in Drainage Channel F.

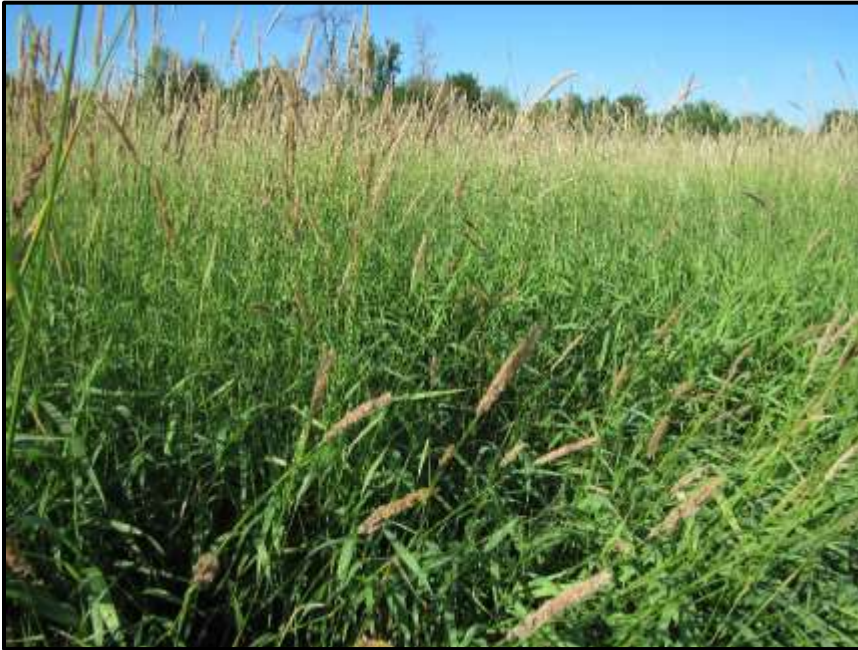
Photograph 31: Survey Site #3 (Channel F), facing upstream (July 4th, 2018).
