Combined Environmental Impact Statement &  
Tree Conservation Report  
1053/1075/1145 March Road

June 2018  
Prepared for CU Developments Inc.

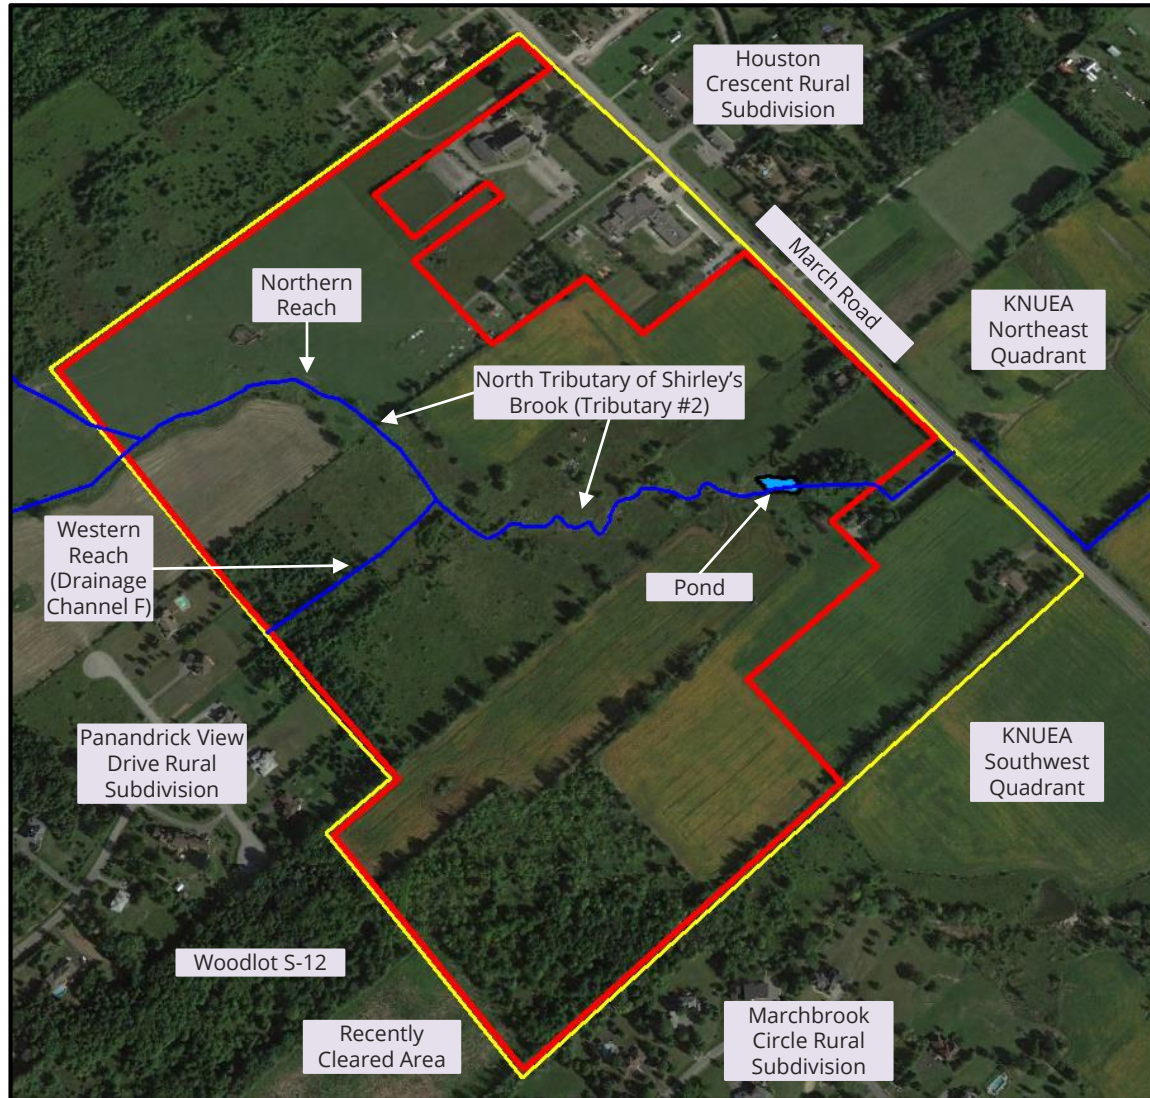
# FIGURE 1: SITE OVERVIEW

- Study Area (Northwest Quadrant)
  - Development Limits

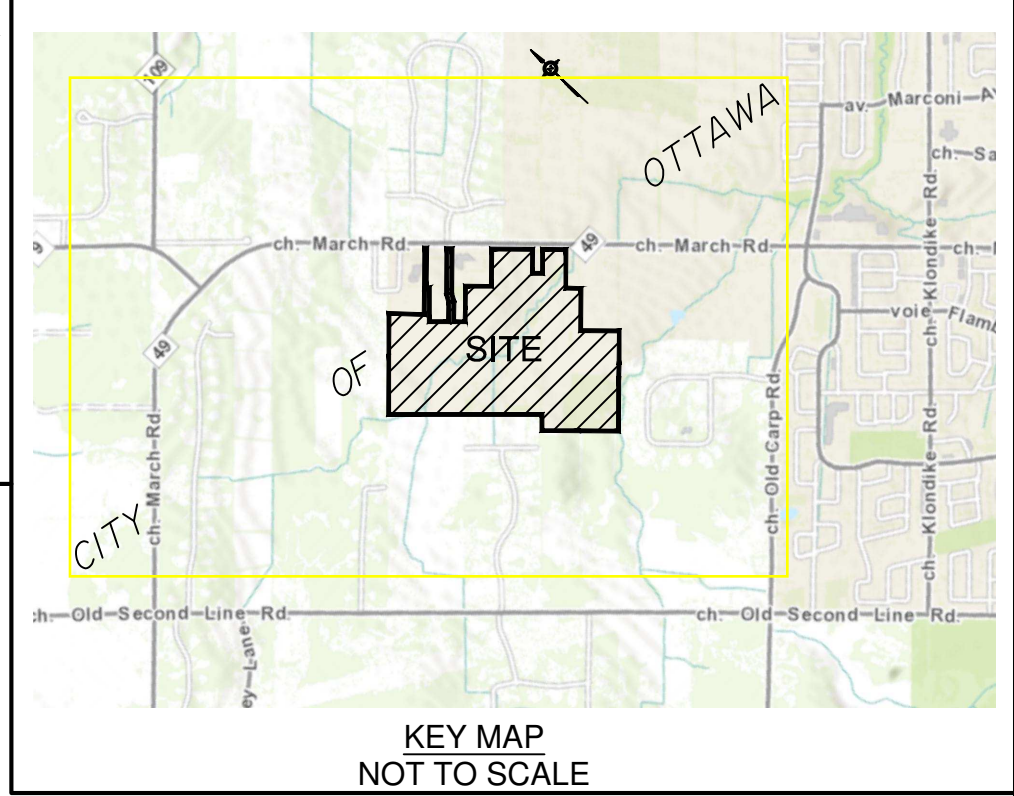
**DRAFT PLAN OF SUBDIVISION OF  
PART OF LOTS 13 And 14  
CONCESSION 3**  
Geographic Township of March  
**CITY OF OTTAWA**  
Prepared by Annis, O'Sullivan, Vollebek Ltd.

The Draft Plan of Subdivision is included below. As noted above, the Study Area as a whole is approximately 64 ha in size, however, the current development proposal only includes approximately 48.05 ha (the Site). The Site will be developed in multiple phases, each of which will include a mixture of single detached homes, townhomes, and multi-unit residential dwellings, as well as institutional uses. In total, the current development proposal includes approximately 825 residential units including 295 single detached dwellings, 314 townhouse dwellings, and 216 multi-unit residential dwellings. The development will also include three (3) institutional blocks including a Park and Ride (Block 310) and Fire Hall (Block 309) to be located at March Road, and a third institutional block (Block 304), which provides a portion of a future school site. An approximately 2.13 ha municipal park block (Block 294) is included along the western Site boundary. The Site will receive municipal services. Stormwater runoff will be addressed through construction of a new Stormwater Management (SWM) Pond (Block 308) adjacent to March Road. The new SWM Pond will outlet clean water to the realigned North Tributary of Shirley's Brook.

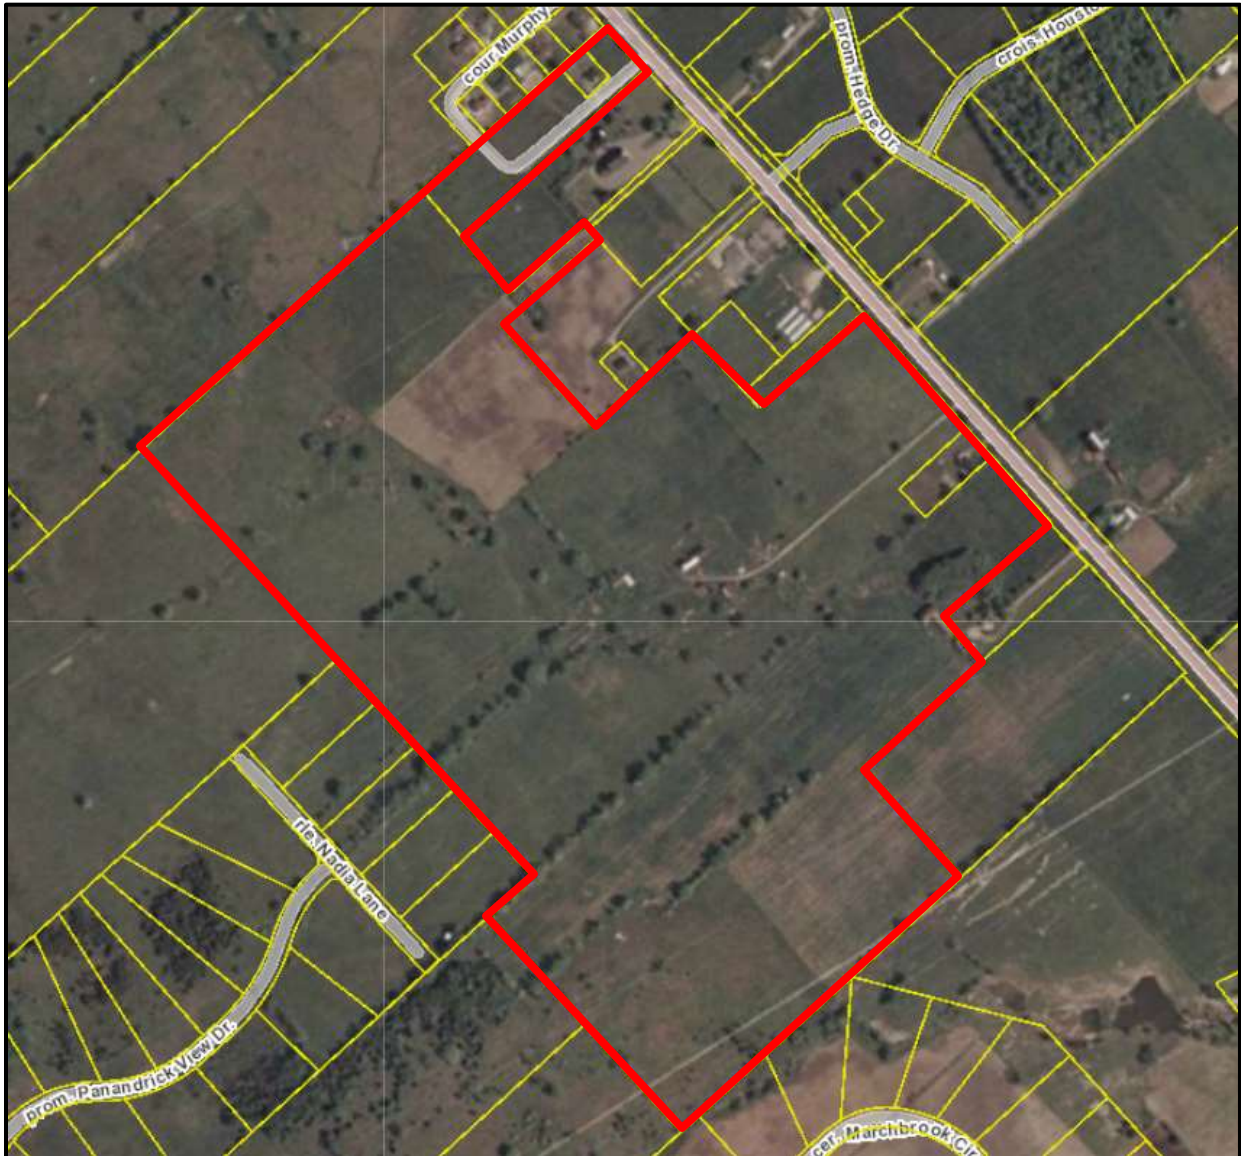
**Historic Air Photograph 1:** Historic Air Photo from 1976 (Site development limits shown in red). Note the Study Area was intensively farmed and tree cover was limited to the hedgerows in 1976. Regeneration of trees and shrubs in the southwestern part of the Study Area was not yet underway in 1976 (Photos from City of Ottawa 2018).

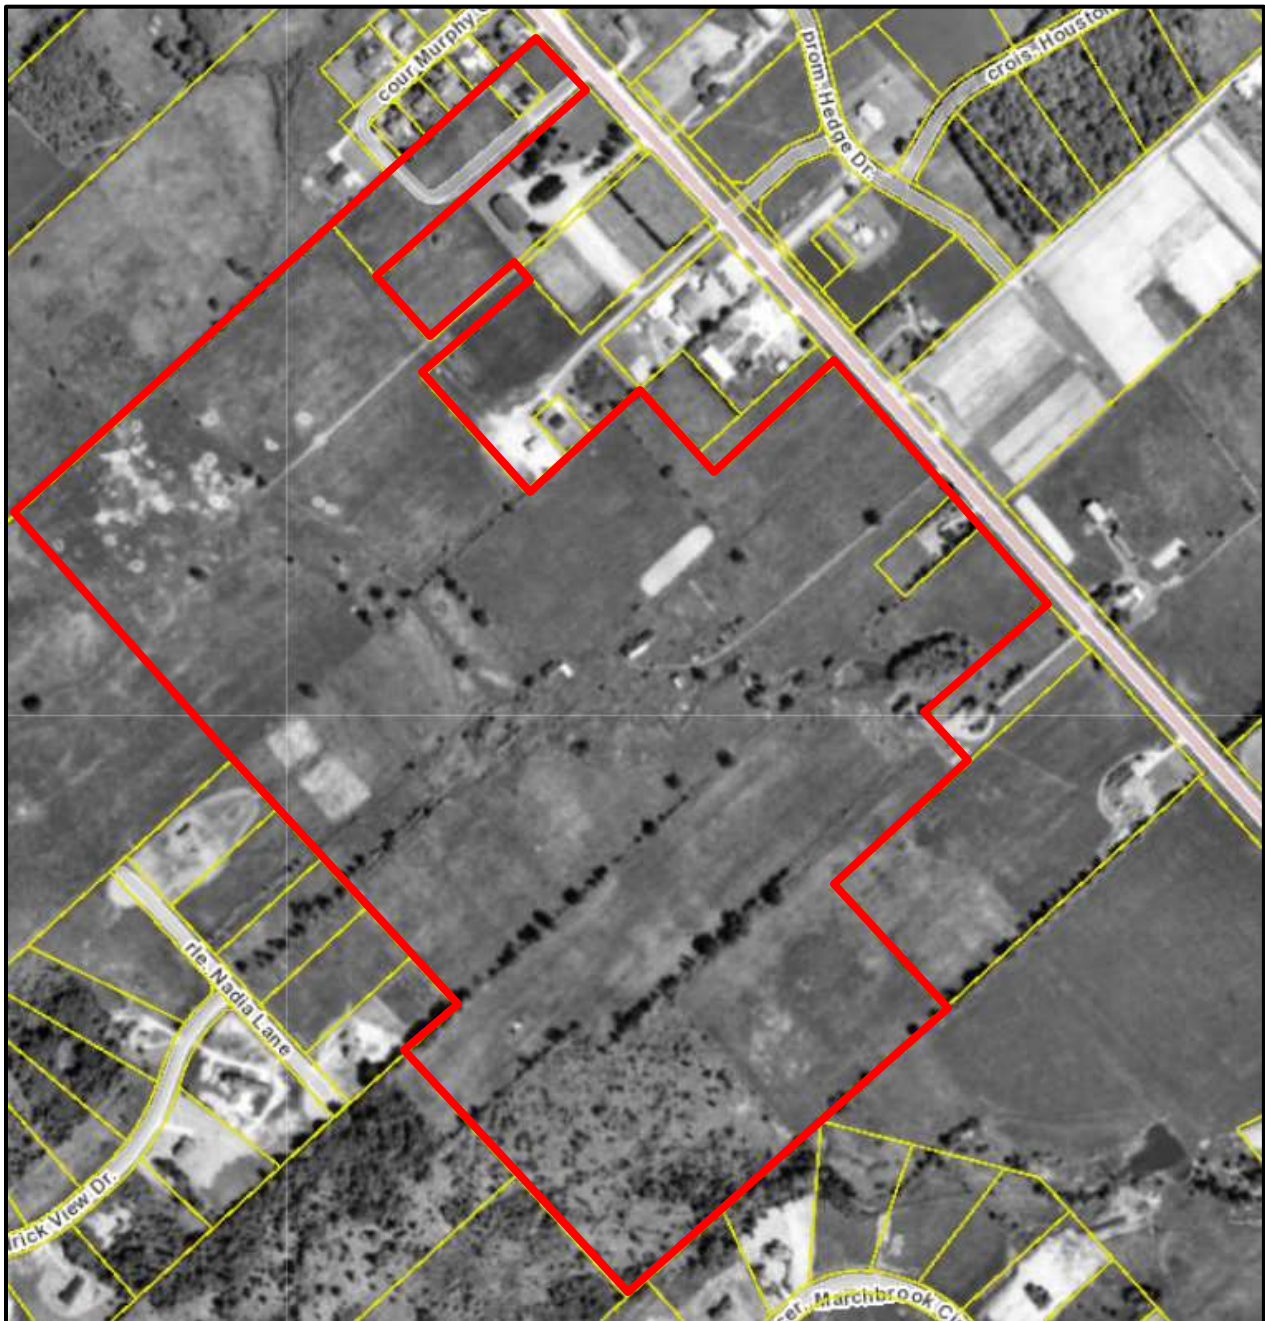
**Historic Air Photograph 2:** Historic Air Photo from 1991 (Site development limits shown in red). Note the majority of the Study Area continued to be intensively farmed in 1991, and tree cover was predominantly limited to the hedgerows. However, regeneration of trees and shrubs in the southwestern corner of the Study Area and surrounding areas was underway by 1991 (Photos from City of Ottawa 2018).

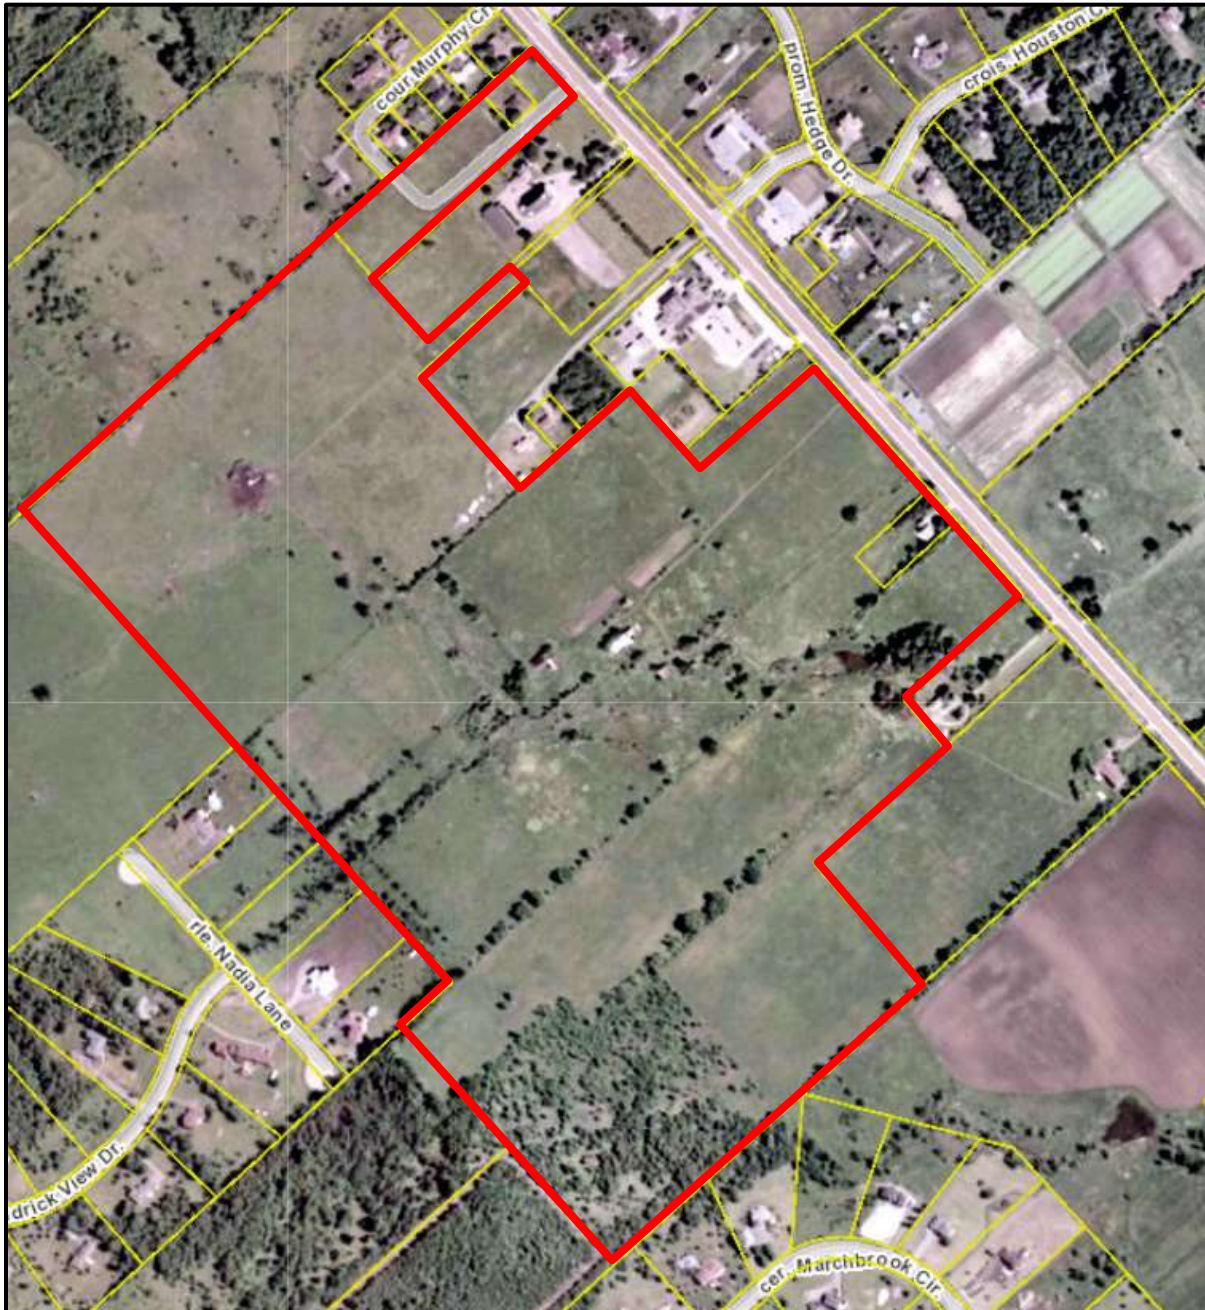
Historic Air Photograph 3: Historic Air Photo from 2005 (Site development limits shown in red). Note the majority of the Study Area continued to be intensively farmed. Tree cover was limited to the hedgerows and Cultural Woodlot F and G in 2005. However, regeneration of trees and shrubs in the southwestern corner of the Study Area and surrounding areas had advanced significantly by 2005 (Photos from City of Ottawa 2018).

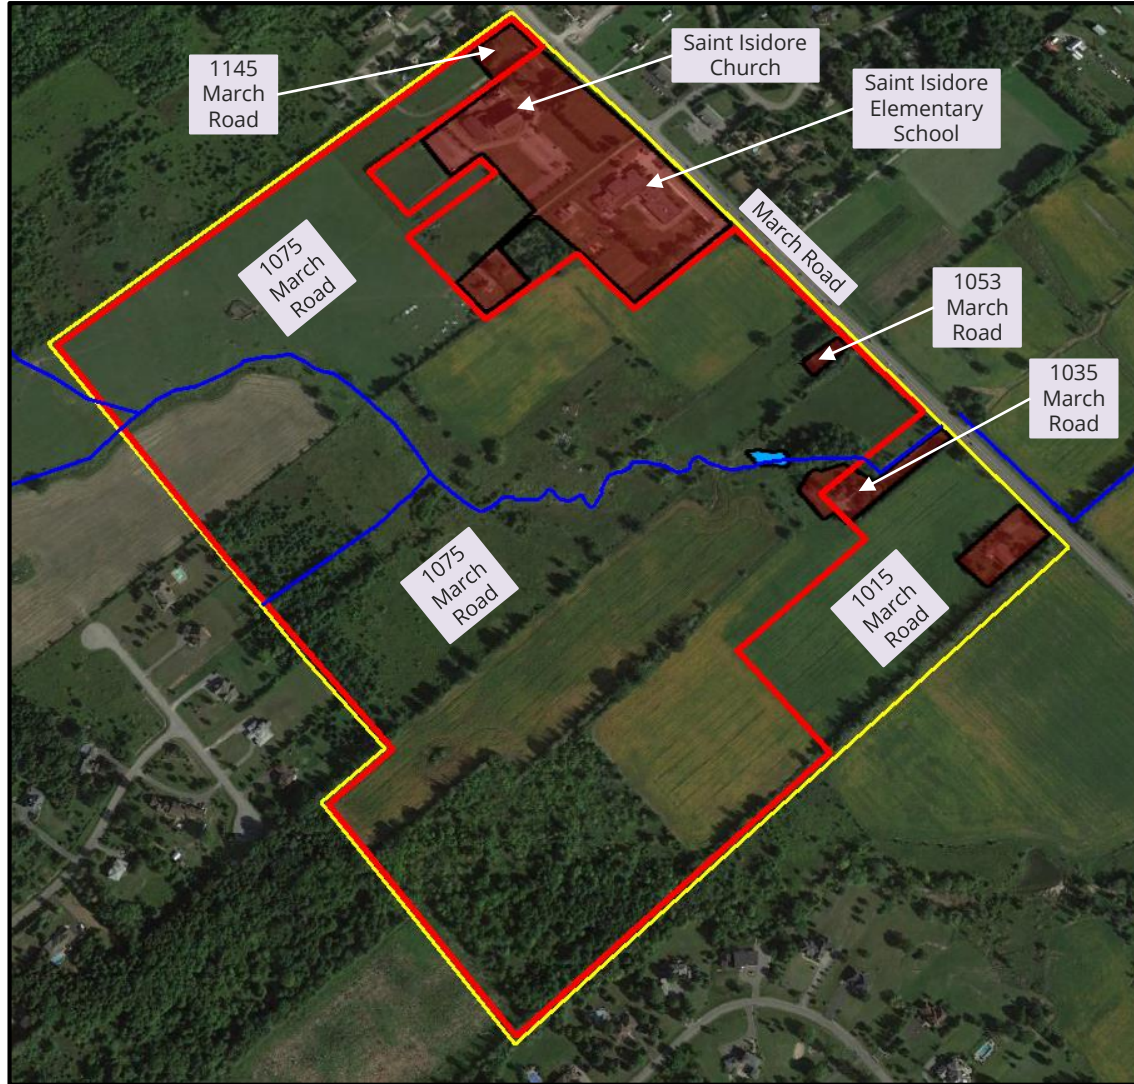
# FIGURE 2: PREVIOUSLY DEVELOPED AREAS

- Study Area (Northwest Quadrant)

The extent of these vegetation communities is shown in Figures 1 to 4. Appendix A includes a list of plant species noted during the vegetation surveys. Each of the vegetation communities is described in greater detail below.

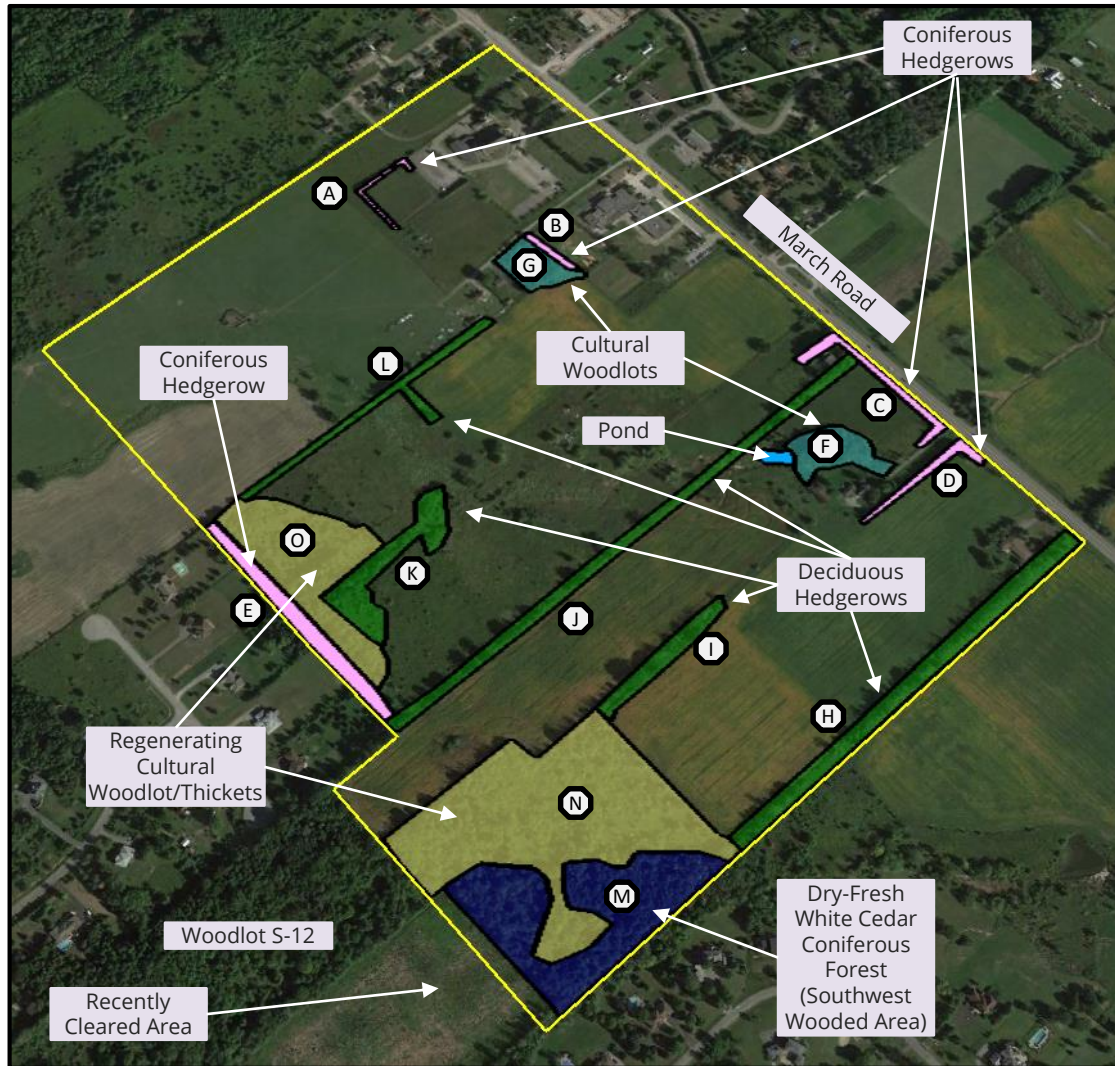
# FIGURE 3: TREED HABITATS

- Study Area (Northwest Quadrant)

There are five (5) Deciduous Hedgerows within the Study Area. Deciduous Hedgerows are shown in Figure 3 and tree sizes are shown in Table C. The Deciduous Hedgerows throughout the Study Area all have similar species composition. Throughout the Study Area White/Green Ash are the dominant tree within the Deciduous Hedgerows. Virtually all White/Green Ash over 20 cm dbh in size are either dead or severely stressed as a result of the effects of the invasive Emerald Ash Borer. This die-off of large Ash trees has significantly degraded the hedgerows. Other trees that are common throughout the Deciduous Hedgerows include Bur Oak, Manitoba Maple, American Elm, American Basswood, Domestic Apple and Black Cherry. Trembling Aspen, White Cedar, White Birch, Sugar Maple, and White Pine are also present but are less common. All of the Deciduous Hedgerows include thick shrub cover including regenerating Ash stems, Common Buckthorn, Common Apple, Prickly Ash, Tartarian Honeysuckle, Choke Cherry, Hawthorn, Wild Red Raspberry, and Riverbank Grape. Groundcover is reflective of disturbed conditions and includes various grasses, Dandelion, Poison Ivy, Virginia Creeper, Common Milkweed, Canada Goldenrod, Common Strawberry, Common Ragweed, and Red and White Clover. Tree sizes vary within the hedgerows as follows:

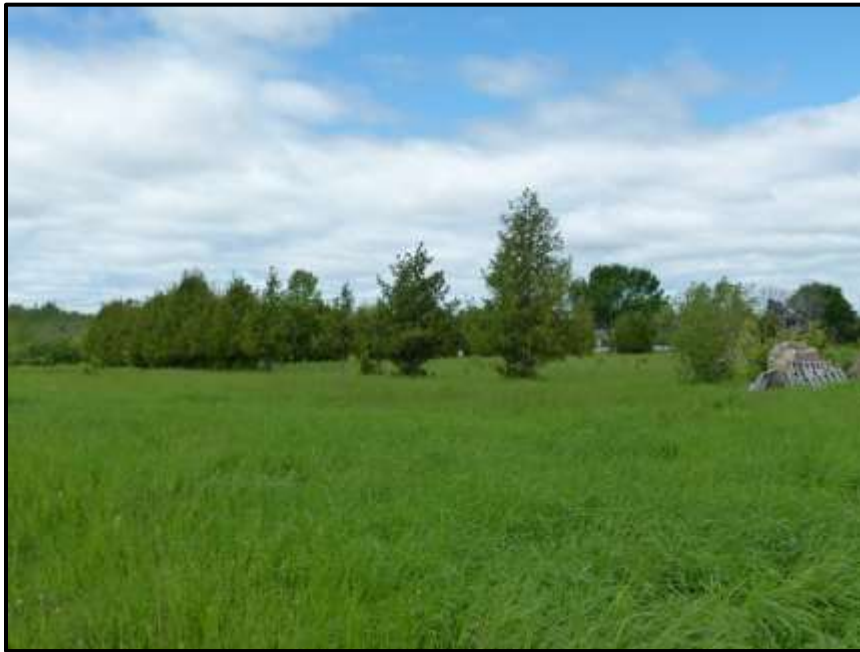
**Photograph 1:** The White Cedar hedge (Feature A) is shown, looking northwest from the Fallow Fields (June 3<sup>rd</sup>, 2017).

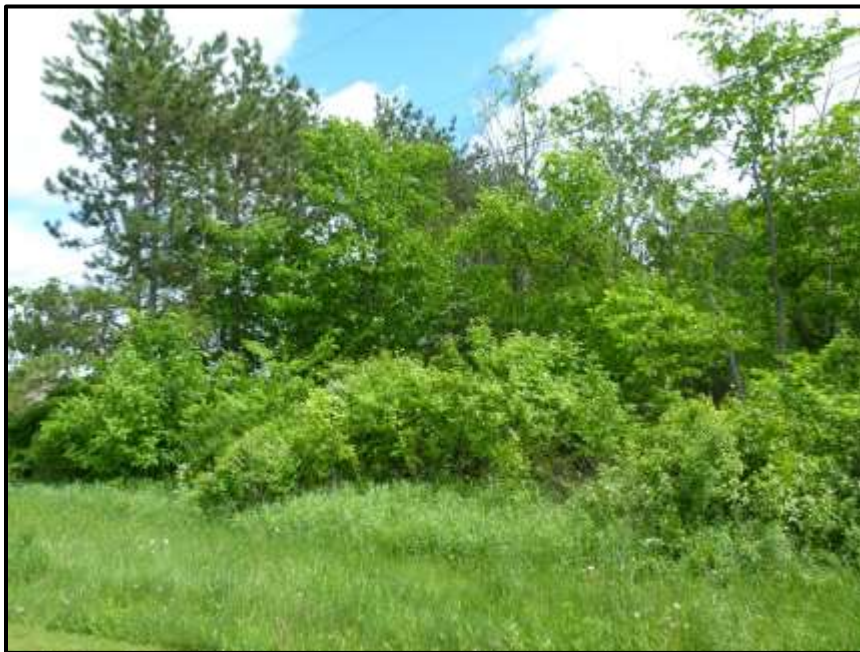
**Photograph 2:** White Pines forming the Coniferous Hedgerow (Feature B) are shown in the background, the Cultural Woodlot (Feature G) is on the right. Looking northeast (June 3<sup>rd</sup>, 2017).

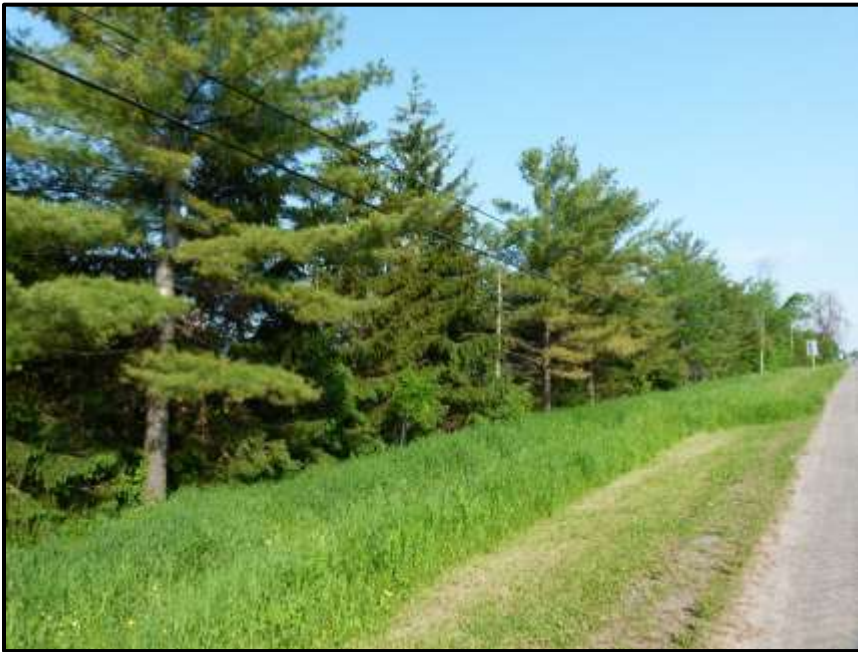
**Photograph 3:** White Pines and White Spruce (Feature C) are shown, looking north along March Road (June 12<sup>th</sup>, 2017).

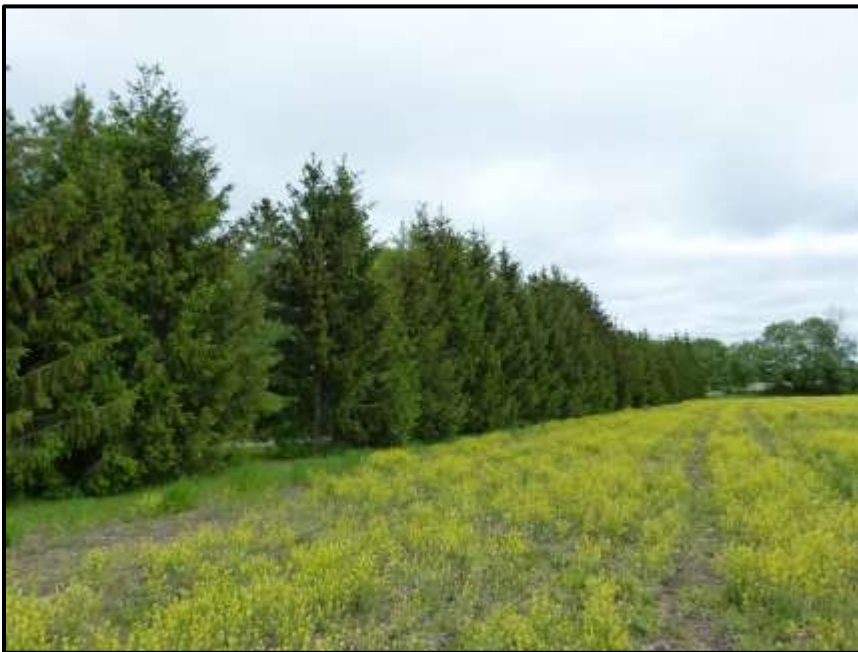
**Photograph 4:** White Spruce forming the Coniferous Hedgerow (Feature D) are shown, looking northeast towards March Road (June 3<sup>rd</sup>, 2017).

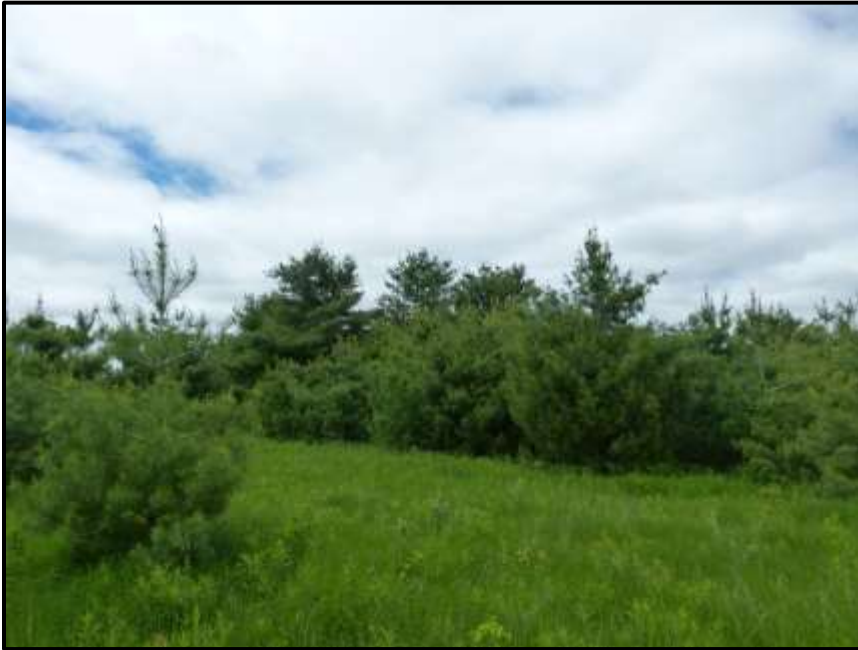
**Photograph 5:** White Pines forming the Coniferous Hedgerow (Feature E) are shown in the background, Regrowth Cultural Thicket/Cultural Woodlot (Feature O) dominated by White Pine are shown in the foreground. Looking west (June 3<sup>rd</sup>, 2017).

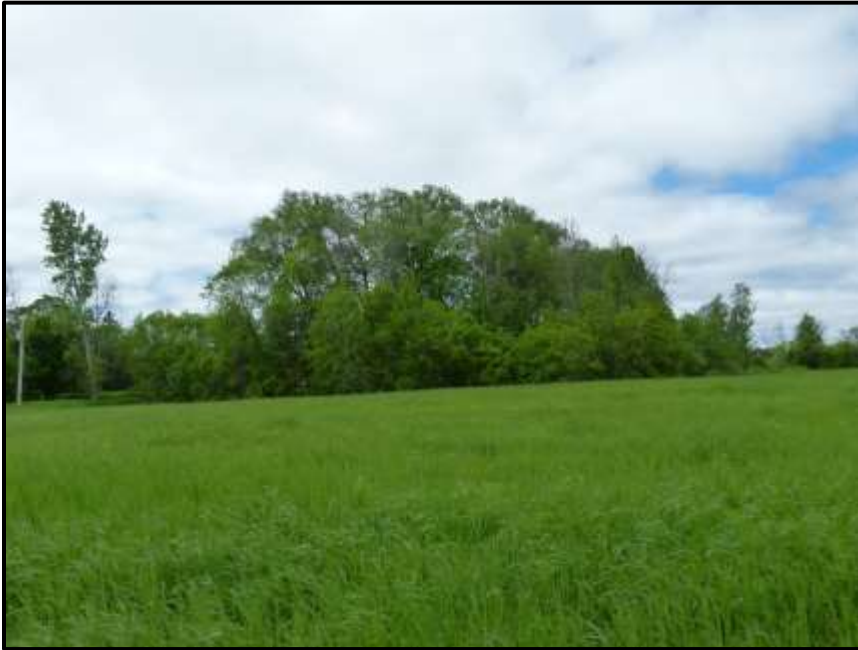
**Photograph 6:** The Southern Cultural Woodlot (Feature F), facing southwest from the adjacent Fallow Field. Note that the emergent trees are Black Willow, surrounded by recent regrowth (June 3<sup>rd</sup>, 2017).

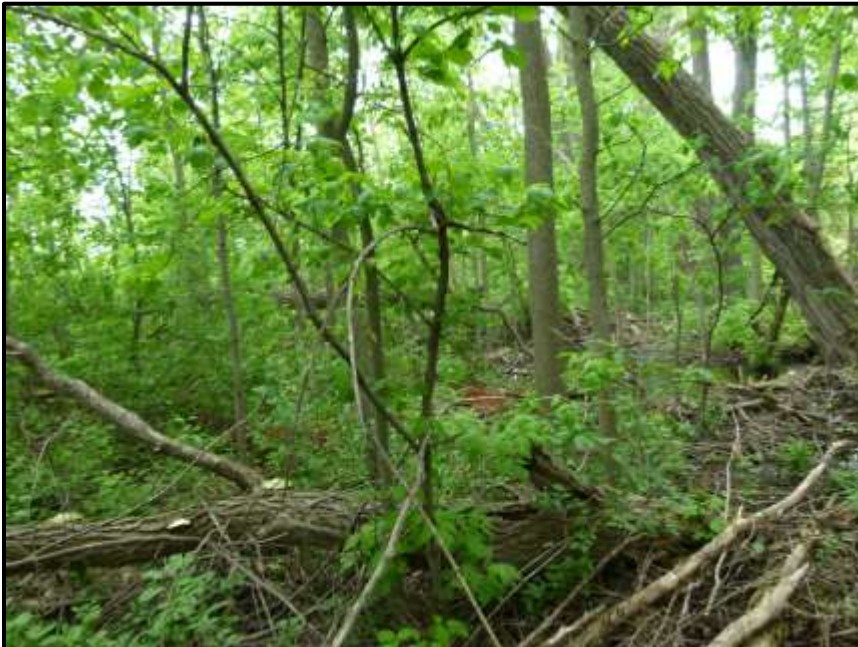
**Photograph 7:** Interior of the Southern Cultural Woodlot (Feature F). The larger Black Willow are shown on the right (June 3<sup>rd</sup>, 2017).

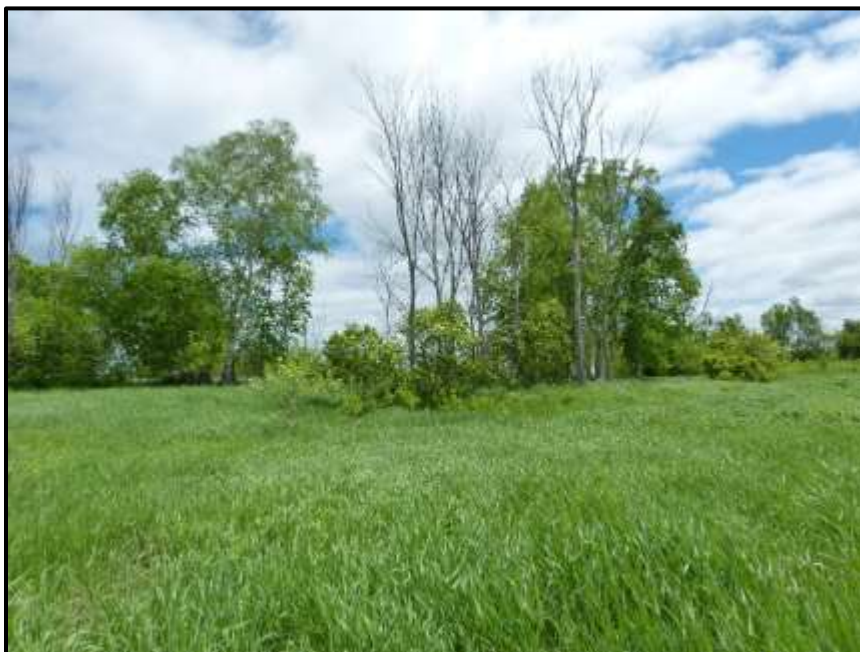
**Photograph 12:** Deciduous Hedgerow K looking southwest, a dead American Elm is shown in the foreground (June 3<sup>rd</sup>, 2017).

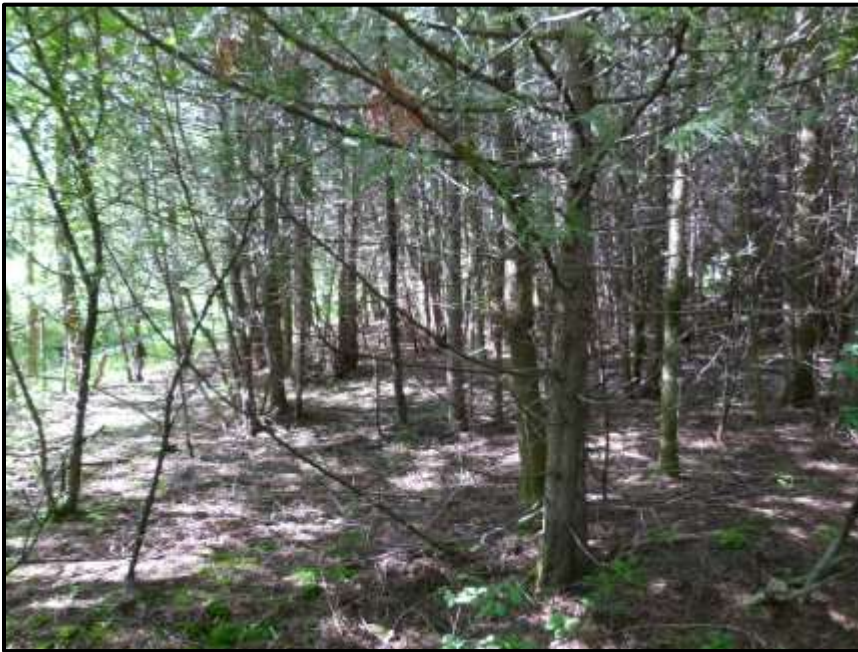
**Photograph 14:** Interior of the Dry-Fresh White Cedar Forest (Southwest Wooded Area/Feature M) (June 3<sup>rd</sup>, 2017).

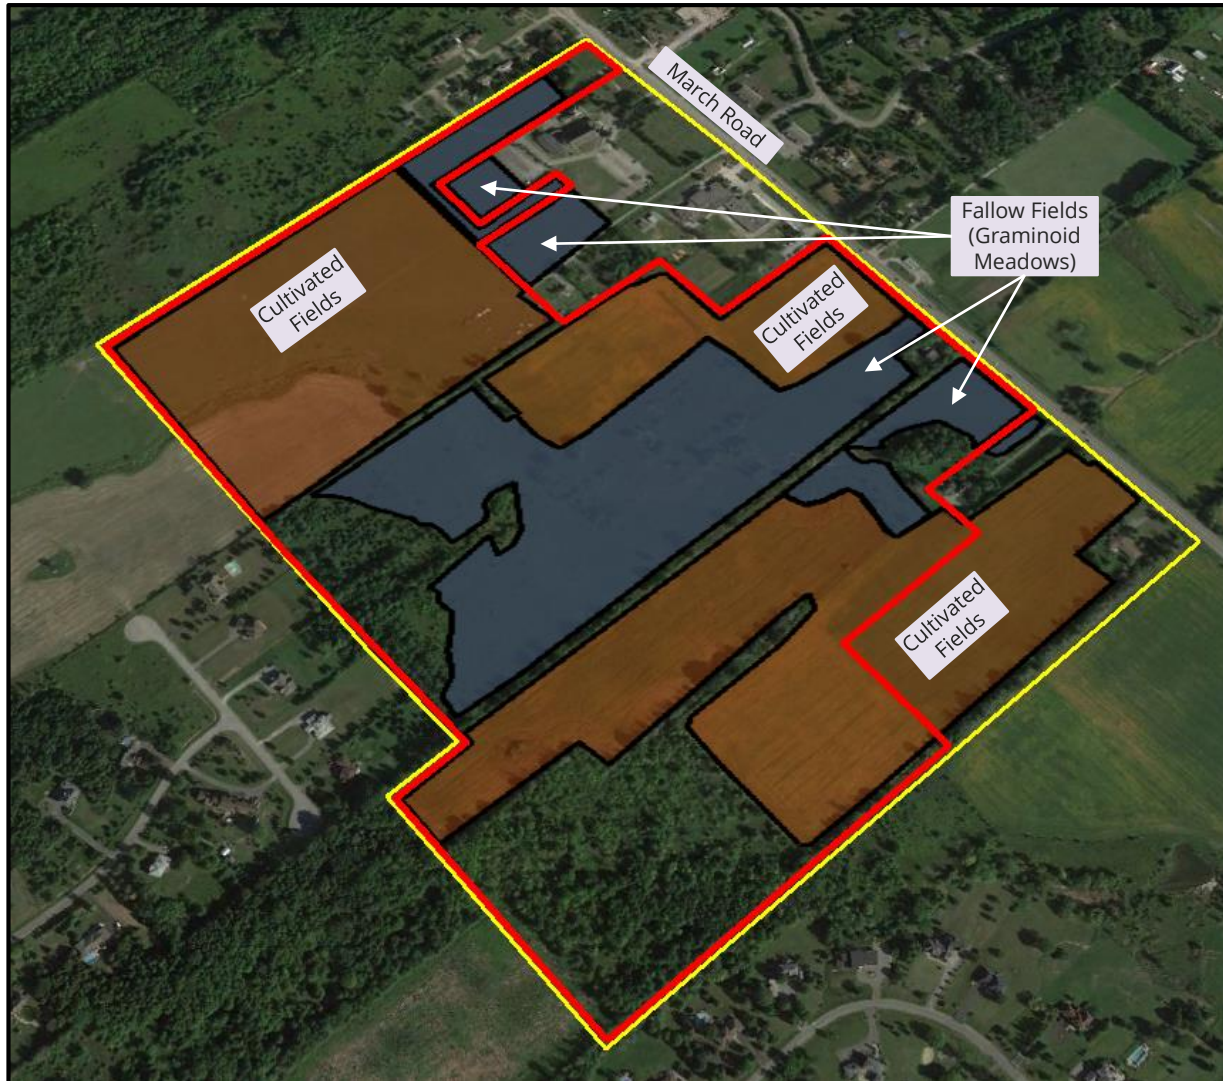
# FIGURE 4: OPEN HABITATS

The majority of the Study Area is dominated by open habitats including Cultivated Fields planted with soybeans or corn and regenerating Fallow Fields. Open habitats are shown in Figure 4 and are described below:

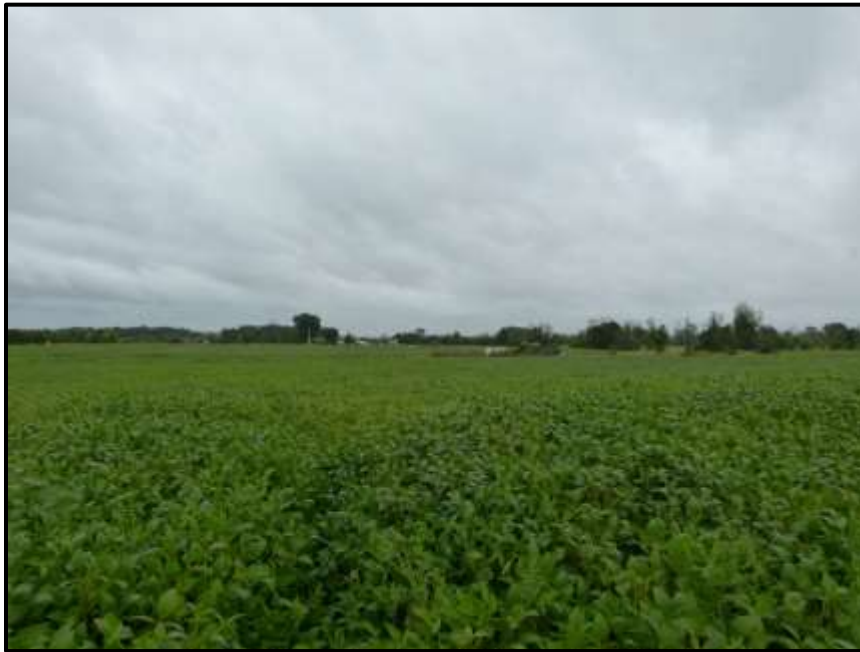
**Photograph 21:** Former Cattle Pasture within 1075 March Road, facing east. The Cattle Pasture is shown after planting with soybeans (September 3<sup>rd</sup>, 2017).

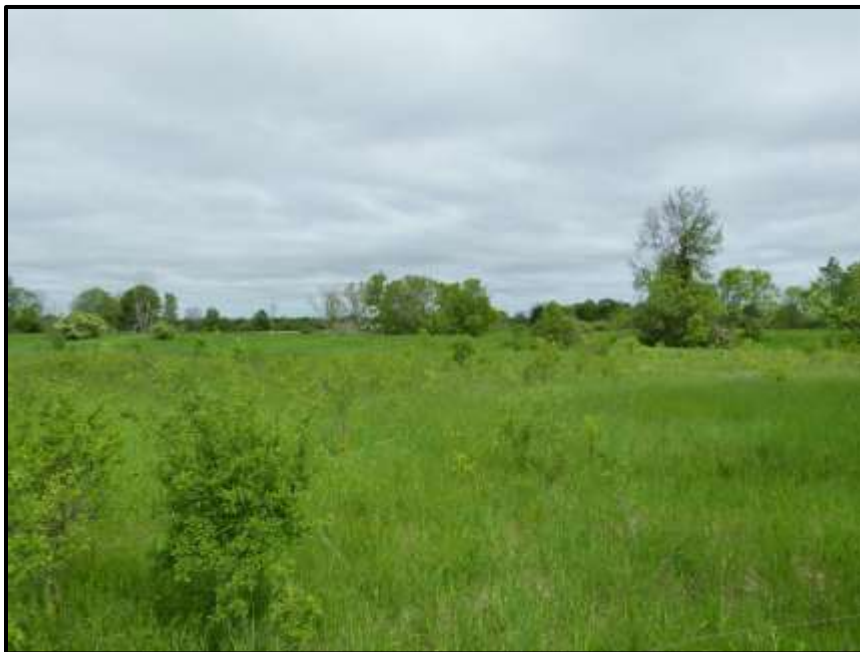
**Photograph 22:** Regenerating Fallow Fields with sparse shrub growth (western part of 1075 March Road) (June 3<sup>rd</sup>, 2017).

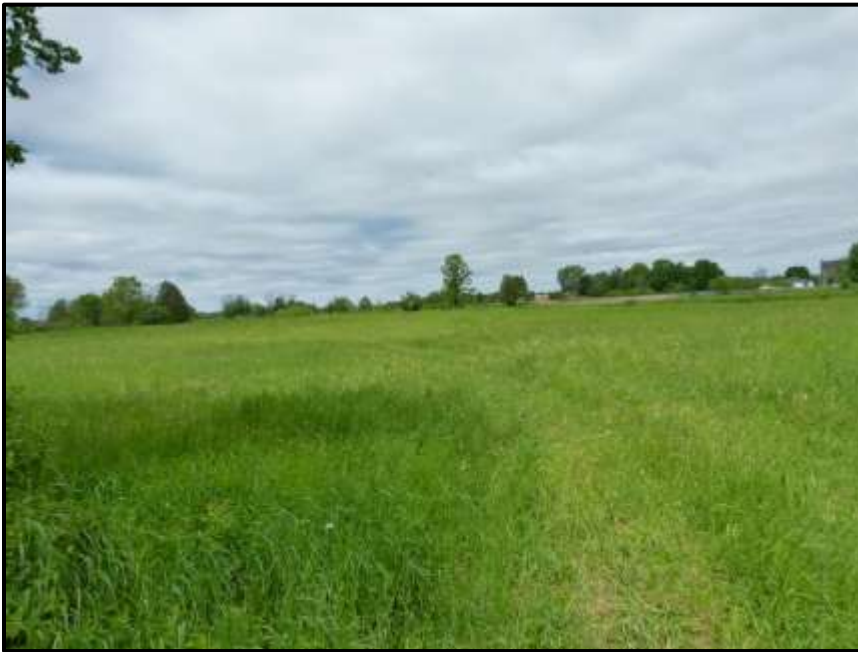
**Photograph 23:** Recently Fallow Field with almost no shrub growth (eastern part of 1075 March Road) (June 3<sup>rd</sup>, 2017).

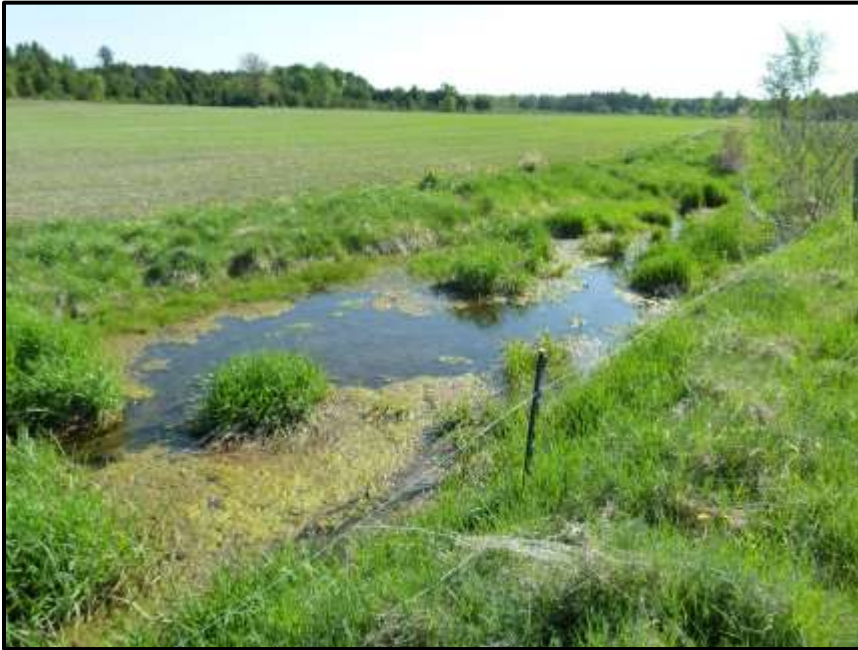
**Photograph 24:** Looking south at the northern reach of the North Tributary. The area shown is where the watercourse enters the Study Area (May 23<sup>rd</sup>, 2016).

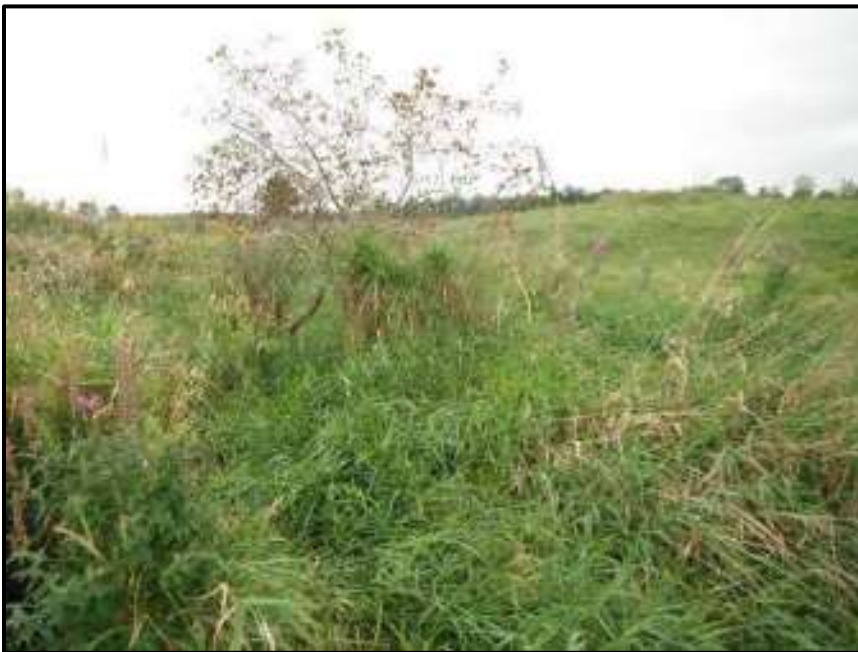
**Photograph 25:** The North Tributary during typical summer conditions. Note the channel is overgrown by terrestrial vegetation (September 3<sup>rd</sup>, 2013) (Photo from MEP 2016).

As a whole, the North Tributary can be characterized as a highly degraded agricultural drain that has limited water depths and a hydro-period that is typically confined to the spring in most years. Throughout the majority of the Study Area, the watercourse has very little shade and low quality riparian habitat. Much of the North Tributary becomes overgrown with terrestrial vegetation by mid-summer each year, limiting its ability to provide fish habitat throughout much of the growing season. The North Tributary provides intermittent, low quality fish habitat, which supports a low diversity, tolerant warm-water fish community. As described above, the western reach is likely too ephemeral and too limited in terms of water depth to provide fish habitat.

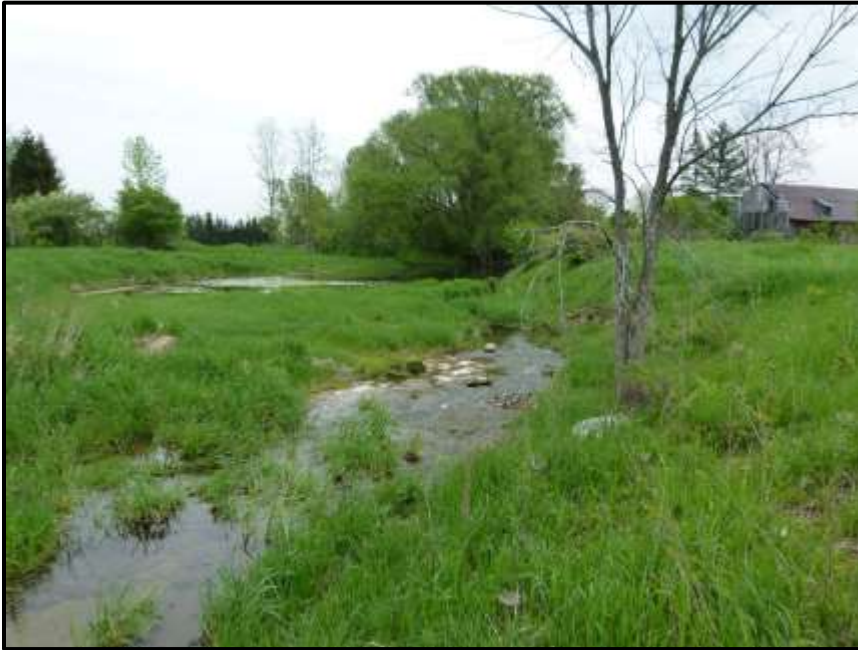
**Photograph 26:** Looking east along the North Tributary, with the pond in the background. Note that the channel is shallow, narrow, and mostly overgrown with terrestrial vegetation. The barn shown on the right was demolished during the winter of 2017-2018 (May 24<sup>th</sup>, 2017).

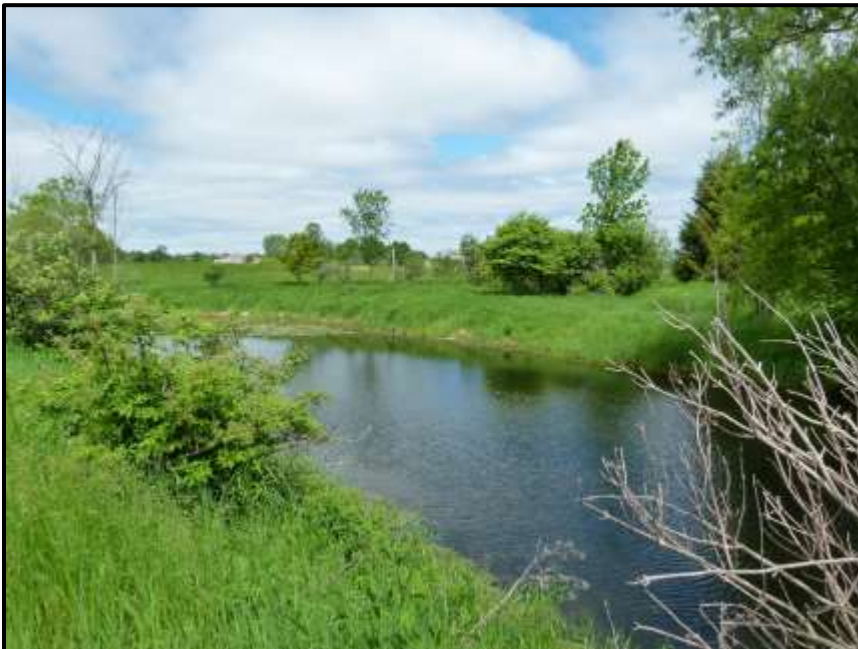
**Photograph 27:** Looking west at the pond. Note that the majority of the pond's surface area remains as open water, even in mid-summer (June 3<sup>rd</sup>, 2017).

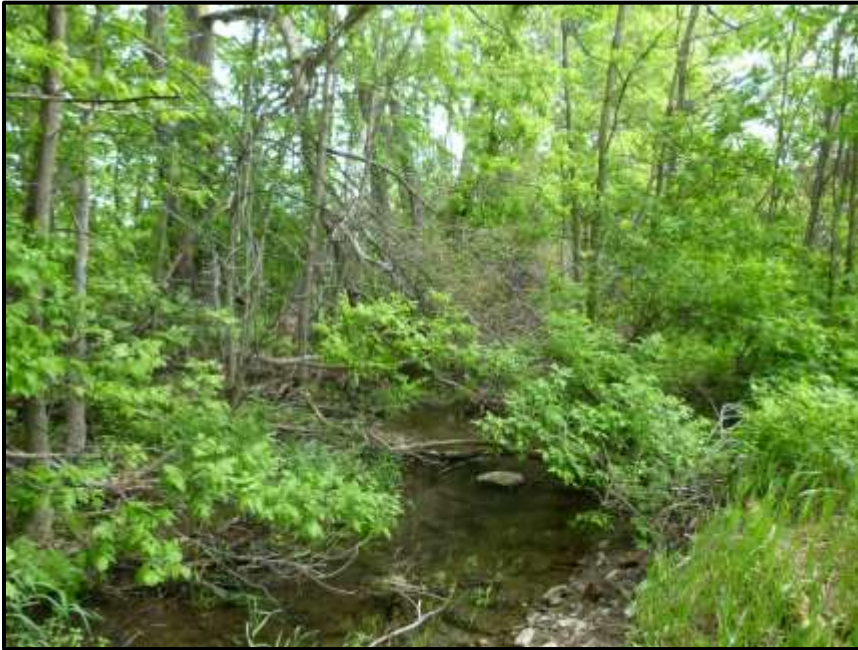
**Photograph 28:** Looking east at the North Tributary as it flows through the Cultural Woodlot (Feature F) (June 3<sup>rd</sup>, 2017).
