Combined Environmental Impact Statement &  
Tree Conservation Report  
1053/1075/1145 March Road

June 2018  
Prepared for CU Developments Inc.

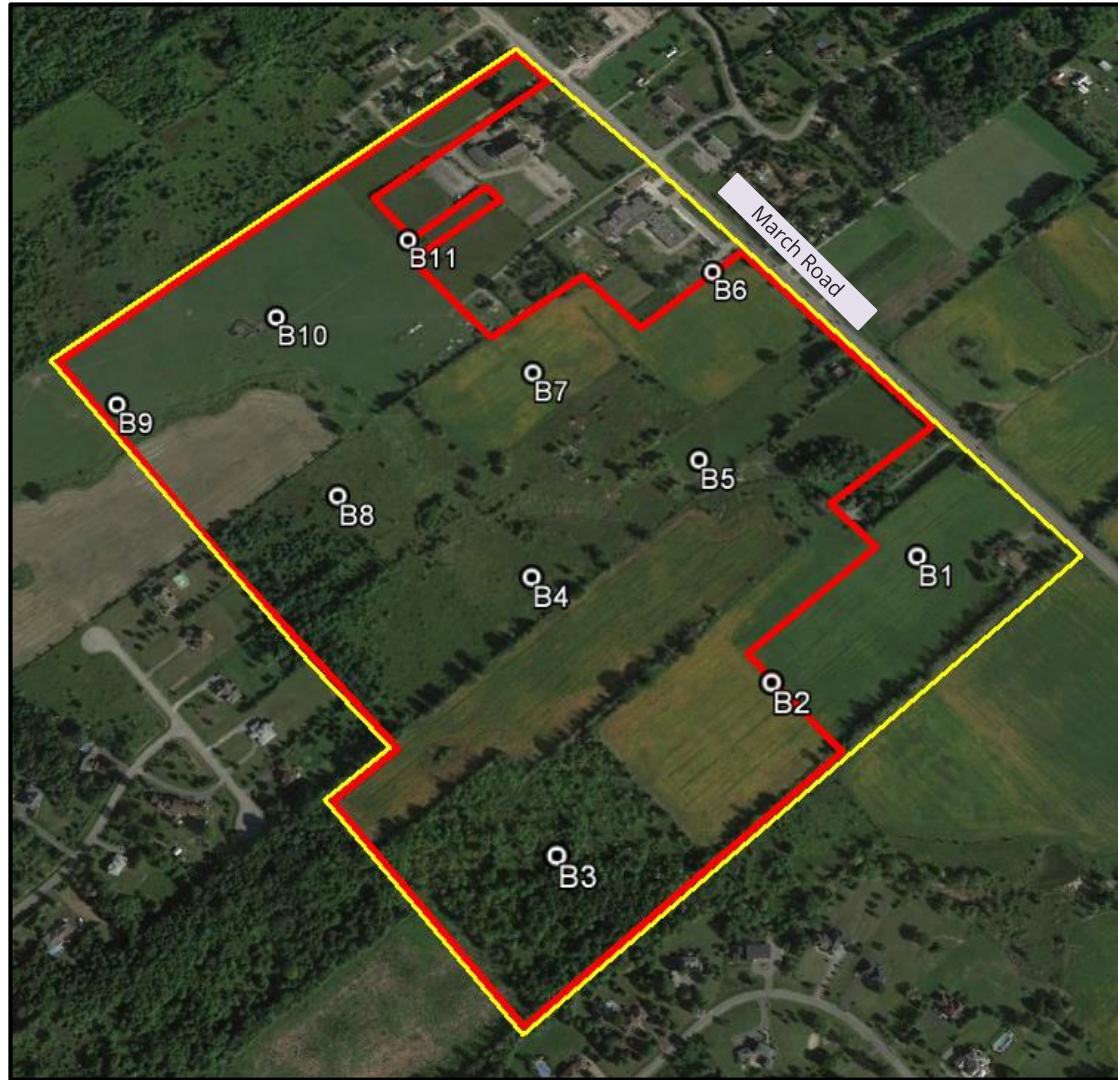
# FIGURE 5: BIRD SURVEY POINTS

Breeding bird survey points are shown below in Figure 5. A total of sixty (60) bird species were noted within the Study Area. This included several common species of migratory birds typically found in suburban and rural areas (including Barn Swallow and Bobolink). Other wildlife observed within the Study Area included Eastern Grey Squirrel, Red Squirrel, Eastern Chipmunk, White Tailed Deer, Common Raccoon, Groundhog, Green Frog, American Bullfrog, Painted Turtle, Garter Snake and Blanding's Turtle (threatened).

- **Plant Inventory and ELC Classification:** See description above.
- **Bird Point Counts (Barn Swallow, Bobolink, Eastern Meadowlark):** Breeding bird surveys were completed in 2013 and 2015 as part of the Natural Environment Existing Conditions Report, during which Bobolink and Barn Swallows were noted within the KNUEA northwest quadrant (MEP 2016). As noted above, all structures containing Barn Swallow nests were demolished in the winter of 2015-2016 and winter of 2017-2018. As such, additional surveying for Barn Swallows was not required. Updated surveying to delineate the extent of Bobolink habitat, and to confirm the presence/absence of Eastern Meadowlark, was completed on May 24<sup>th</sup>, June 3<sup>rd</sup>, and June 12<sup>th</sup>, 2017. Surveys were completed following the OMNRF *Wildlife Monitoring Programs and Inventory Techniques - Technical Manual* (Konze & McLaren 1998) Breeding Bird Survey (BBS) method. The survey timing followed the requirements outlined in the OMNRF *Survey Methodology under the Endangered Species Act: Dolichonyx oryzivorus (Bobolink)* (OMNRF 2011a). Bird survey points are shown in Figure 5 (below).

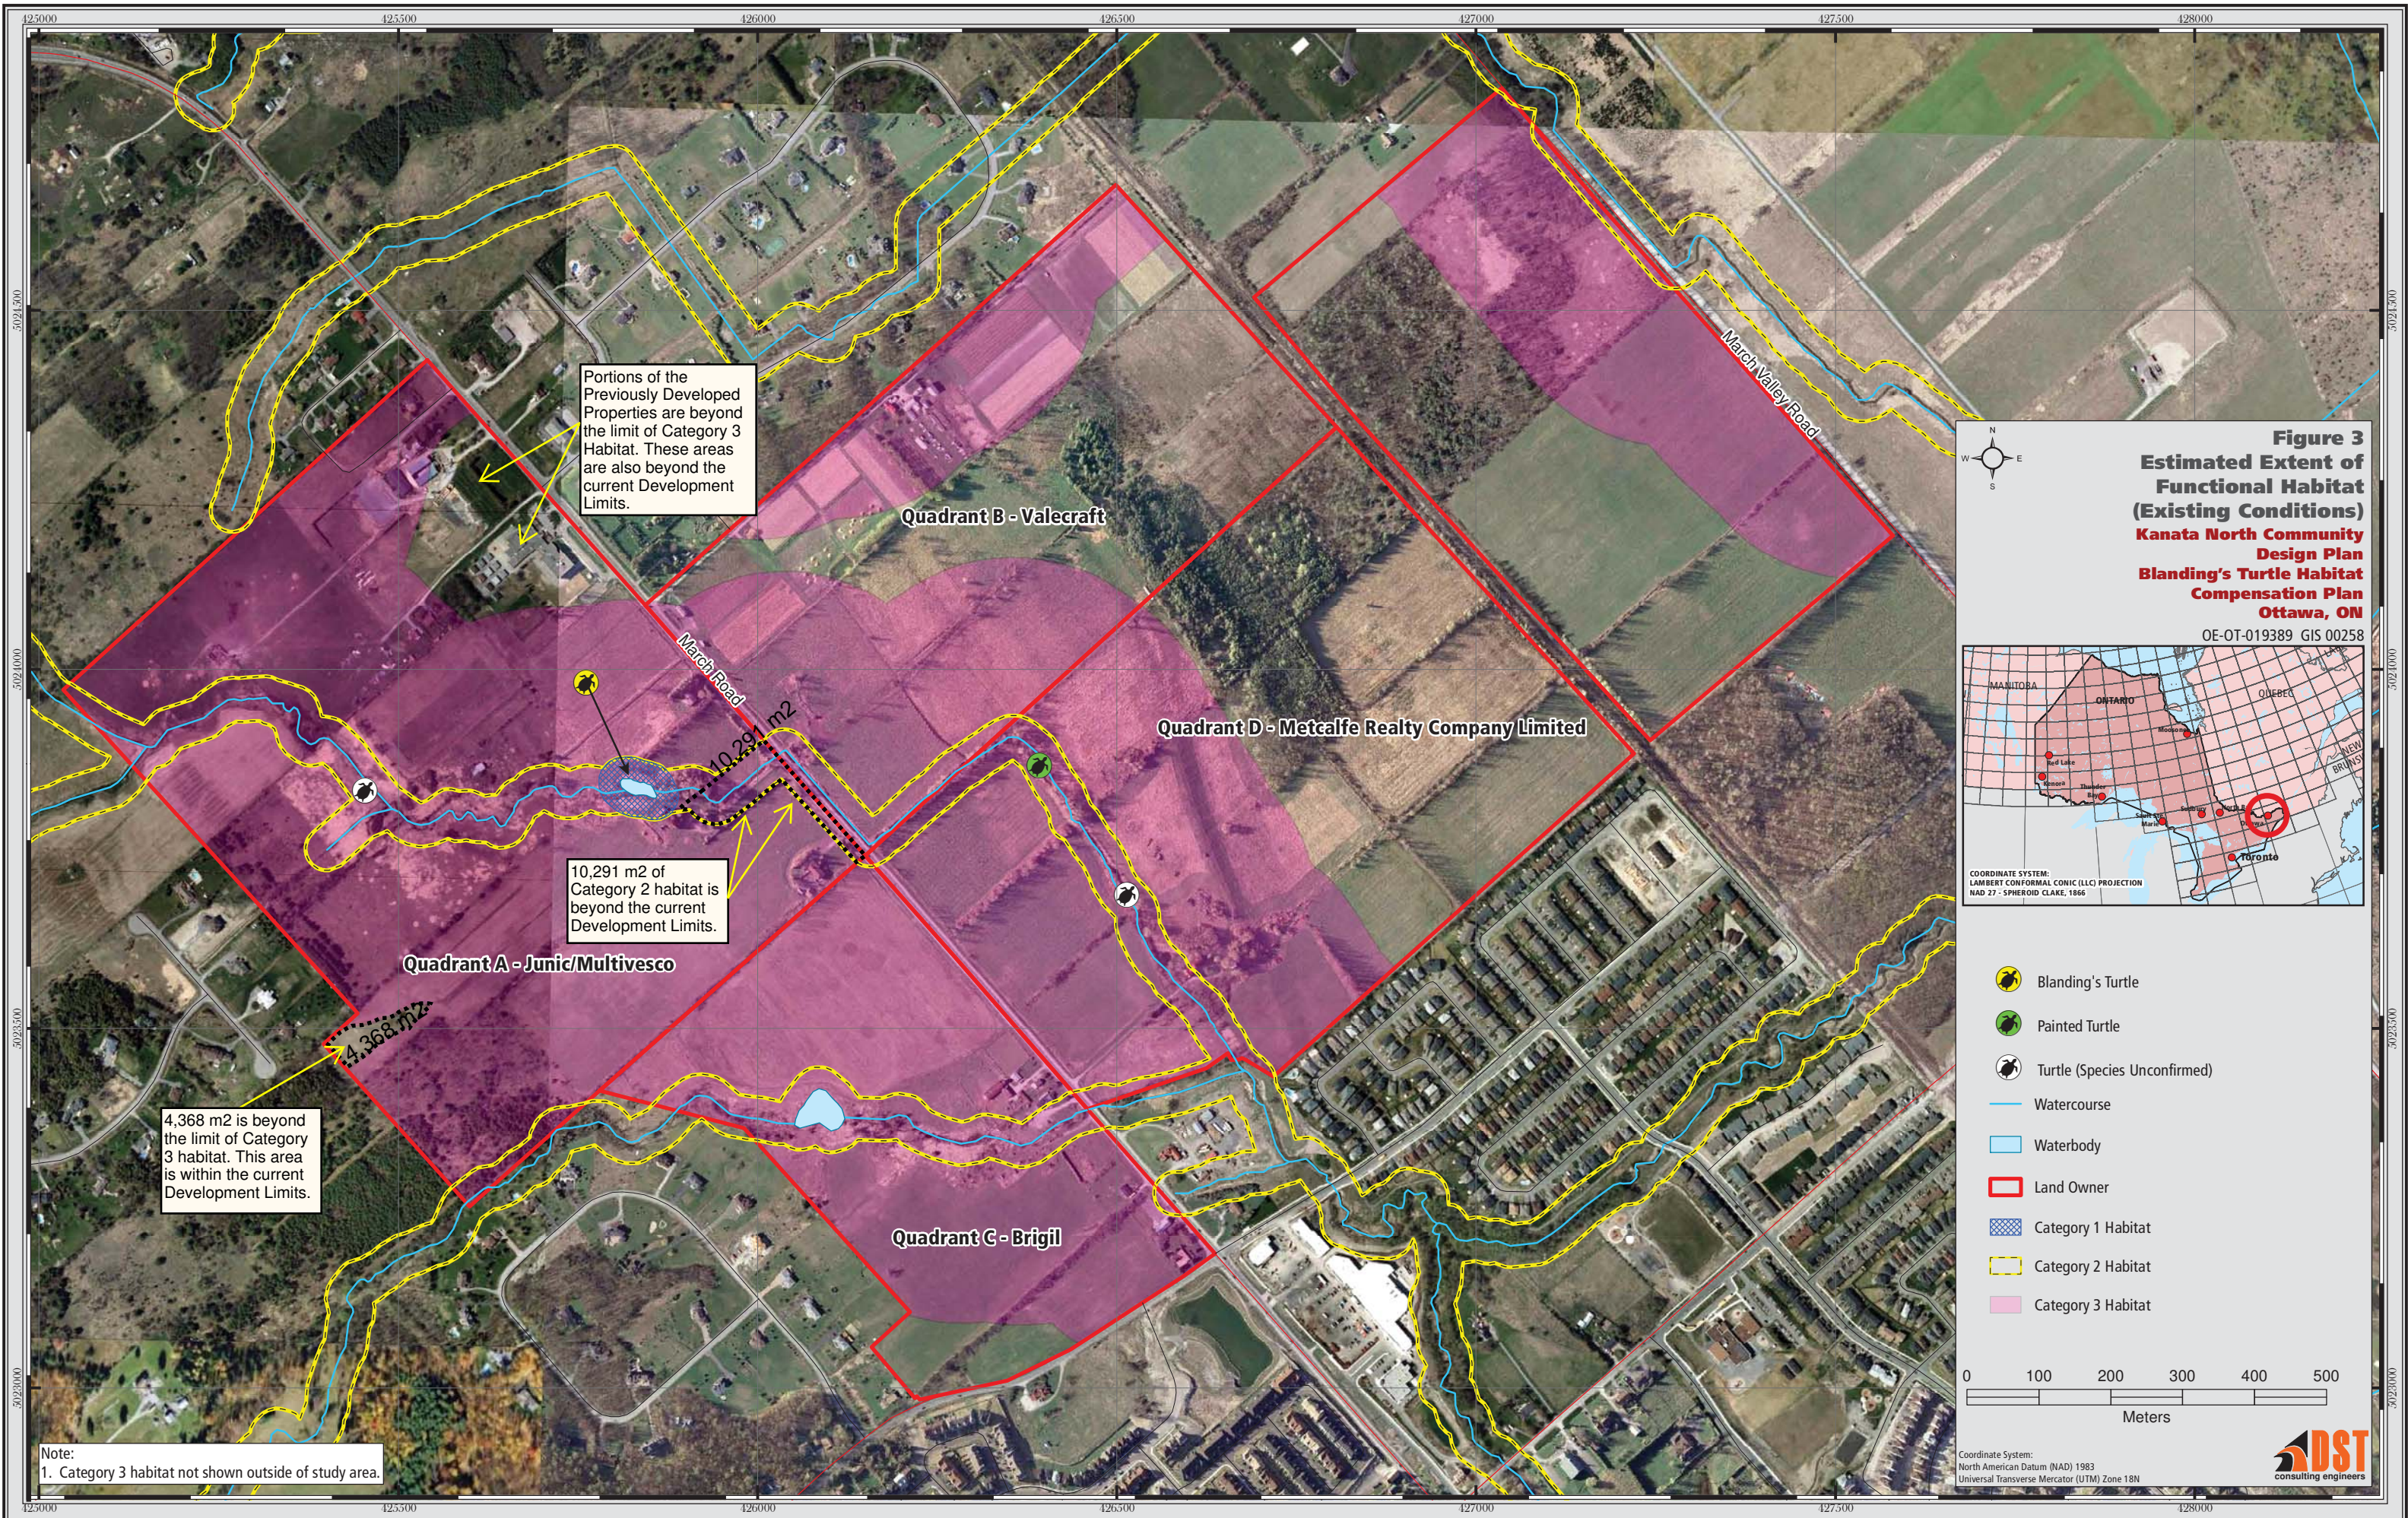
**Figure 3**  
**Estimated Extent of Functional Habitat (Existing Conditions)**  
**Kanata North Community Design Plan**  
**Blanding's Turtle Habitat Compensation Plan**  
**Ottawa, ON**

Portions of the Previously Developed Properties are beyond the limit of Category 3 Habitat. These areas are also beyond the current Development Limits.

10,291 m2 of Category 2 habitat is beyond the current Development Limits.

Regulatory, mitigation, and habitat compensation requirements for Blanding's Turtle are discussed in detail in Section 4.4.3.

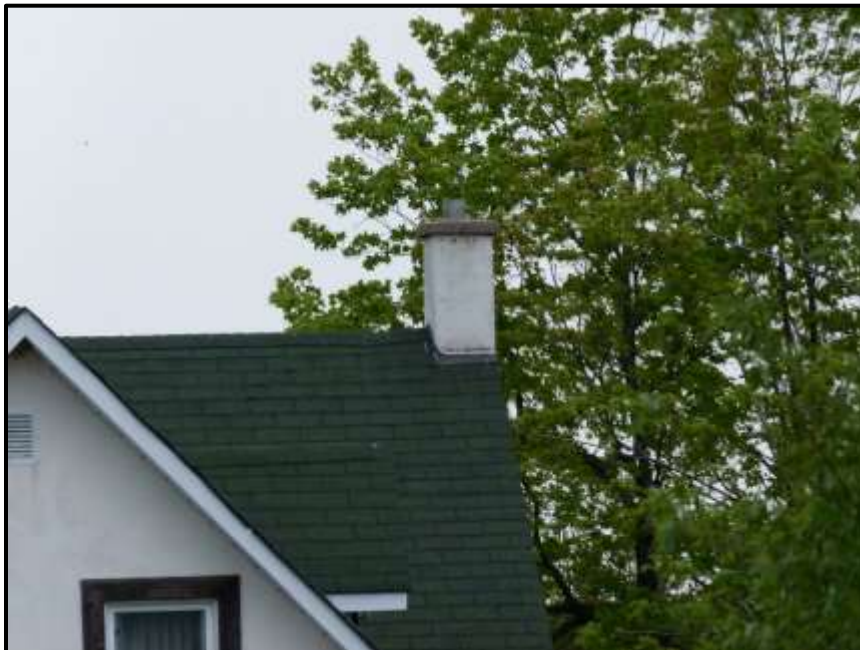
Photograph 32: Chimney at 1035 March Road. Note metal liner (May 24<sup>th</sup>, 2017).

Photographs of the chimneys are included below. Chimney Swift will not typically nest in chimneys with ceramic liners, as they are unable to affix their nests to the smooth interior surface. Chimney Swift are unable to enter chimneys with wire mesh or metal caps. There are therefore no chimneys within the Study Area which may be suitable for Chimney Swift nesting. Due to the absence of potentially suitable chimneys within the Study Area, a survey for Chimney Swifts was not required.

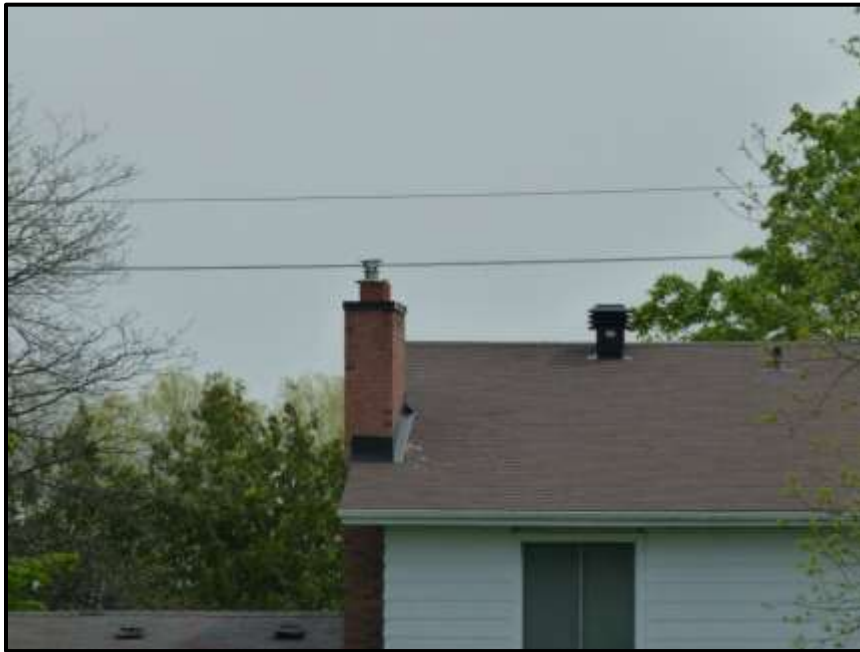
Photograph 33: Chimney at 1053 March Road. Note ceramic liner and metal cap (May 24<sup>th</sup>, 2017).

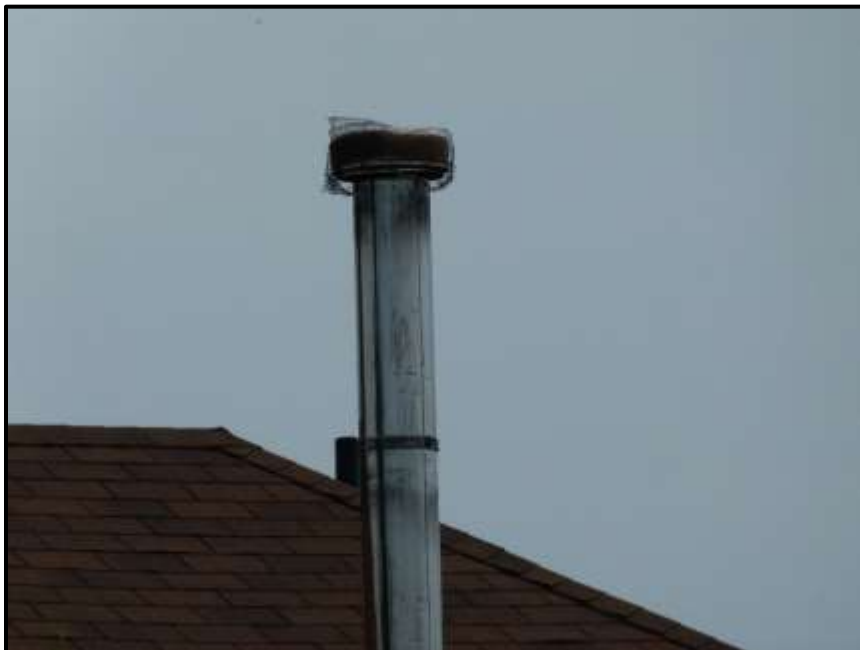
Photograph 34: Chimney at 1113 March Road. Note metal liner and wire mesh cap (May 24<sup>th</sup>, 2017).

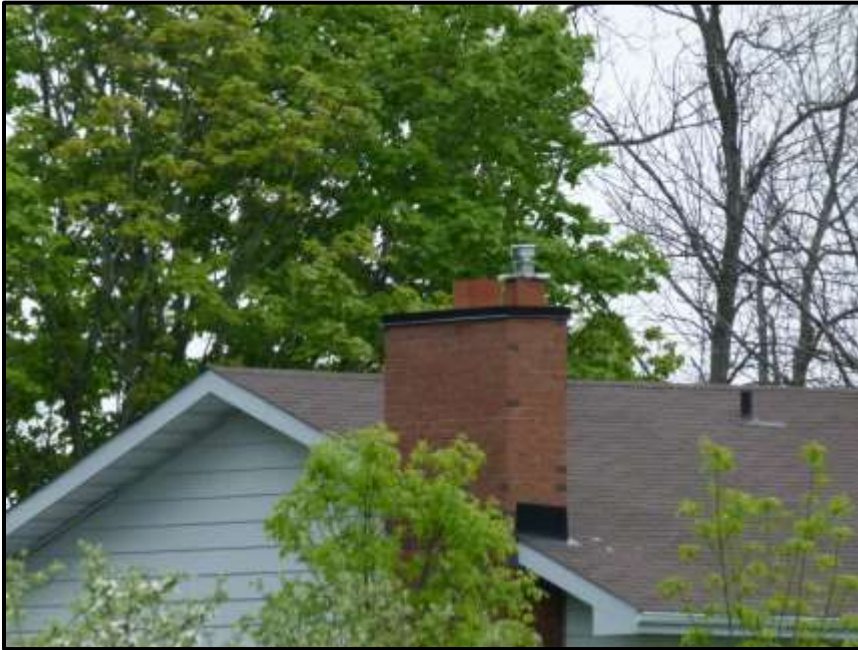
Photograph 35: Chimney at 1145 March Road. Note ceramic liner and metal cap (May 24<sup>th</sup>, 2017).

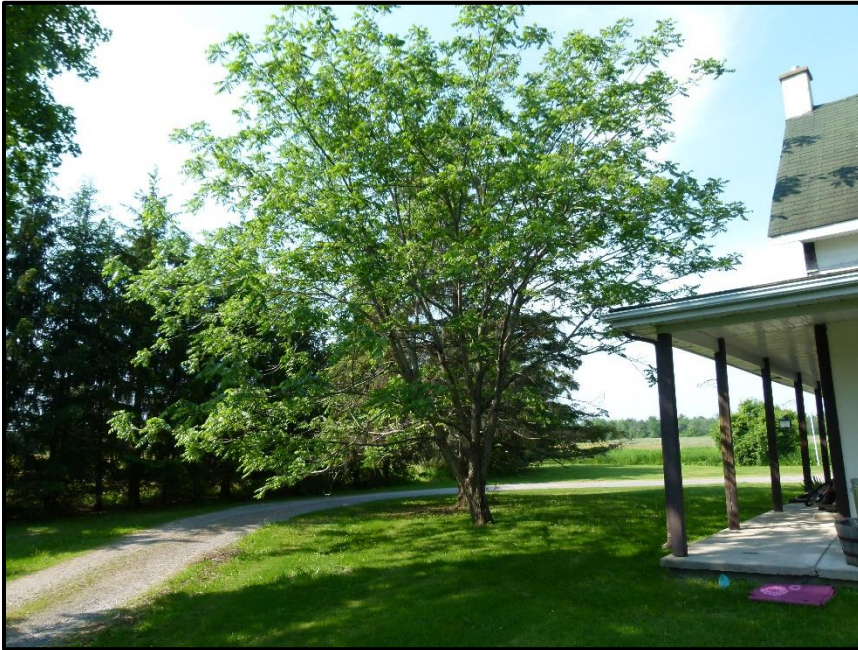
Photograph 1: Butternut Tree #1 (41 cm dbh) (June 12<sup>th</sup>, 2017).

nearby. A Butternut Health Assessment (BHA) addressing both trees was completed by a Certified Butternut Health Assessor (Appendix C). Both trees were judged to be Category 1 trees (non-retainable) and no further requirements for Butternut Trees were noted. No other Butternut Trees were found throughout the remainder of the Study Area.

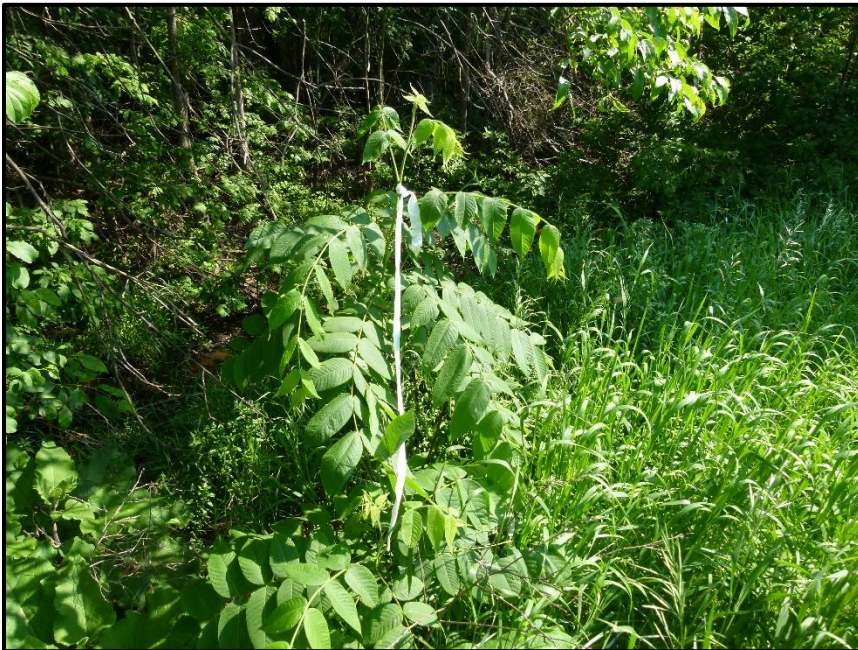
Photograph 2: Butternut Tree #2 (2 cm dbh) (June 12<sup>th</sup>, 2017).
