Phase I - Environmental Site Assessment

1919 Maple Grove Road
Ottawa, Ontario

May 11, 2018

Report: PE4308-1

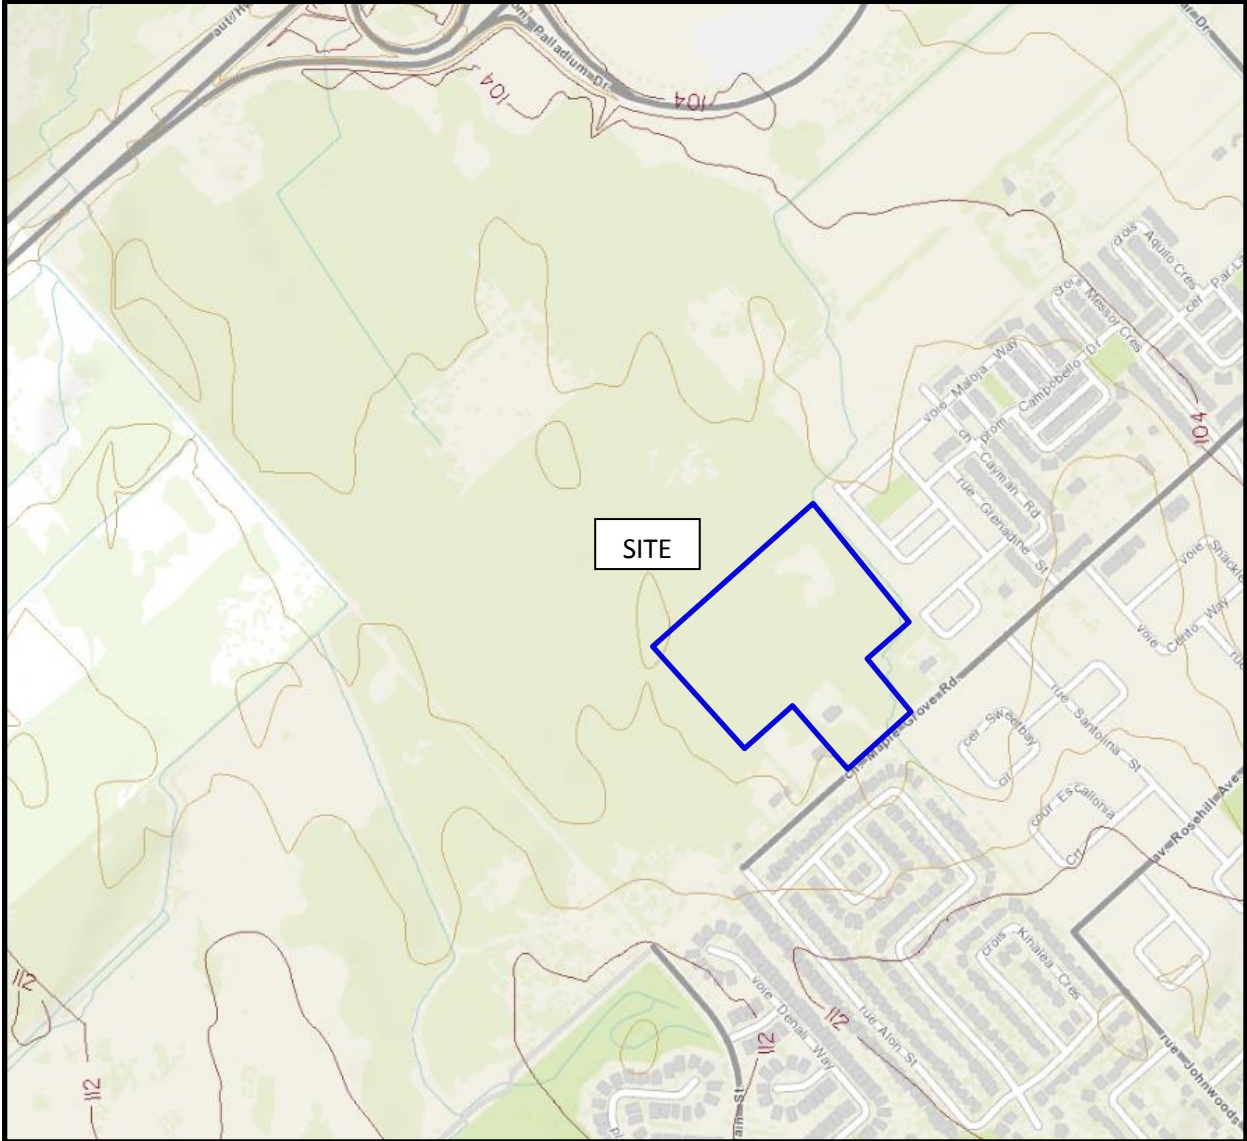
FIGURE 2
TOPOGRAPHIC MAP

Topographic maps were obtained from Natural Resources Canada - The Atlas of Canada website. The topographic maps indicate that the subject site lies between 106-108m in elevation. The regional topography in the general area of the subject site slopes downward to the east. Feedmill Creek is located approximately 400m west of the subject site, running from a storm water management pond west of the subject site to a marshland. No environmental concerns were identified on the topographic mapping. An illustration of the referenced topographic map is present on Figure 2 - Topographic Map following the body of this report.

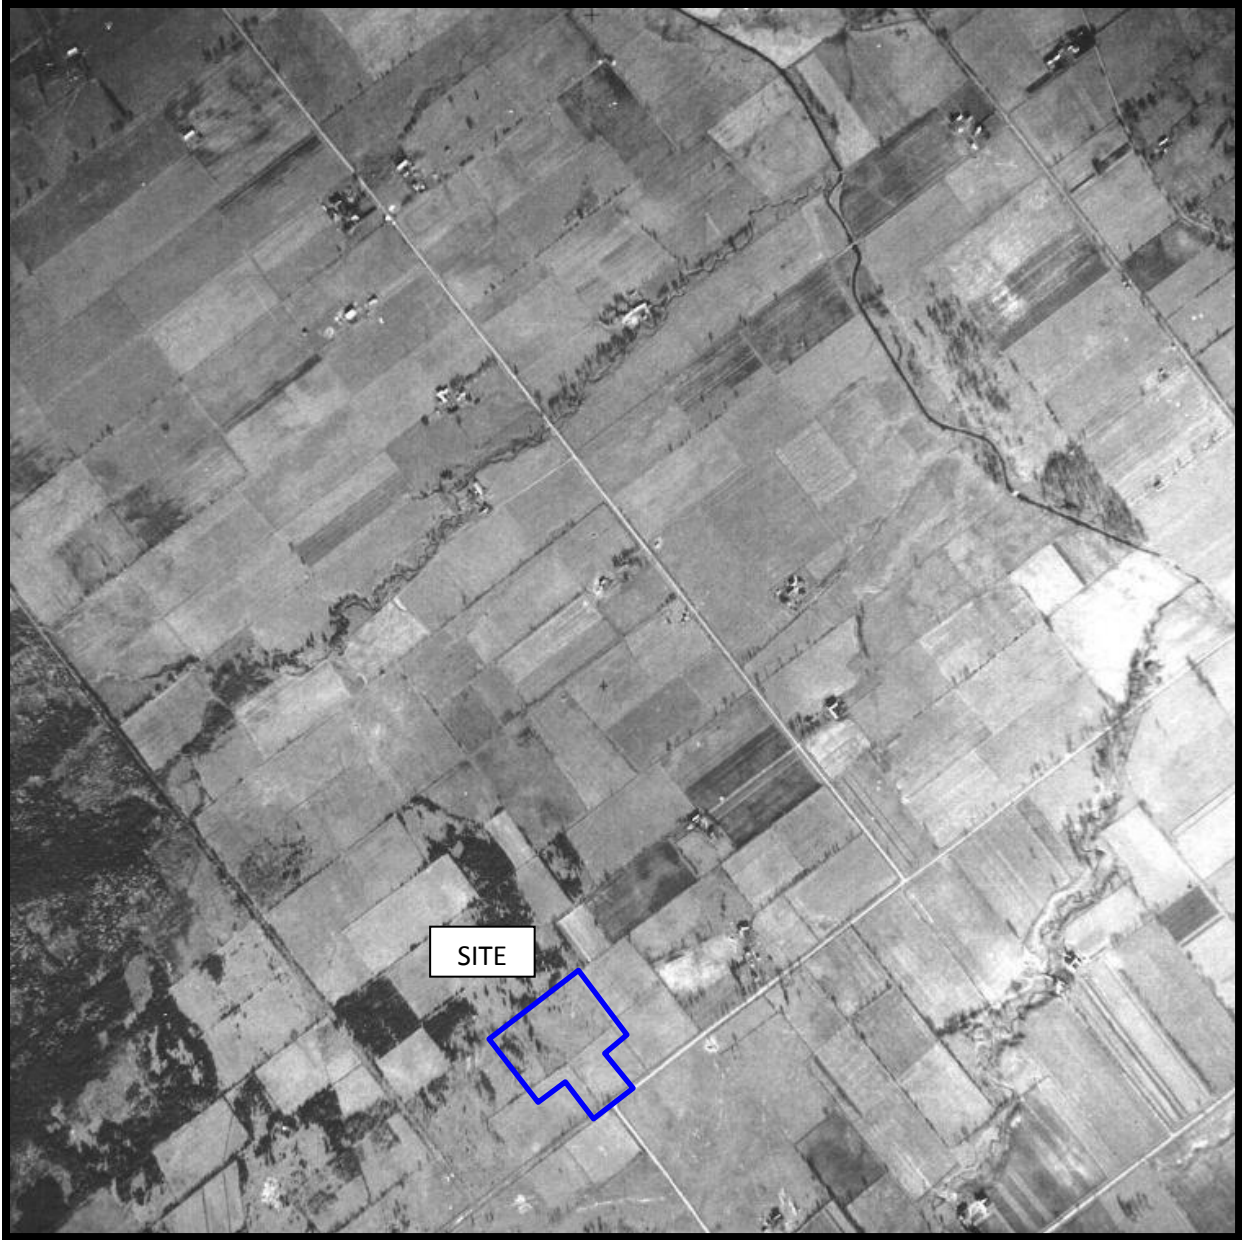
AERIAL PHOTOGRAPH
1945

| 1945 | The subject site appears vacant and undeveloped. Surrounding lands are predominantly undeveloped or used for agricultural purposes. The intersection of Maple Grove Road and Johnwoods Street is visible directly south of the subject site. |

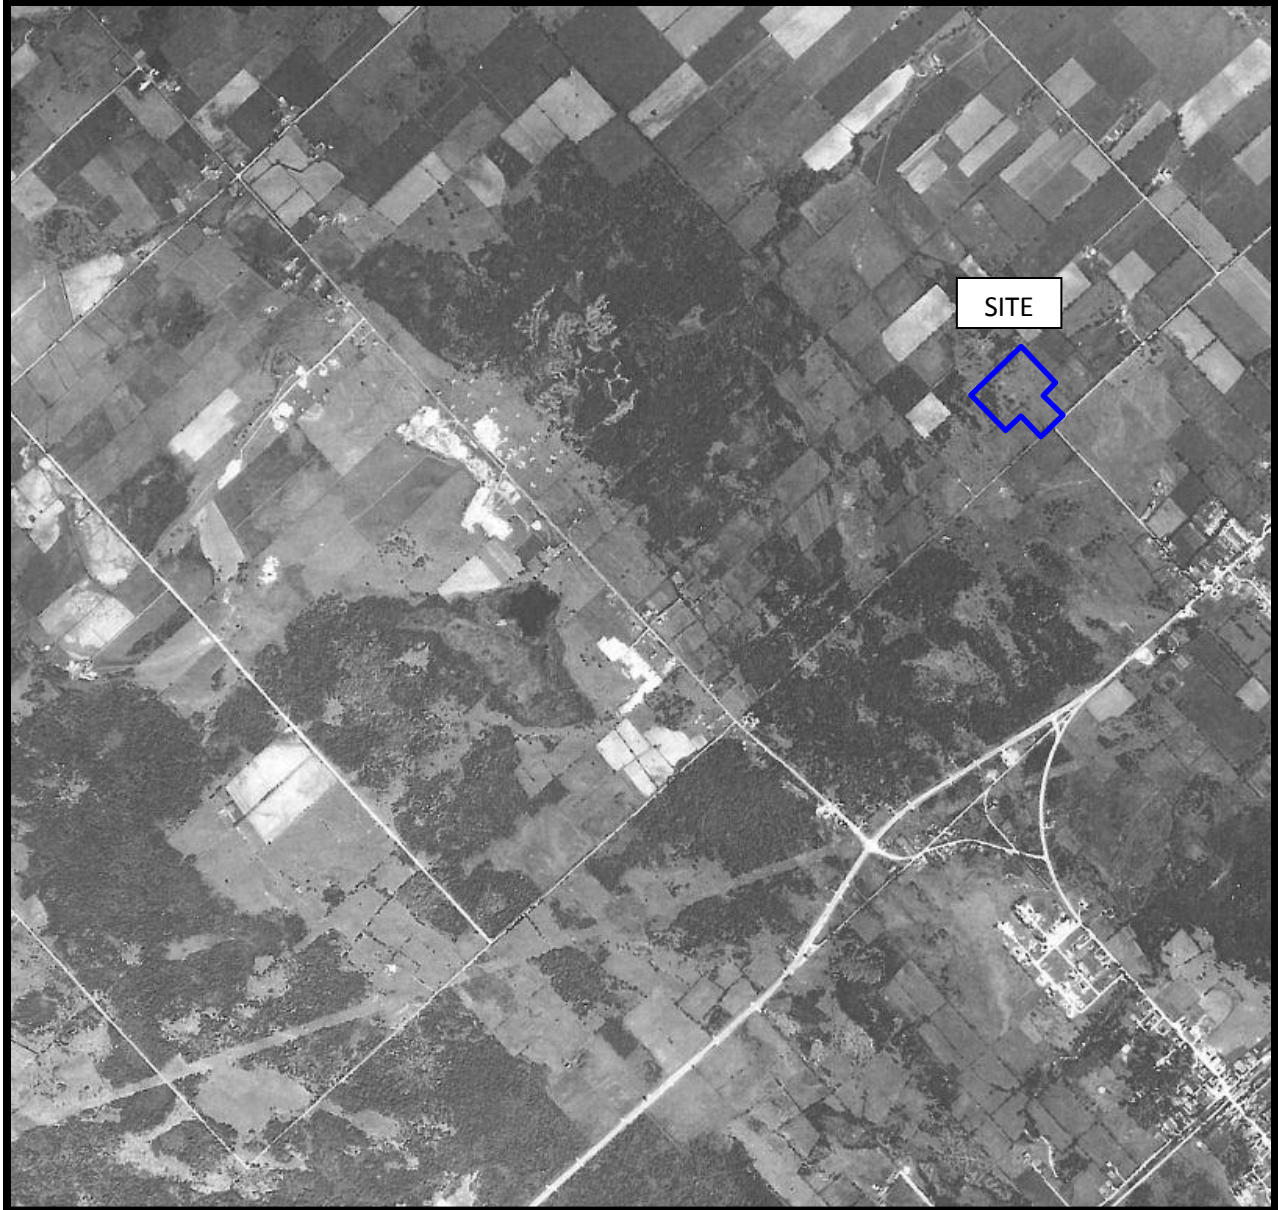
AERIAL PHOTOGRAPH
1959

| 1959 | No significant changes appear to have been made to the subject site or neighbouring properties. |

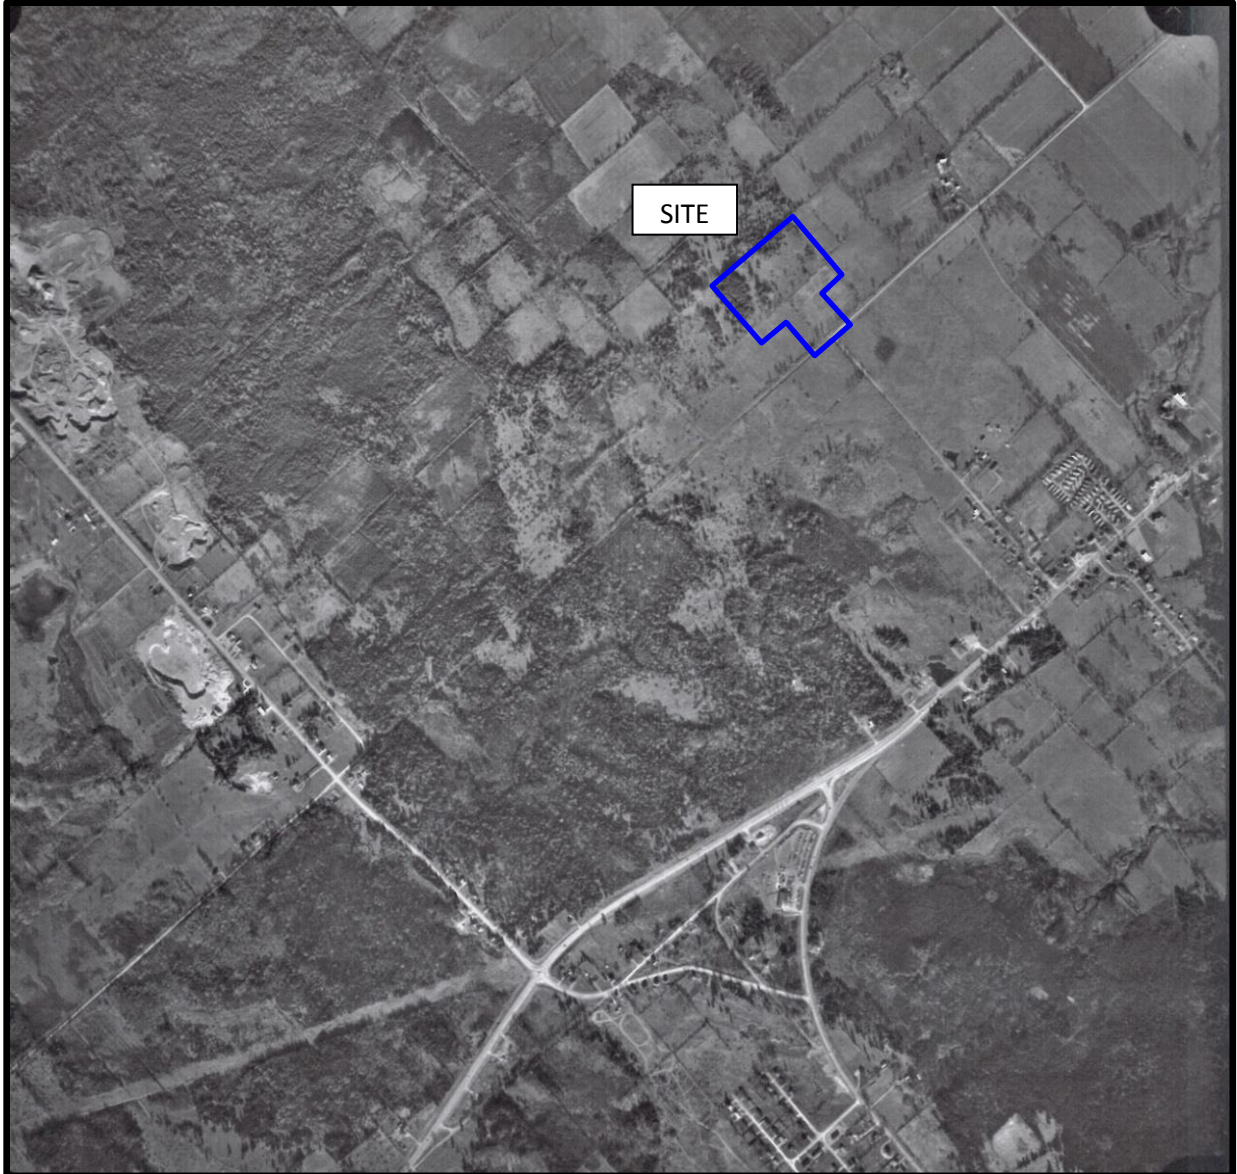
AERIAL PHOTOGRAPH
1971

| 1971 | No significant changes appear to have been made to the subject site or neighbouring properties. |

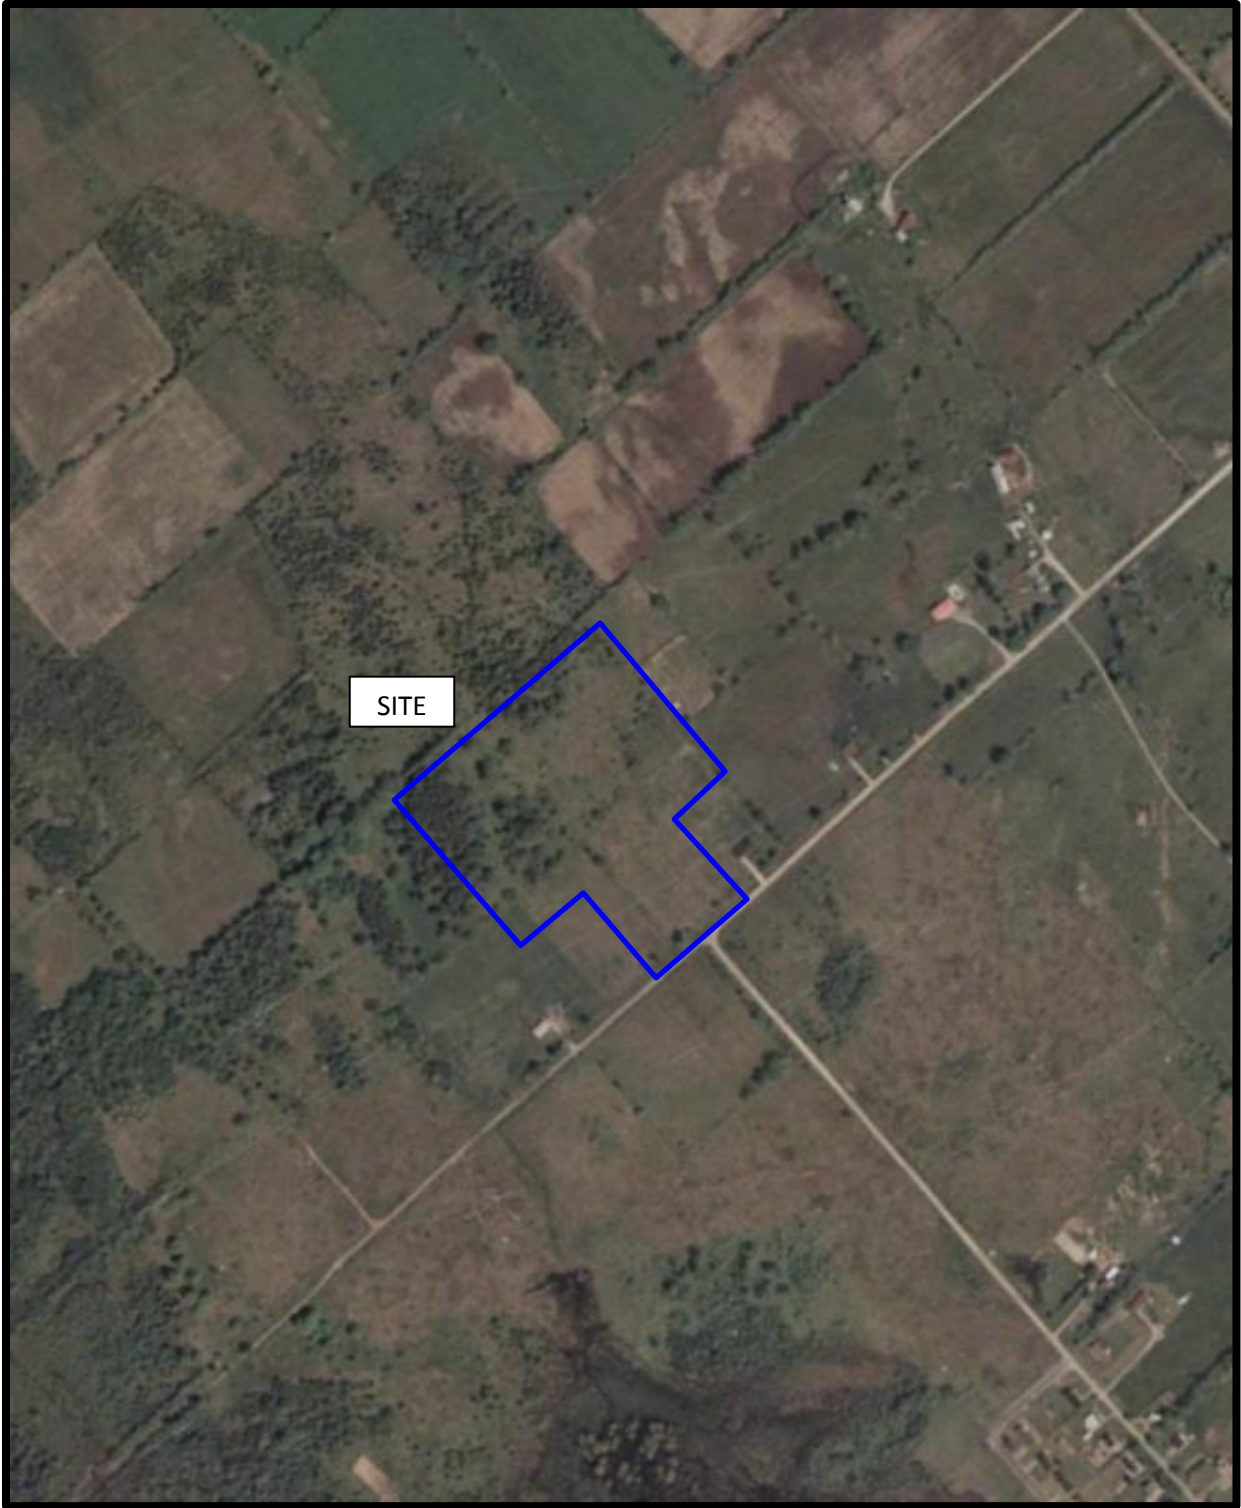
AERIAL PHOTOGRAPH
1976

| 1976 | (City of Ottawa website) No significant changes appear to have been made to the subject site. Several residential dwellings have been built on the north side of Maple Grove Road, east and west of the subject site. |

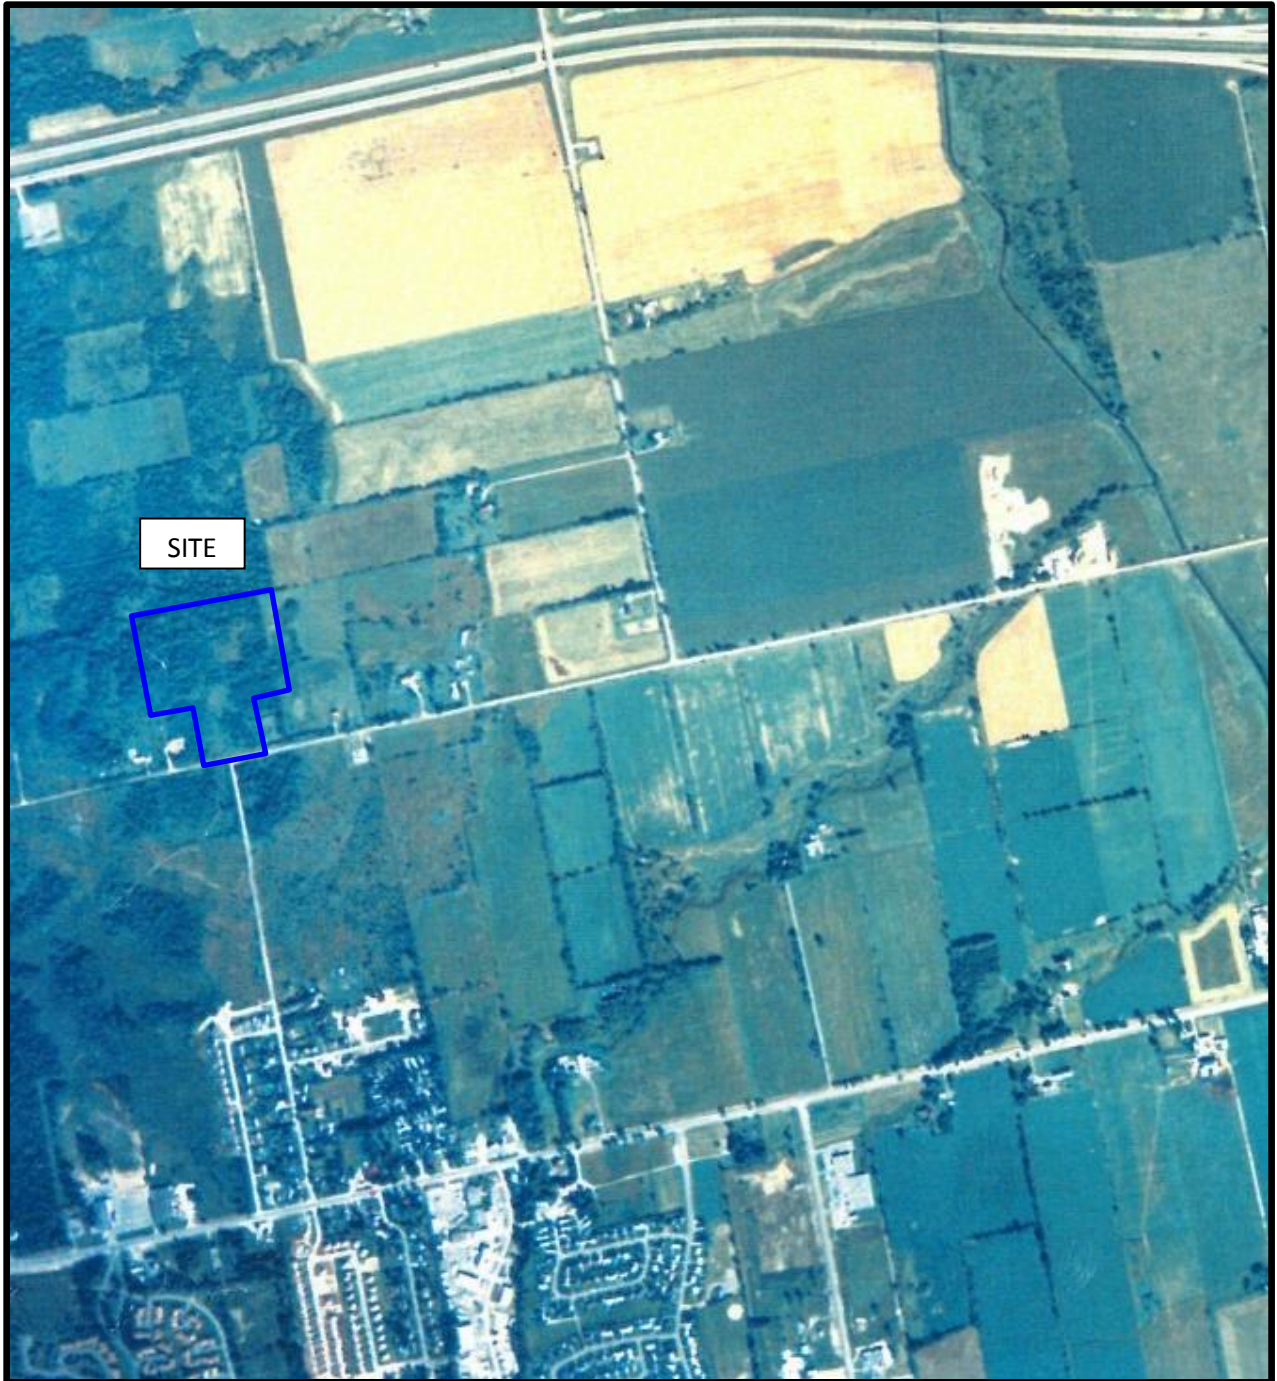
AERIAL PHOTOGRAPH
1987

| 1987 | The site appears largely tree covered and remains undeveloped. A residential dwelling has been constructed southwest of the subject site at 1939 Maple Grove Road. |

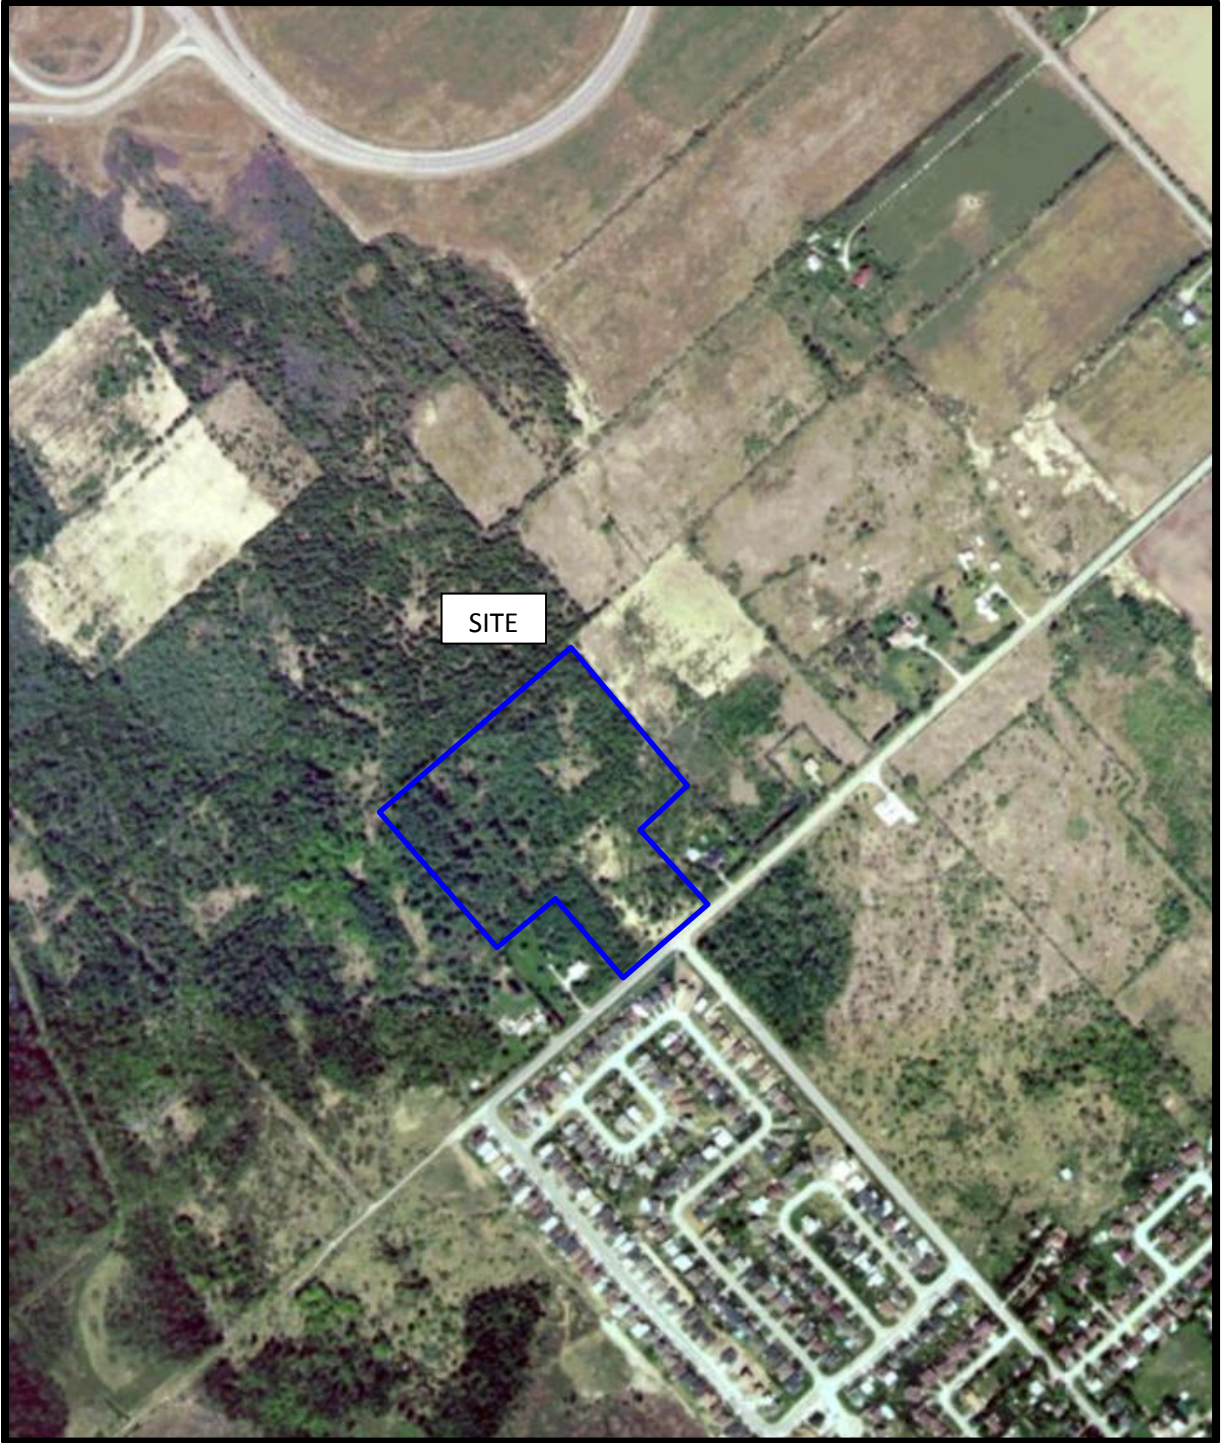
AERIAL PHOTOGRAPH
1999

| 1999 | (City of Ottawa website) No significant changes appear to have been made to the subject site. A residential subdivision has been constructed on the south side of Maple Grove Road and west of Johnwoods Street. |

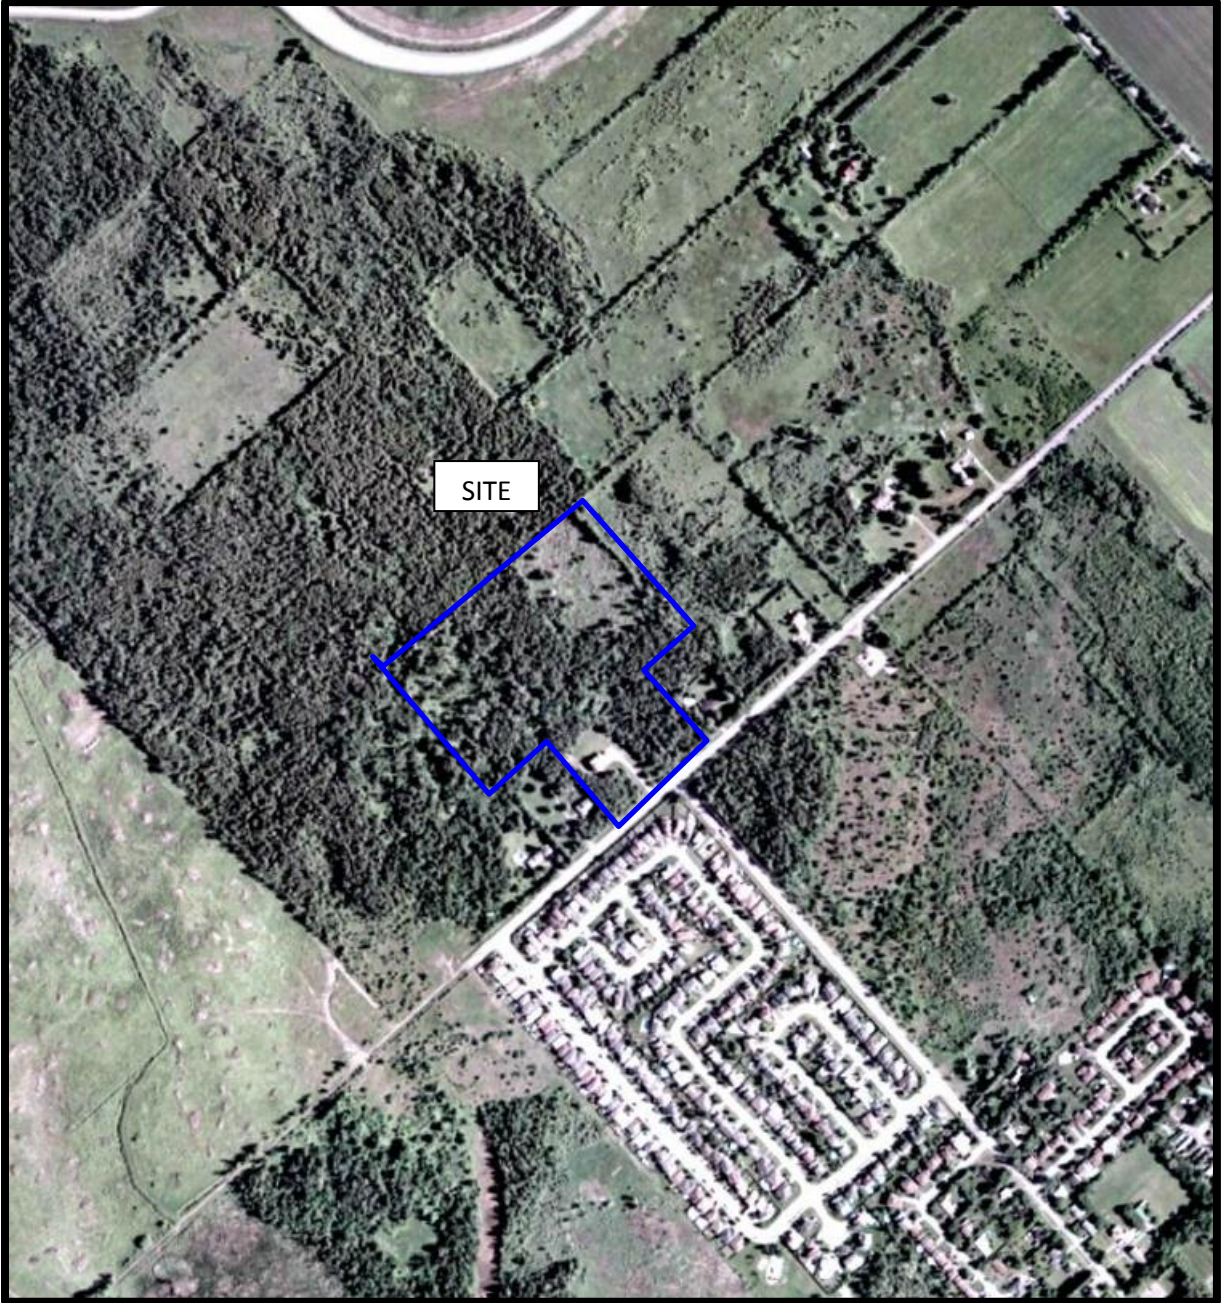
AERIAL PHOTOGRAPH
2005

| 2005 | (City of Ottawa website) A residential dwelling has been constructed on the southern portion of the subject site. No significant changes appear to have been made to neighbouring properties. |

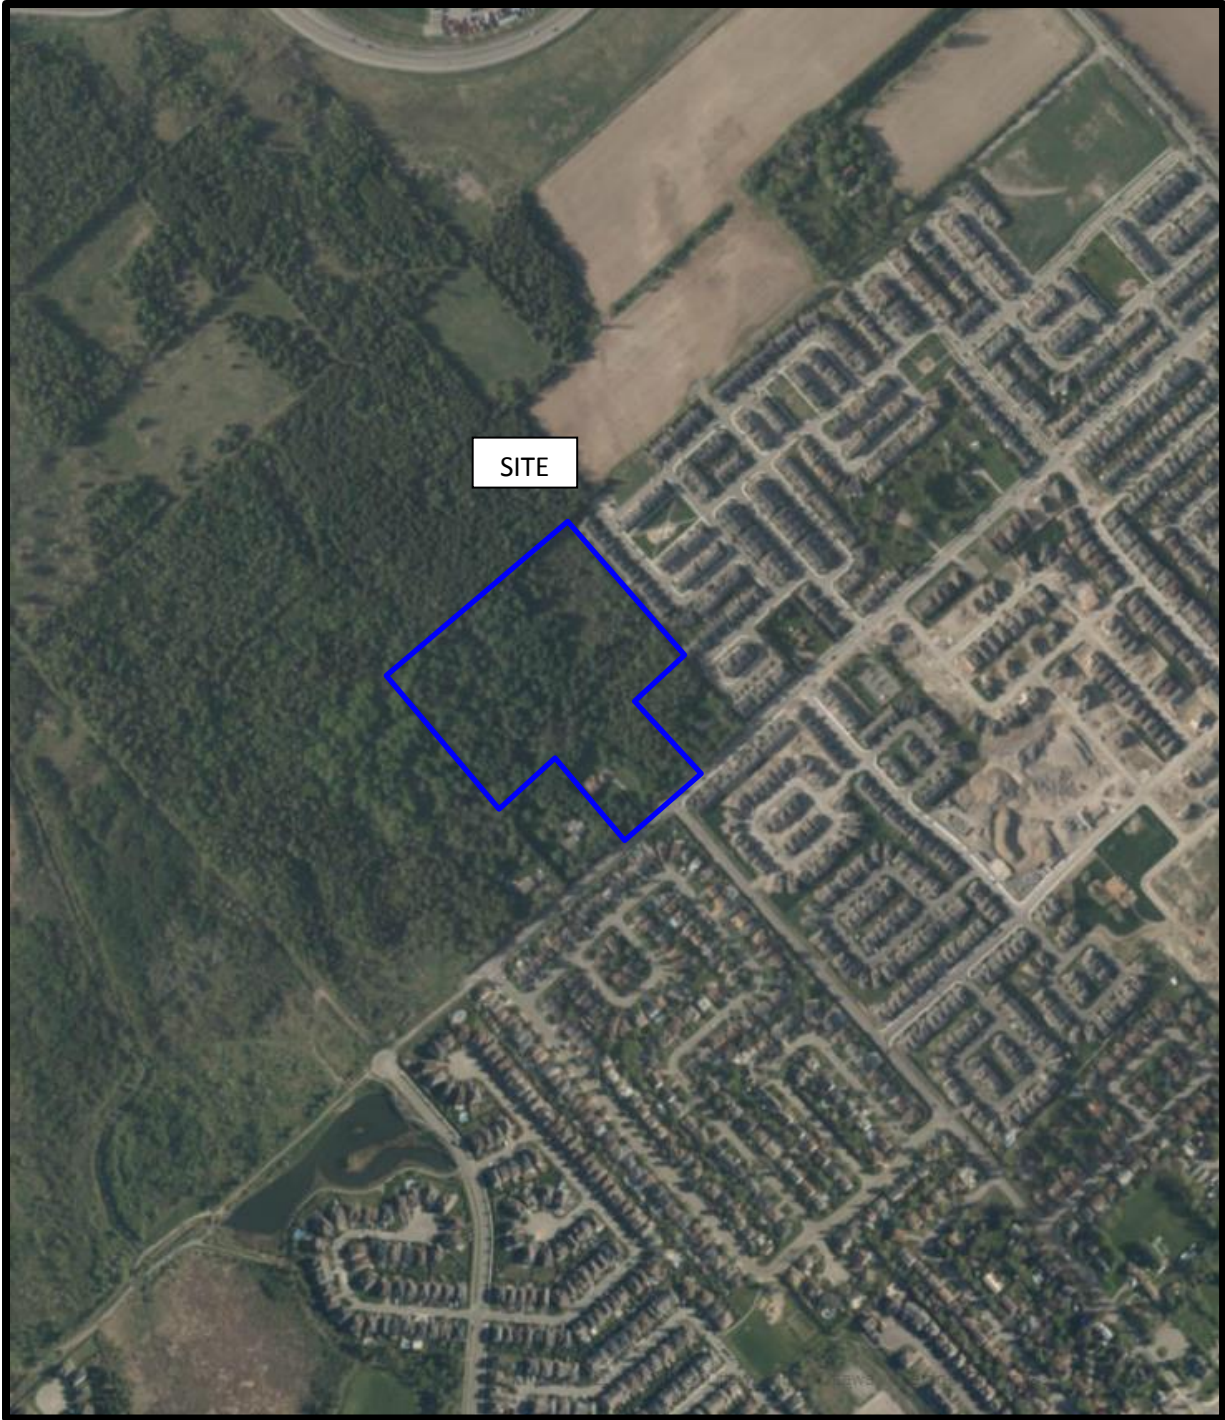
AERIAL PHOTOGRAPH
2017

| 2017 | (City of Ottawa website) No significant changes have been made to the subject site. The adjacent property to the east and properties southeast of the subject site have been developed with residential subdivisions. |

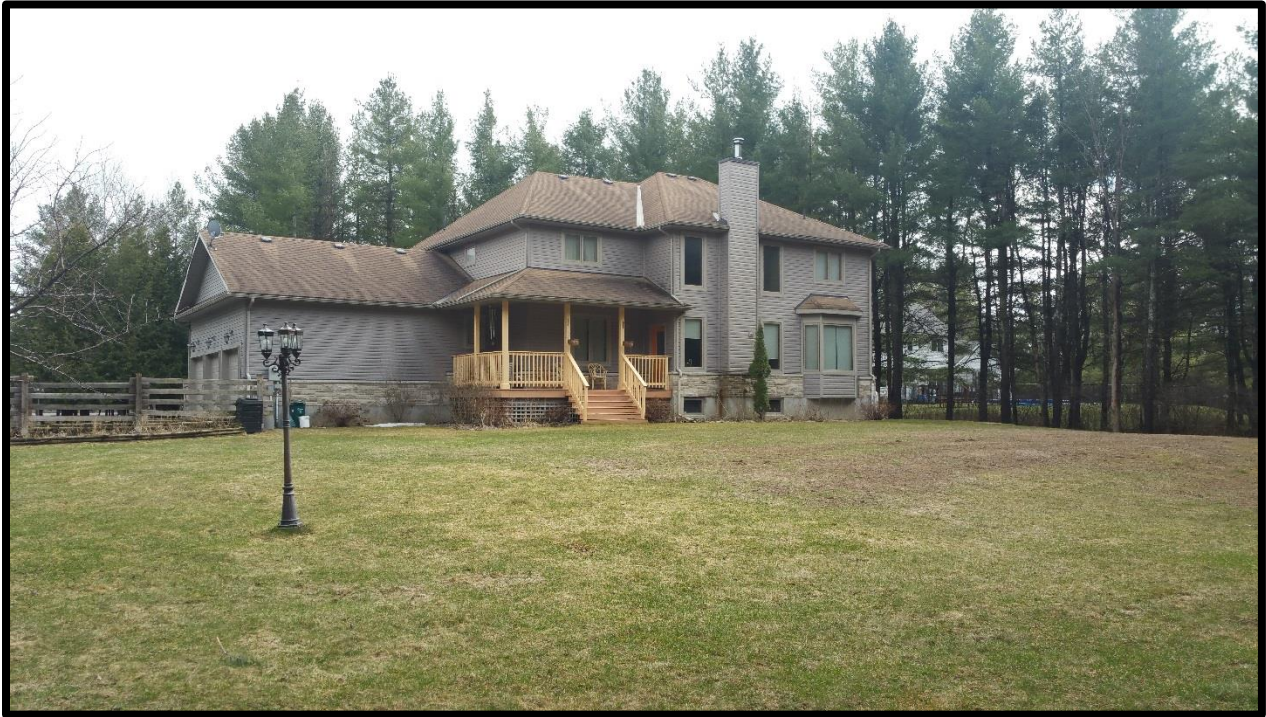
A two-storey residential dwelling is located on the southern portion of the subject site. The dwelling is clad with vinyl siding, stone blocks and concrete and has a poured concrete foundation and a single basement level.

Photograph 1: View of the southern portion of the site, facing northeast. Photograph illustrates a two-storey residential dwelling.

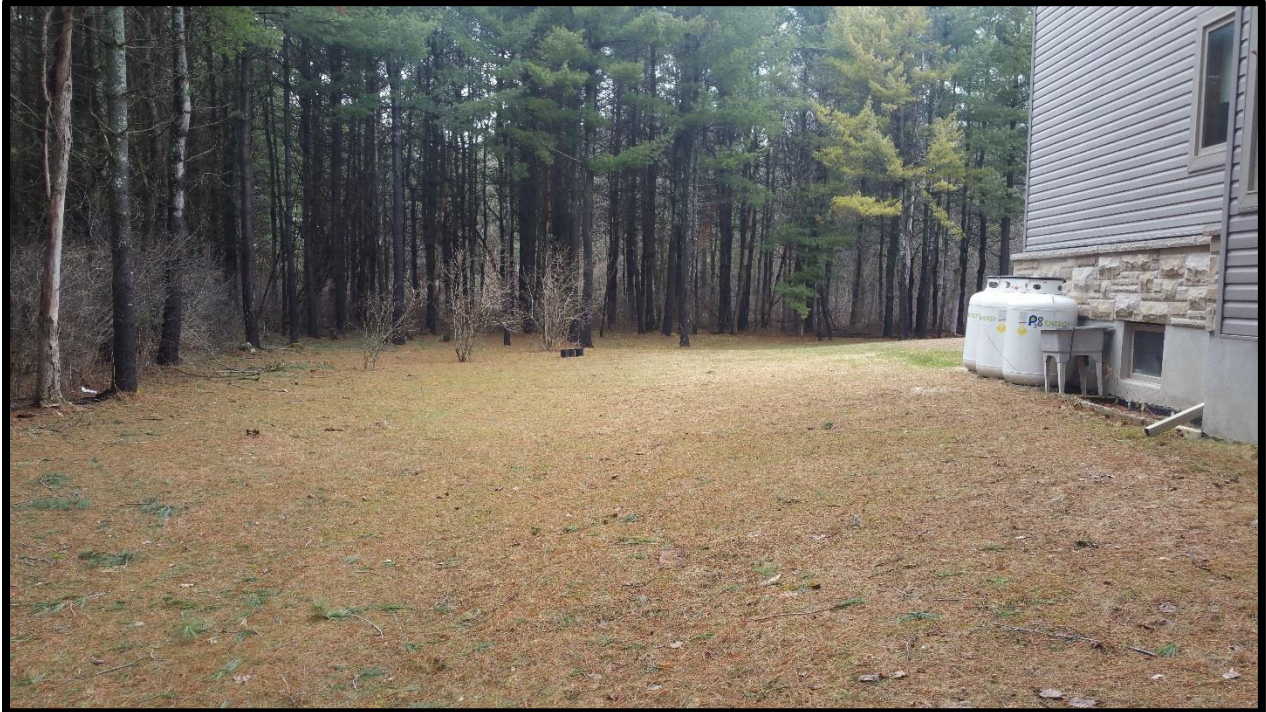
Photograph 2: View from the southwestern portion of the subject site, facing north. Photograph illustrates a landscaped area adjacent to the residential dwelling.

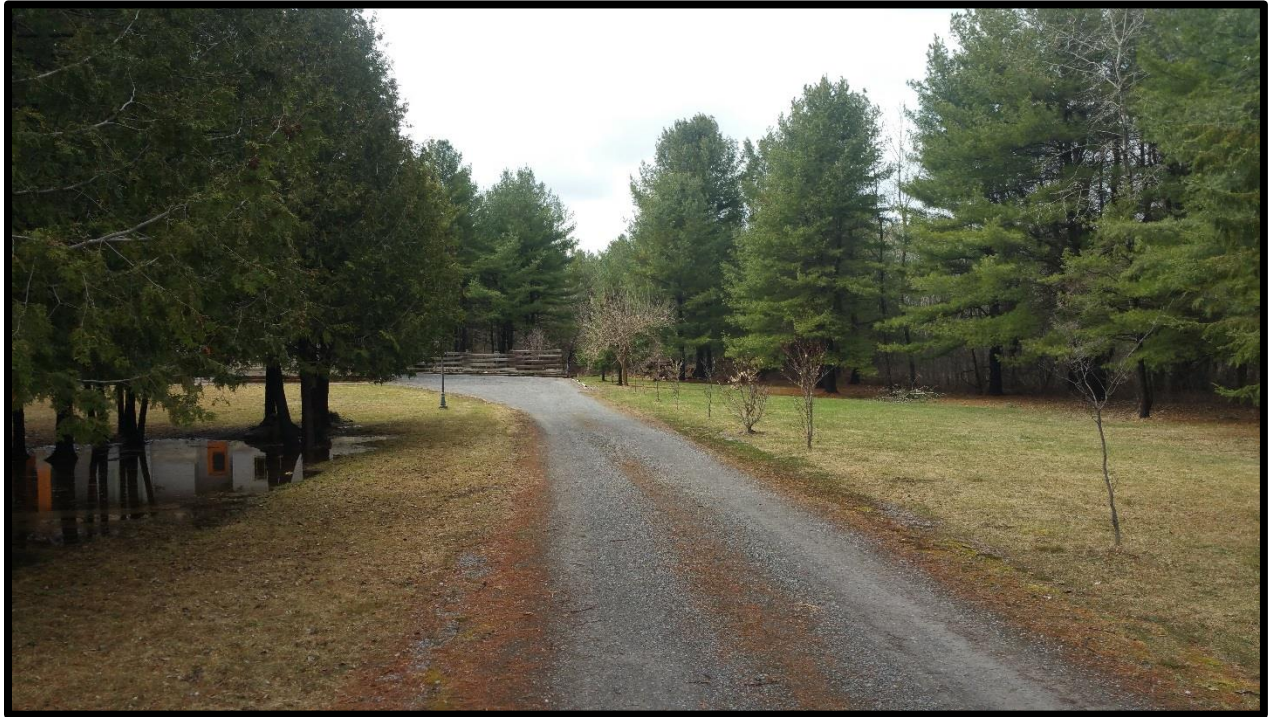
Photograph 3: View from southern portion of the subject site, facing north. Photograph illustrates a gravel driveway, a treed area and a landscaped area.

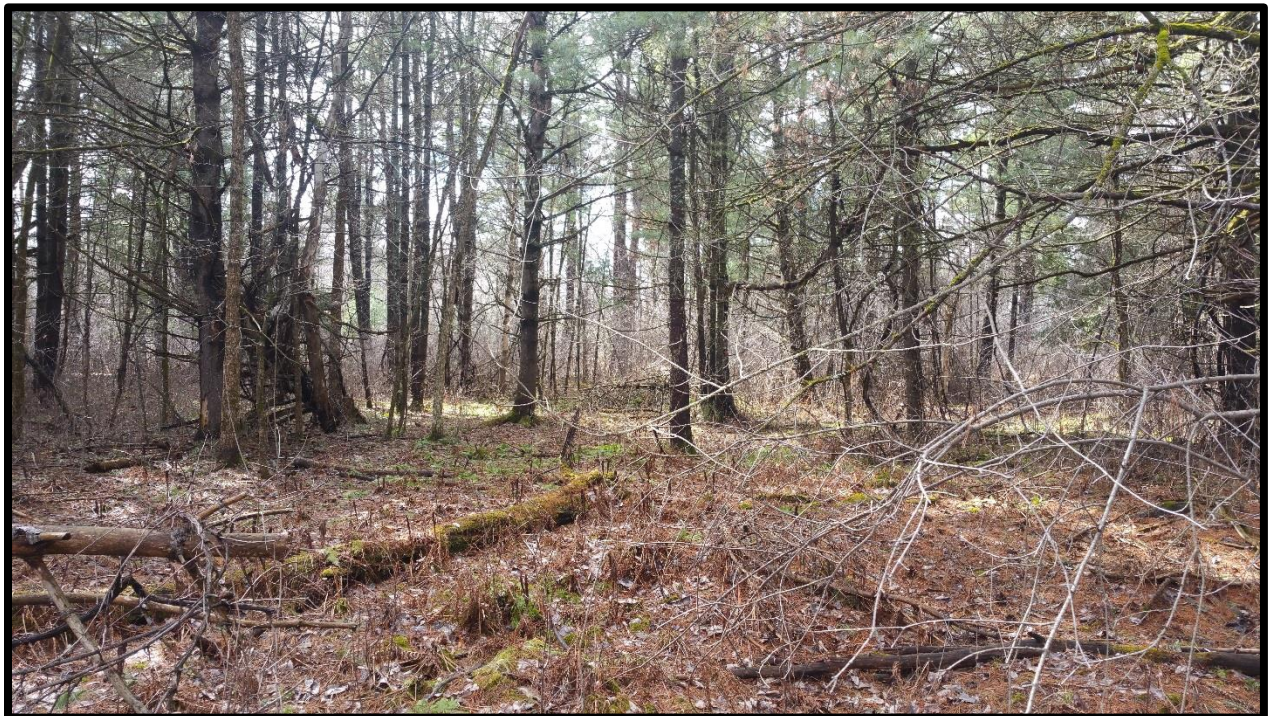
Photograph 4: View from the northern portion of the subject site, facing northeast. Photograph illustrates a forested area in the vicinity of the proposed residential development.
