## Phase II Environmental Site Assessment

7000 Campeau Drive  
Ottawa, Ontario

Prepared For  
ClubLink Corporation ULC

April 1, 2021  
Report: PE4321-2 Rev 2

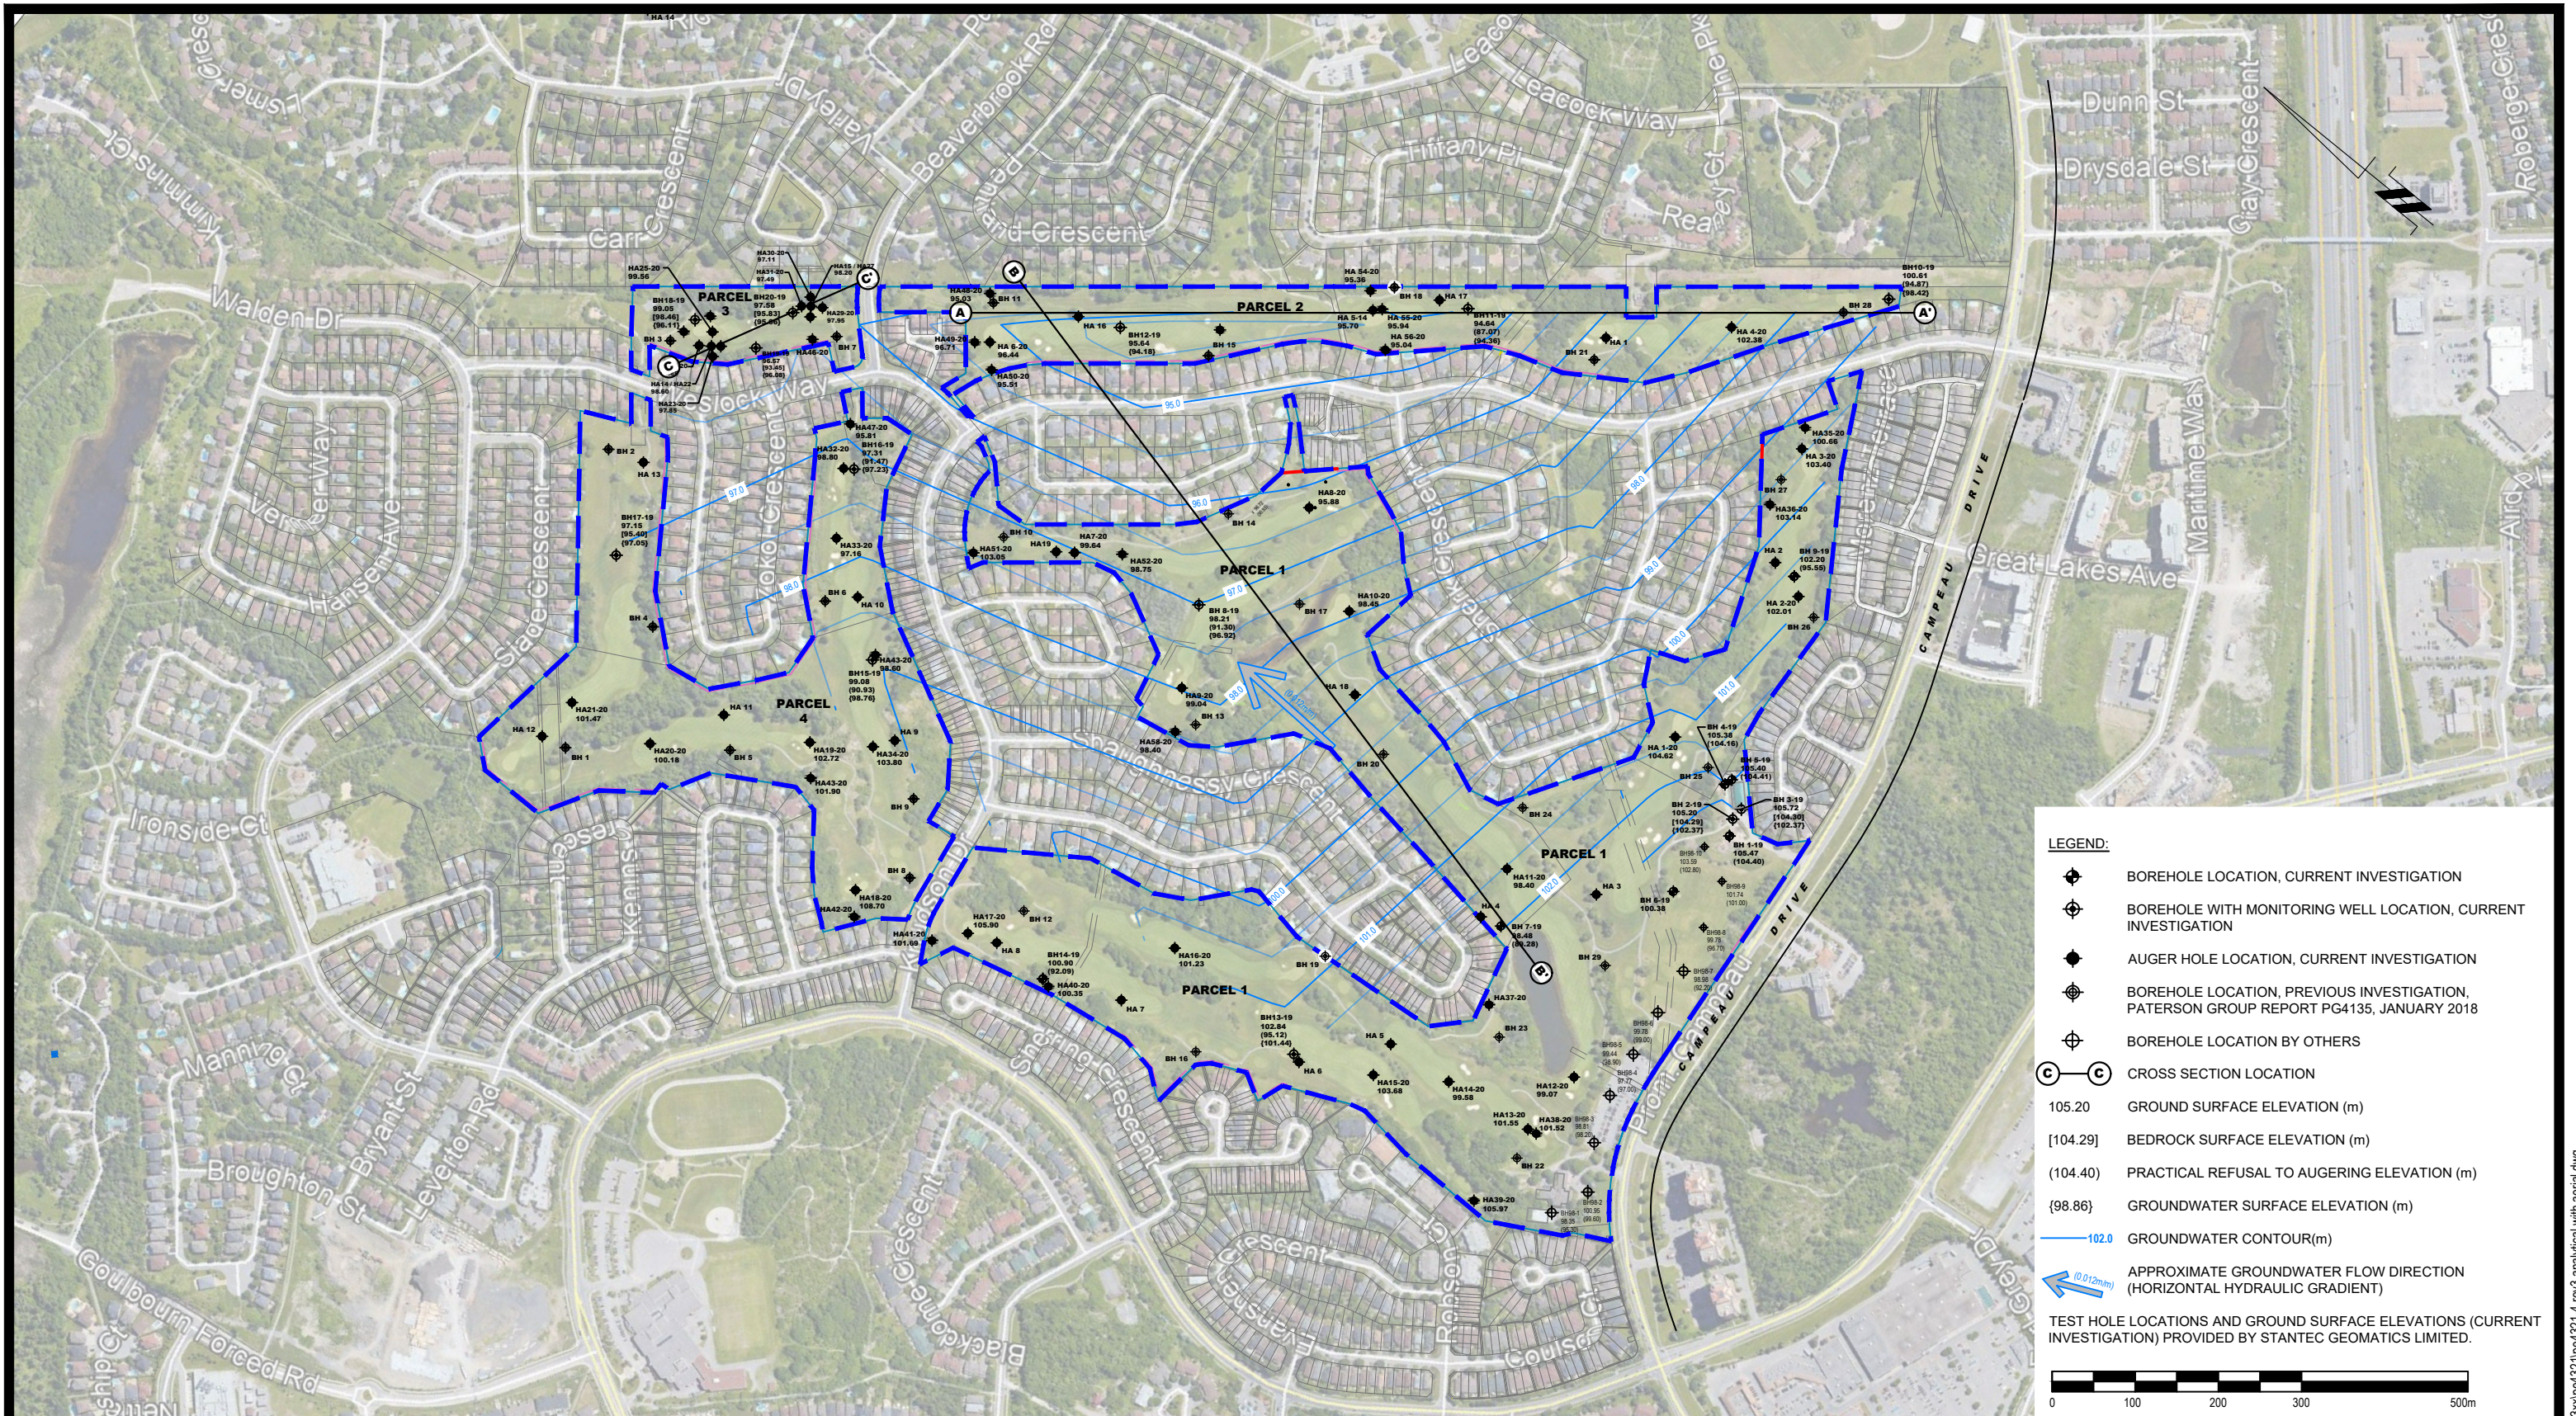
Scale:	1:7500	Date:	01/2021
Drawn by:	RCG	Report No.:	PE4321-2
Checked by:	KM	<b>PE4321-3R</b>	Revision No.:
Approved by:	MSD

It should be noted that approximately 190 probeholes were placed across the Phase II Property, as part of the concurrent Geotechnical Investigation, to confirm bedrock depths. Bedrock across the Phase II Property generally ranges from approximately 0 to 20m below grade. Probehole locations have been shown on Drawing PE4321-3R – Test Hole Location Plan, for informative purposes.

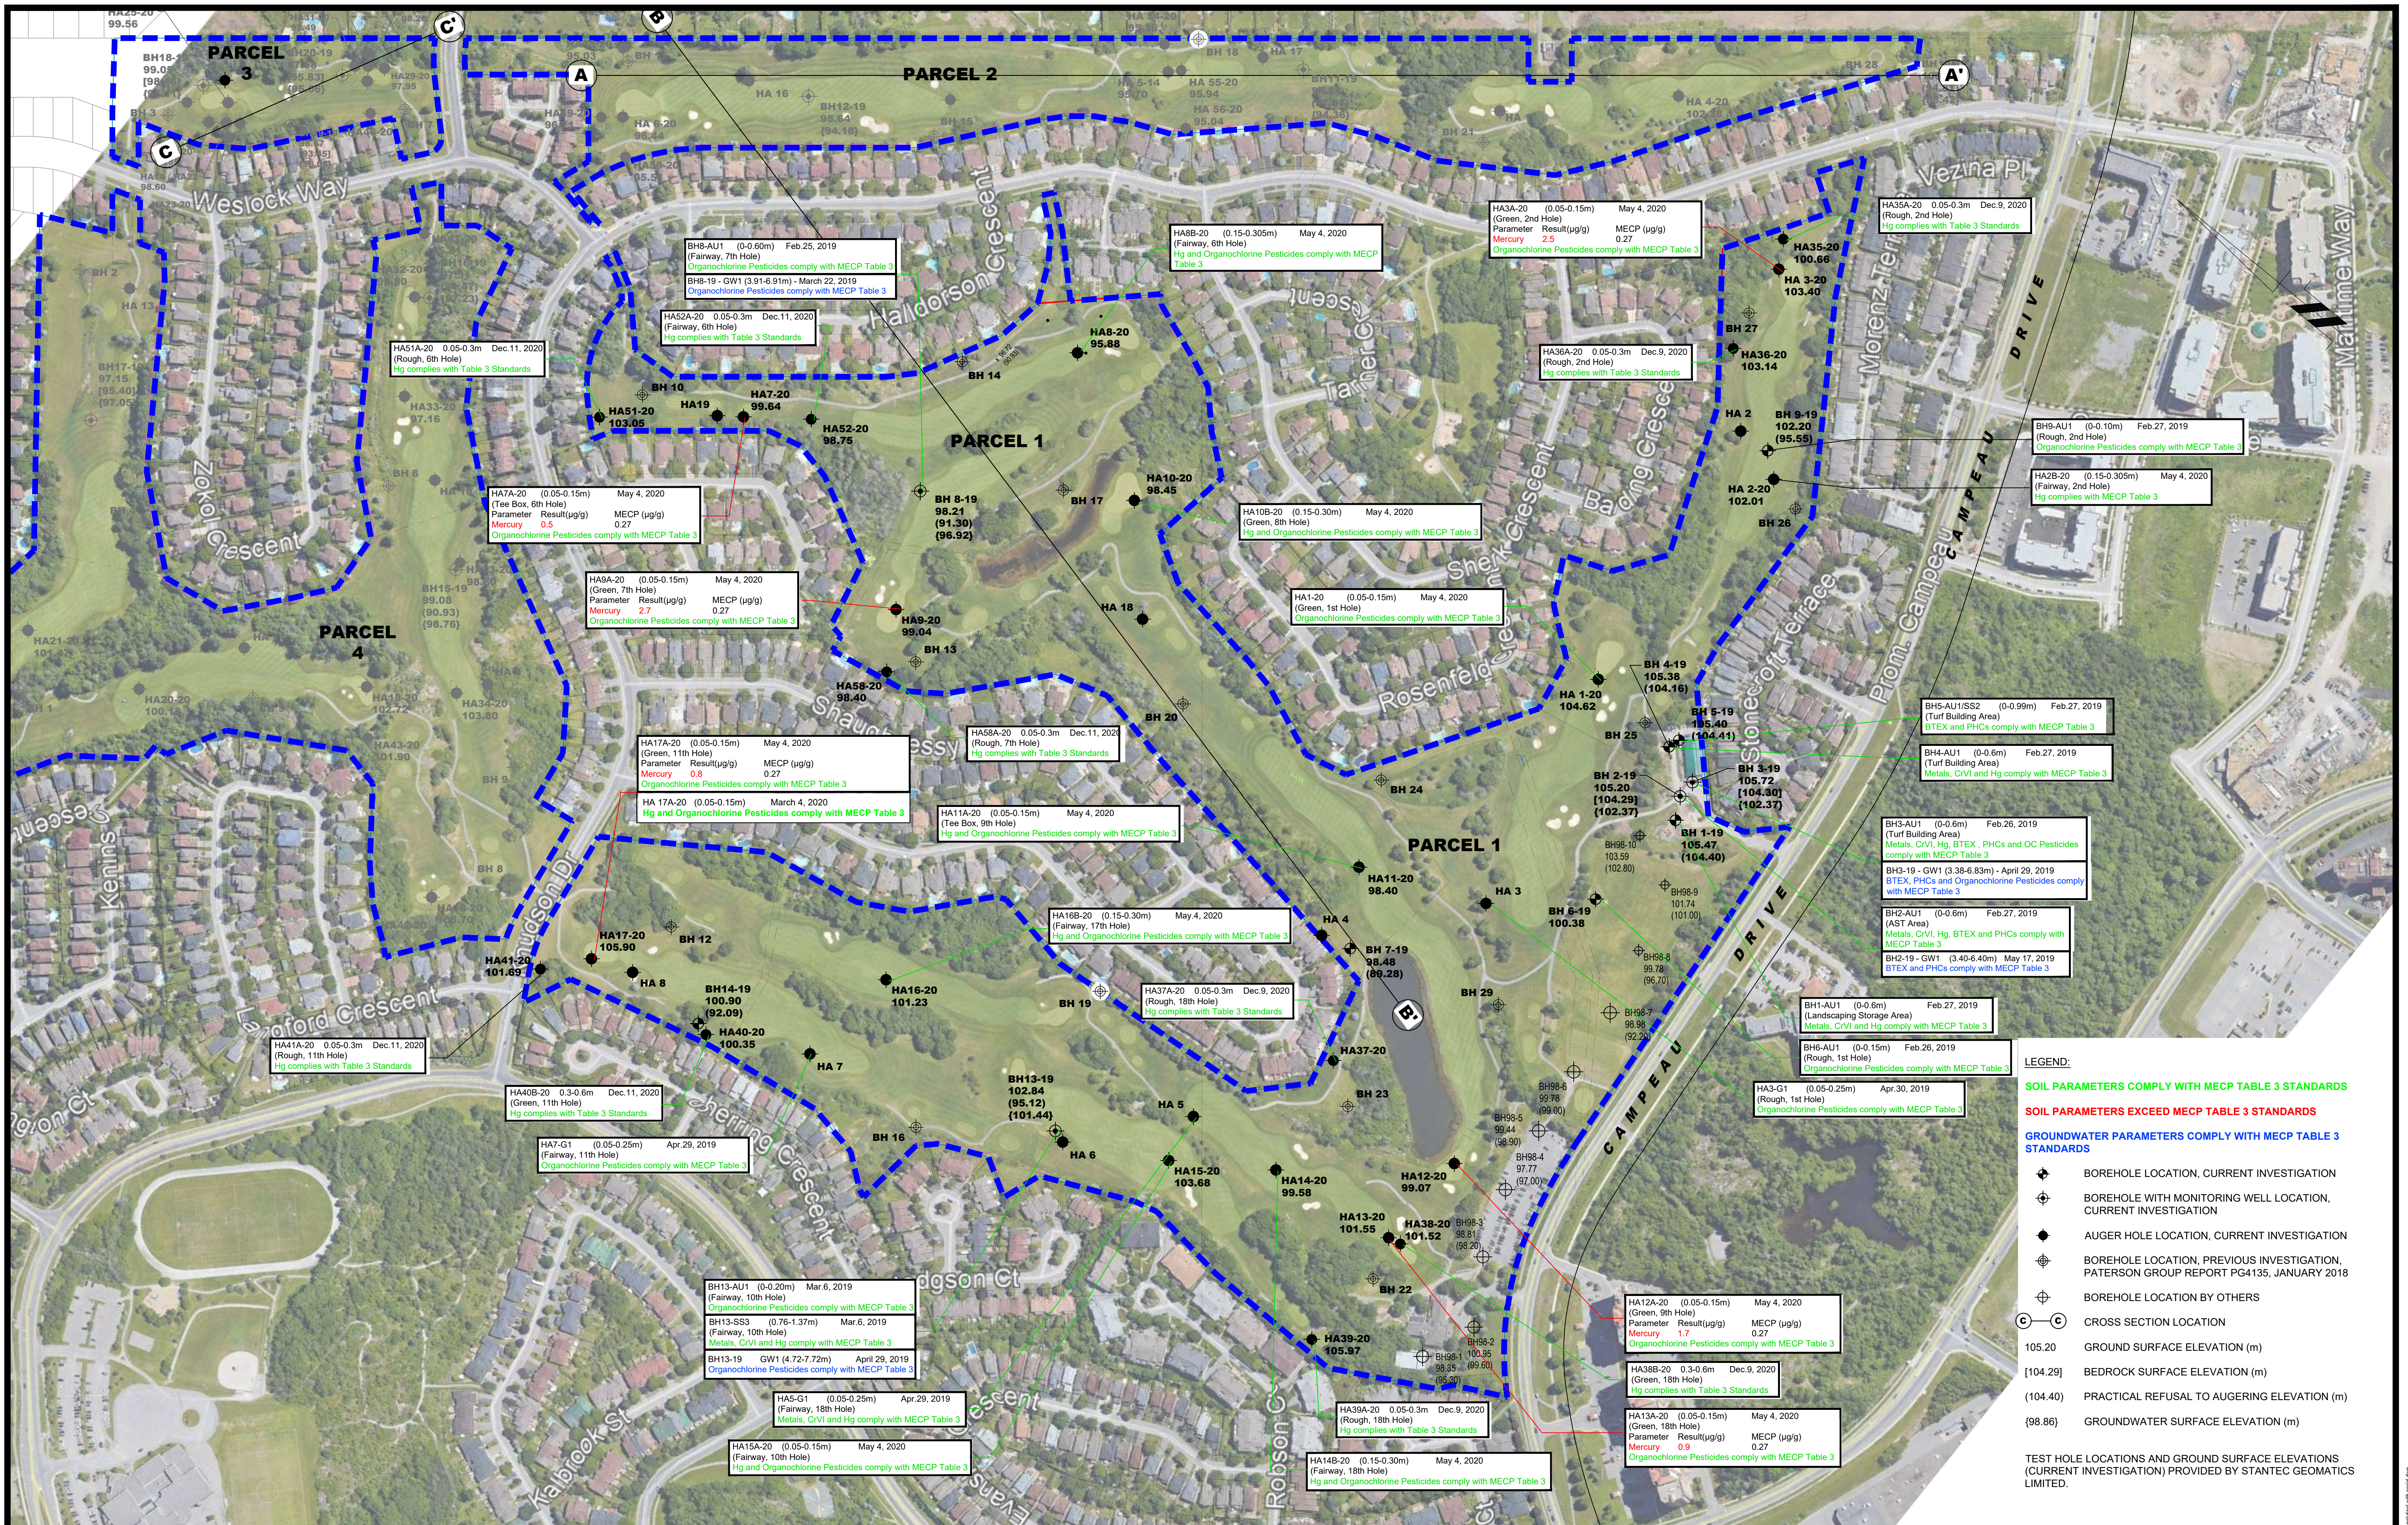
**LEGEND:**

**SOIL PARAMETERS COMPLY WITH MECP TABLE 3 STANDARDS**
