## Phase II Environmental Site Assessment

7000 Campeau Drive  
Ottawa, Ontario

Prepared For  
ClubLink Corporation ULC

May 20, 2020  
Report: PE4321-2R

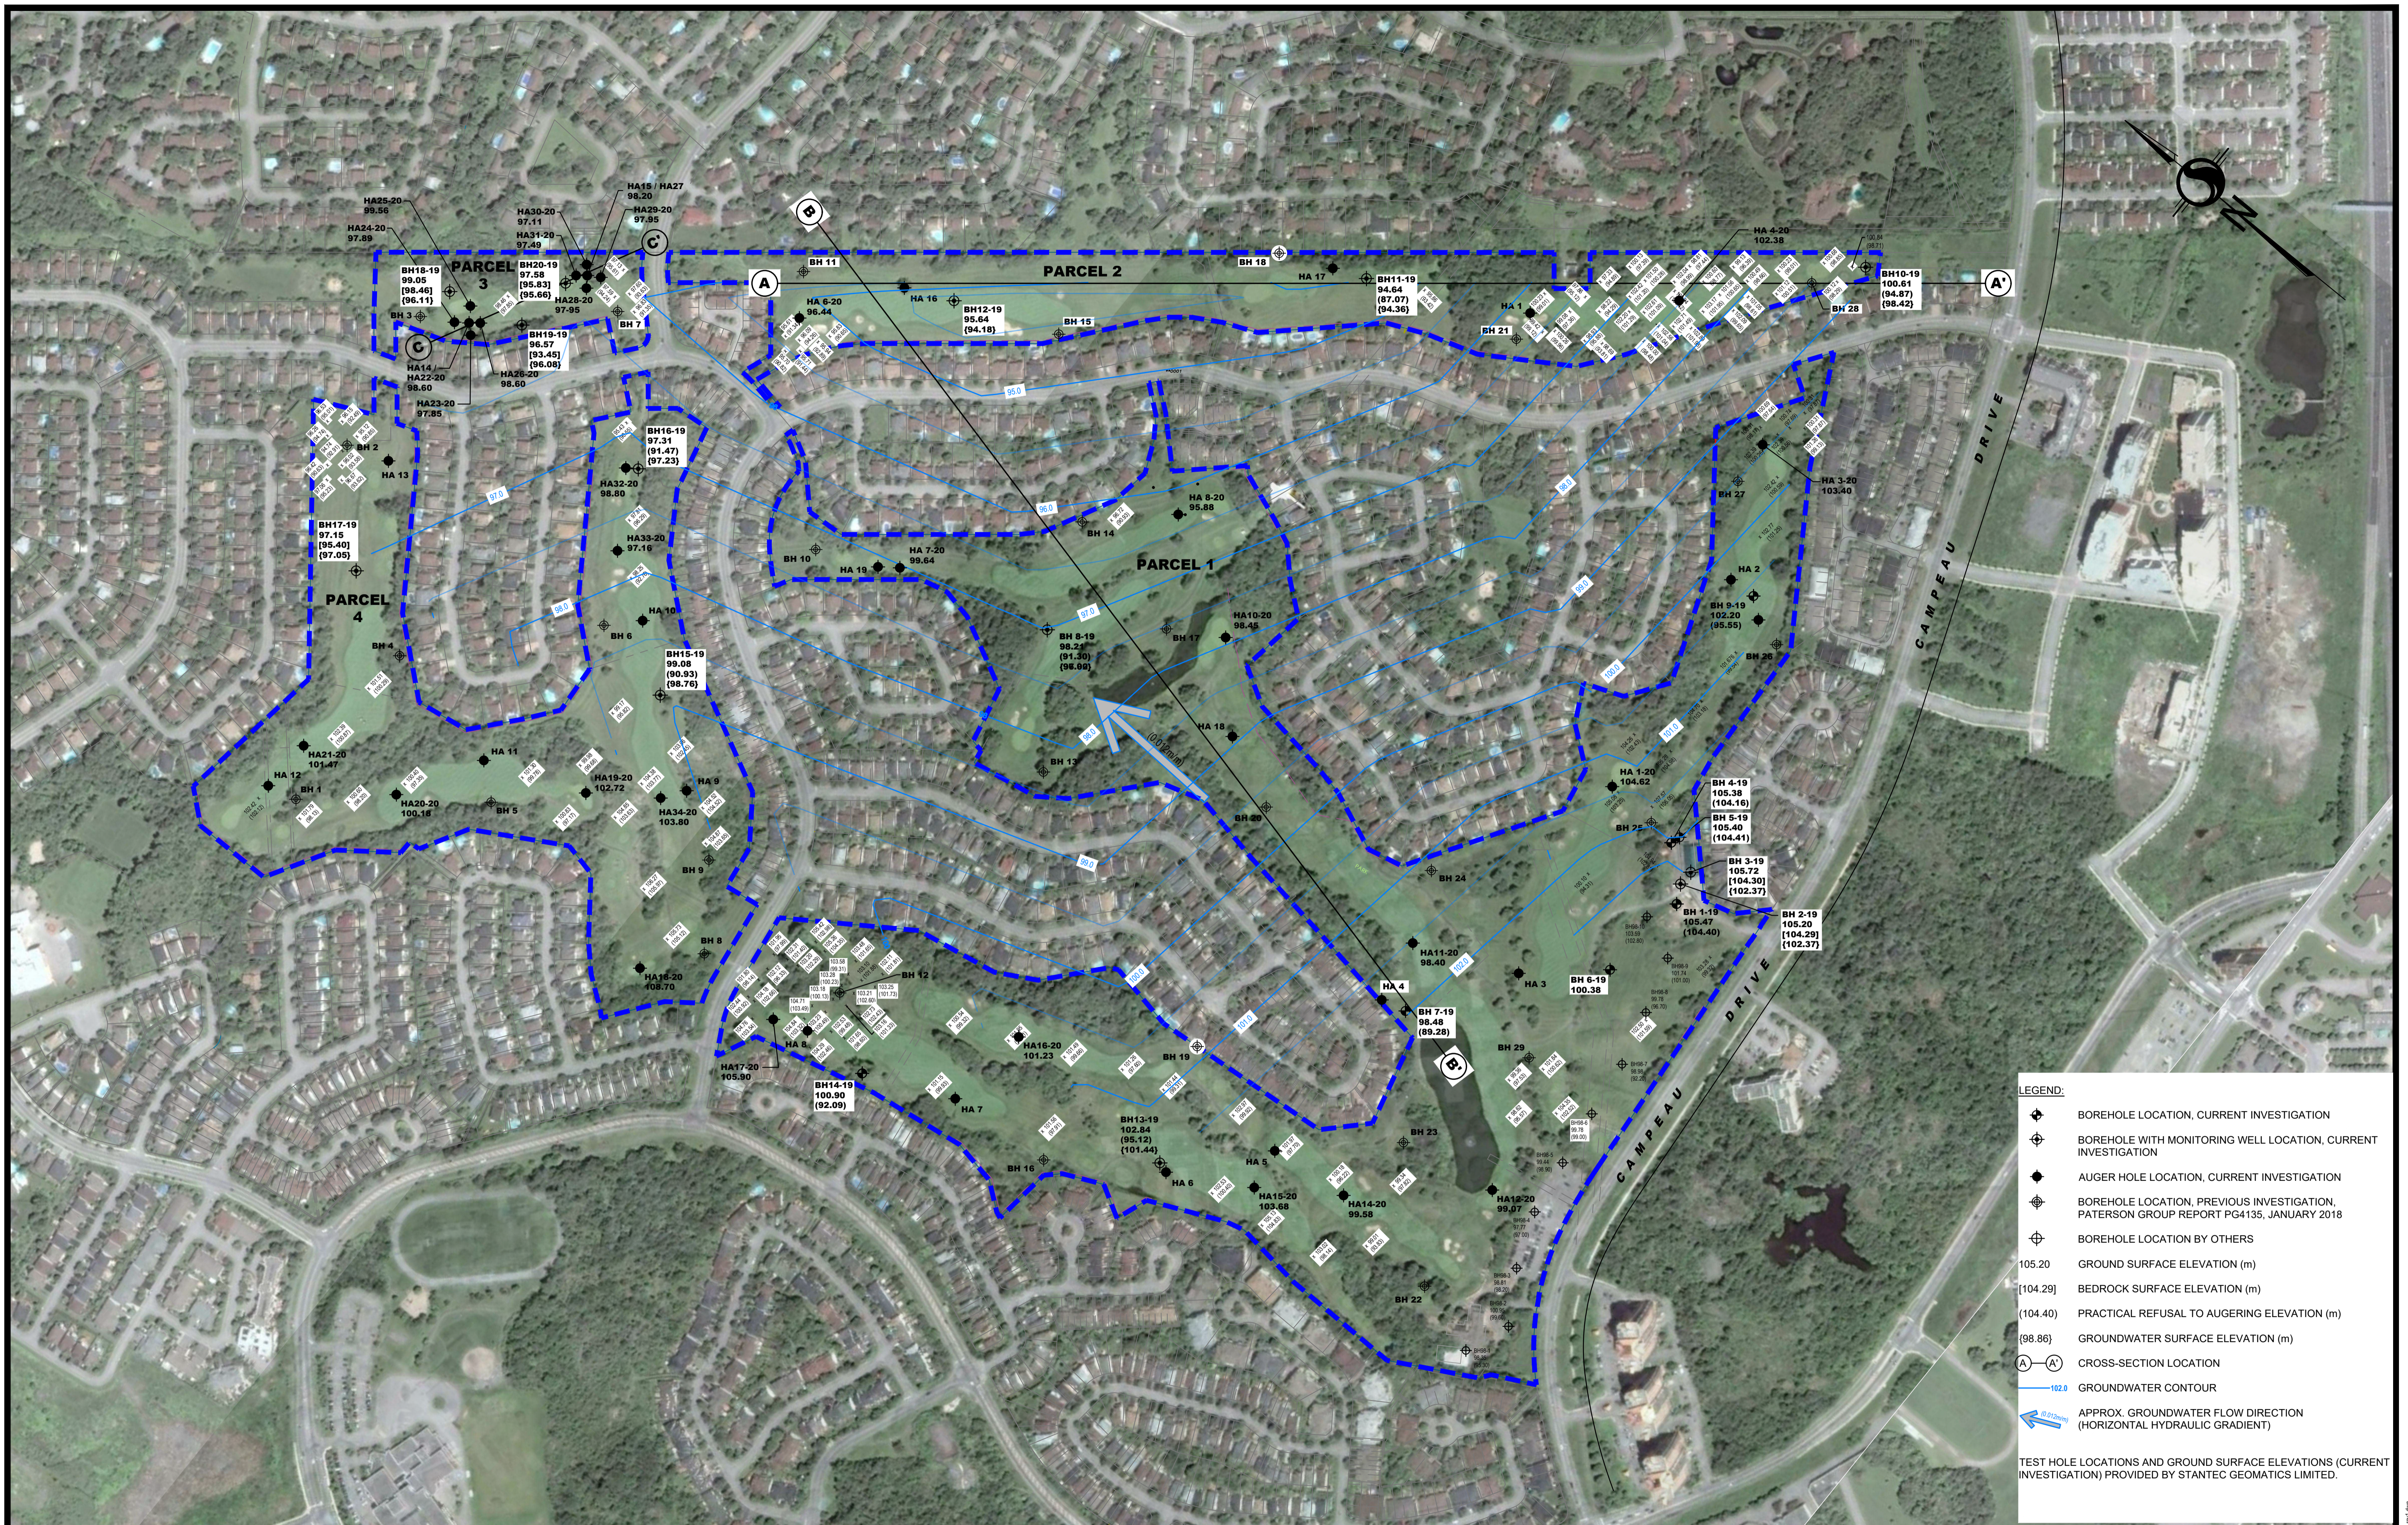
Scale:	1:3000	Report No.:	PE4321-2
Drawn by:	MPG	Drawing No.:	
Checked by:	KM		
Approved by:	MSD		<b>PE4321-3</b>
Date:	05/2019	Revision No.:	1

It should be noted that approximately 190 probeholes were placed across the Phase II Property, as part of the concurrent Geotechnical Investigation, to confirm bedrock depths. Bedrock across the Phase II Property generally ranges from approximately 0 to 20m below grade. Probehole locations have been shown on Drawing PE4321-3R – Test Hole Location Plan, for informative purposes.

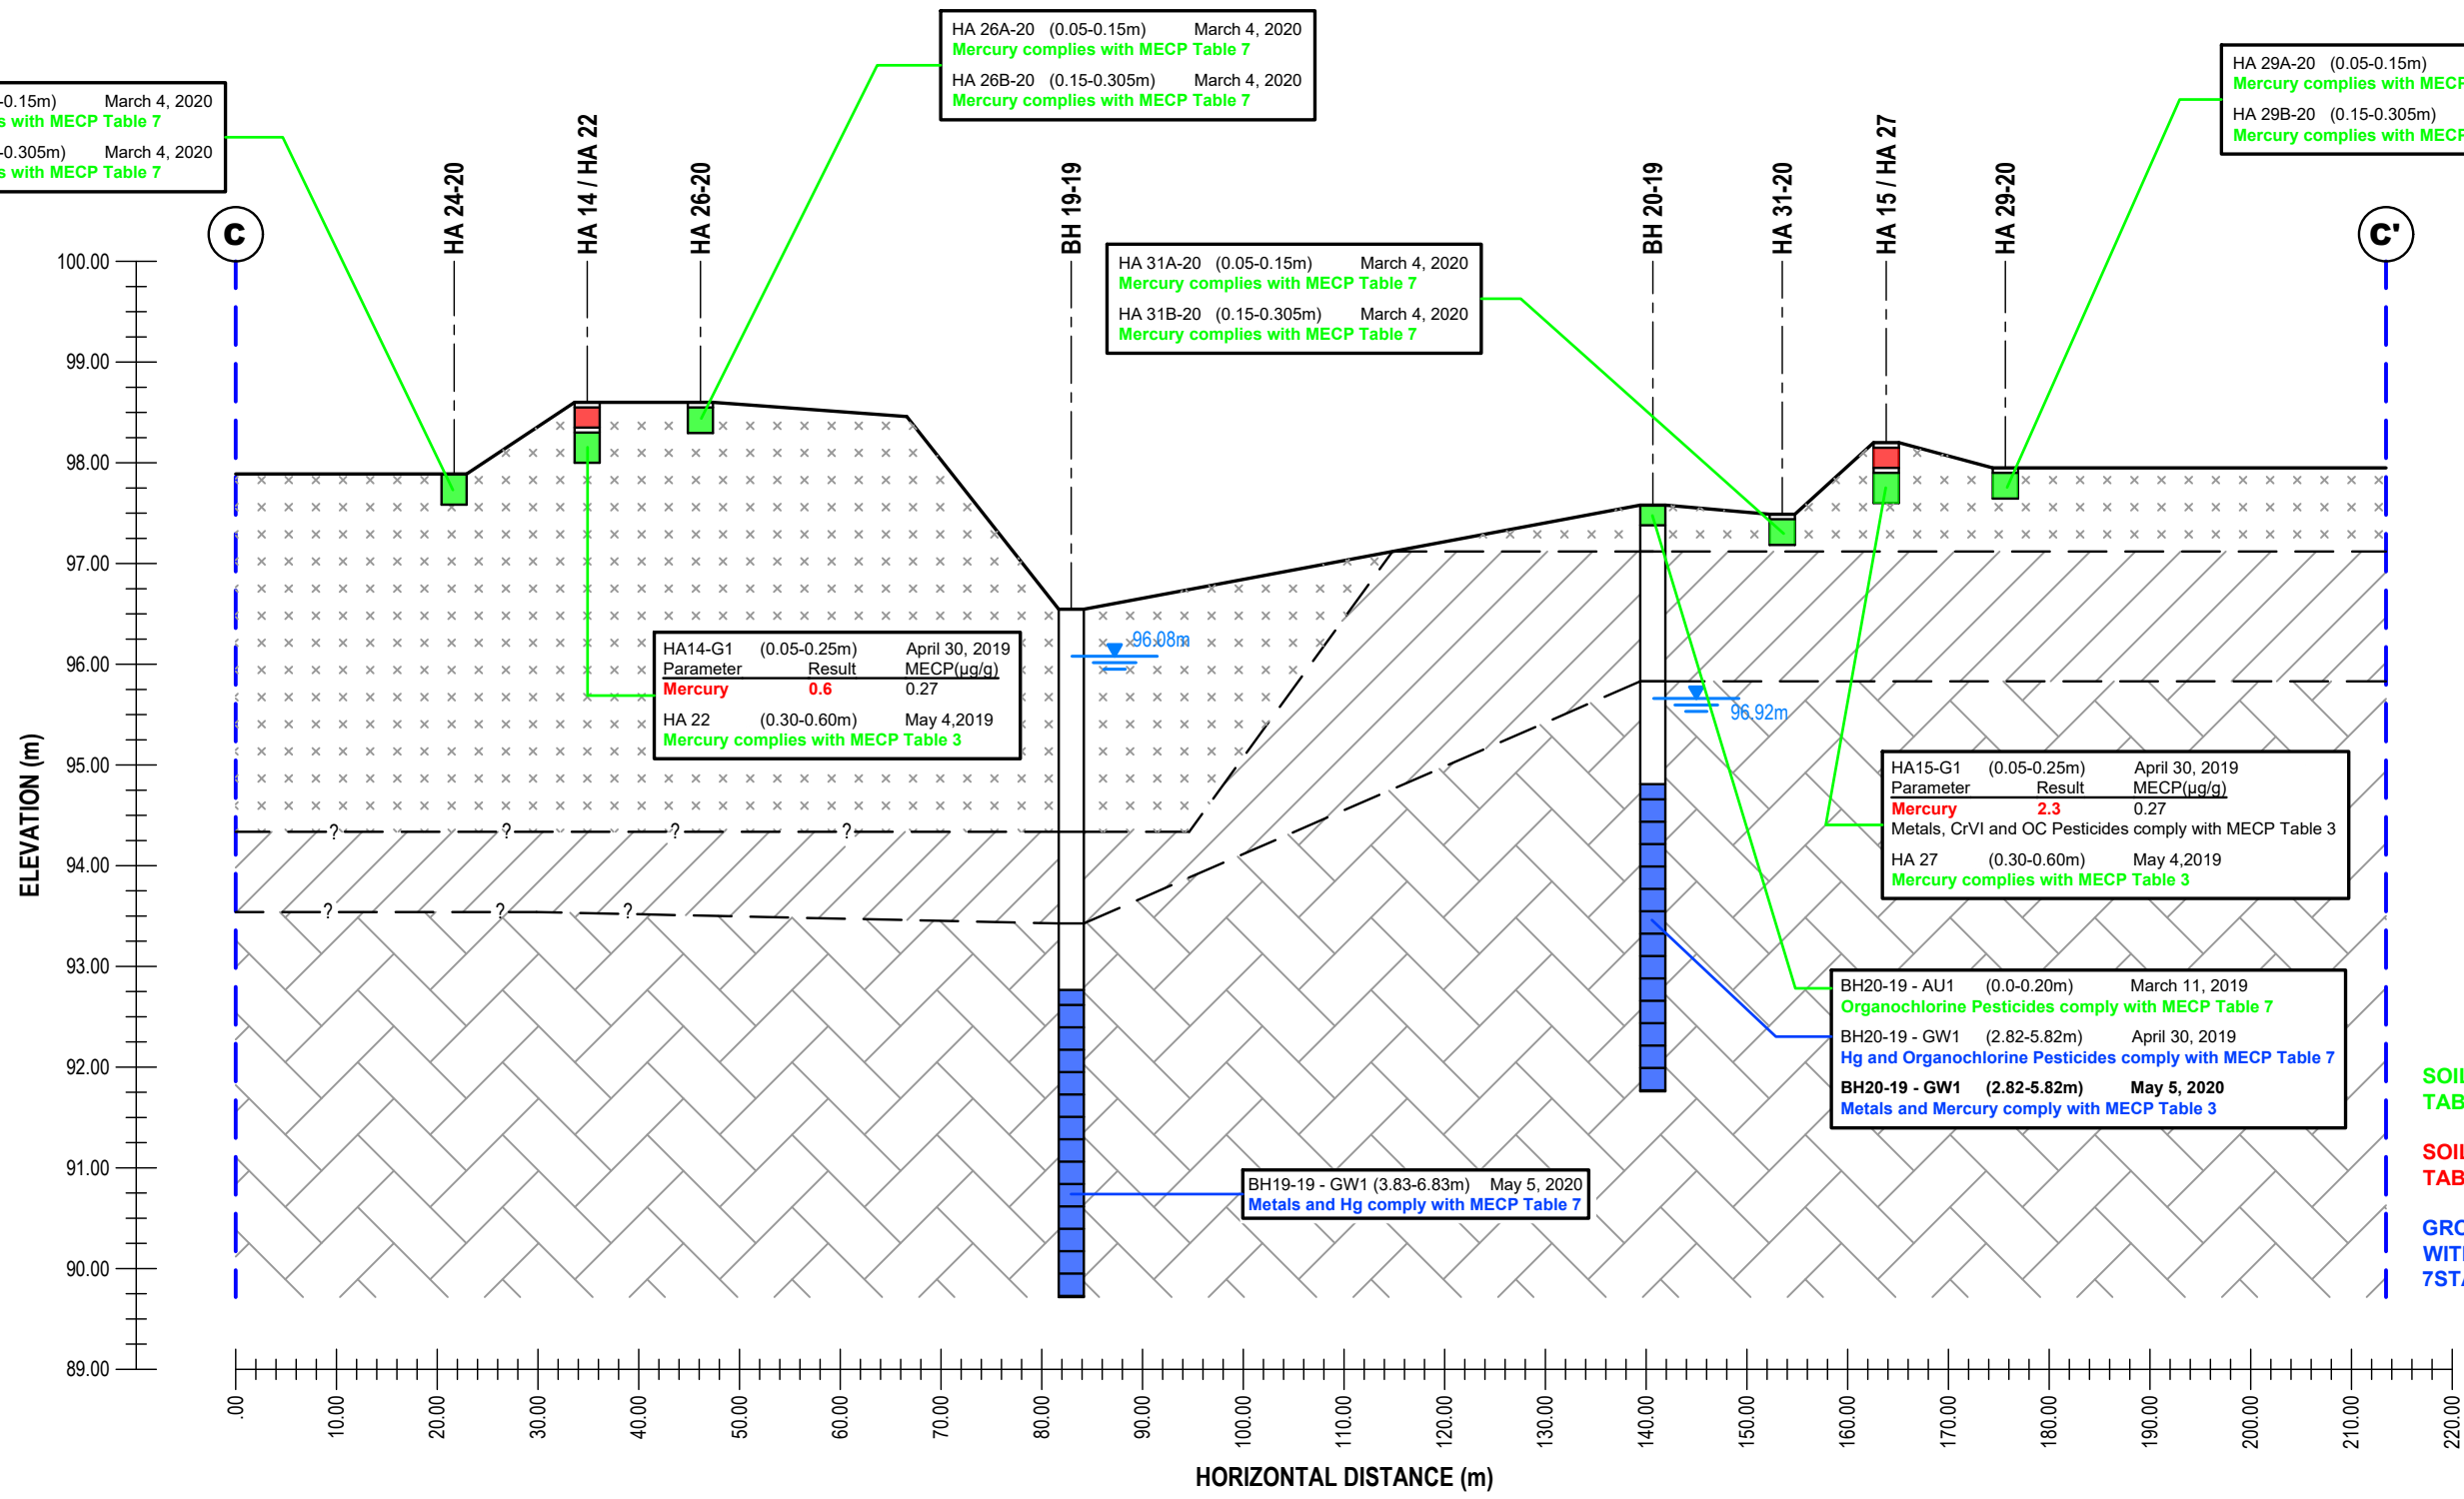
SOIL PARAMETERS COMPLY WITH MECP TABLE 3 OR TABLE 7 STANDARDS

SOIL PARAMETERS EXCEED MECP TABLE 3 OR TABLE 7 STANDARDS
