Phase I-Environmental Site Assessment

3252 Navan Road
Ottawa, Ontario

Claridge Homes (Gladstone) Inc.

December 9, 2019
Report: PE4588-1

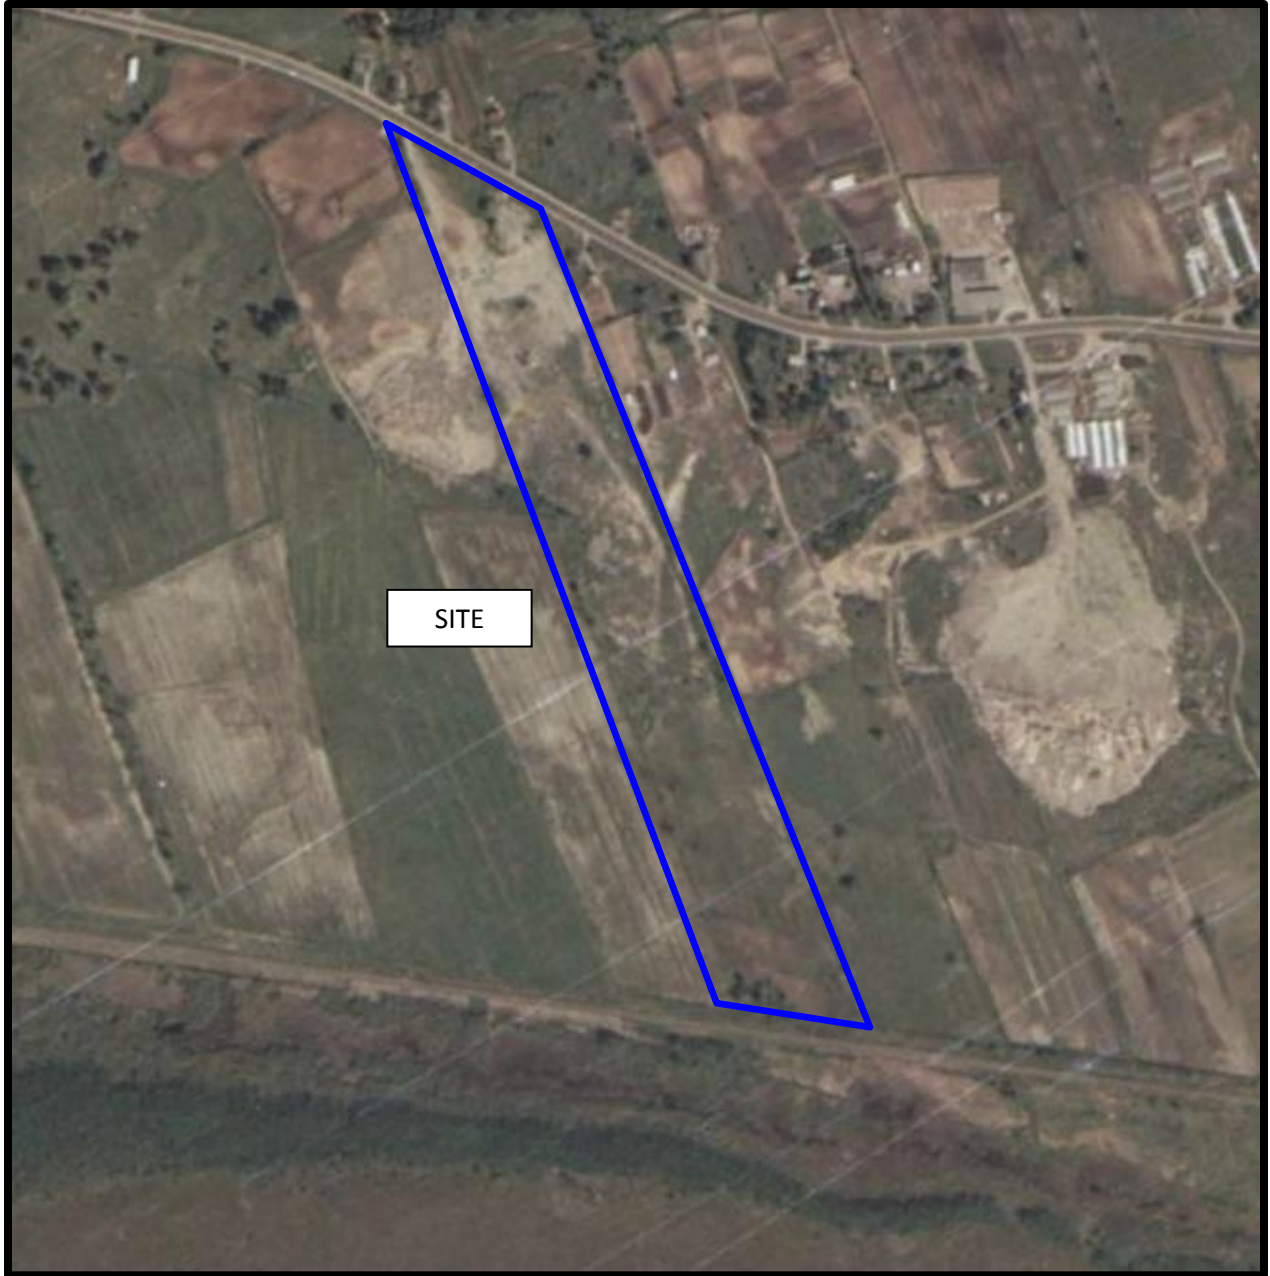
AERIAL PHOTOGRAPH
1976

- the subject site. To the east, a small area of landfilling can be seen. The remainder of the area comprises agricultural or vacant land.
- 1976 The resolution of the image is poor however no significant change appears to have occurred on the subject site. The landfill to the east of the subject site appears larger and more established. Grading or excavation of overburden material is present on the adjacent property to the west. The railway to the south no longer appears to be in use.

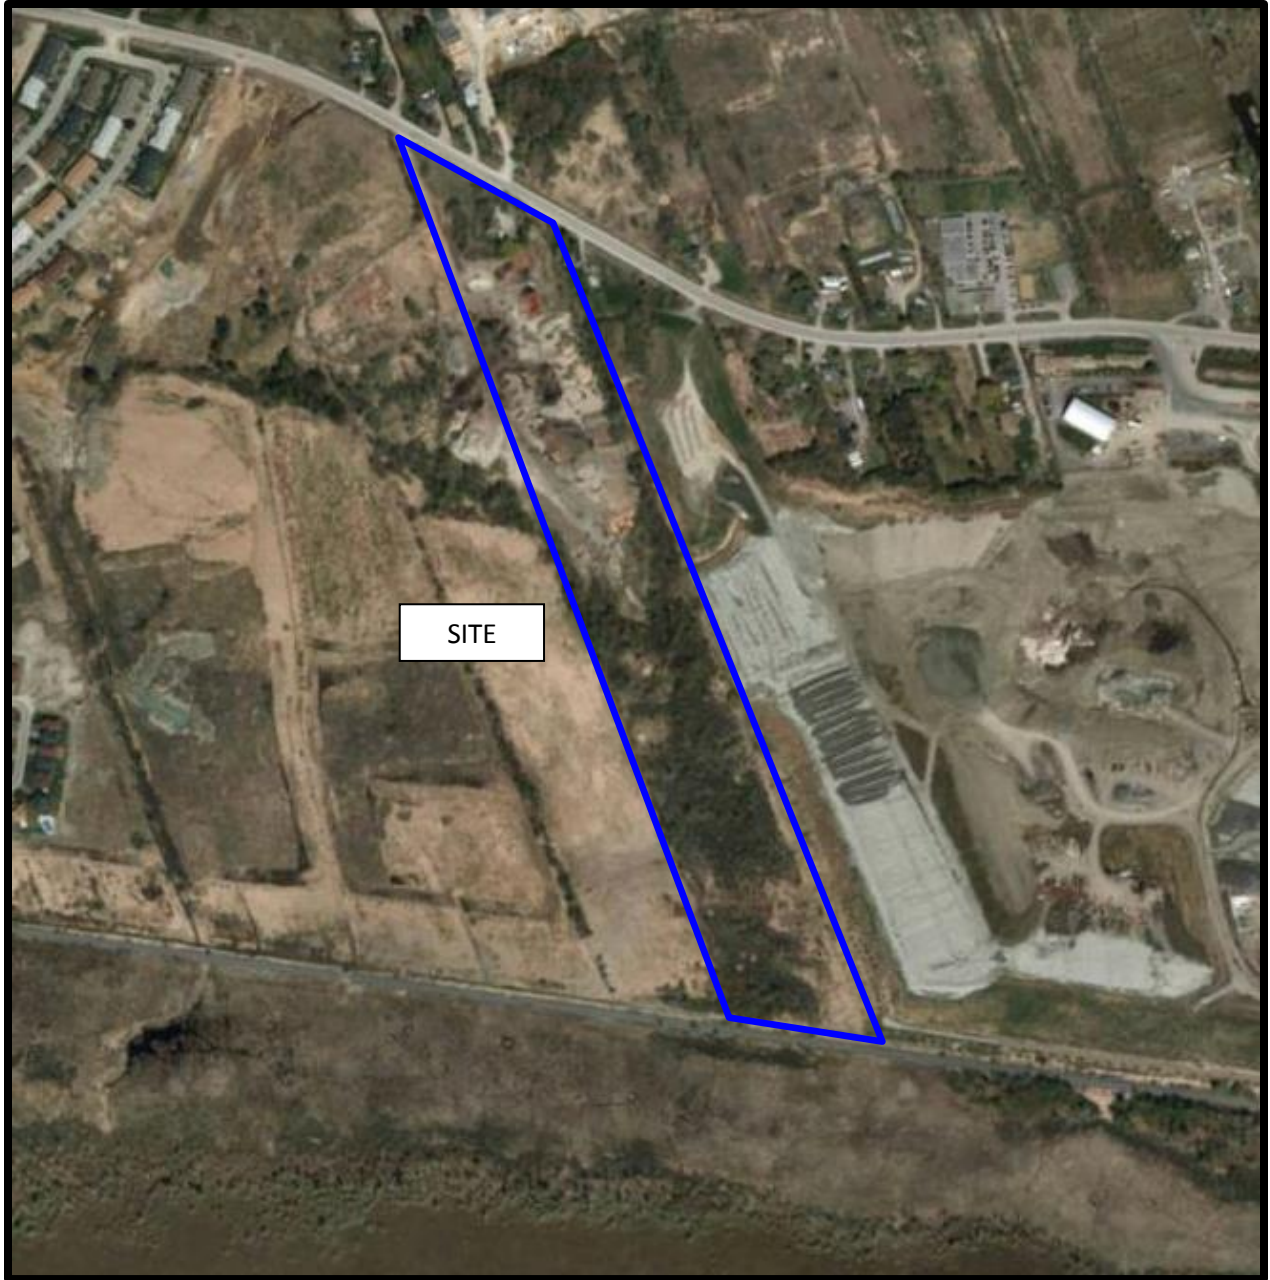
AERIAL PHOTOGRAPH
2011

- 2011 No significant changes appear on the subject site or in the surrounding area.
- 2015 The photograph has not been included in the appendix however an above-ground storage tank (AST) can be seen on the northern portion of the subject site, south of the house. The two ASTs noted during the site visit and discussed below cannot be seen at this time. No significant change can be seen in the land use of either the subject site or the surrounding area.

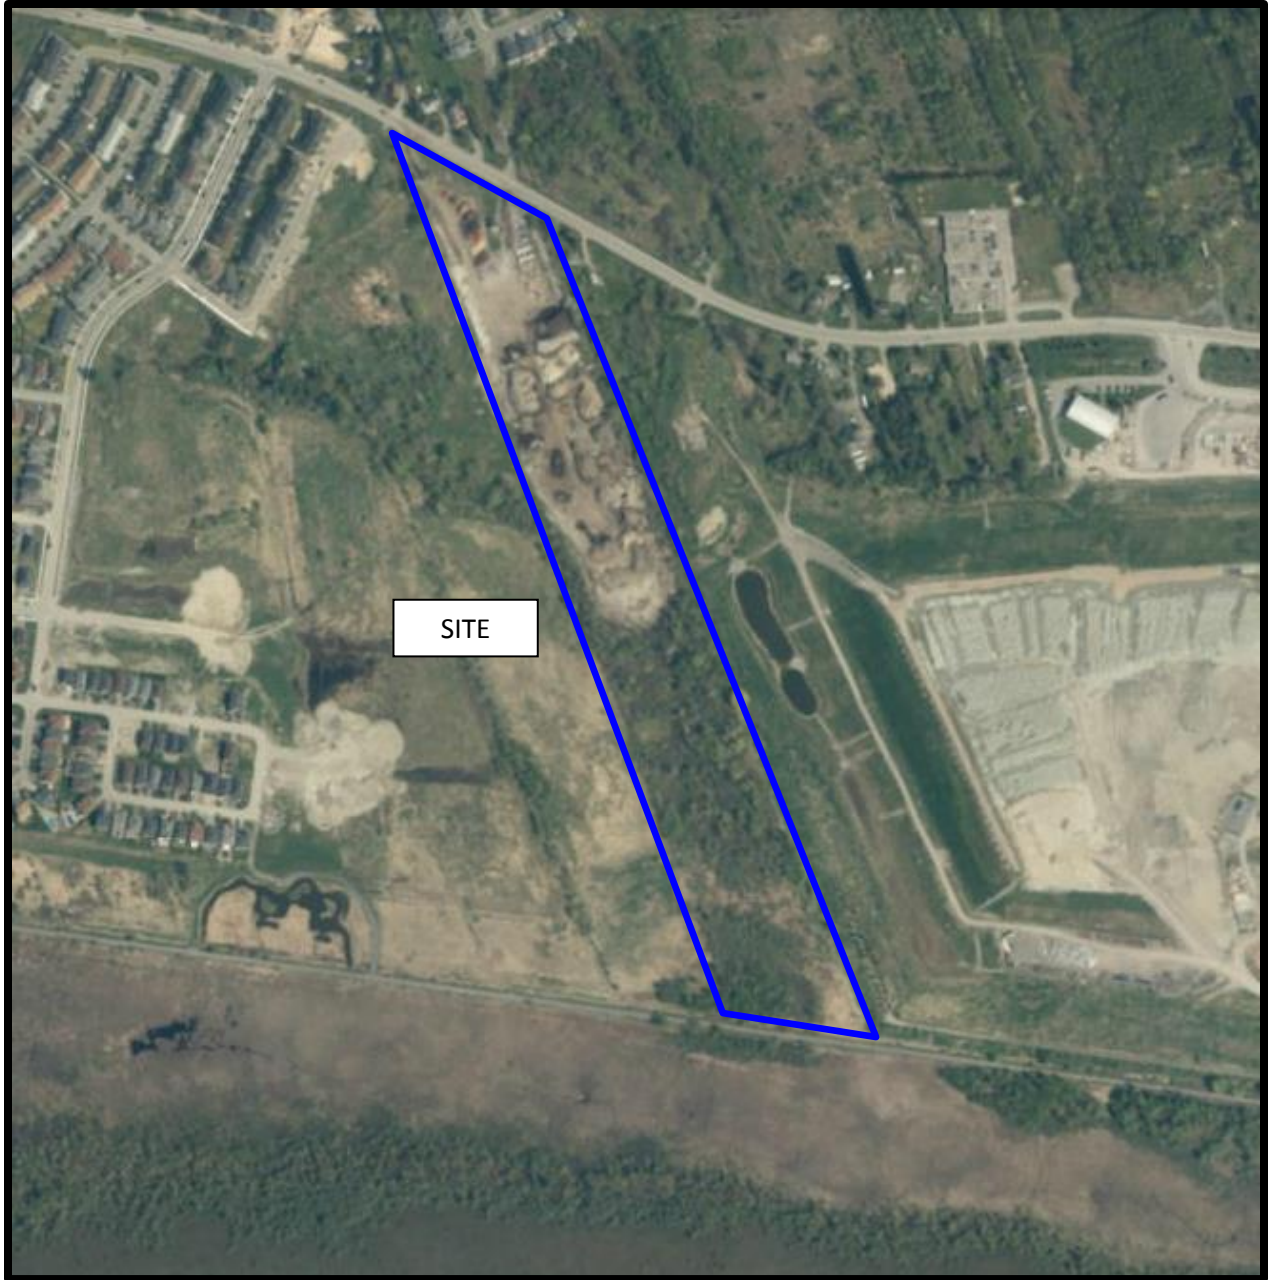
AERIAL PHOTOGRAPH
2017

- 2017 The landfill east of the site continues to be developed. To the west of the subject site, residential development is underway.
