Phase Two Environmental Site Assessment

6171 Hazeldean Road, Ottawa, Ontario

OTT-00258780-C0

July 24, 2020

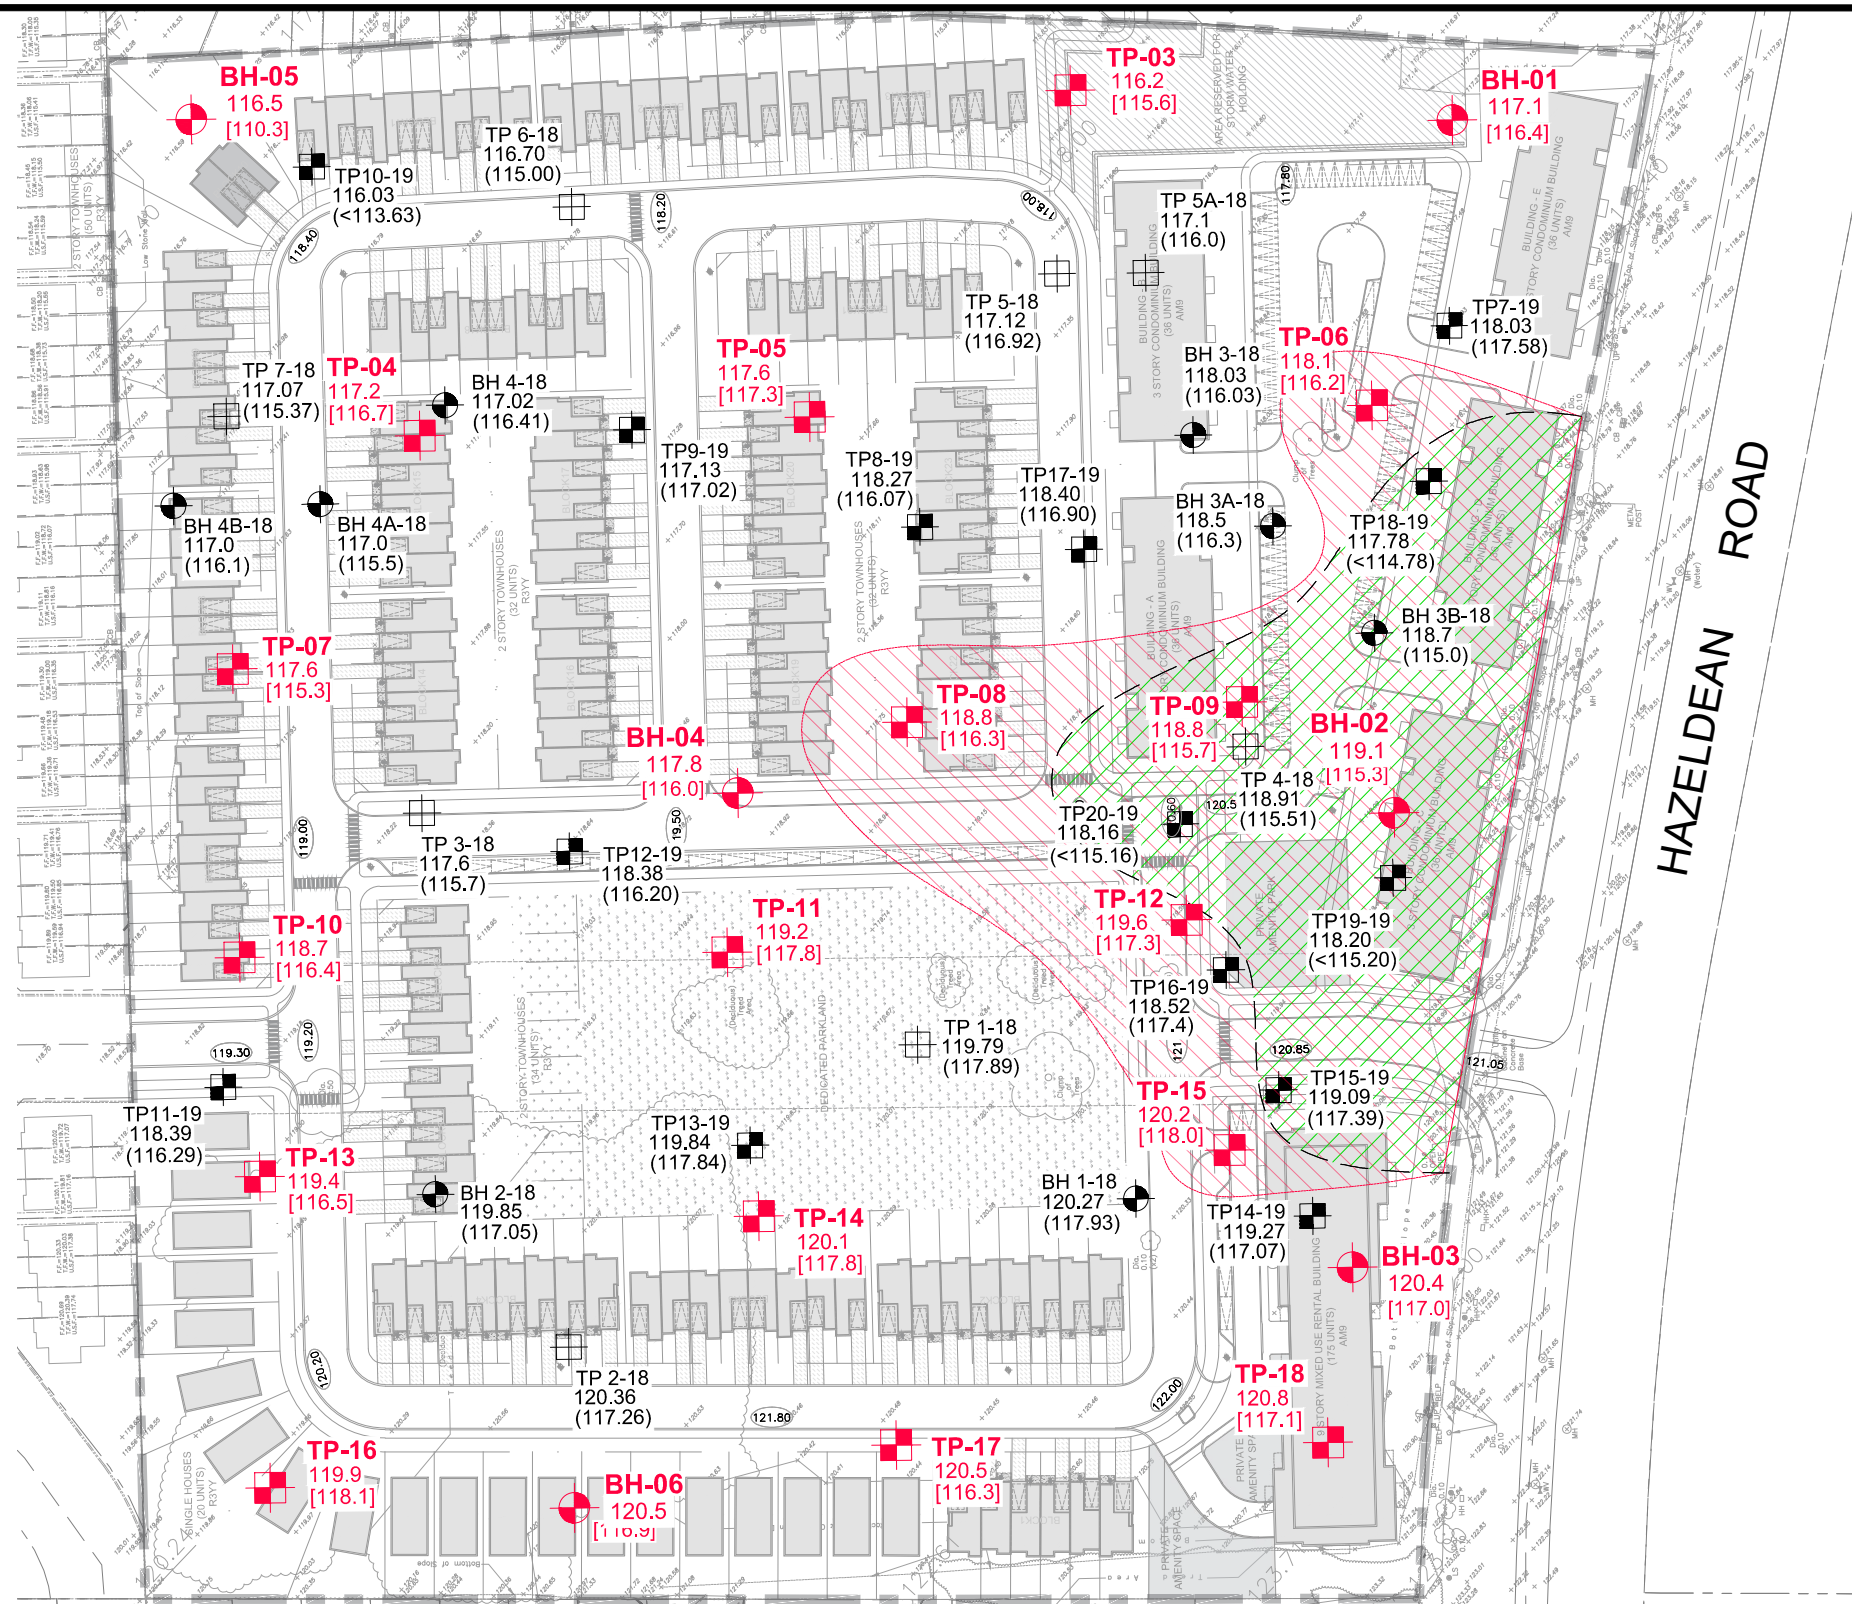
| FIG 2 |

The location of the APEC that may be affected by the PCA are shown on Figure 2 in Appendix A.

Ontario Regulation 153/04 defines an APEC as an area on a property where one or more contaminants are potentially present. The following APEC were identified on the Phase Two property, as shown on Figure 2 in Appendix A:

The purpose of the Phase Two ESA was to investigate the soil quality at the Phase Two property and to obtain soil data to further characterize conditions in the soil related to the PCA described above and within the APEC shown on Figure 2 in Appendix A.
