**Phase One Environmental
Site Assessment
6171 Hazeldean Road
Ottawa, Ontario**

OTT-00258780-C0

Phase One Environmental Site Assessment 6171 Hazeldean Road, Ottawa, Ontario

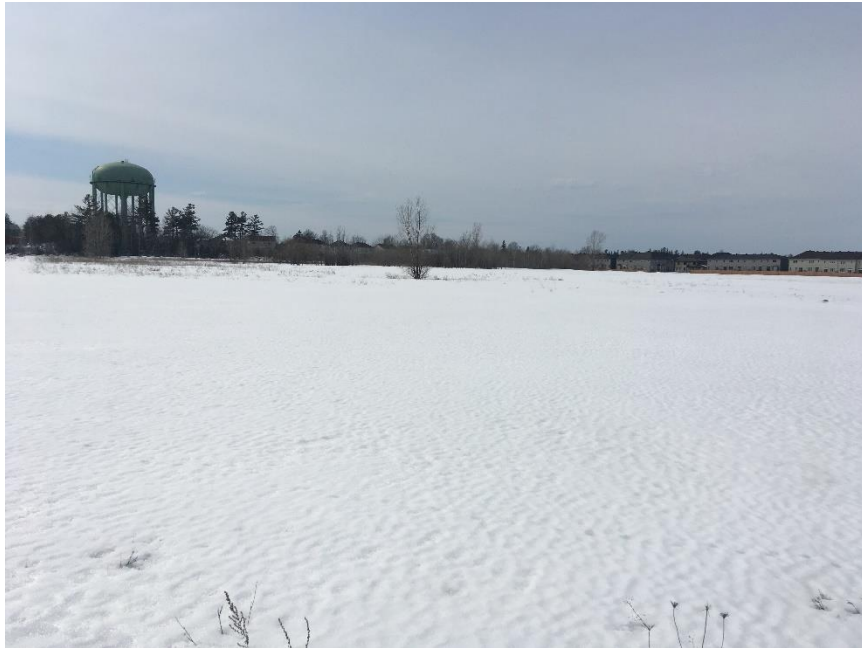
Photograph No. 1

View of west part Phase One property looking northwest

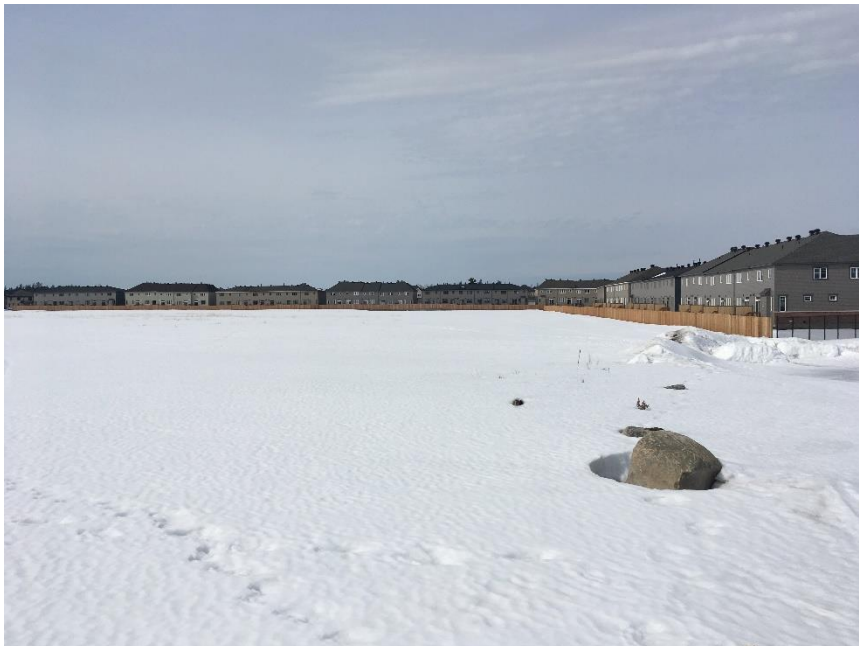
Photograph No. 2

View of east part of Phase One property looking north

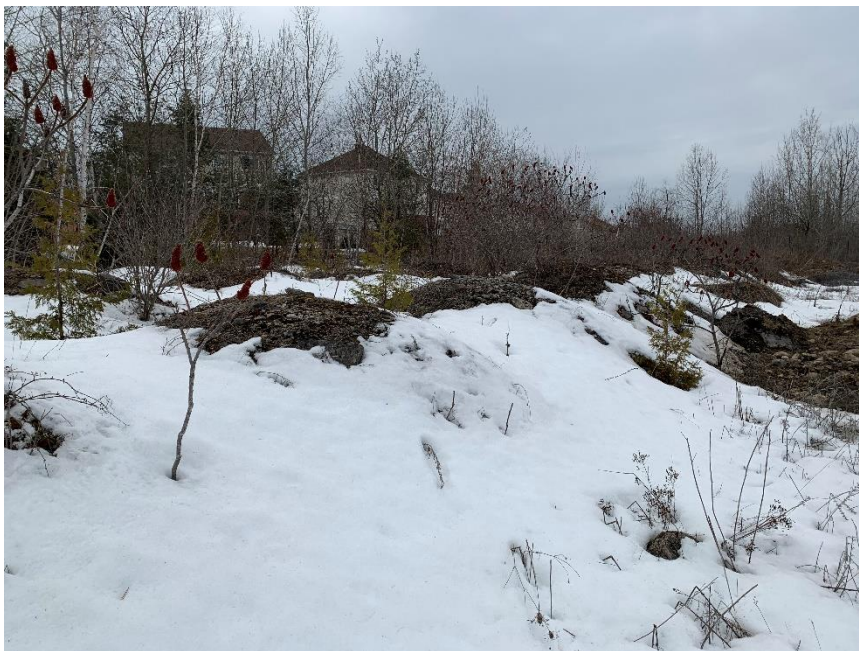
Photograph No. 6

Several stockpiles were noted along the western edge of the property. The stockpiles consisted mainly of re-work site material as well as some concrete and mixed asphalt/gravel.

View of fill piles along west property line
