## **Phase Two Environmental Site Assessment**

**6171 Hazeldean Road, Ottawa, Ontario**

OTT-00258780-C0

April 30, 2021

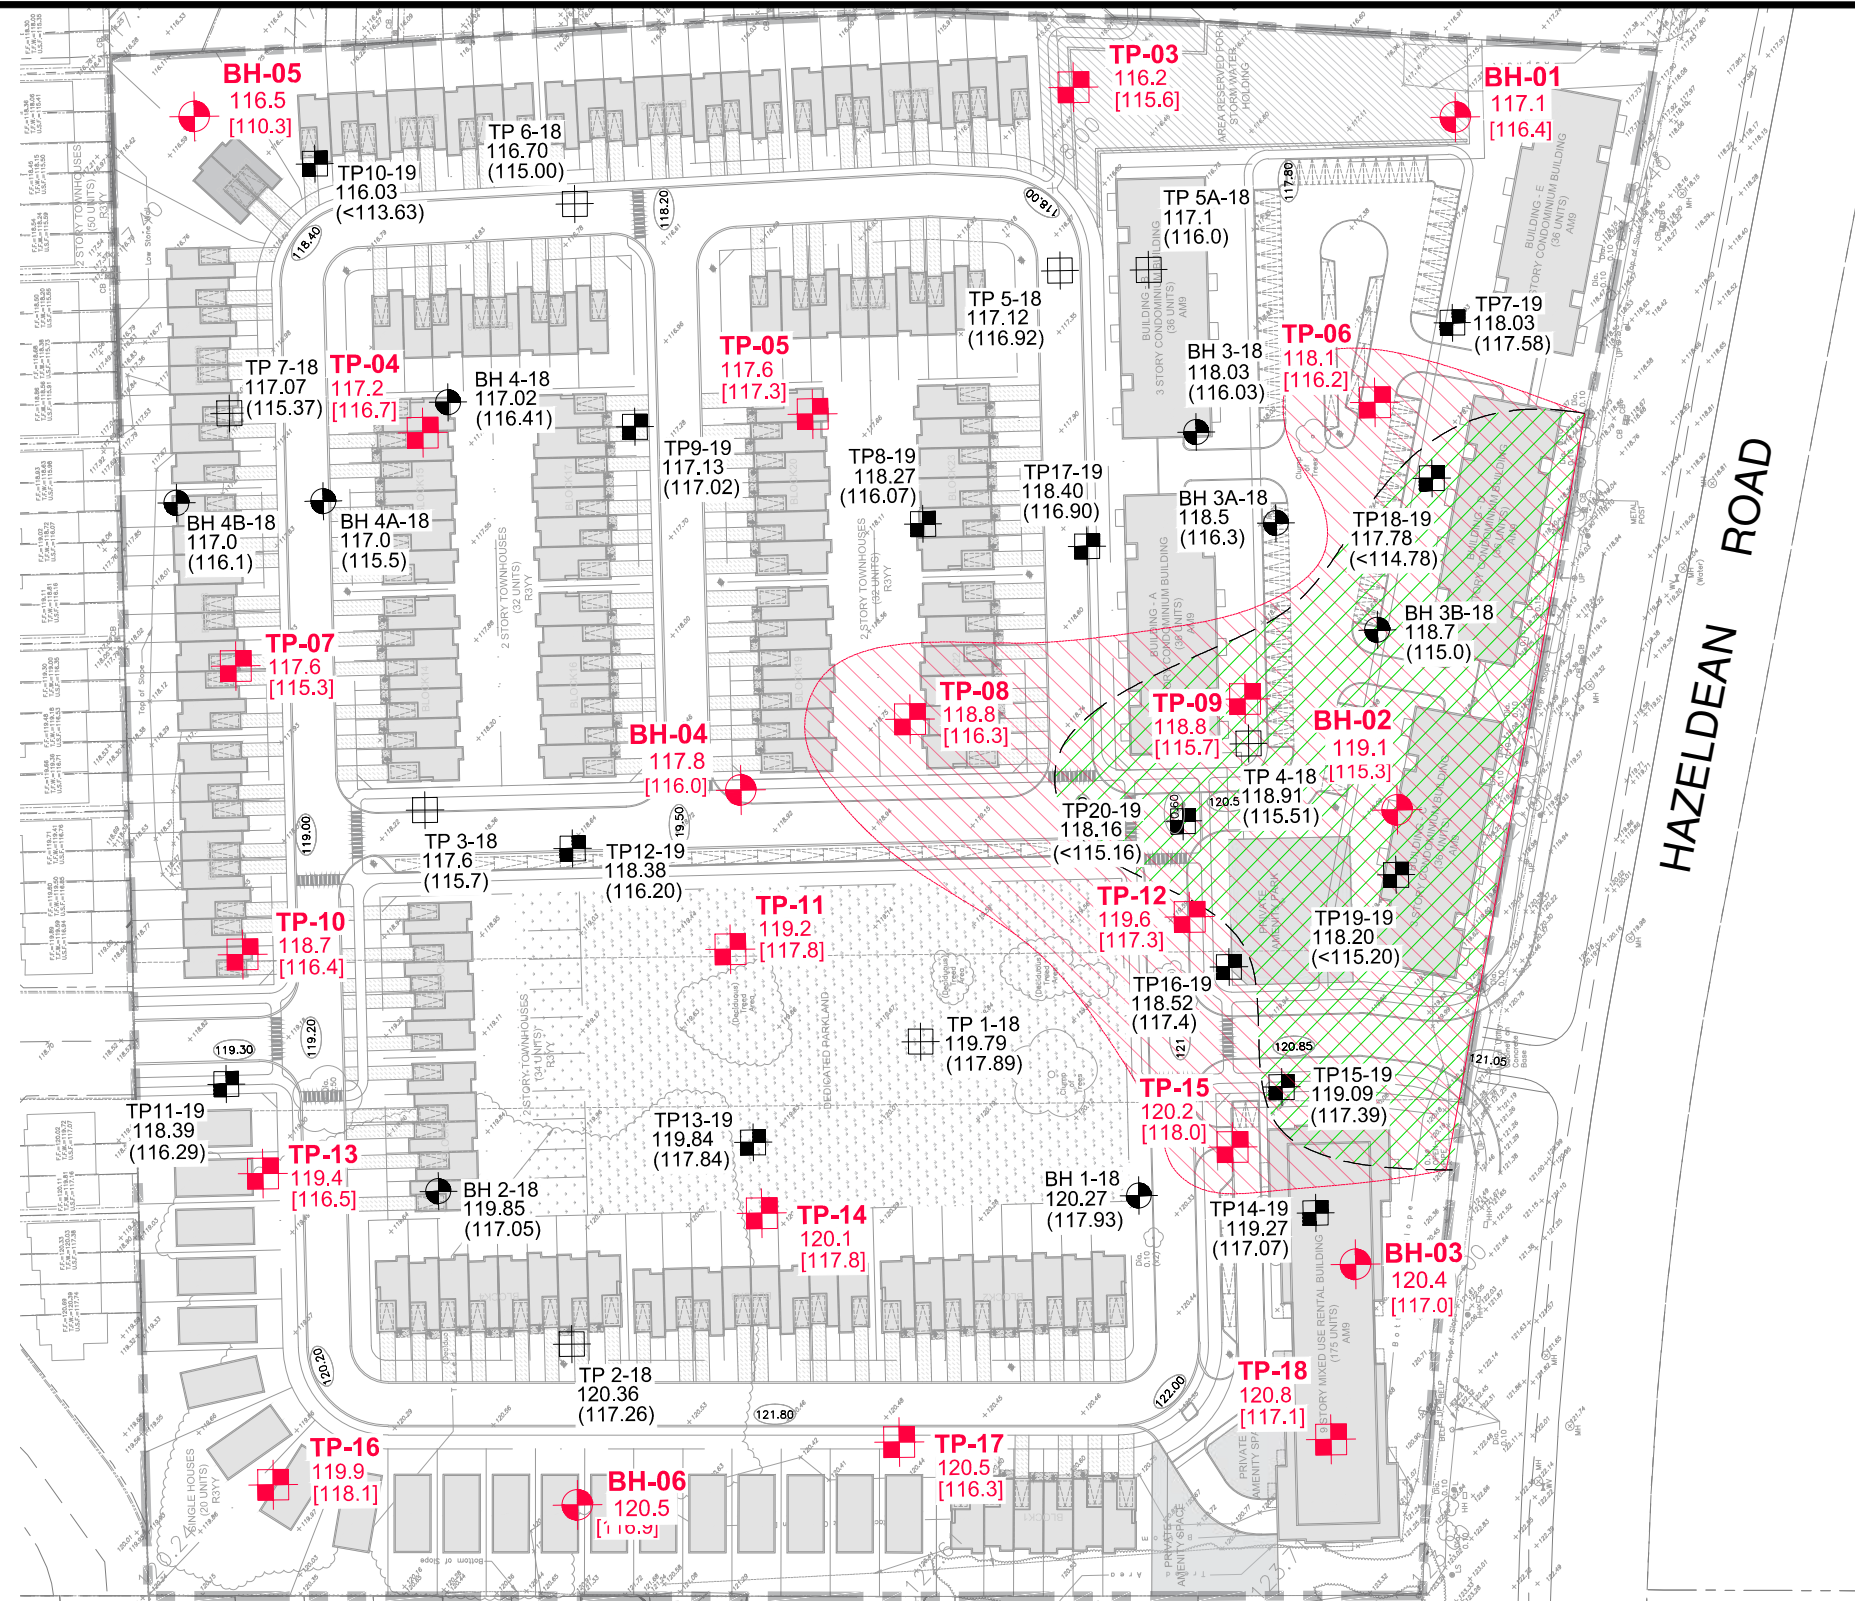
DATE	JUNE 2020	CLIENT:	11654128 CANADA INC	project no.	OTT-00258780-B0
DESIGN	I.T.	CHECKED	I.T.	scale	1:1,500
DRAWN BY	S.K.		TITLE:	<b>TESTHOLE LOCATION PLAN          PROPOSED RESIDENTIAL DEVELOPMENT          6171 HAZELDEAN ROAD, OTTAWA, ON</b>

Heterogeneous fill material was encountered at all borehole and test pit locations and extended to depths ranging between 0.3 m to 2.9 m (Elevations 119.8 m to 114.2 m). Concrete construction debris was observed in Test Pit Nos. 11 and 13. The fill extends to the surface of the bedrock/auger refusal depths of 0.3 m 2.3 m (Elevation 117.8 m to 115.7 m) in Borehole Nos. 1, 3 and 4 and in Test Pit Nos. 3 to 5, 10, 11, 13 and 14.

- BH-01** TESTHOLE NUMBER AND LOCATION (EXP, MARCH 2020)
- TP-03** TEST PIT NUMBER AND LOCATION (EXP, MARCH 2020)
- TP 1-19** TEST PIT NUMBER AND LOCATION (PREVIOUS PATTERSON GROUP INVESTIGATION PG4917-1 DATED MAY 2019)
- BH 1-18** TESTHOLE NUMBER AND LOCATION (PREVIOUS PATTERSON GROUP INVESTIGATION PG4706 DATED OCT. 2018)
- TP 1-18** TEST PIT NUMBER AND LOCATION (PREVIOUS PATTERSON GROUP INVESTIGATION PG4706 DATED OCT. 2018)
- 117.0 116.2** GEODETIC ELEVATION (m)
- (115.5) [116.6]** BEDROCK ELEVATION (m)
- APPROXIMATE EXTENT OF PEAT BELOW FILL LAYER (PREVIOUS PATTERSON GROUP INVESTIGATION PG4917-1 DATED MAY 2019)
- ADDITIONAL EXTENT OF PEAT BELOW FILL LAYER
