Environmental Impact Statement for the Proposed Development of 6012 Ottawa Street Area

Draft Report

January 14, 2020

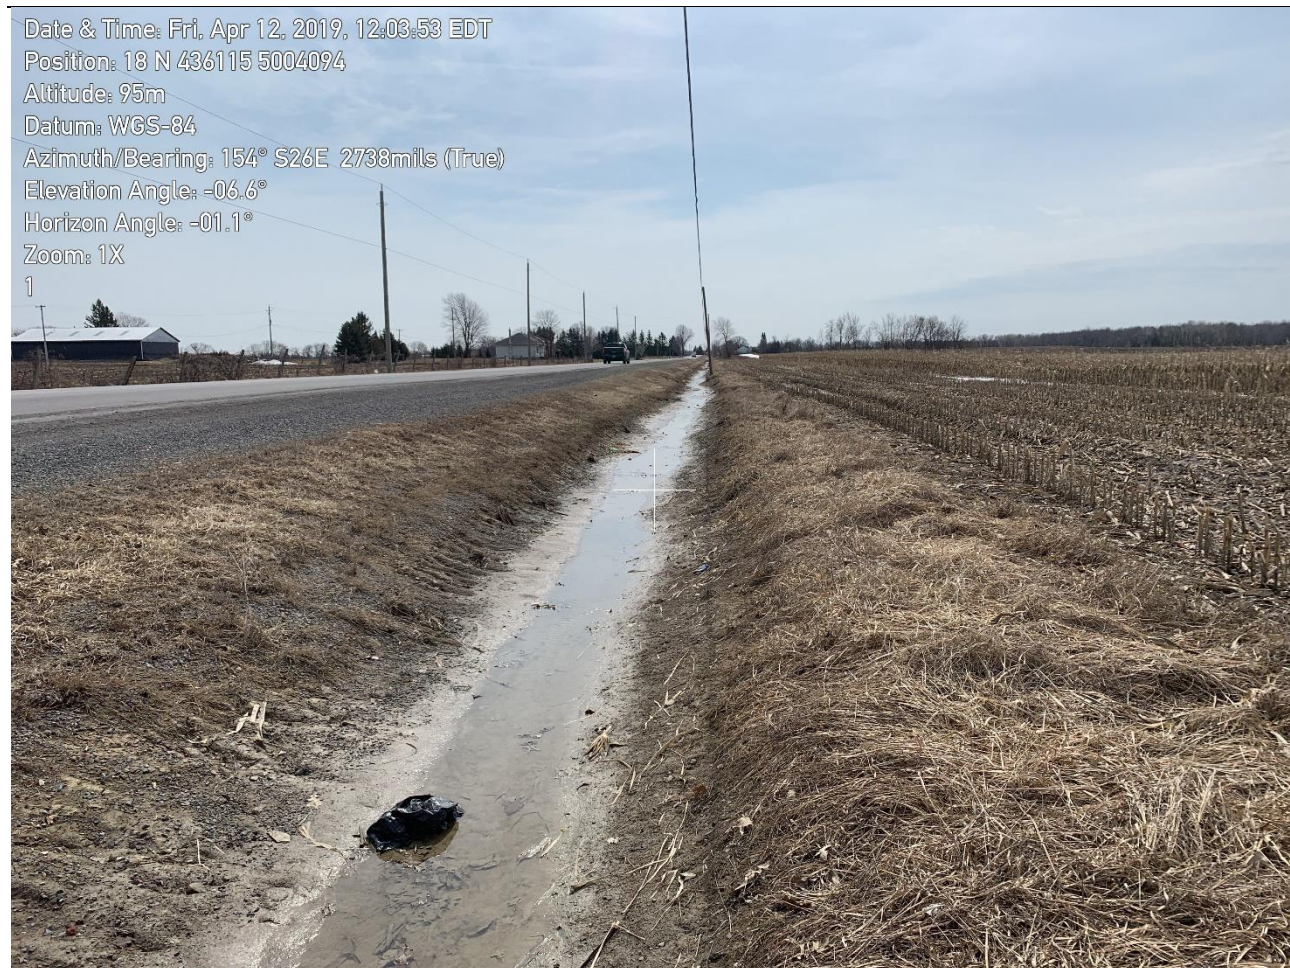
Figure 4 Photo showing the roadside ditch along Eagleson Road taken on April 12, 2019

A roadside ditch system stretches along Eagleson Road surrounding the corn field on Site and along Ottawa Street at the northeast corner of the Site. When originally assessed in the spring, there was no flow through most of the ditch length along the property. The water found along most of the ditches consisted of small, disconnected puddles; by late spring they had dried up completely. Only the portion nearest to Reach 1 (see below) held some standing water (i.e., the ditch was presumably draining into Reach 1, but with no detectable flow). The substrate consisted primarily of silt and sand, while the banks had grass along the shoulder of the road. Submergent vegetation was not present. No frogs or turtles were observed in the roadside ditches, but American Toads (*Anaxyrus americanus*), Spring Peepers (*Pseudacris crucifer*), and Green Frogs (*Rana clamitans*) could be heard calling from Marlborough Creek westward from the north end of the ditch down Ottawa Street (i.e., frogs were detected audibly from this ditch but were not observed directly in the ditch).

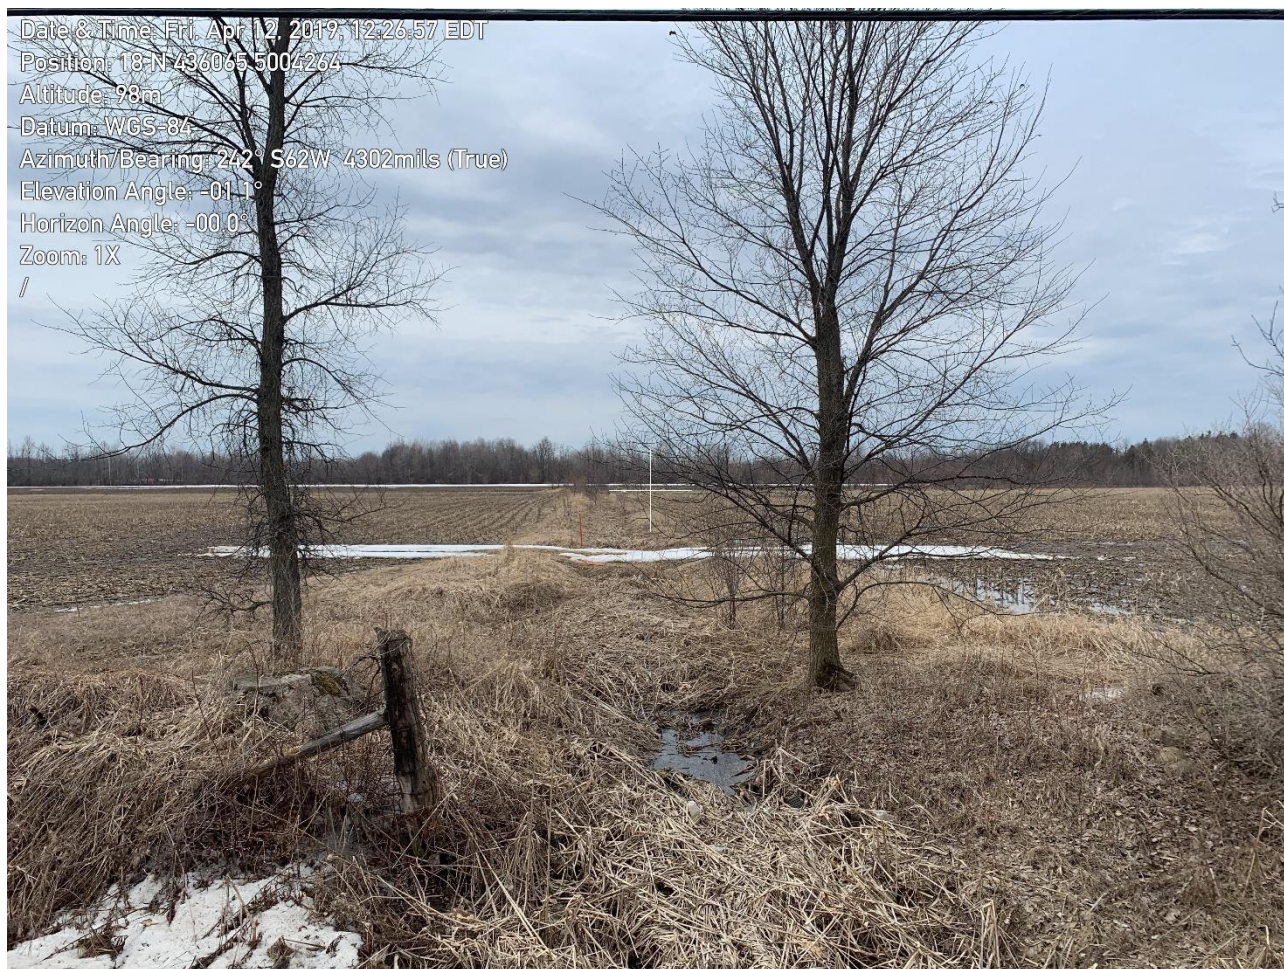
Figure 5 Photo showing Reach 1 on Site taken on April 12, 2019

Reach 1 runs 232 m from northeast to southwest of the Site between corn fields, starting at a culvert along the side of Eagleson Road, to a 90° bend northward into Reach 2. There was limited flow here in the initial visits in the early spring, and by mid-spring the area was dry. The feature has corn fields on either side and a few small trees along the banks. The substrate was mostly organic matter and cattails were found in the channel. Instream vegetation is otherwise limited, likely due to the buildup of organic matter. There is grass on either side of the banks, and cropped land (corn) at the edge of the grass. No frogs or turtles were observed in or along this feature.

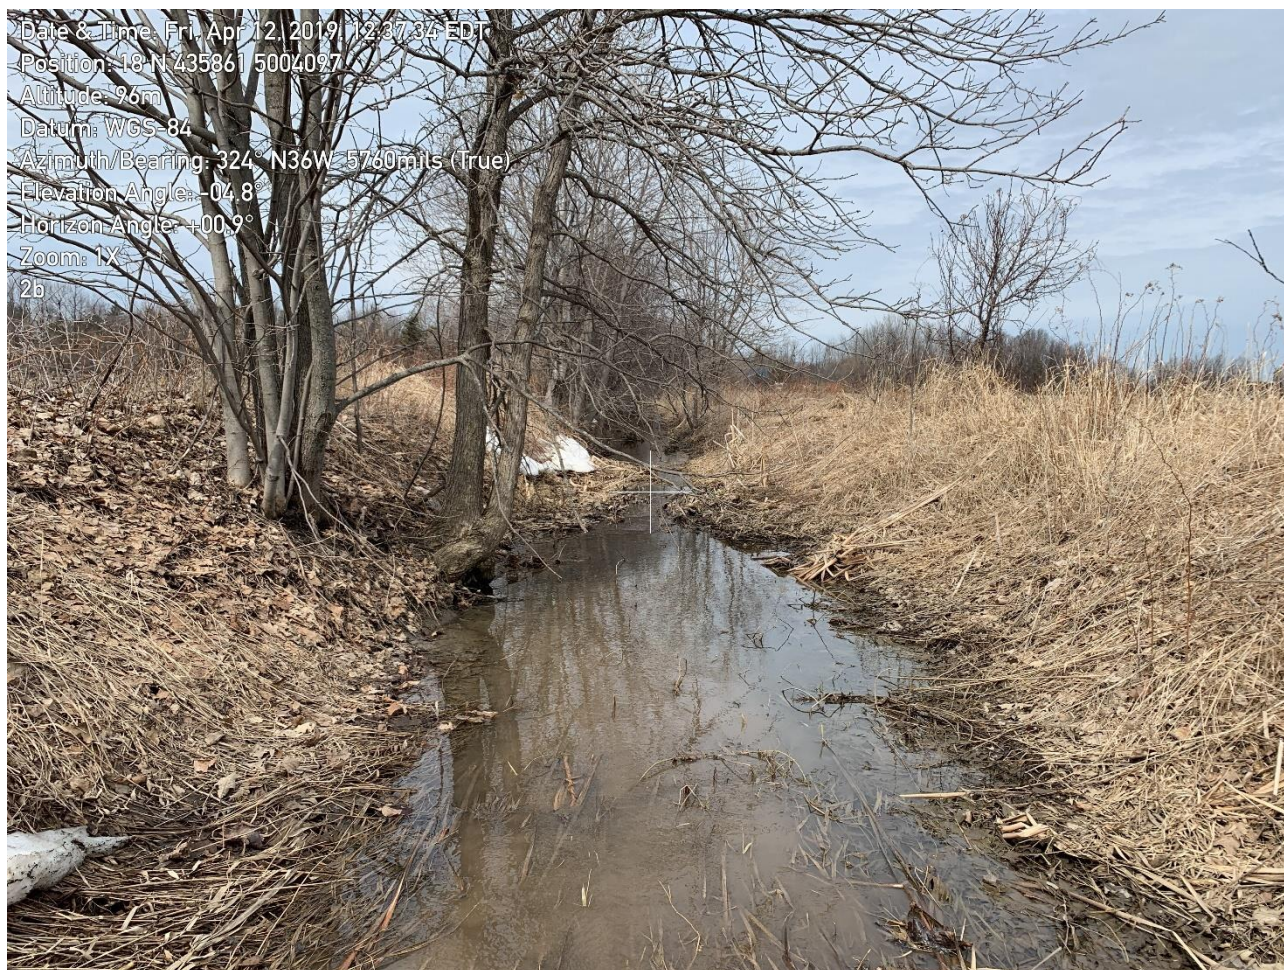
Figure 6 Photo showing Reach 2 on Site taken on April 12, 2019

Reach 2 runs 305 m southeast to northwest from the turn at the end of Reach 1 to Marlborough Creek on the northwestern side. The downstream-most end of the channel passes through the wooded riparian corridor of Marlborough Creek but most of the channel is situated between two corn fields. This reach appears to have been constructed as a drainage feature for the adjacent agricultural fields. Early spring flows in Reach 2 were somewhat more evident than in Reach 1, though grass and woody debris maintained pooled areas where flow was not apparent. The substrate consists of mostly organic matter. Like Reach 1, the banks of this feature are lined with grass, but some trees are present and the banks are much more defined. The trees and shrubs adjacent to Reach 2 include Common Buckthorn (*Rhamnus cathartica*), American Elm (*Ulmus americana*), Ash (*Fraxinus*), Willow (*Salix*), Raspberry (*Rubus*), Red Maple (*Acer rubrum*), Cedar (*Thuja*), and Red Osier Dogwood (*Cornus sericea*). This reach still held standing water in late spring (likely retained by minor debris jams) but it was generally very shallow (<5 cm) and there were no fish observed or caught in the channel. It was dry by early summer. No frogs or turtles were observed in this feature.

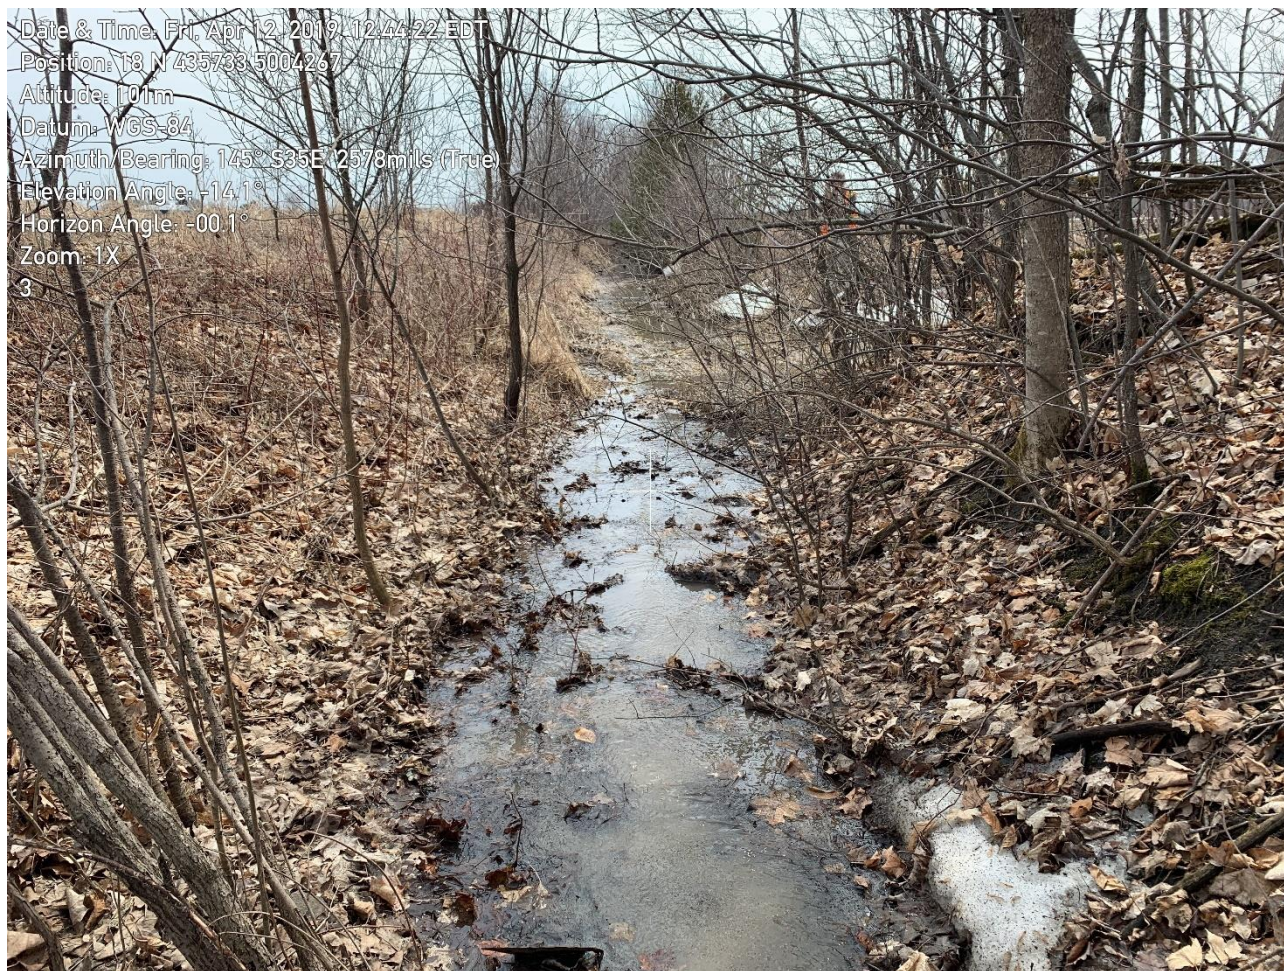
Figure 7 Photo showing Reach 3 on Site taken on April 12, 2019

Reach 3 is an 86 m channel along the northwestern edge of the eastern agricultural field. It conveys spring meltwater from the field to Reach 2 but runs dry after that. Consequently, no fish, frogs, or turtles were observed in this reach. There were a few frogs heard calling nearby during evening amphibian surveys, closer to Marlborough Creek. The substrate consisted mainly of organic matter and silt. The banks of this feature are grassy with trees present. These include Poplar (*Populus*), Pine (*Pinus*), and Ash (*Fraxinus*) trees.

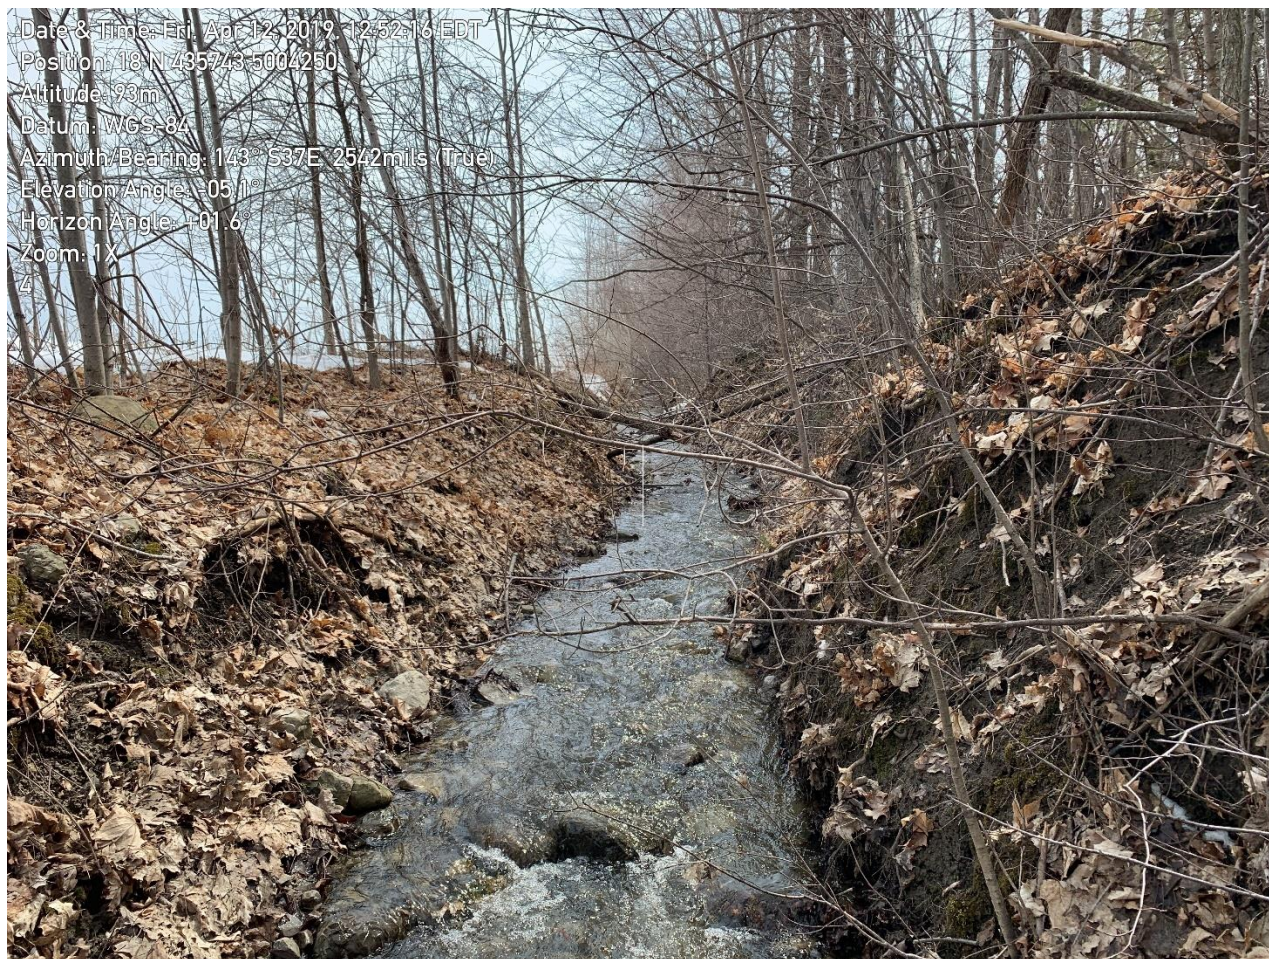
Figure 8 Photo showing Reach 4 on Site taken on April 12, 2019

Reach 4 is a linear, U-shaped channel with very well-defined banks and swift springtime flows that extend along the centre of the property, wrapping around to the southern and eastern sides of areas of successional regrowth towards the centre of the southern border of the property. This entire reach spans a distance of 795 m along the edge of active agricultural lands from a tile drain input and into Marlborough Creek. Older air photos suggest this feature previously received surface flows from a swale over the farm fields to the south, but that swale is no longer apparent. The tile drain is the main source of water in this reach. The presence of the tile drain resulted in steady flows through Reach 4 in late spring, and some standing water was still present in early summer. Given the substantial decrease of water depth by early July, and the lack of any apparent seeps, the feature was dry by late summer. This drainage ditch has a layer of cobble/gravel on the substrate. The west bank is lined with trees and continues up into a sparsely wooded area. There are some trees along the east bank, but the edge of the feature is generally contiguous with the adjacent corn/winter wheat fields. The steep banks and heavy flowing water in the spring did not make ideal habitat for turtles directly in the feature and none were noted here, but two Painted Turtles (*Chrysemys picta*) were observed in Marlborough Creek just beyond the end of Reach 4. There were no frogs observed in the area during any of the three evening frog surveys.

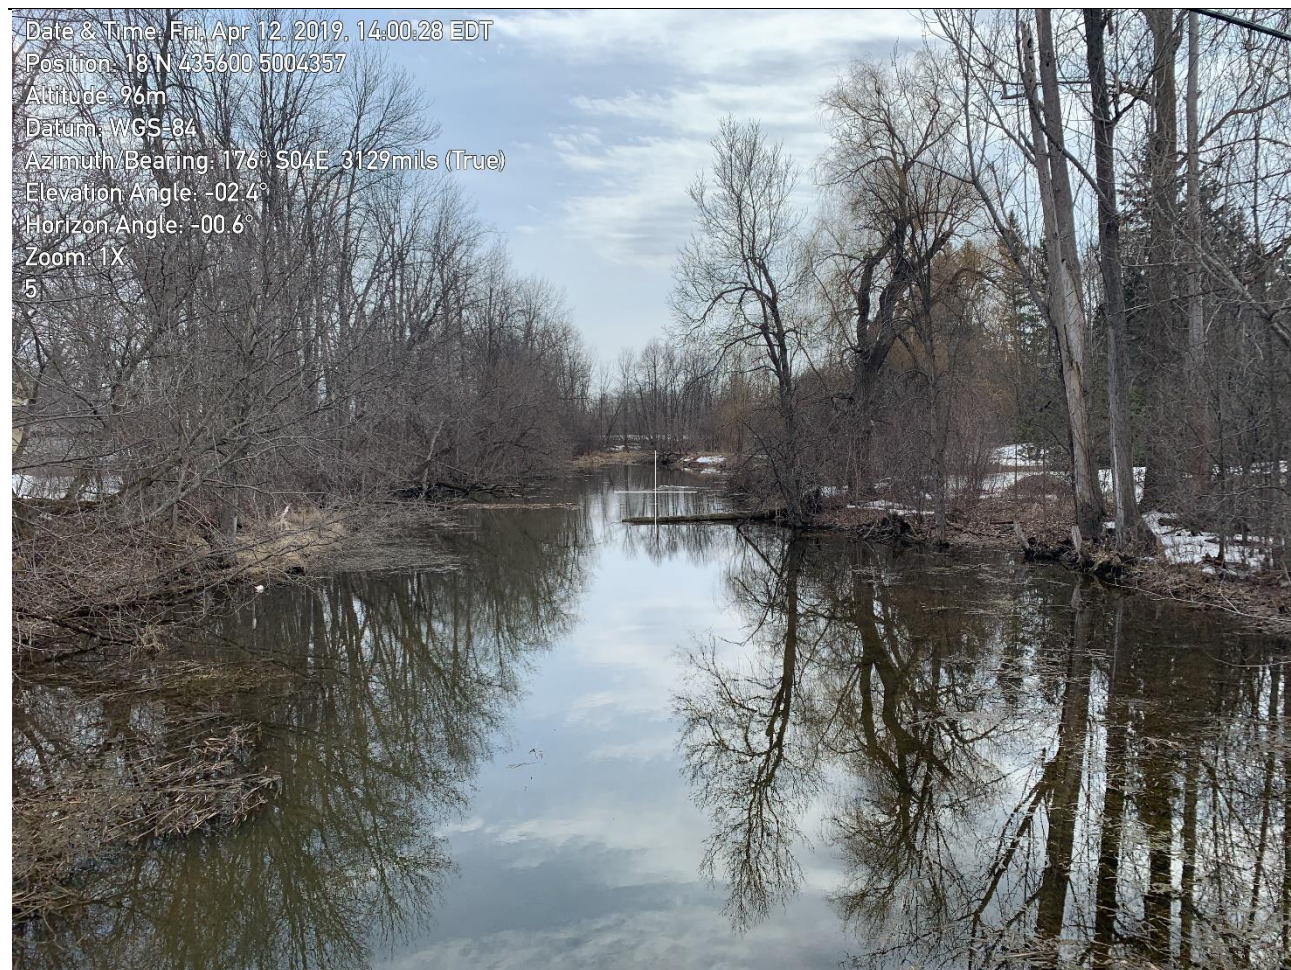
Figure 9 Photo showing Marlborough Creek on Site taken on April 12, 2019

Marlborough Creek, an important tributary of the Jock River with the confluence located immediately downstream of Eagleson Road, flows along the northern edge of the property. The permanent creek has fast and heavy spring flows and maintains a wetted width often over 15 m, even in mid-summer. According to the most recent Jock River Subwatershed Report by RVCA (2016), there were minimal anthropogenic alterations observed along the system, and 80% of Marlborough Creek remains “unaltered” with no anthropogenic alterations. The remaining 20% of Marlborough Creek was classified as natural with minor anthropogenic changes.
