**Environmental Impact Statement
6150 Thunder Road, Ottawa**

Updated Report

July 15, 2021

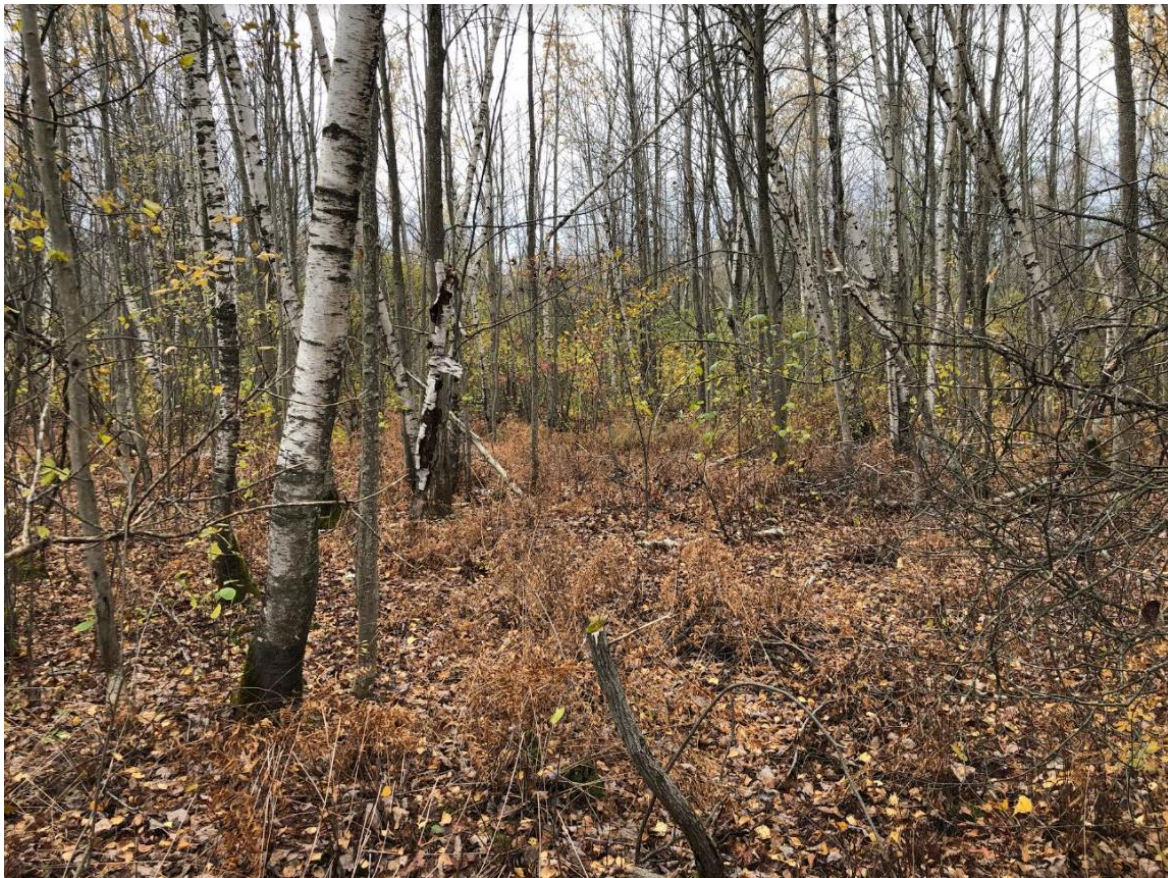
FOD8-2 Ecosite

The northern end of the site – north of R7 – is a Fresh-Moist Poplar Deciduous Forest (FOD8-2). The ecosite is co-dominated by Balsam Poplar (*Populus balsamifera*) and Trembling Aspen (*Populus tremuloides*). These trees have a diameter at breast height (DBH) that ranges from 10 to 35 cm. Other tree species present in small numbers include Red Maple (*Acer rubrum*), European Birch (*Betula pendula*), Eastern Cottonwood (*Populus deltoids*) and Green Ash (*Fraxinus pennsylvanica*). This is the oldest contiguously wooded area on the Site, though it is still no more than 45 years old (City of Ottawa, 2020a).

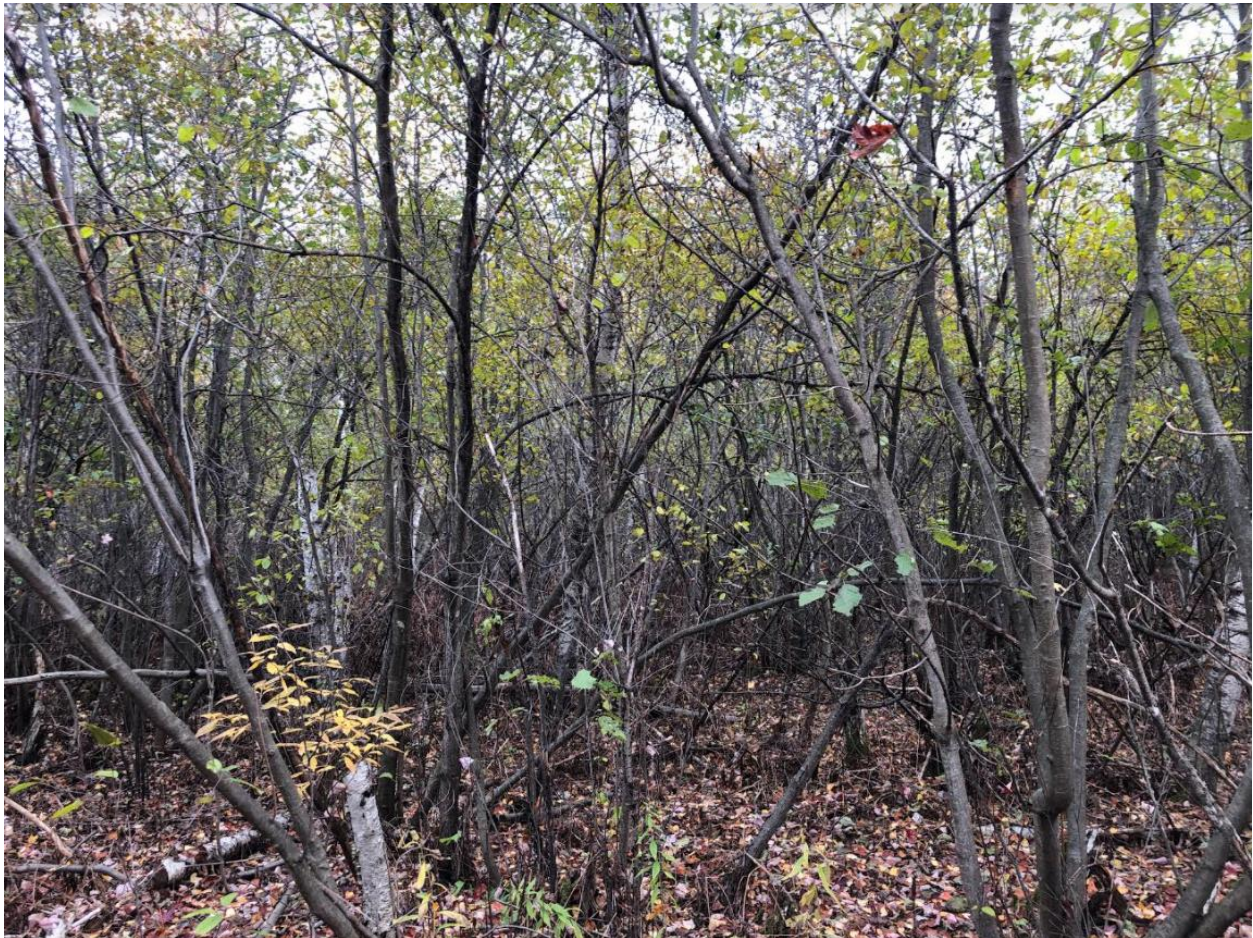
FOD7 Ecosite

The remainder of this original plantation area has grown over with species of trees common to the older forested areas south and west of the Site, with most of those areas now consisting of Fresh–Moist Lowland Deciduous Forest (FOD7). This ecosite consists of a mix of Red Maple and Green Ash, with subordinate species of Black Ash (*Fraxinus nigra*), American Elm (*Ulmus americana*), European Birch, Balsam Poplar, Largetooth Aspen (*Populus grandidentata*), Trembling Aspen, and Manitoba Maple (*Acer negundo*). A small number of the Red Maple, Trembling Aspen, and Balsam Poplar in the FOD7 ecosite are as large as 30 cm DBH, but most of the area is composed of smaller trees and saplings, representing a regenerating forest habitat that may be recovering from tree loss to due to occasional beaver-induced flooding. Common Buckthorn (*Rhamnus cathartica*) is also common in the understory. Within the re-naturalizing area of the FOD7 ecosite, some pockets have retained sufficient numbers of White Spruce and to suggest

up a Fresh – Moist White Spruce – Hardwood Mixed Forest (FOMM10-2) inclusions, though these pockets generally too small to delineate as separate ecosites.
