**Environmental Impact Statement
6150 Thunder Road, Ottawa**

Updated Report

April 26, 2021

Michel Pilon
Avenue31 Capital Inc.

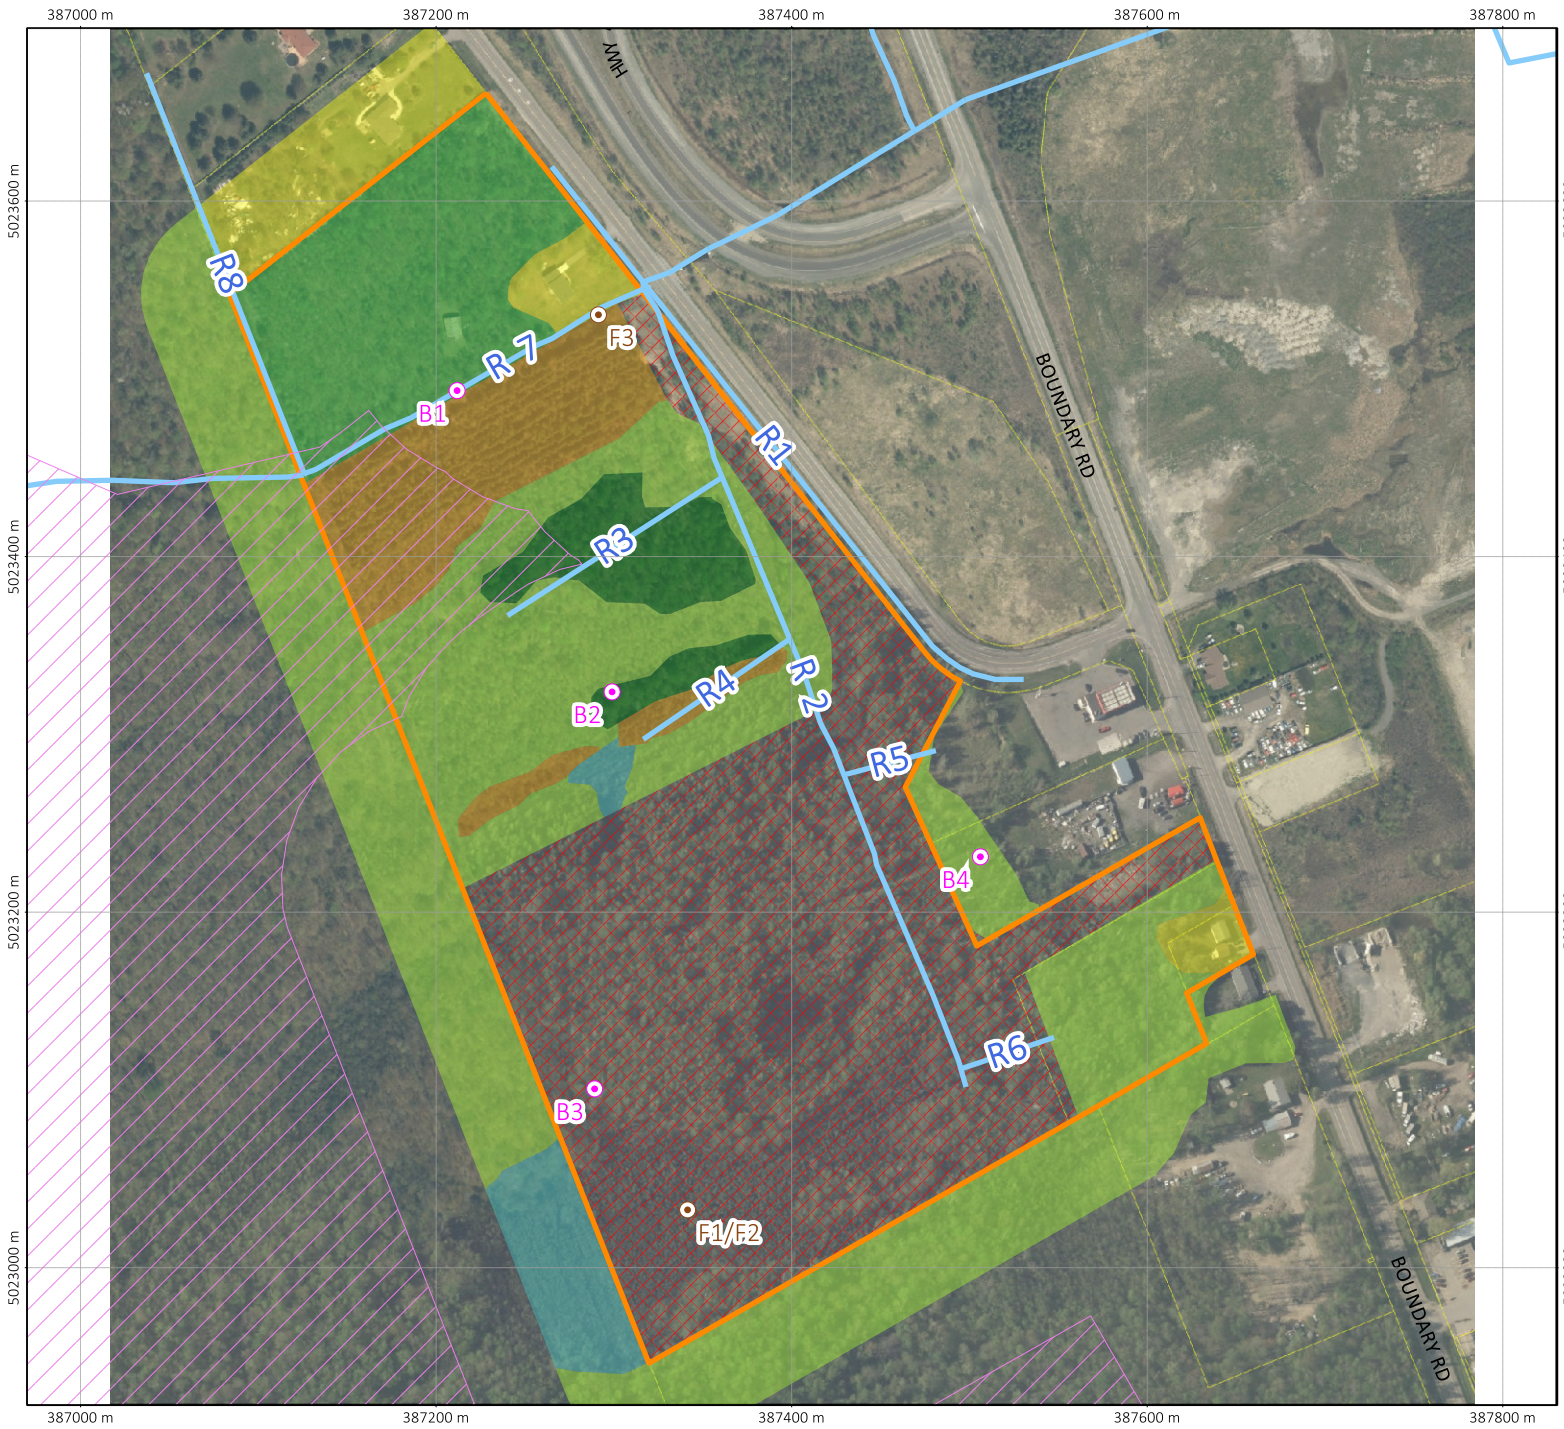
Figure 2 Existing Site conditions

Amphibian surveys were performed on April 23, May 30, and June 21, 2018 (Table 2). Three stations were surveyed in wetland and aquatic habitats (F1 through F3; Figure 2). Station F3 was located at the north
