Environmental Impact Statement and Tree Conservation Report

5494-5510 Boundary Road Ottawa, Ontario

February 15, 2021

Holly Bickerton, BASc, MES

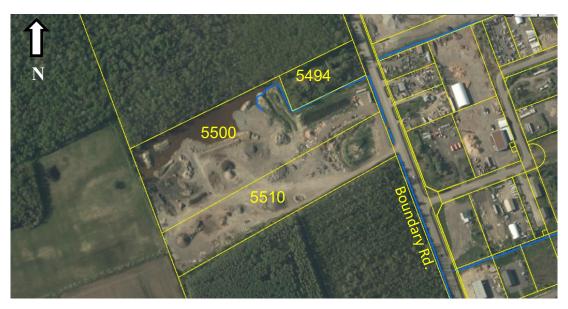
Figure 2 Location of 5494-5510 Boundary Road. Parcel mapping shown in yellow. Source: GeoOttawa Dec. 16 2019, imagery date 2017.

This Environmental Impact Statement and Tree Conservation Report addresses the existing conditions, potential environmental impacts and mitigations for a proposed development at 5495-5510 Boundary Road, Navan, in the City Ottawa (Figure 1). The subject site consists of three properties (Figure 2):

- An identified watercourse along the southern property line of 5494 Boundary Road (Figure 2);
- Potential Significant Woodlands identified to the north and south of the property;
- Unevaluated wetlands identified on the adjacent property to the north;
- Significant Wildlife Habitat as per the Provincial Policy Statement;
- Potential for Species at Risk as per the Ontario Endangered Species Act;

The three lots that constitute the subject site are approximately 8.46 ha in area. They are designated **Rural Natural Feature** (Figure 2) . as a result of a variety of high level/older mapping and study in the 1997 Ottawa Natural Environment and Systems Study (NESS). Despite the site's rezoning and subsequent development in the early 2000s, the two southern lots remain designated as Rural Natural Features and are consequently identified as part of Ottawa's Natural Heritage System. A primary purpose of this EIS is therefore to identify potential for existing natural heritage features on and within

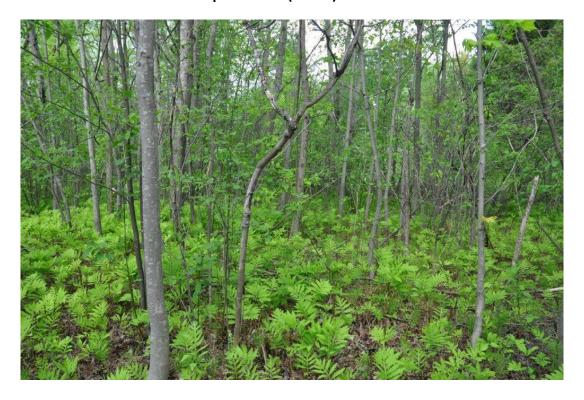
Photo 2. Fresh-Moist Deciduous Poplar Forest (FOD 8)

Fresh-Moist Poplar Deciduous Forest (FOD 8, Photo 2): This mid-successional forest is on the former residential lot at 5494 Boundary Road (northeast corner of site). It is dominated by species characteristic of mesic to moist woodlands (Photo 3). The overstory is dominated by poplars (*Populus grandidentata*, *P. tremuloides*, *P. deltoides*), with Red Maple (*Acer rubrum*), and Green Ash (*Fraxinus pensylvanica*). The forest is approximately ~40-50 years in age (GeoOttawa 2020). Most trees in this community range between 10-20 cm DBH, with three larger Cottonwoods (*P. deltoides*) with DBH ranging around 30 cm. Trees are in generally good health, with the exception of Ash (*Fraxinus* sp.), which are in poor health or dead. The mid-story is dominated by invasive Glossy Buckthorn (*Frangula alnus*), with Speckled Alder (*Alnus incana* ssp. *rugosa*) toward the watercourse. The understory includes a mix of upland species

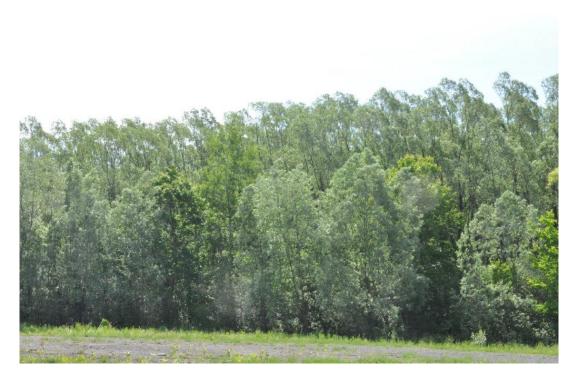
Photo 9. Willow Deciduous Plantation

Willow Deciduous Plantation (Photo 9): This polygon has no ELC code because it is planted and there it is a very unusual vegetation type for which no code exists. It was planted in the 1980s or 1990s in Crack Willow (*Salix* x *fragilis*), a non-native tree willow (GeoOttawa imagery); rows are still apparent within the woodland. The understory has naturalized with mostly native facultative wetland species including Sensitive Fern, Dwarf Raspberry, and Royal Fern (*Osmunda regalis*) and it is considered to be a wetland for this reason, according using OWES criteria. The mid-story is dominated by invasive Glossy Buckthorn (*Frangula alnus*).
