5494, 5500 and 5510 Boundary Road

Environmental Impact Statement

Fisheries Component

April 2021

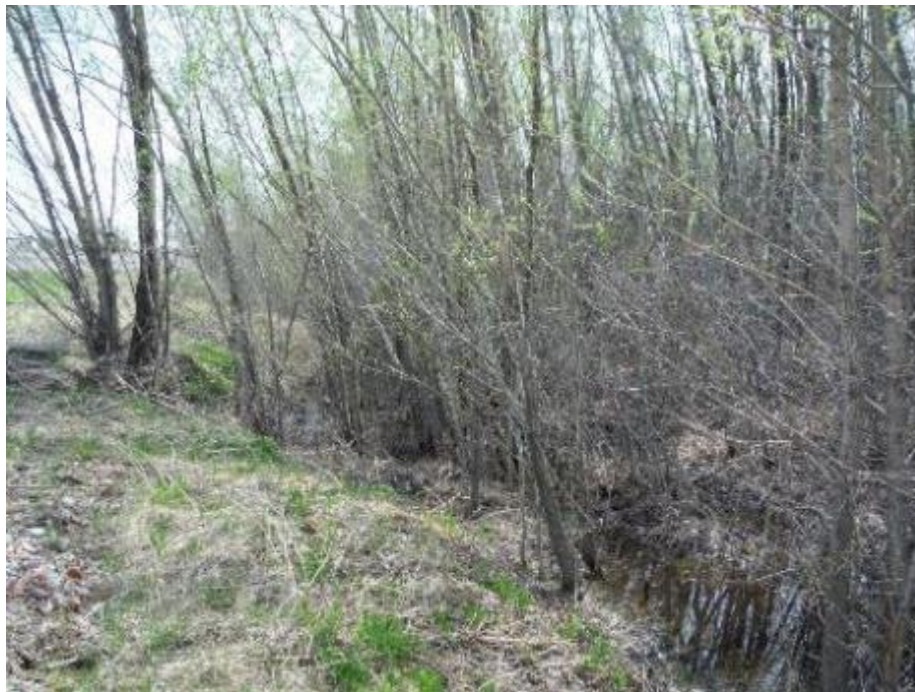
Photo 10: Feature 3b, downstream of station 4, looking upstream (May 17, 2020)

Feature 3b also ran along the southwest perimeter of the site and measured 80 m. This feature contained some water in the spring but was only connected to Feature 4. That feature was isolated from all fish bearing watercourses. No stations were created.

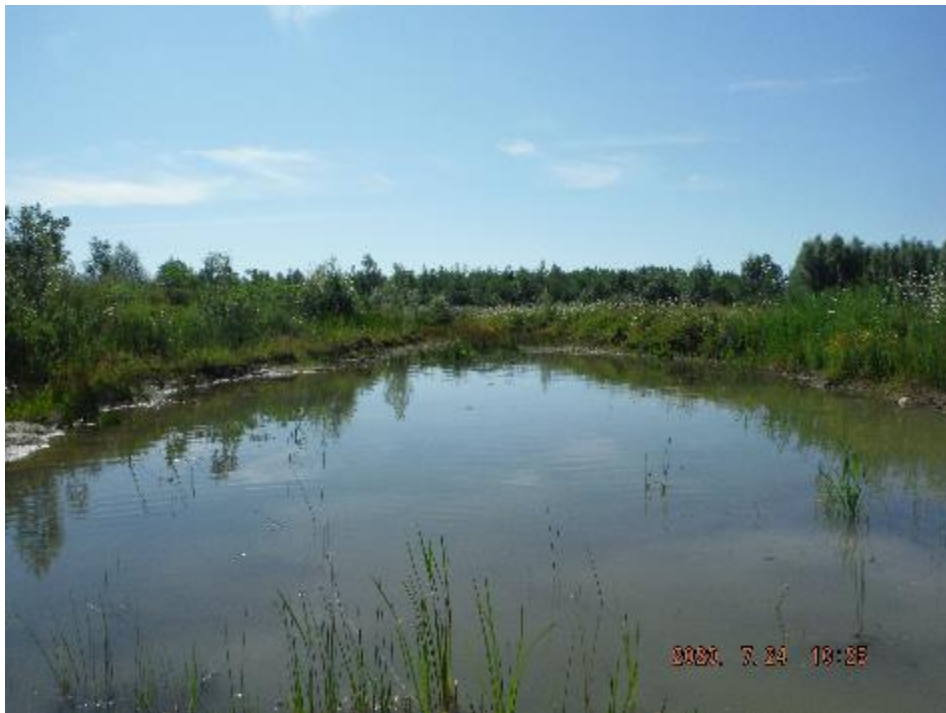
Photo 16; Feature 5 (pond), downstream of station 7, looking south (July 24, 2020)

This station was not sampled in the spring as it shared fish habitat with station 8. The station was sampled in the summer using two hoop nets. Two central mudminnows (length 76 and 90 mm) and three pumpkinseeds (size range: 86 to 89 mm) were captured. A brook stickleback (approximately 15 mm in size) was observed in the water and a painted turtle was also captured in the nets.

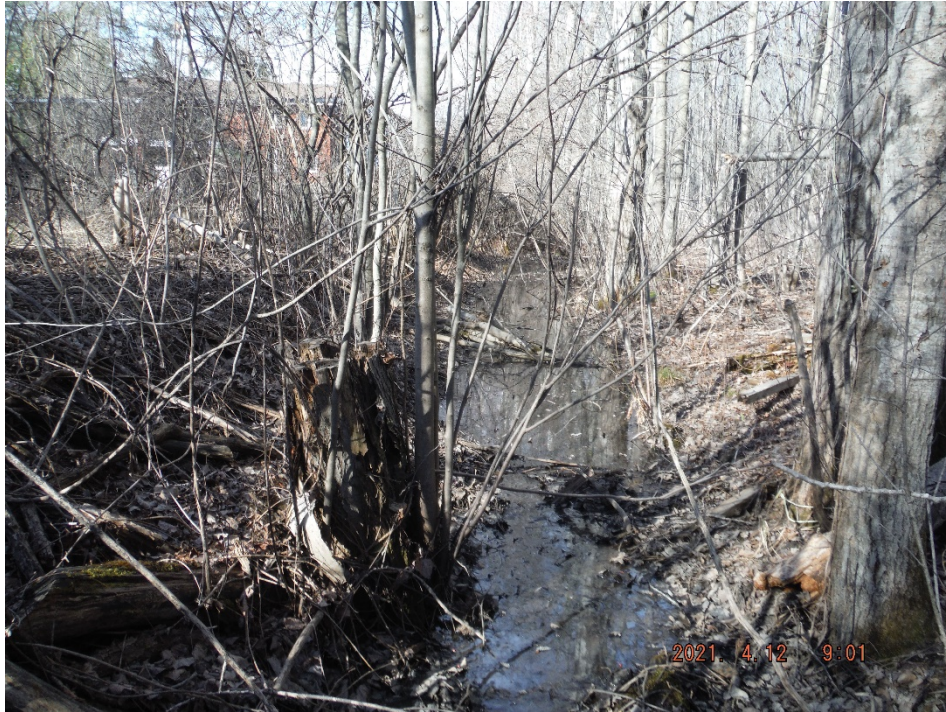
Photo 23: Downstream of the station, looking at the standing water (April 12, 2021)

The substrate consisted primarily of soil (no sorting) and the hydrological flow consisted of standing water (held back by the humps of soil). The in-water cover consisted of leaf litter. The top of the banks was mostly vegetated with trees and shrubs. The station had good canopy cover overall.

During the April 13, 2021 visit, the station was fished using a dipnet over an area of approximately 120 m² (over 50 dipnets). No fish were seen or caught.
