Environmental Impact Statement and Tree Conservation Report

5494-5510 Boundary Road Ottawa, Ontario

> February 15, 2021 Updated November 9, 2021

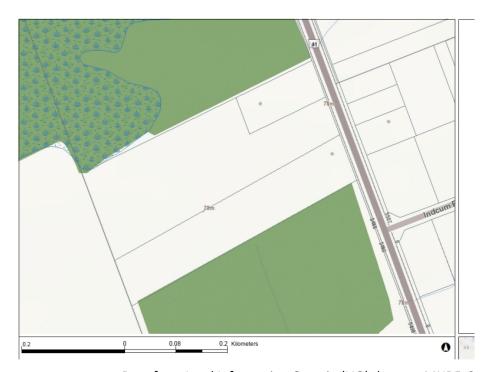
Figure 3 MNRF Wetland mapping. Data from Land Information Ontario (LIO) dataset, MNRF. See unevaluated wetland (open blue at top right) and woodlands north and south of site.

The subject site is directly adjacent to an unevaluated wetland to the north (Figure 3). There are no designated Provincially Significant Wetlands on or adjacent to the site. Woodlands occur to the north and south of the subject site and will be discussed in section 3.6.4 (Figure 3).

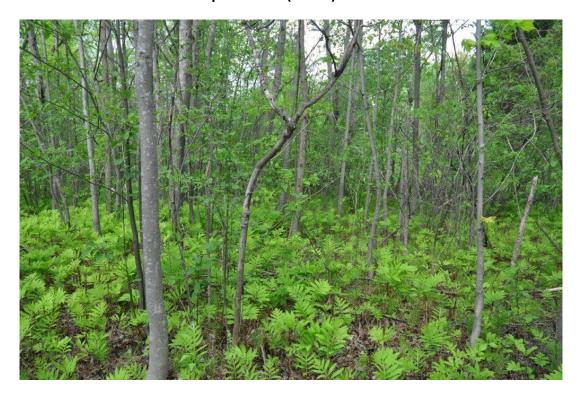
Photo 2. Fresh-Moist Deciduous Poplar Forest (FOD 8)

Fresh-Moist Poplar Deciduous Forest (FOD 8, Photo 2): This mid-successional forest is on the former residential lot at 5494 Boundary Road (northeast corner of site). It is dominated by species characteristic of mesic to moist woodlands (Photo 3). The overstory is dominated by poplars (*Populus grandidentata*, *P. tremuloides*, *P. deltoides*), with Red Maple (*Acer rubrum*), and Green Ash (*Fraxinus pensylvanica*). The forest is approximately ~40-50 years in age (GeoOttawa 2020). Most trees in this community range between 10-20 cm DBH, with three larger Cottonwoods (*P. deltoides*) with DBH ranging around 30 cm. Trees are in generally good health, with the exception of Ash (*Fraxinus* sp.), which are in poor health or dead. The mid-story is dominated by invasive Glossy Buckthorn (*Frangula alnus*), with Speckled Alder (*Alnus incana* ssp. *rugosa*) toward the watercourse. The understory includes a mix of upland species

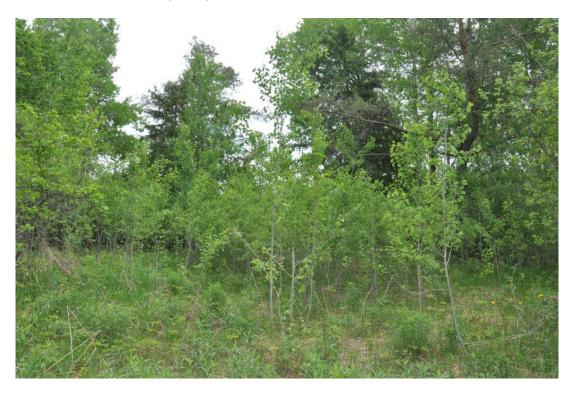
Photo 3. Cultural Woodland (CUW)

Cultural Woodland (CUW, Photo 3): The area near the residence at 5494 Boundary Road was previously cleared, but now consists of 75% cover of naturally regenerating young saplings of Trembling Aspen (*Populus tremuloides*), with remaining landscape plantings such as Blue Spruce (*Picea pungens*) and Eastern White Cedar (*Thuja occidentalis*) (Photo 4). Trees are generally in good health, with the exception of planted Jack Pine which is in moderate health. Invasive Common and Glossy Buckthorn dominate the mid-story. Virginia Creeper (*Parthenocissus inserta*), Frost Grape (*Vitis riparia*) and Common Dandelion (*Taraxacum officinalis*) are common in the understory.

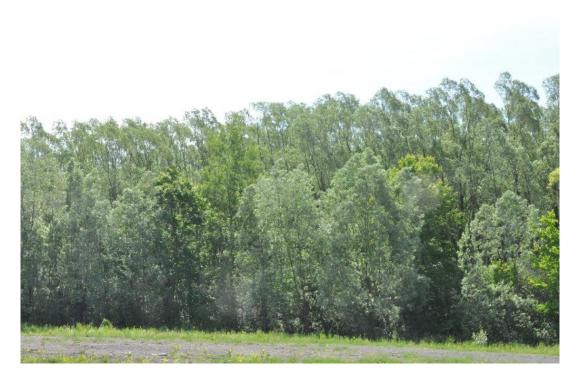
Photo 9. Willow Deciduous Plantation

Willow Deciduous Plantation (Photo 9): This polygon has no ELC code because it is planted and there it is a very unusual vegetation type for which no code exists. It was planted in the 1980s or 1990s in Crack Willow (*Salix x fragilis*), a non-native tree willow (GeoOttawa imagery); rows are still apparent within the woodland. The understory has naturalized with mostly native facultative wetland species including Sensitive Fern, Dwarf Raspberry, and Royal Fern (*Osmunda regalis*) and it is considered to be a wetland for this reason, according using OWES criteria. The mid-story is dominated by invasive Glossy Buckthorn (*Frangula alnus*).
