5494, 5500 and 5510 Boundary Road

Environmental Impact Statement

Fisheries Component

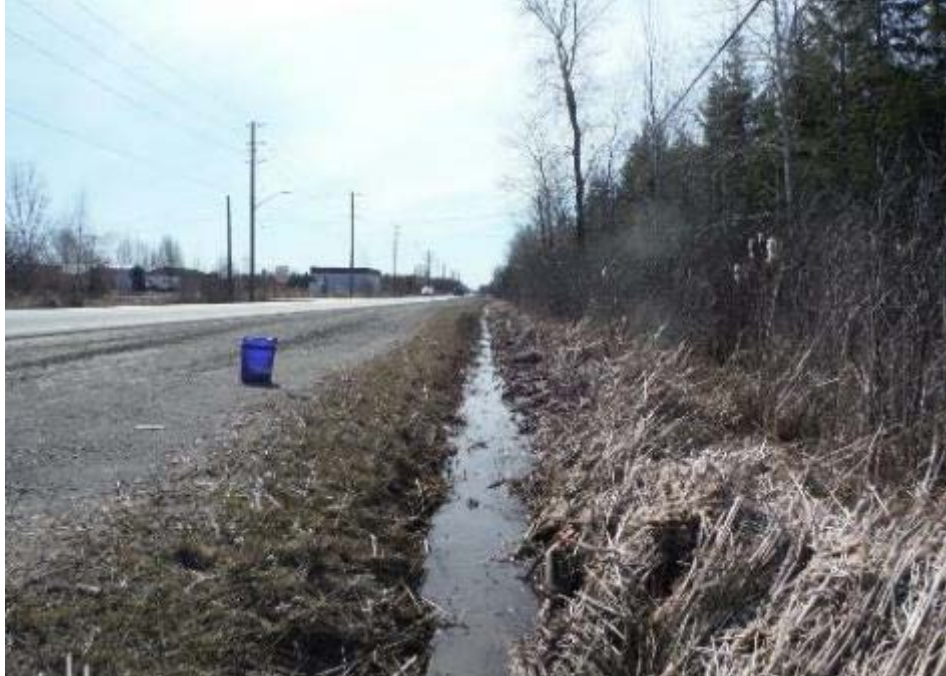
Photo 1: Roadside Ditch, upstream of station 1, looking downstream (April 7, 2020)

The substrate consisted primarily of fines and the stream morphology was a glide. The in-water cover throughout the station was provided mostly by aquatic vegetation (cattails and purple loosestrife), with some overhanging vegetation. The top of the banks was fully vegetated (purple loosestrife, Canada goldenrod, cow vetch, American hog-peanut, bird’s-foot trefoil, glossy buckthorn, and narrow-leaved meadowsweet). There was some glossy buckthorn and trembling aspen on the west bank. Much of the station contained no or poor canopy cover.

During the April 7, 2020 visit, the station was electroshocked over an area of approximately 72 m² for 648 seconds. A total of 5 central mudminnow were captured (size range: 30 – 50 mm). The electrofishing effort was of 9 s/m². No sampling took place during the summer as the station was dry (July 29, 2020).

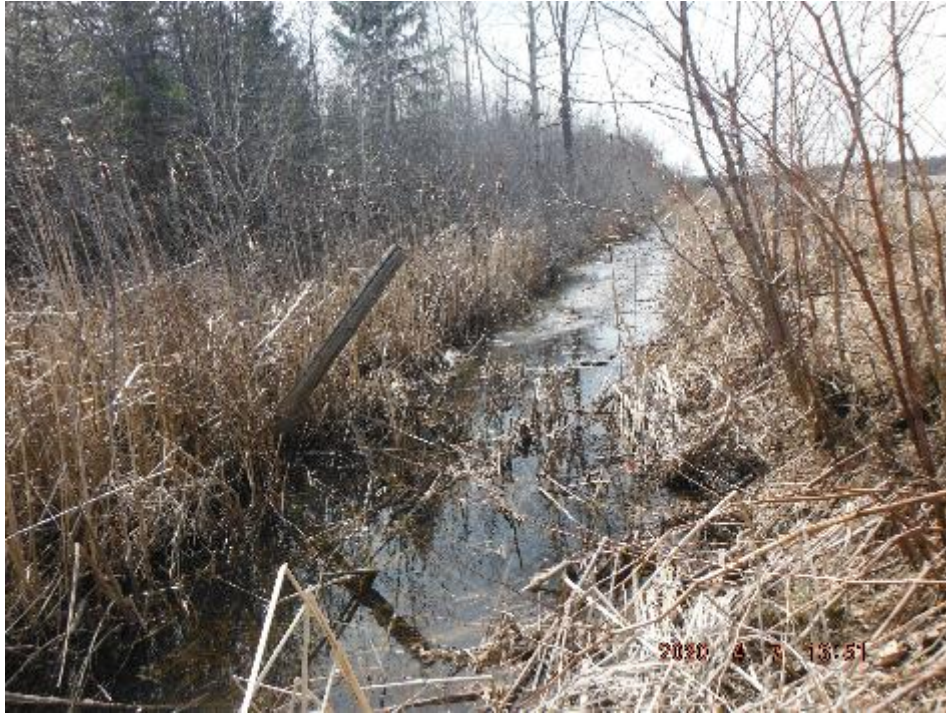
Photo 3: Feature 1a, downstream of station 2, looking upstream (April 4, 2020)

The substrate consisted primarily of fines and the stream morphology was standing water. The in-water cover throughout the station was provided by aquatic vegetation (reed canary grasses, cut-leaved water horehound, lakebank sedge, purple loosestrife, smartweed, broad-leaved cattail, and cow vetch). The top of the banks was fully vegetated (reed canary grass, water horehound, lakebank sedge, purple loosestrife, smart weed, broad-leaved cattails, willow, speckled alder, and glossy buckthorn). Much of the station contained areas of no canopy cover on the north side but was entirely shaded by the dense woody vegetation on the south and inside the channel by the dense common reed.

The area was not fished in the spring because it was covered in snow and ice during the sampling visit. A few days later, when the water melted, it was confirmed to be connected to the Roadside Ditch without any barriers to fish movement along the first 100 m. No sampling took place during the summer as the station was dry (July 29, 2020).

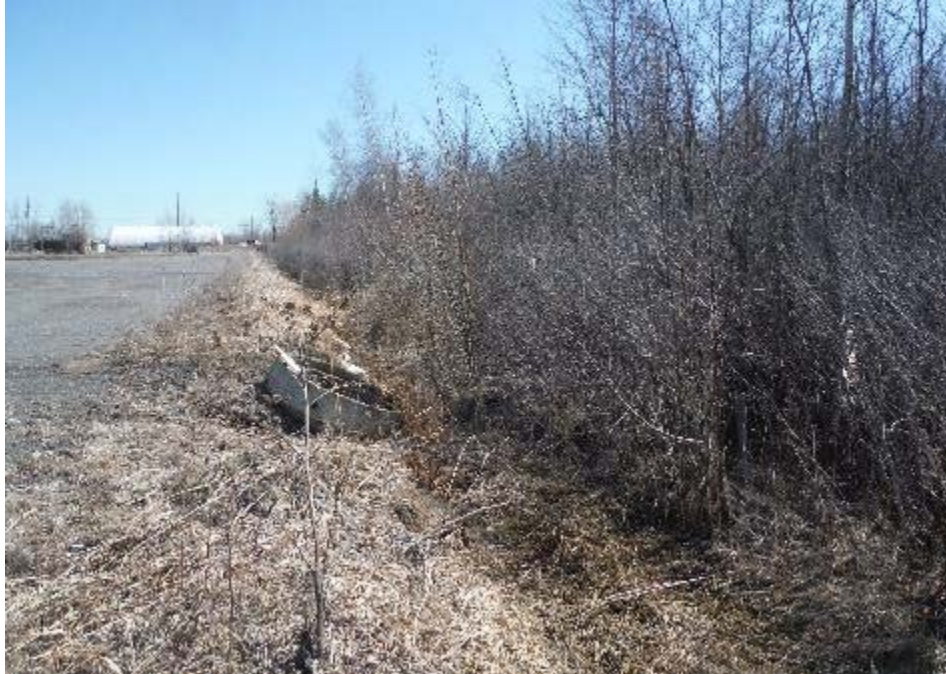
Photo 5: Feature 1b, looking upstream from downstream (April 7, 2020)

The remaining section (labelled as 1b) could direct flow towards feature 2 but it was already dry by April 7, 2020 and as such does not provide fish habitat (Photo 5).

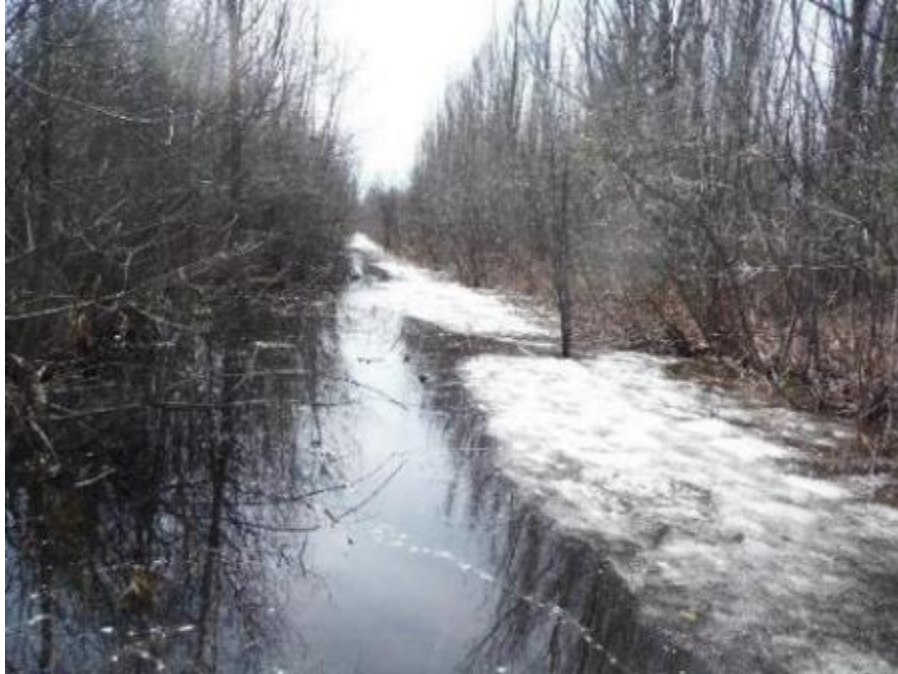
Photo 6: Feature 2, upstream of station 3, looking downstream (April 7, 2020)

The substrate consisted primarily of fines and the stream morphology was a glide. The in-water cover consisted of leaf litter, and large and small woody debris. There was also overhanging vegetation providing some cover. The banks were fully vegetated with trees (red maple and green ash), shrubs (speckled alder and glossy buckthorn) and herbs (purple loosestrife, sensitive fern, broad-leaved cattail, narrow-leaved and tall meadowsweet, and lakebank sedge). Most of the station contained little to no canopy cover.

During the April 7, 2020 visit, the station was electroshocked over an area of approximately 153 m² (1274 seconds). The electrofishing effort was of 8 s/m². A total of 4 central mudminnow

(size range: 28 – 100 mm) and one brook stickleback (45 mm) were captured. In addition, 3 central mudminnows were observed but not captured. No sampling took place during the summer as the station was dry (July 29, 2020)

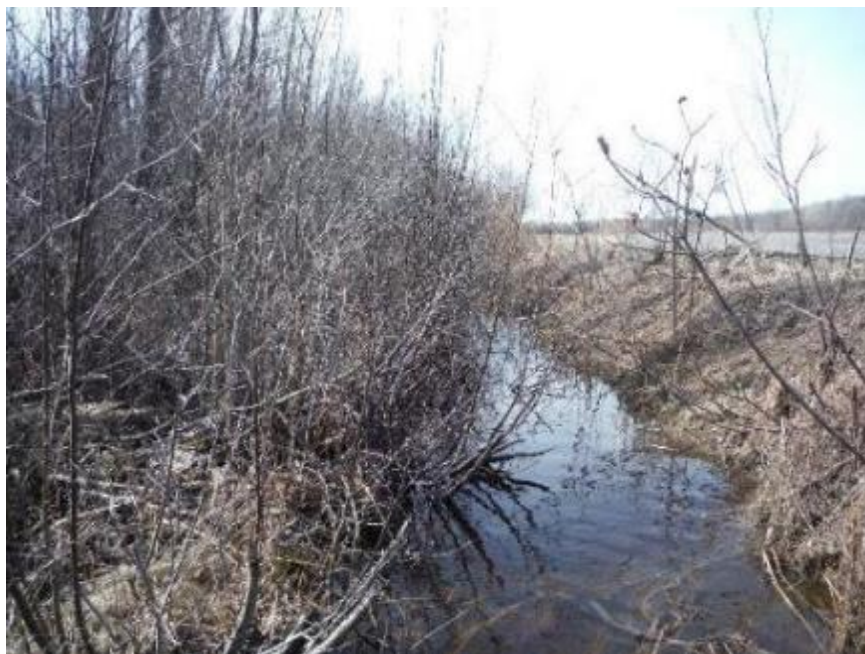
Photo 8: Feature 3a looking upstream from its connection with Feature 2 (April 7, 2020)

The substrate consisted primarily of fines and the stream morphology was a glide. The in-water cover throughout the station was provided by overhanging vegetation, aquatic vegetation, and small wooded debris. The top of the banks was fully vegetated (speckled alder, glossy buckthorn, willow, lakebank sedge, sensitive fern, purple loosestrife, glossy buckthorn, grasses, and horsetail). The left bank was a treed swamp (willow, red maple). Much of the station had complete canopy cover.

The area was not sampled in the spring. Even during the first visit only the downstream 20 m was accessible to fish. The remaining 110 m is not considered fish habitat due to its lack of connectivity with feature 2. No sampling took place during the summer as the station was dry (July 29, 2020).

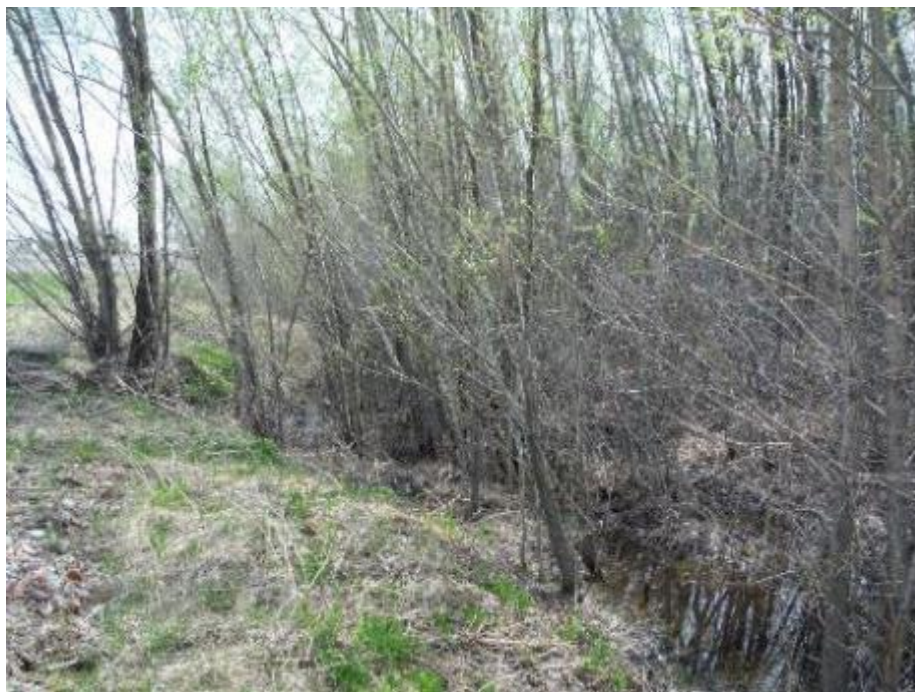
Photo 10: Feature 3b, downstream of station 4, looking upstream (May 17, 2020)

Feature 3b also ran along the southwest perimeter of the site and measured 80 m. This feature contained some water in the spring but was only connected to Feature 4. That feature was isolated from all fish bearing watercourses. No stations were created.

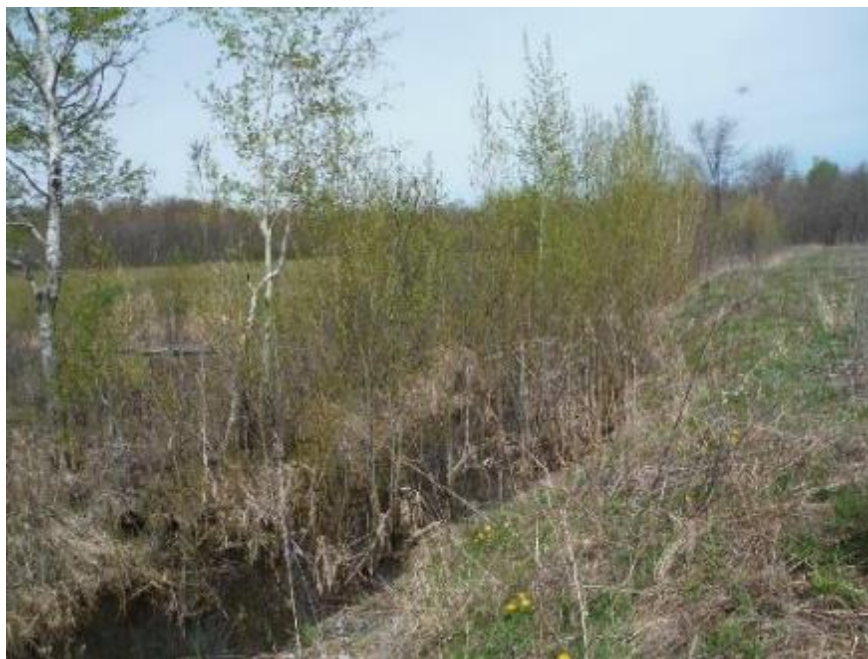
Photo 11: Feature 4, downstream of Station 5, looking upstream (May 17, 2020)

The substrate consisted primarily of fines and the stream morphology was standing water, with a few pools. The in-water cover throughout the station was provided by terrestrial and aquatic vegetation (purple loosestrife, reed canary grass, grasses, purple clover, bird's-foot trefoil, cow vetch, and willows). The top of the banks was fully vegetated (wild carrot, cow vetch, bird's-foot trefoil, sow thistle, glossy buckthorn, trembling aspen, willow, purple loosestrife). Much of the drain had no canopy cover but some had complete cover from the willows growing within the channel.

The area was not sampled in the spring as it was covered in snow. It was then found that it is not fish habitat due to its lack of connectivity with any other features.

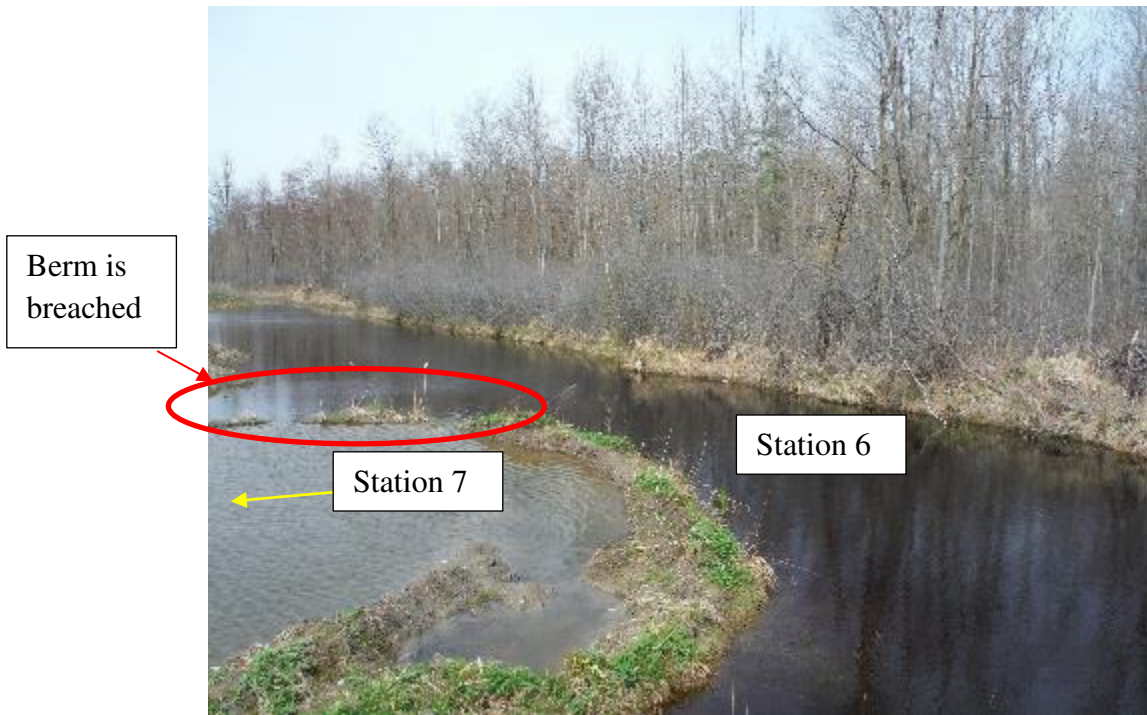
Photo 13: Feature 5 (upper ponds), downstream of station 6, looking upstream (May 17, 2020)

The substrate consisted primarily of fines and the stream morphology was a pool. The in-water cover consisted of aquatic vegetation (algae, water plantain, water plant, grasses, and softstem bulrush) and large woody debris. The banks were mostly vegetated (burweed, stonewort, Joe-pye-weed, wild carrot, sensitive fern, purple loosestrife, broad-leaved cattail, willow, and eastern cottonwood). The cottonwood was young (regenerating) and did not provide canopy cover. Most of the station contained little to no canopy cover.

This station was not sampled in the spring as it shared fish habitat with station 8 and is considered fish habitat (see species list from station 8). In the summer, this station was dip

netted. One central mudminnow (36 mm) and approximately 60 common shiners (size range: 15-30 mm) were captured. Several other small minnows were observed but not captured.

The entire pond was 75 m in length and Station 7 was placed in the permanent habitat (northern 35 m). The average channel width was 10.9 m and the average bankfull height 46 cm. The spring wetted width and depth were 7.0 m and 80 cm, respectively. In the summer, the southern 44 m in length of the pond was dry. The remainder had a summer average wetted width and depths of 6.7 m and 33 cm, respectively. A seasonal barrier to fish movement was found on the northern edge of this pond. This berm was overtopped during the spring. In the summer, the soil berm created a seasonal barrier and was 49 cm high (Photo 13).

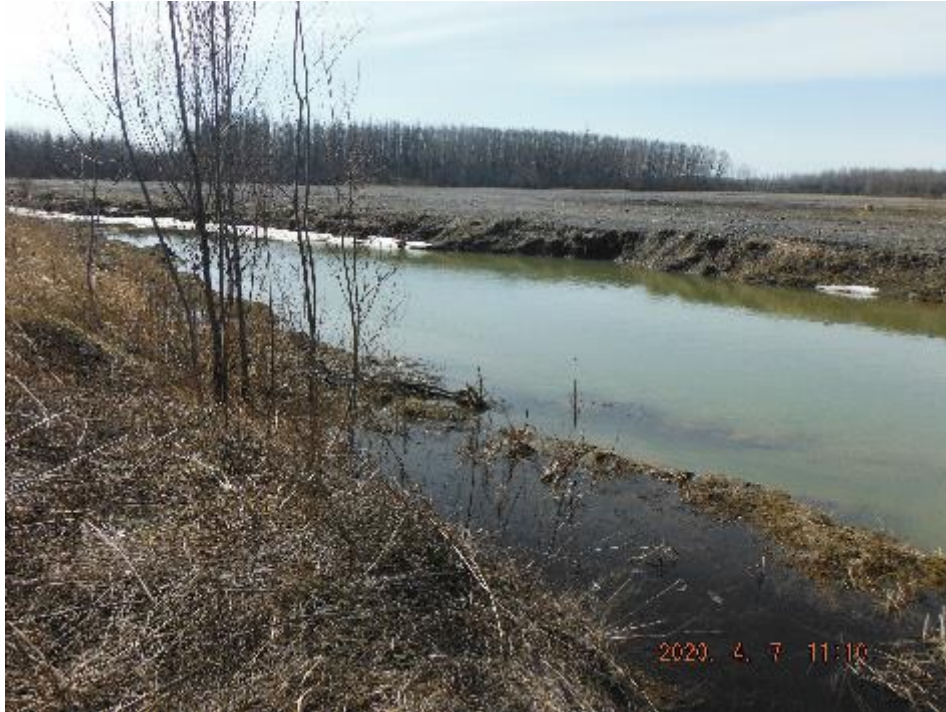
Photo 15: Feature 5 (pond), downstream of station 7, looking southwest (April 7, 2020)

The substrate consisted of fines and the stream morphology was a pond. The in-water cover consisted of aquatic vegetation (softstem bulrush, narrow-leaved cattail, purple loosestrife, stonewort, common reed, water plantain, and woolgrass). The banks were mostly vegetated (willow, common reed, wild carrot, sensitive fern, common vetch, narrow-leaved cattails, and purple loosestrife). The station contained no canopy cover.

This station was not sampled in the spring as it shared fish habitat with station 8. The station was sampled in the summer using two hoop nets. Two central mudminnows (length 76 and 90 mm) and three pumpkinseeds (size range: 86 to 89 mm) were captured. A brook stickleback (approximately 15 mm in size) was observed in the water and a painted turtle was also captured in the nets.

4. Relocation of Feature 5 (including its ponds).
 - a. Design of this habitat is pending.
 - b. It is noted that the current configuration of the habitat is not desirable as the shallow hot water in the summer is likely resulting in fish traps.

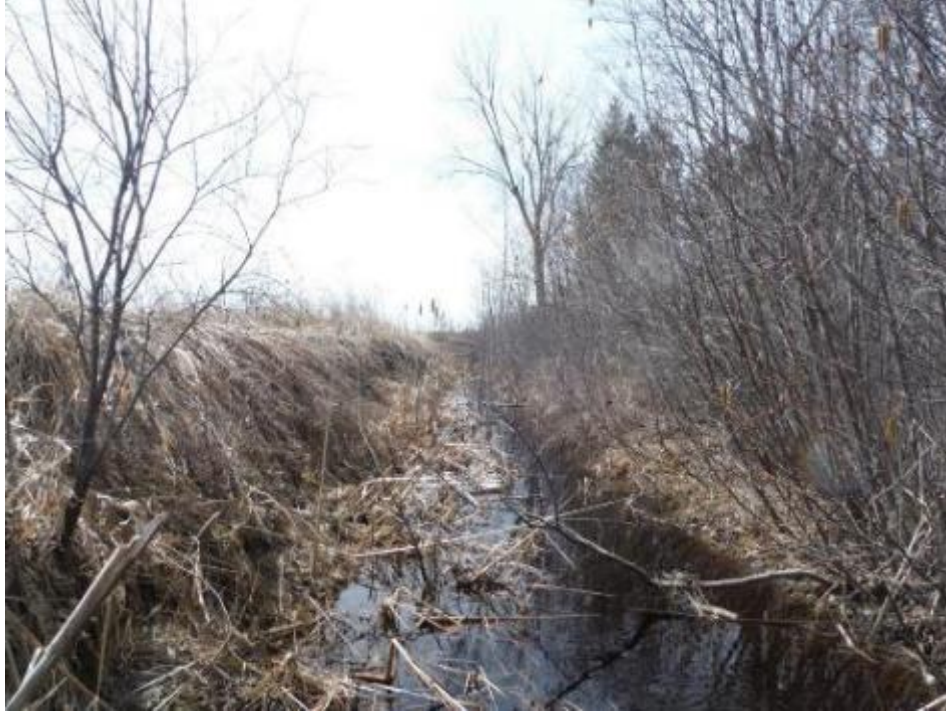
Photo 17: Feature 5 (ditch), downstream of station 8, looking upstream (April 7th, 2020)

The substrate consisted primarily of fines and the hydrological flow was a glide. The in-water cover consisted of aquatic vegetation (narrow-leaved cattail, and purple loosestrife). The top of the banks was mostly vegetated with grasses and shrubs (goldenrod, cow vetch, willows, Manitoba maple, and sensitive fern). Most of the station contained areas of good canopy cover.

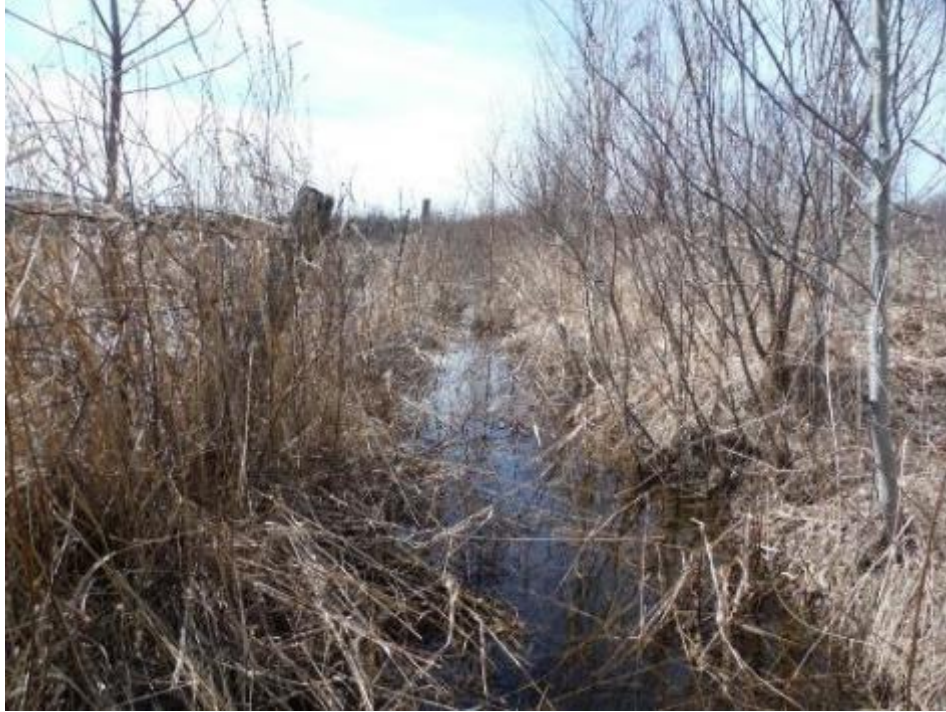
Photo 19: Feature 6, downstream of station 9, looking upstream (April 7th, 2020)

The substrate consisted primarily of fines and the hydrological flow habitat consisted of glide. The in-water cover consisted mostly of aquatic vegetation (purple loosestrife), with some overhanging vegetation (goldenrod, reed canary grass, willow, glossy buckthorn). The top of the banks was fully vegetated with grasses and shrubs (goldenrod, reed-canary grass, willow, glossy buckthorn, and trembling aspen). Most of the station contained areas of poor canopy cover. There was erosion throughout the station.

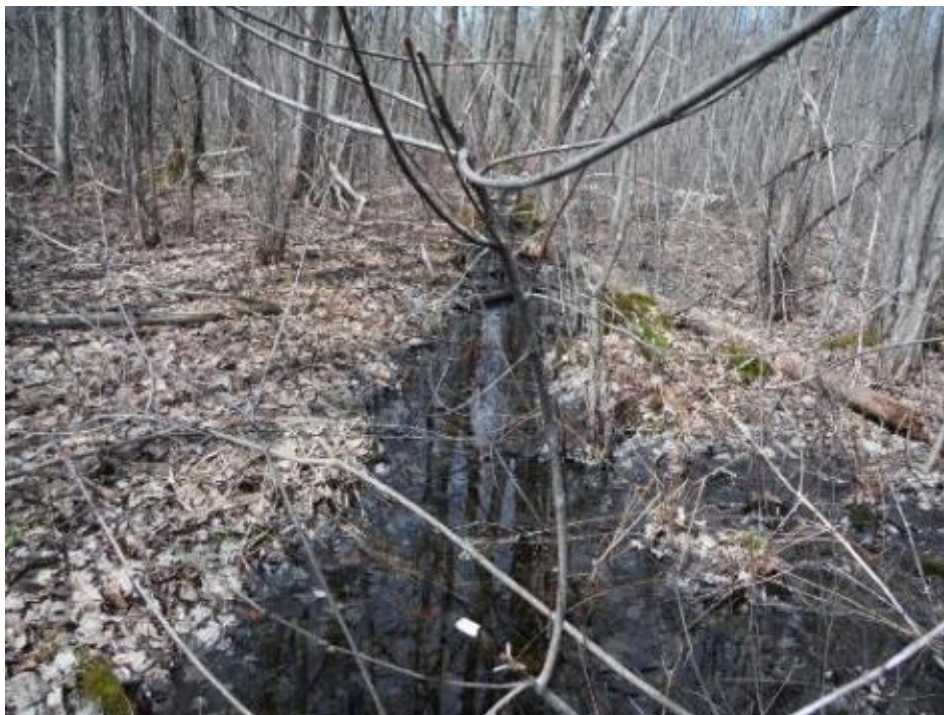
Photo 21: Feature 7, upstream of station 10, looking downstream (April 7th, 2020)

Information was collected from a shallow ephemeral swale without defined banks located immediately north of the site, in the forest. There was no connection with Feature 5 (flow went through the bank, not exit location was found).

The substrate consisted primarily of soil (no sorting) and the hydrological flow consisted of glide. The in-water cover consisted of leaf litter. The top of the banks was mostly vegetated with trees and shrubs. The station had good canopy cover overall.

During the April 7, 2020 visit, the station was fished using a dipnet over an area of approximately 55 m² (50 dipnets). No fish were seen or caught. No sampling took place during the summer as the station was dry (July 29, 2020).

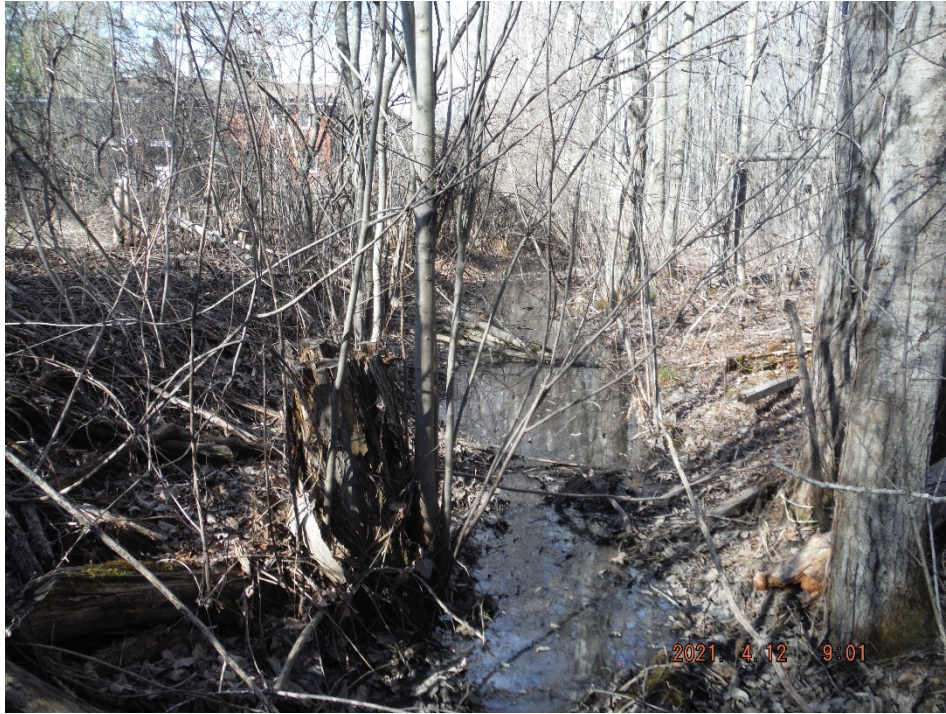
Photo 23: Downstream of the station, looking at the standing water (April 12, 2021)

The substrate consisted primarily of soil (no sorting) and the hydrological flow consisted of standing water (held back by the humps of soil). The in-water cover consisted of leaf litter. The top of the banks was mostly vegetated with trees and shrubs. The station had good canopy cover overall.

During the April 13, 2021 visit, the station was fished using a dipnet over an area of approximately 120 m² (over 50 dipnets). No fish were seen or caught.

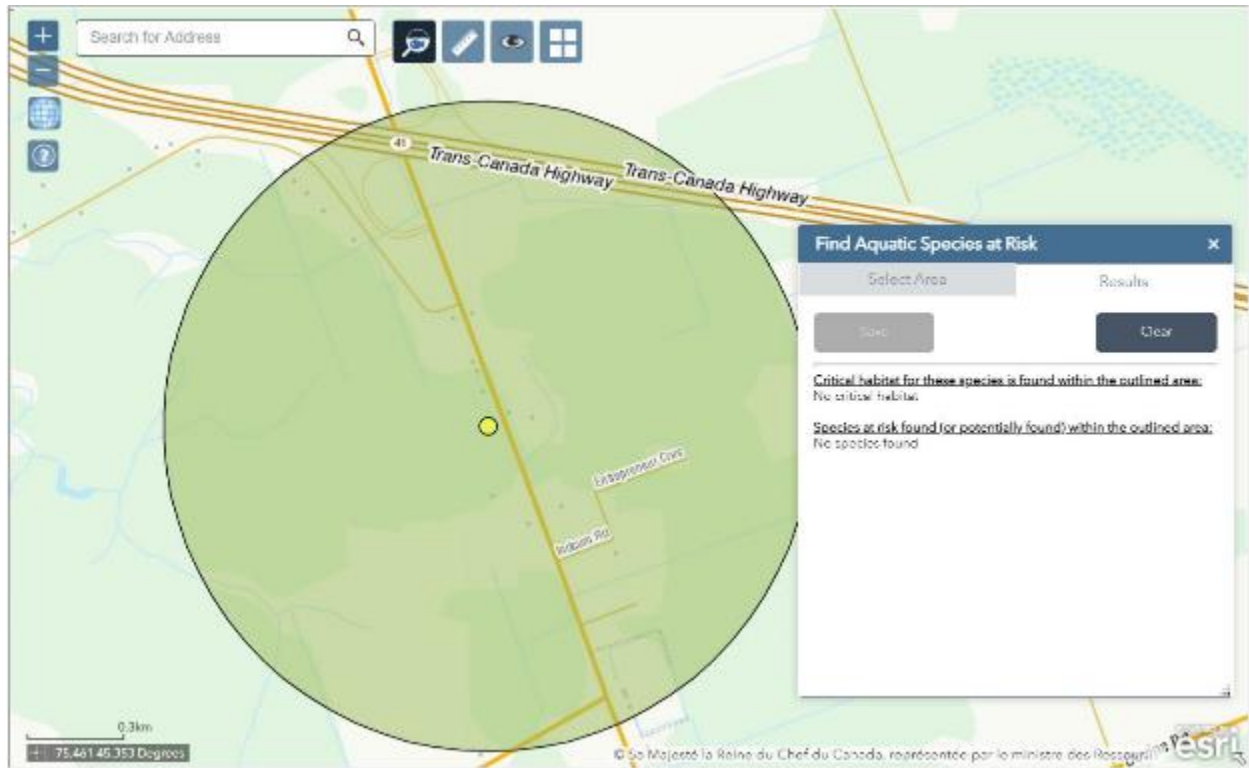
Appendix A: DFO Species at Risk Mapping

There are no known occurrences of aquatic (fish or mussel) species at risk listed in the consultant's report or on LIO. This is supported with the DFO Aquatic Species at Risk Map (on-line mapping accessed March 31, 2020) (Appendix A).
