Phase I - Environmental Site Assessment

1649 Montreal Road & 741 Blair Road Ottawa, Ontario

Report: PE5061-1

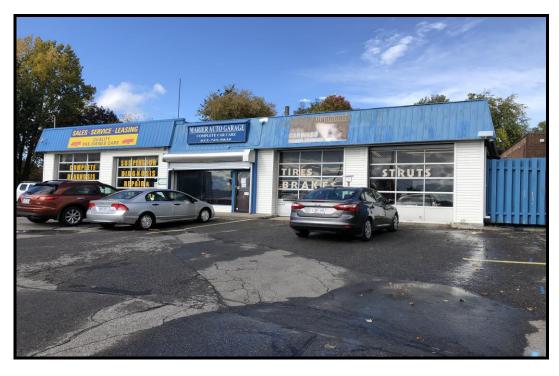
Photograph 1: View of the auto service garage located at 1649 Montreal Road, facing north from Montreal Road.

The property addressed 1649 Montreal Road is currently occupied with a one (1) storey, slab-on-grade style auto service garage. Built sometime in the early 1960's, with the western maintenance bay later added in the early 2000's, the garage is constructed with a poured concrete foundation and is finished on the exterior with metal siding and a flat tar-and-gravel style roof. The building is currently heated via a natural gas-fired heating unit, suspended from the interior ceiling.

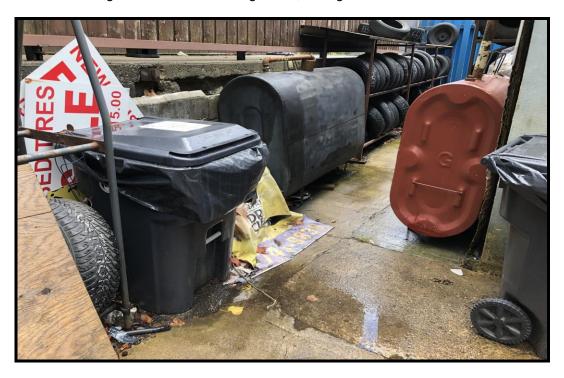
Photograph 6: View of two (2) aboveground waste oil storage tanks, located on the rear exterior of the auto service garage, facing south.

Two (2) aboveground waste oil storage tanks were identified at the rear of the garage building at 1649 Montreal Road. Both tanks, manufactured in 2000, were noted to be constructed with a single 2 mm thick steel wall and contain a capacity for 910 L of waste oil. The tanks were noted to be in good condition, with no signs of leaks or staining observed at the time of the site inspection. The underlying ground surface, consisting of poured concrete, was also noted to be in good condition at the time of the site inspection, with no signs of cracks visible. The presence of these waste oil tanks is considered to represent APECs with respect to the subject site.

Two (2) 900 L waste oil storage tanks were also observed on the exterior of the auto service garage at 1649 Montreal Road. The tanks were noted to be in good condition, with no obvious signs of leaks or staining observed within their vicinity. According to the current property owner, Mr. John Goveat, the waste oil is reportedly collected and disposed of off-site by a licensed contractor as needed.
