McKINLEY
ENVIRONMENTAL
SOLUTIONS

Combined Environmental Impact Statement &
Tree Conservation Report
400 Hunt Club Road, Ottawa, Ontario

May 2021

Prepared for Novatech Engineers, Planners, and Landscape Architects

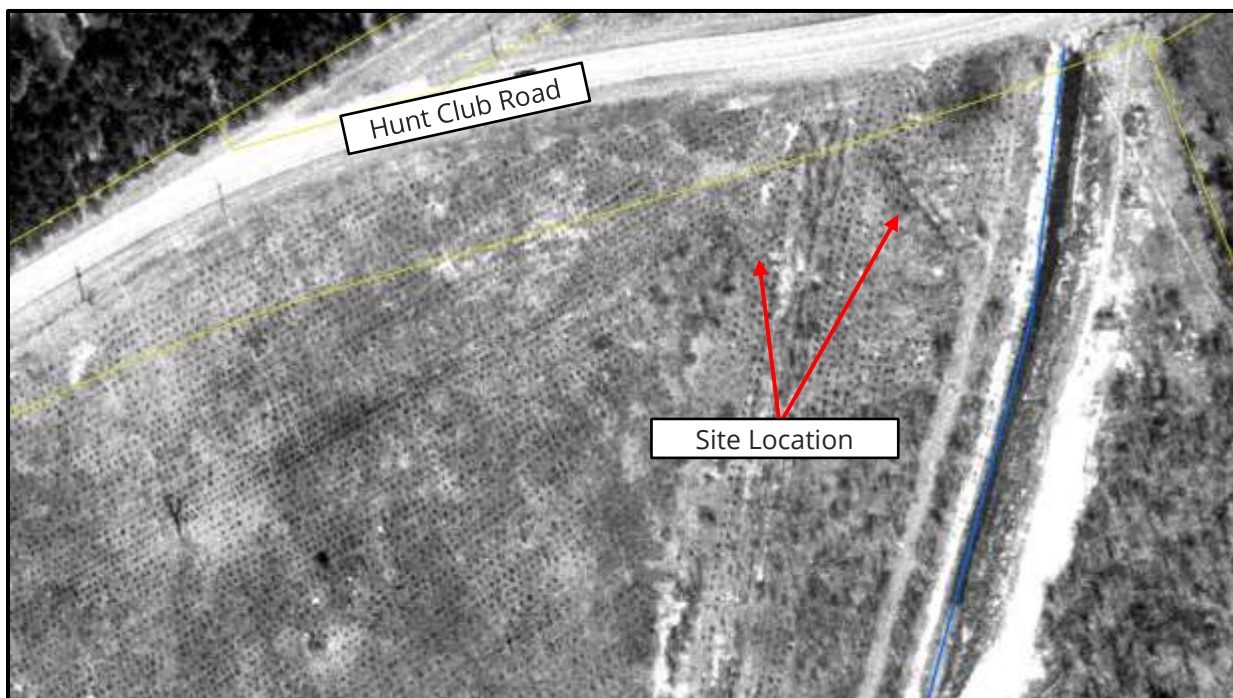
Historic Air Photograph 1: Historic Air Photo from 1965. As shown in the 1965 air photo, the Site was recently planted with Red Pines at that time. This suggests that the Red Pine Plantation is approximately 55 years of age (Photo from City of Ottawa 2020).

An air photo from 1965 is included below. As shown in the 1965 air photo, the Site was recently planted with Red Pines at that time. This suggests that the Red Pine Plantation is approximately 55 years of age (Photo from City of Ottawa 2020).
