Geotechnical - Existing Conditions Report

East Urban Community Mixed Use CDP
Mer Bleue Road
Ottawa - Ontario

July 7, 2019

Report: PG3130-2 Revision 2

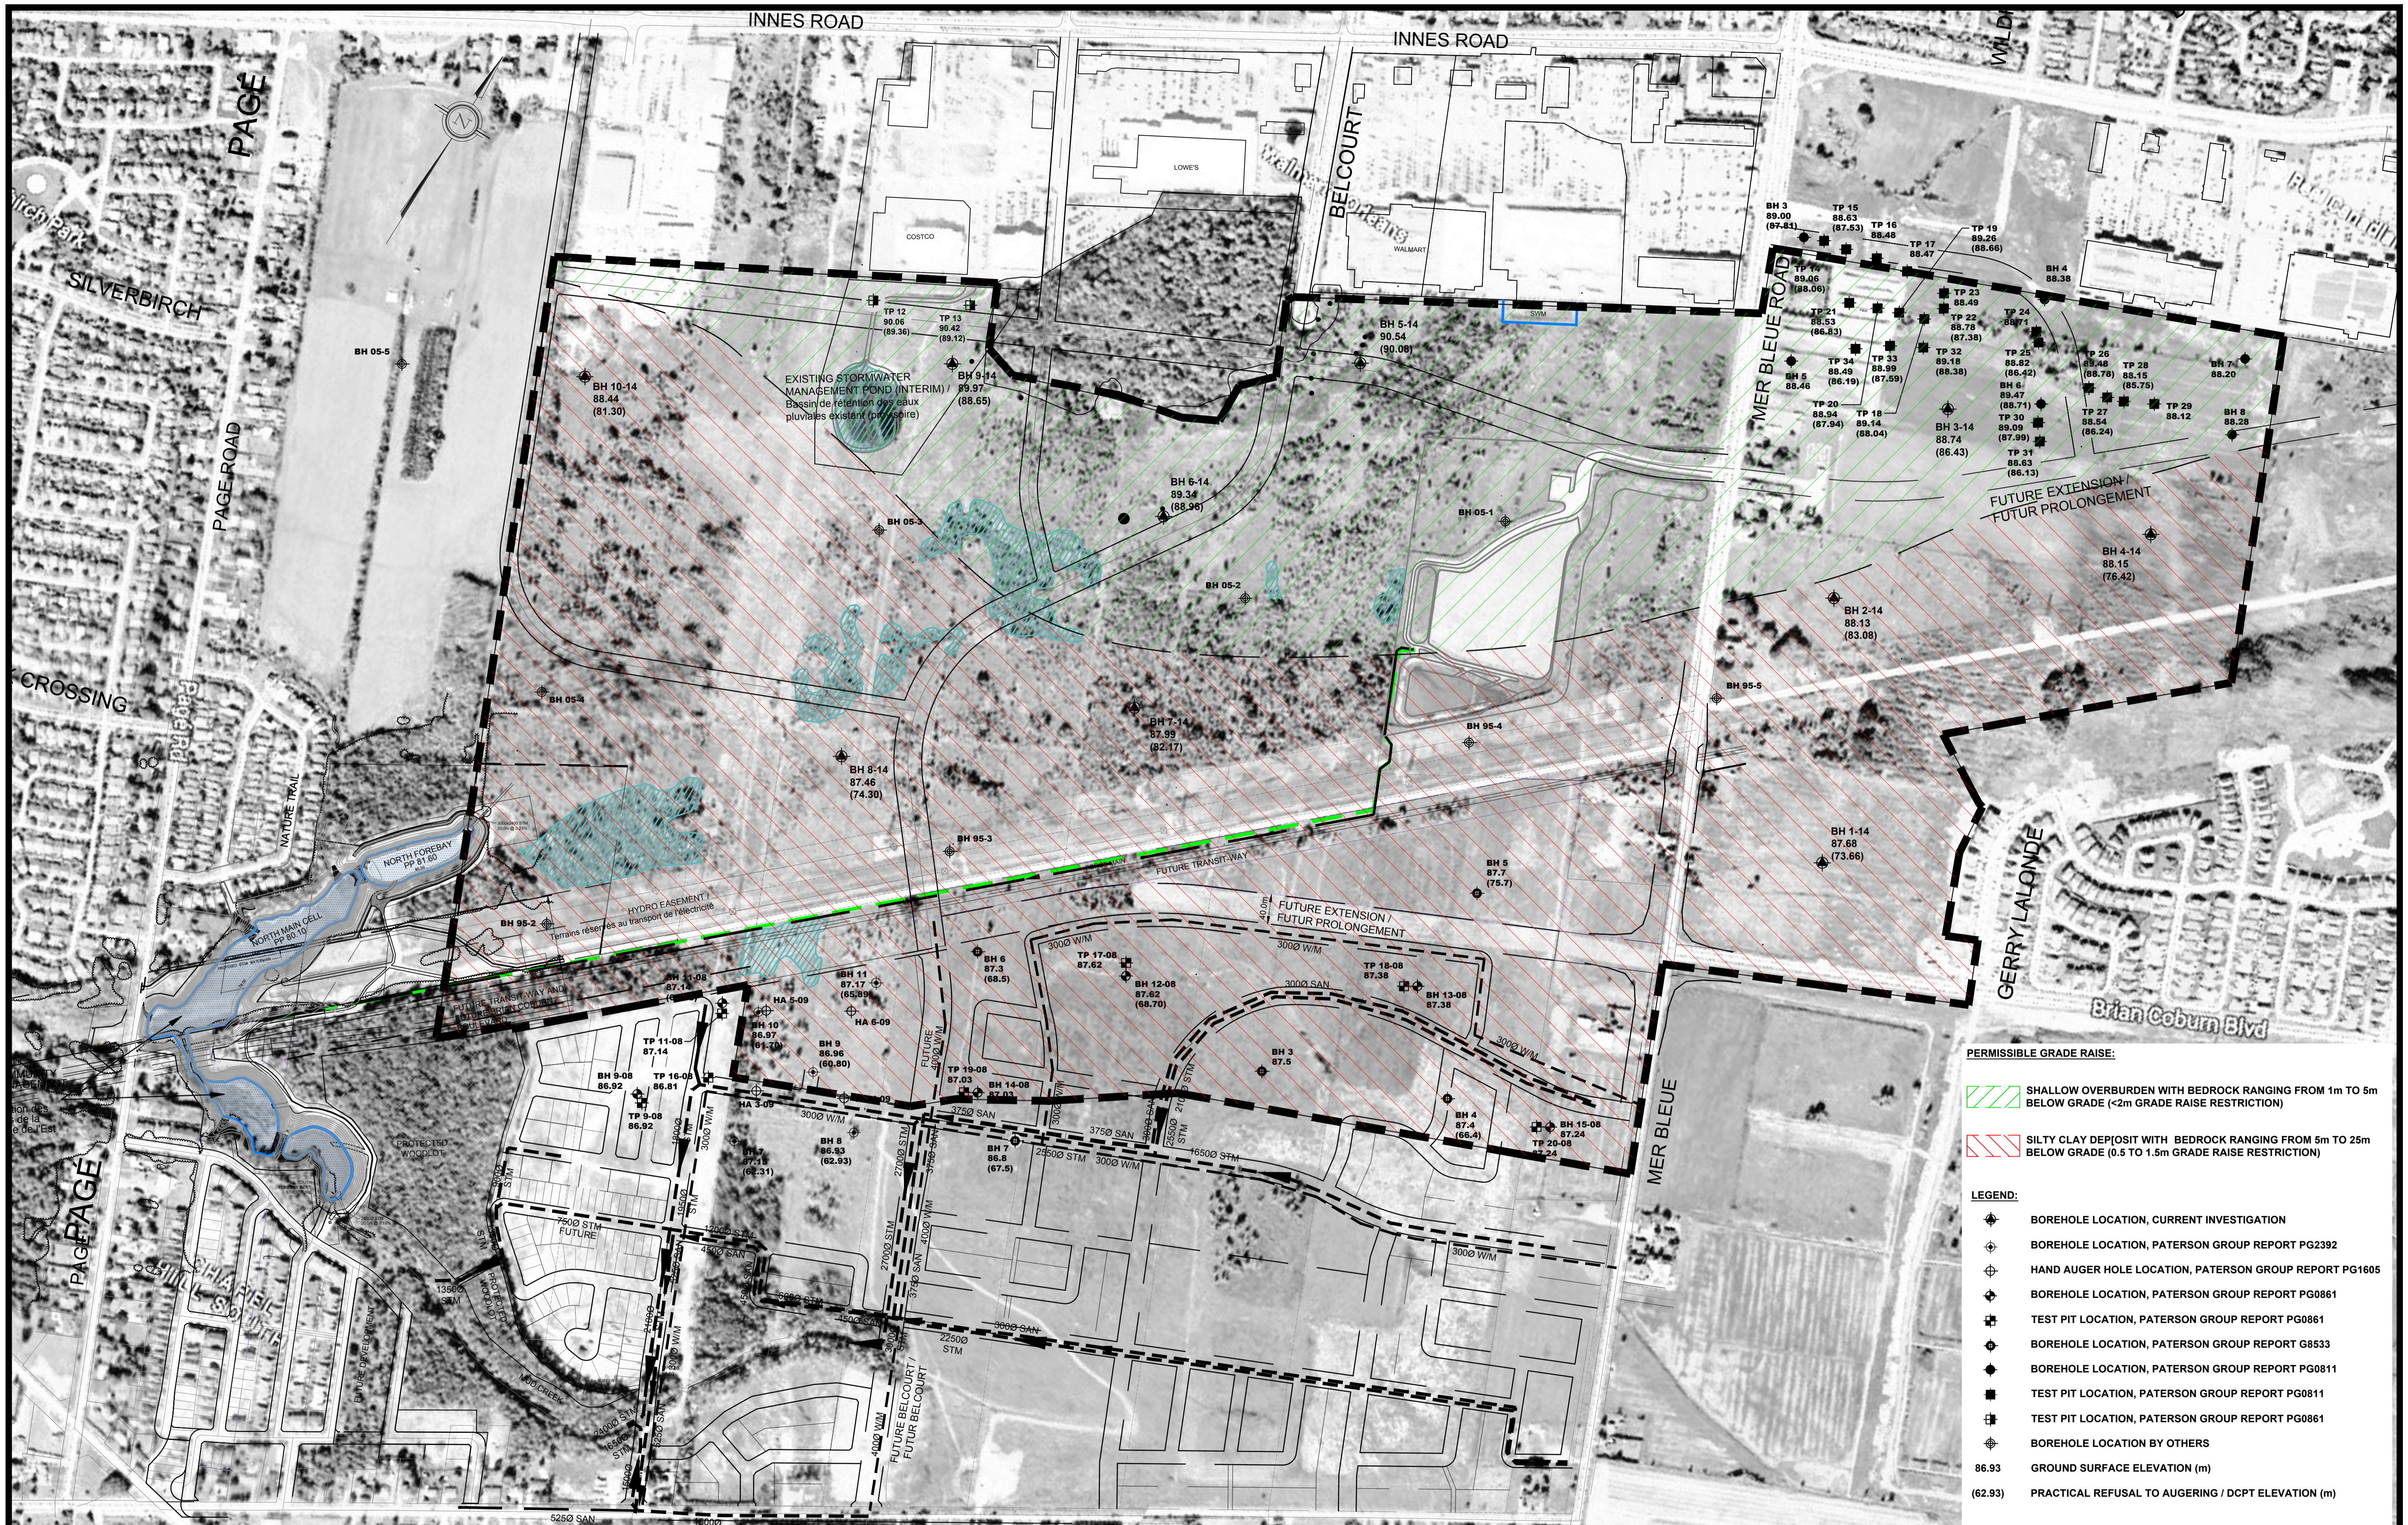
DRAWING PG3130-7 - PERMISSIBLE GRADE RAISE PLAN

Preliminary permissible grade raise recommendations have been designed based on the existing soils information. The recommended permissible grade raise areas are presented in Drawing PG3130-7 - Permissible Grade Raise Plan in Appendix 2. If higher than permissible grade raises are required, preloading with or without a surcharge, lightweight fill and/or other measures should be investigated to reduce the risks of unacceptable long-term post construction total and differential settlements.

The recommended permissible grade raise areas for buildings are defined in Drawing PG3130-7 - Permissible Grade Raise Plan in Appendix 2.

Where the grade raise is close to, but below, the maximum permissible grade raise, consideration should be given to using more reinforcement in the design of the foundation (footings and walls) to reduce the risks of cracking in the concrete foundation. The use of control joints within the brick work between the garage and basement area should also be considered.
