Site Servicing and Stormwater
Management Brief – Mooney's Bay -
729 Ridgewood Avenue, Ottawa, ON

File: 160410536/83

June 9, 2021

Stantec Consulting Ltd.

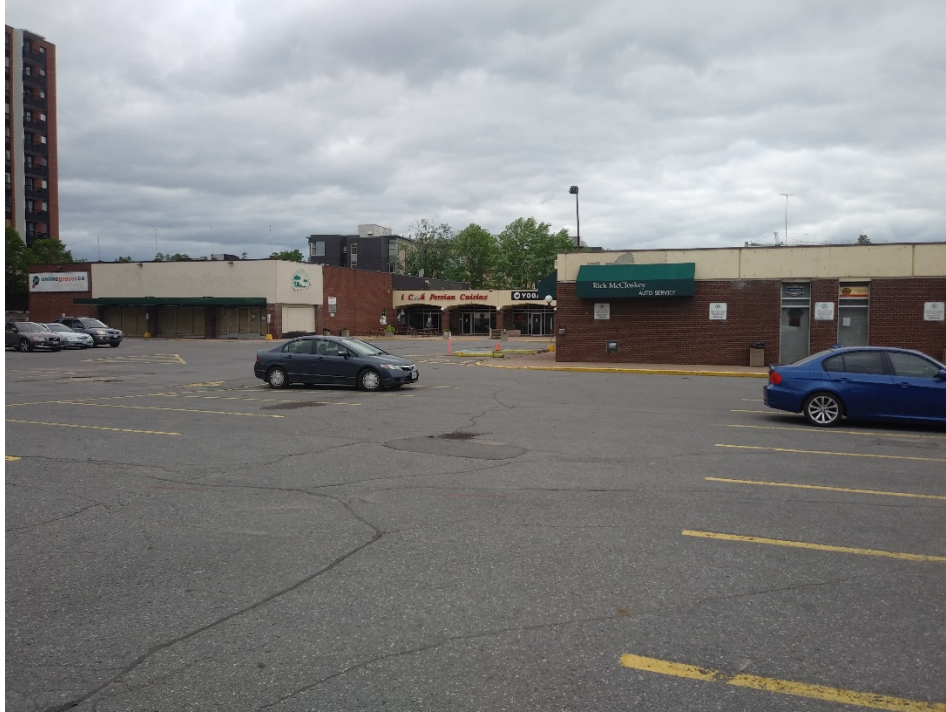
Photograph 1: View of Phase One Property looking north from Ridgewood Drive. View shows the north (right side) and south (left side) commercial buildings at the Property. The automotive service garage is visible in this view.

The presence of an active automotive service garage was observed during the site walk over on the central portion of the Phase One Property at the time of the Site Investigation. Although this garage has only been operating for a short time period (2018 to present), these operations are a PCA which represents an APEC for the Property. Based on the observations at this automotive garage, that contaminants of potential concern are considered to be PHCs and BTEXs.

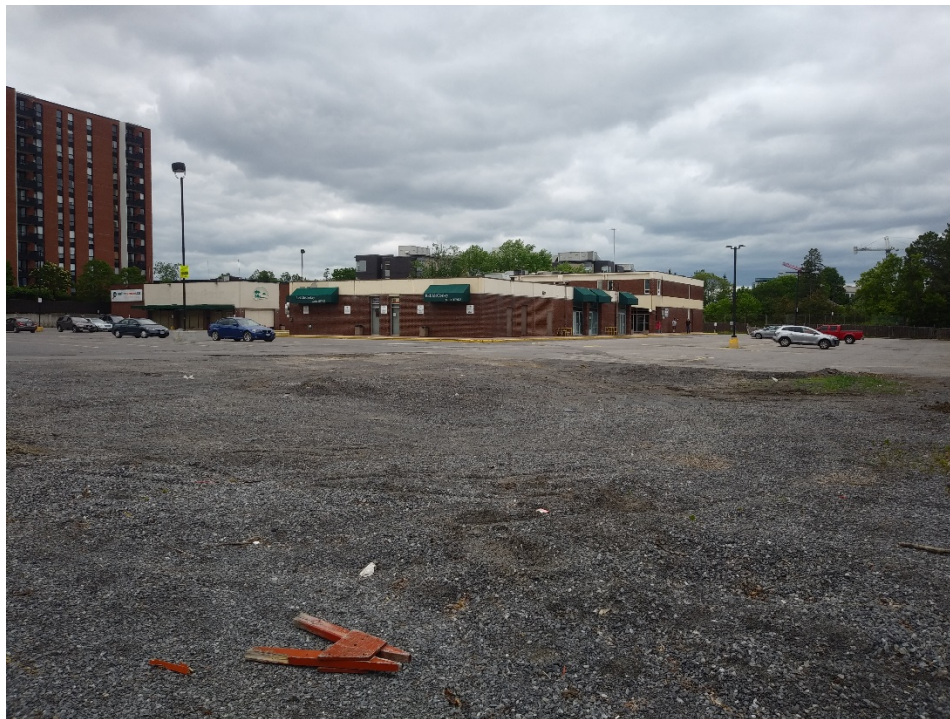
Photograph 2: View of Phase One Property looking northwest southeast corner of the Property. View shows former retail fuel outlet and automotive garage area in the southeast portion of the Site which has been backfilled with granular fill. The commercial buildings are also visible in this view.

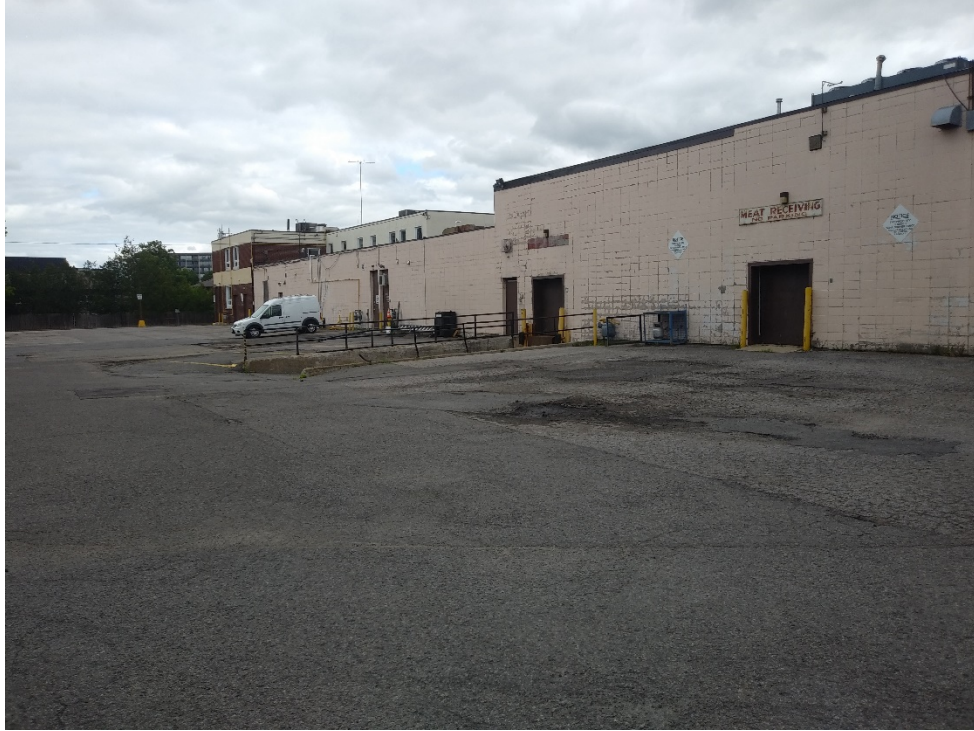
Photograph 3: View of the north side of the Phase One Property looking southeast. View shows the north side of the north commercial building, including the loading dock for the former grocery store and the natural gas meters for the commercial units.

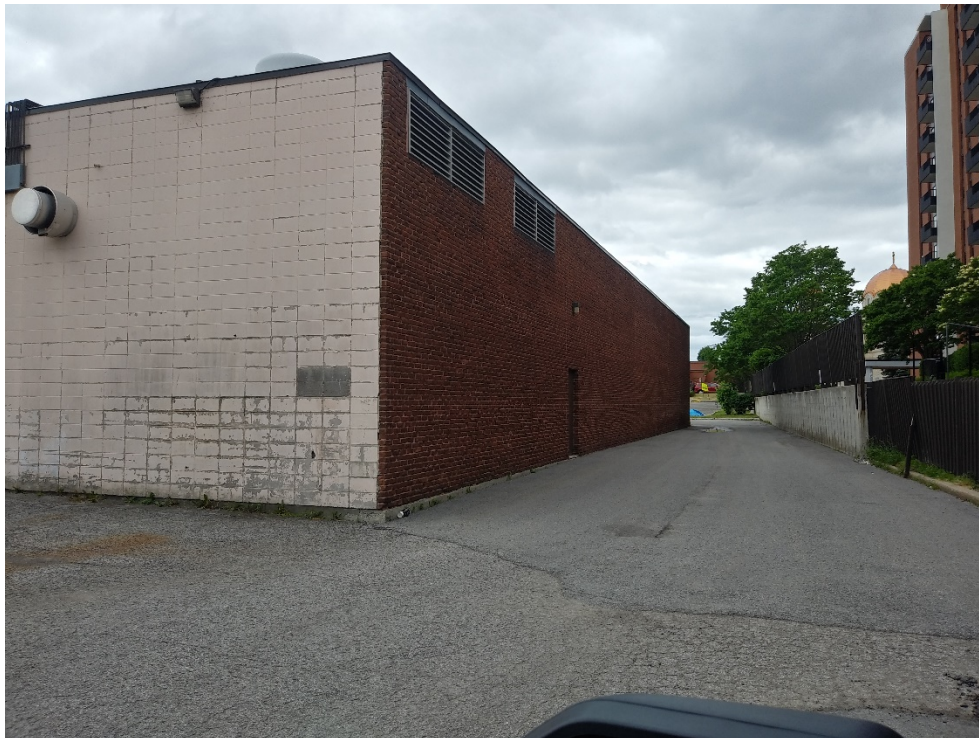
Photograph 4: View of the west side of the Phase One Property looking south. View shows the west side of the north commercial building.

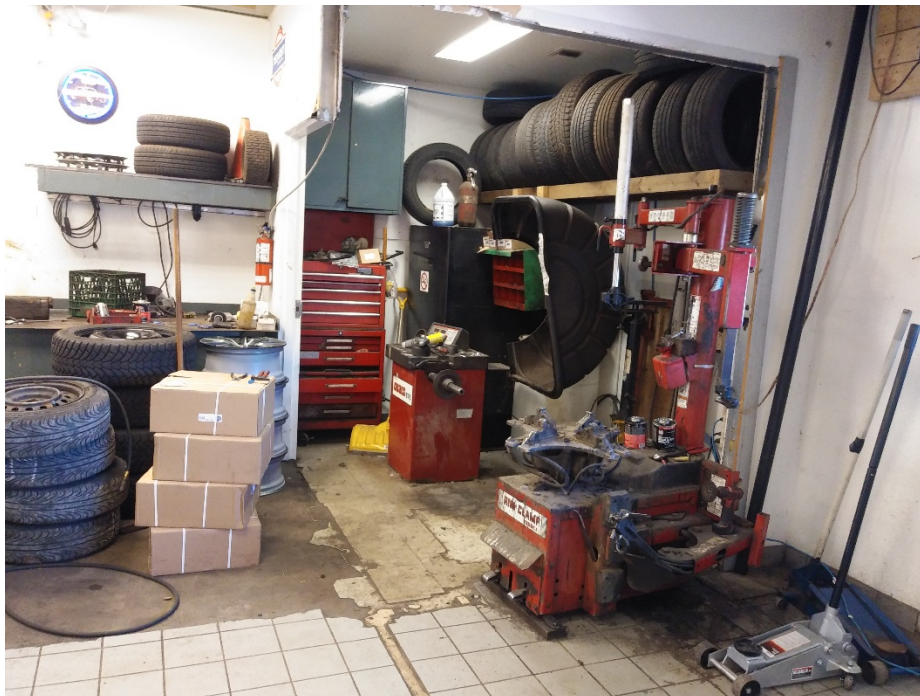
Photograph 6: View of the interior of the automotive service garage in the south unit of the south commercial building. View shows a tire balancing machine and some equipment storage.

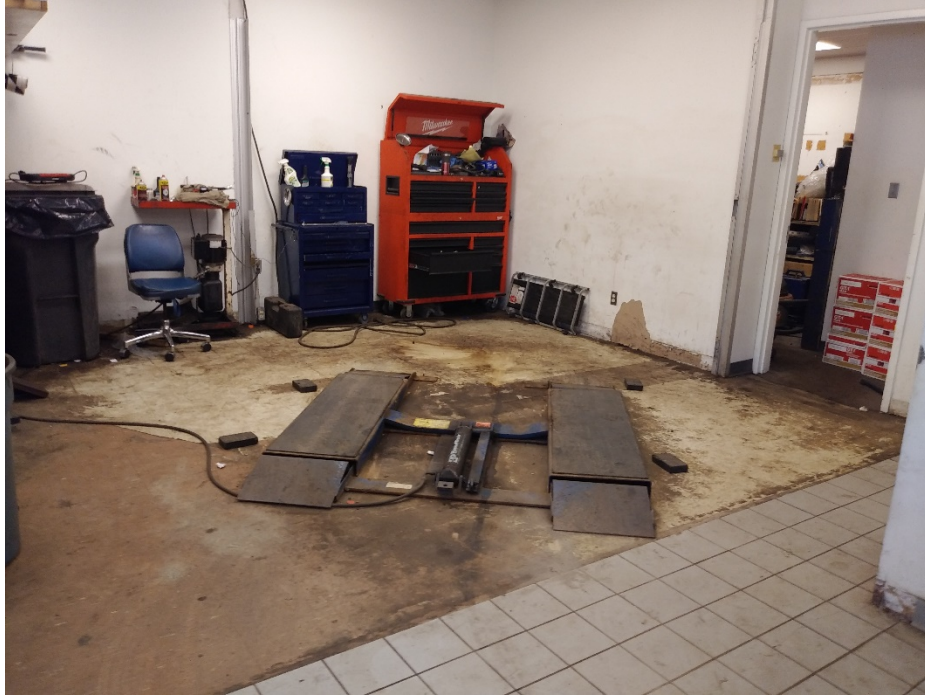
Photograph 7: View of the interior of the automotive service garage in the south unit of the south commercial building. View shows an aboveground hoist and some equipment storage.

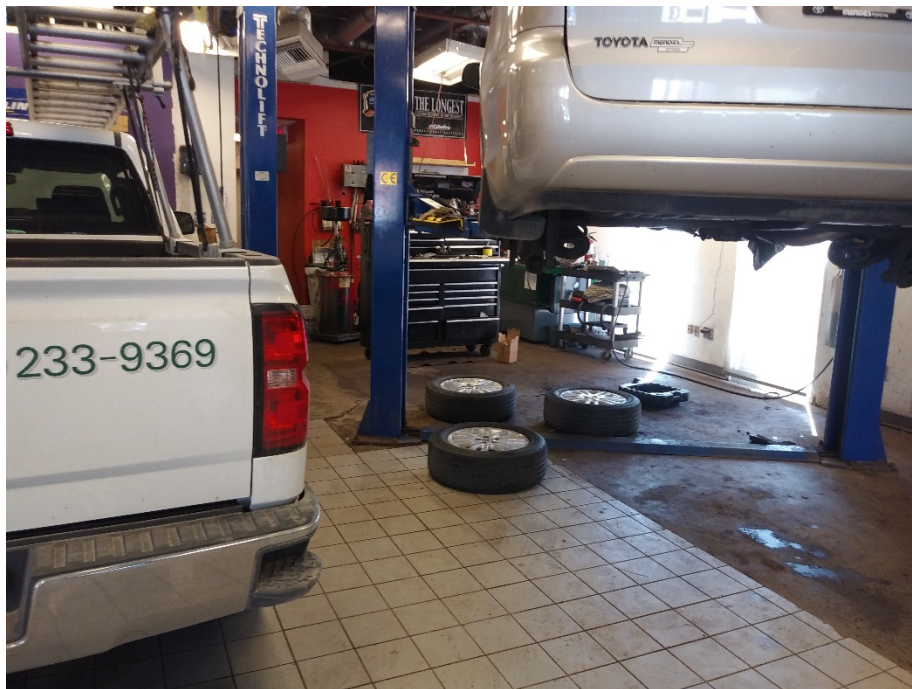
Photograph 8: View of interior of the automotive service garage in the south unit of the south commercial building. View shows two of the aboveground hoists and general operations inside the garage.

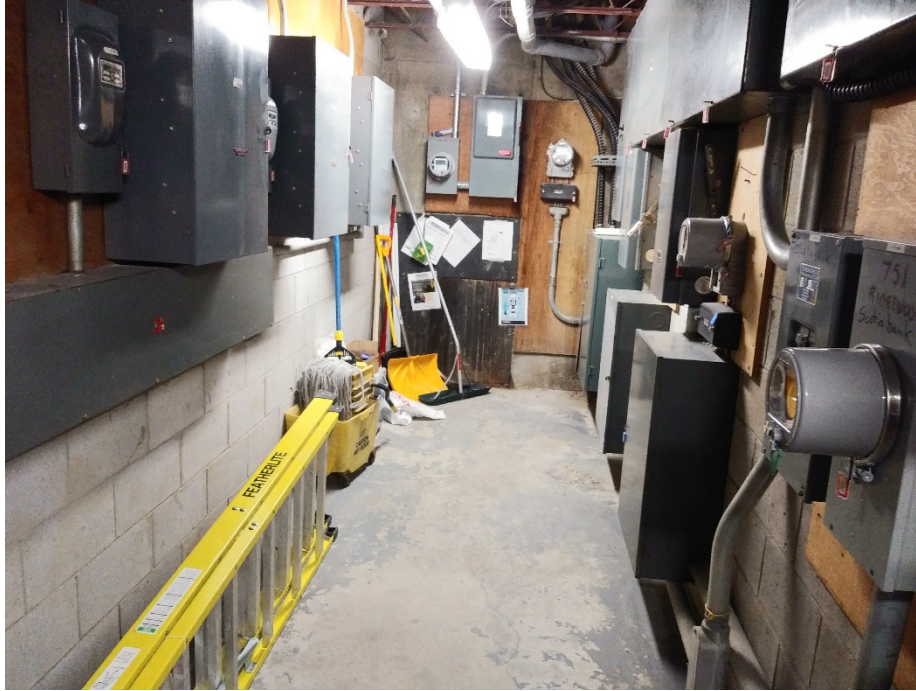
Photograph 9: View of the basement electrical room in the north commercial plaza building.

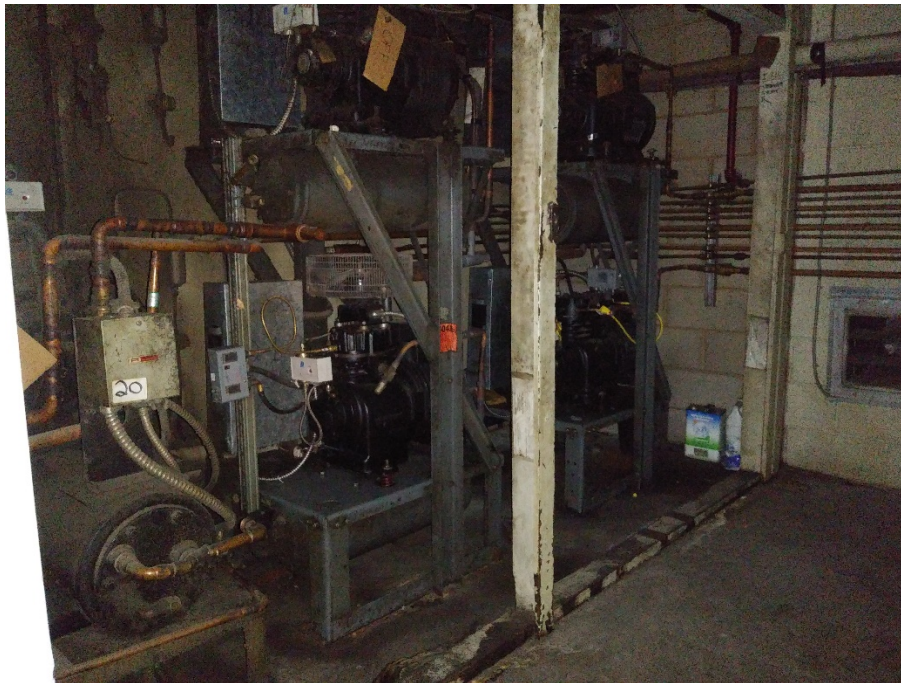
Photograph 10: View of the refrigeration equipment in the penthouse level of the former grocery store in the northwest portion of the north commercial plaza building.

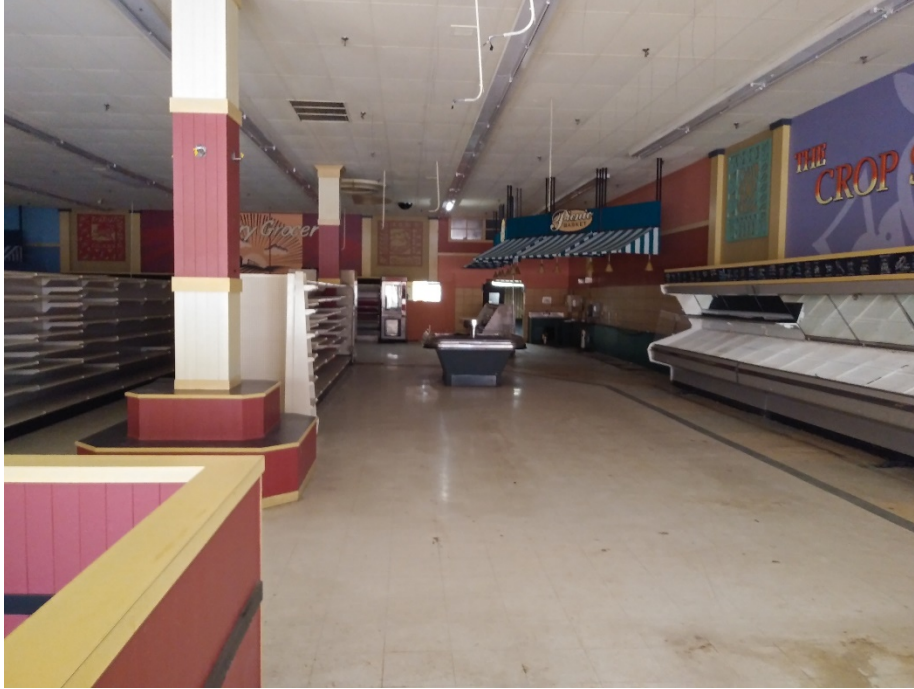
Photograph 11: View of interior of the former grocery store in the northwest portion of the north commercial plaza building.
