Phase One Environmental Site Assessment

729 Ridgewood
Avenue
Ottawa, Ontario

Prepared for:
11684663 Canada Inc.

July 27, 2020

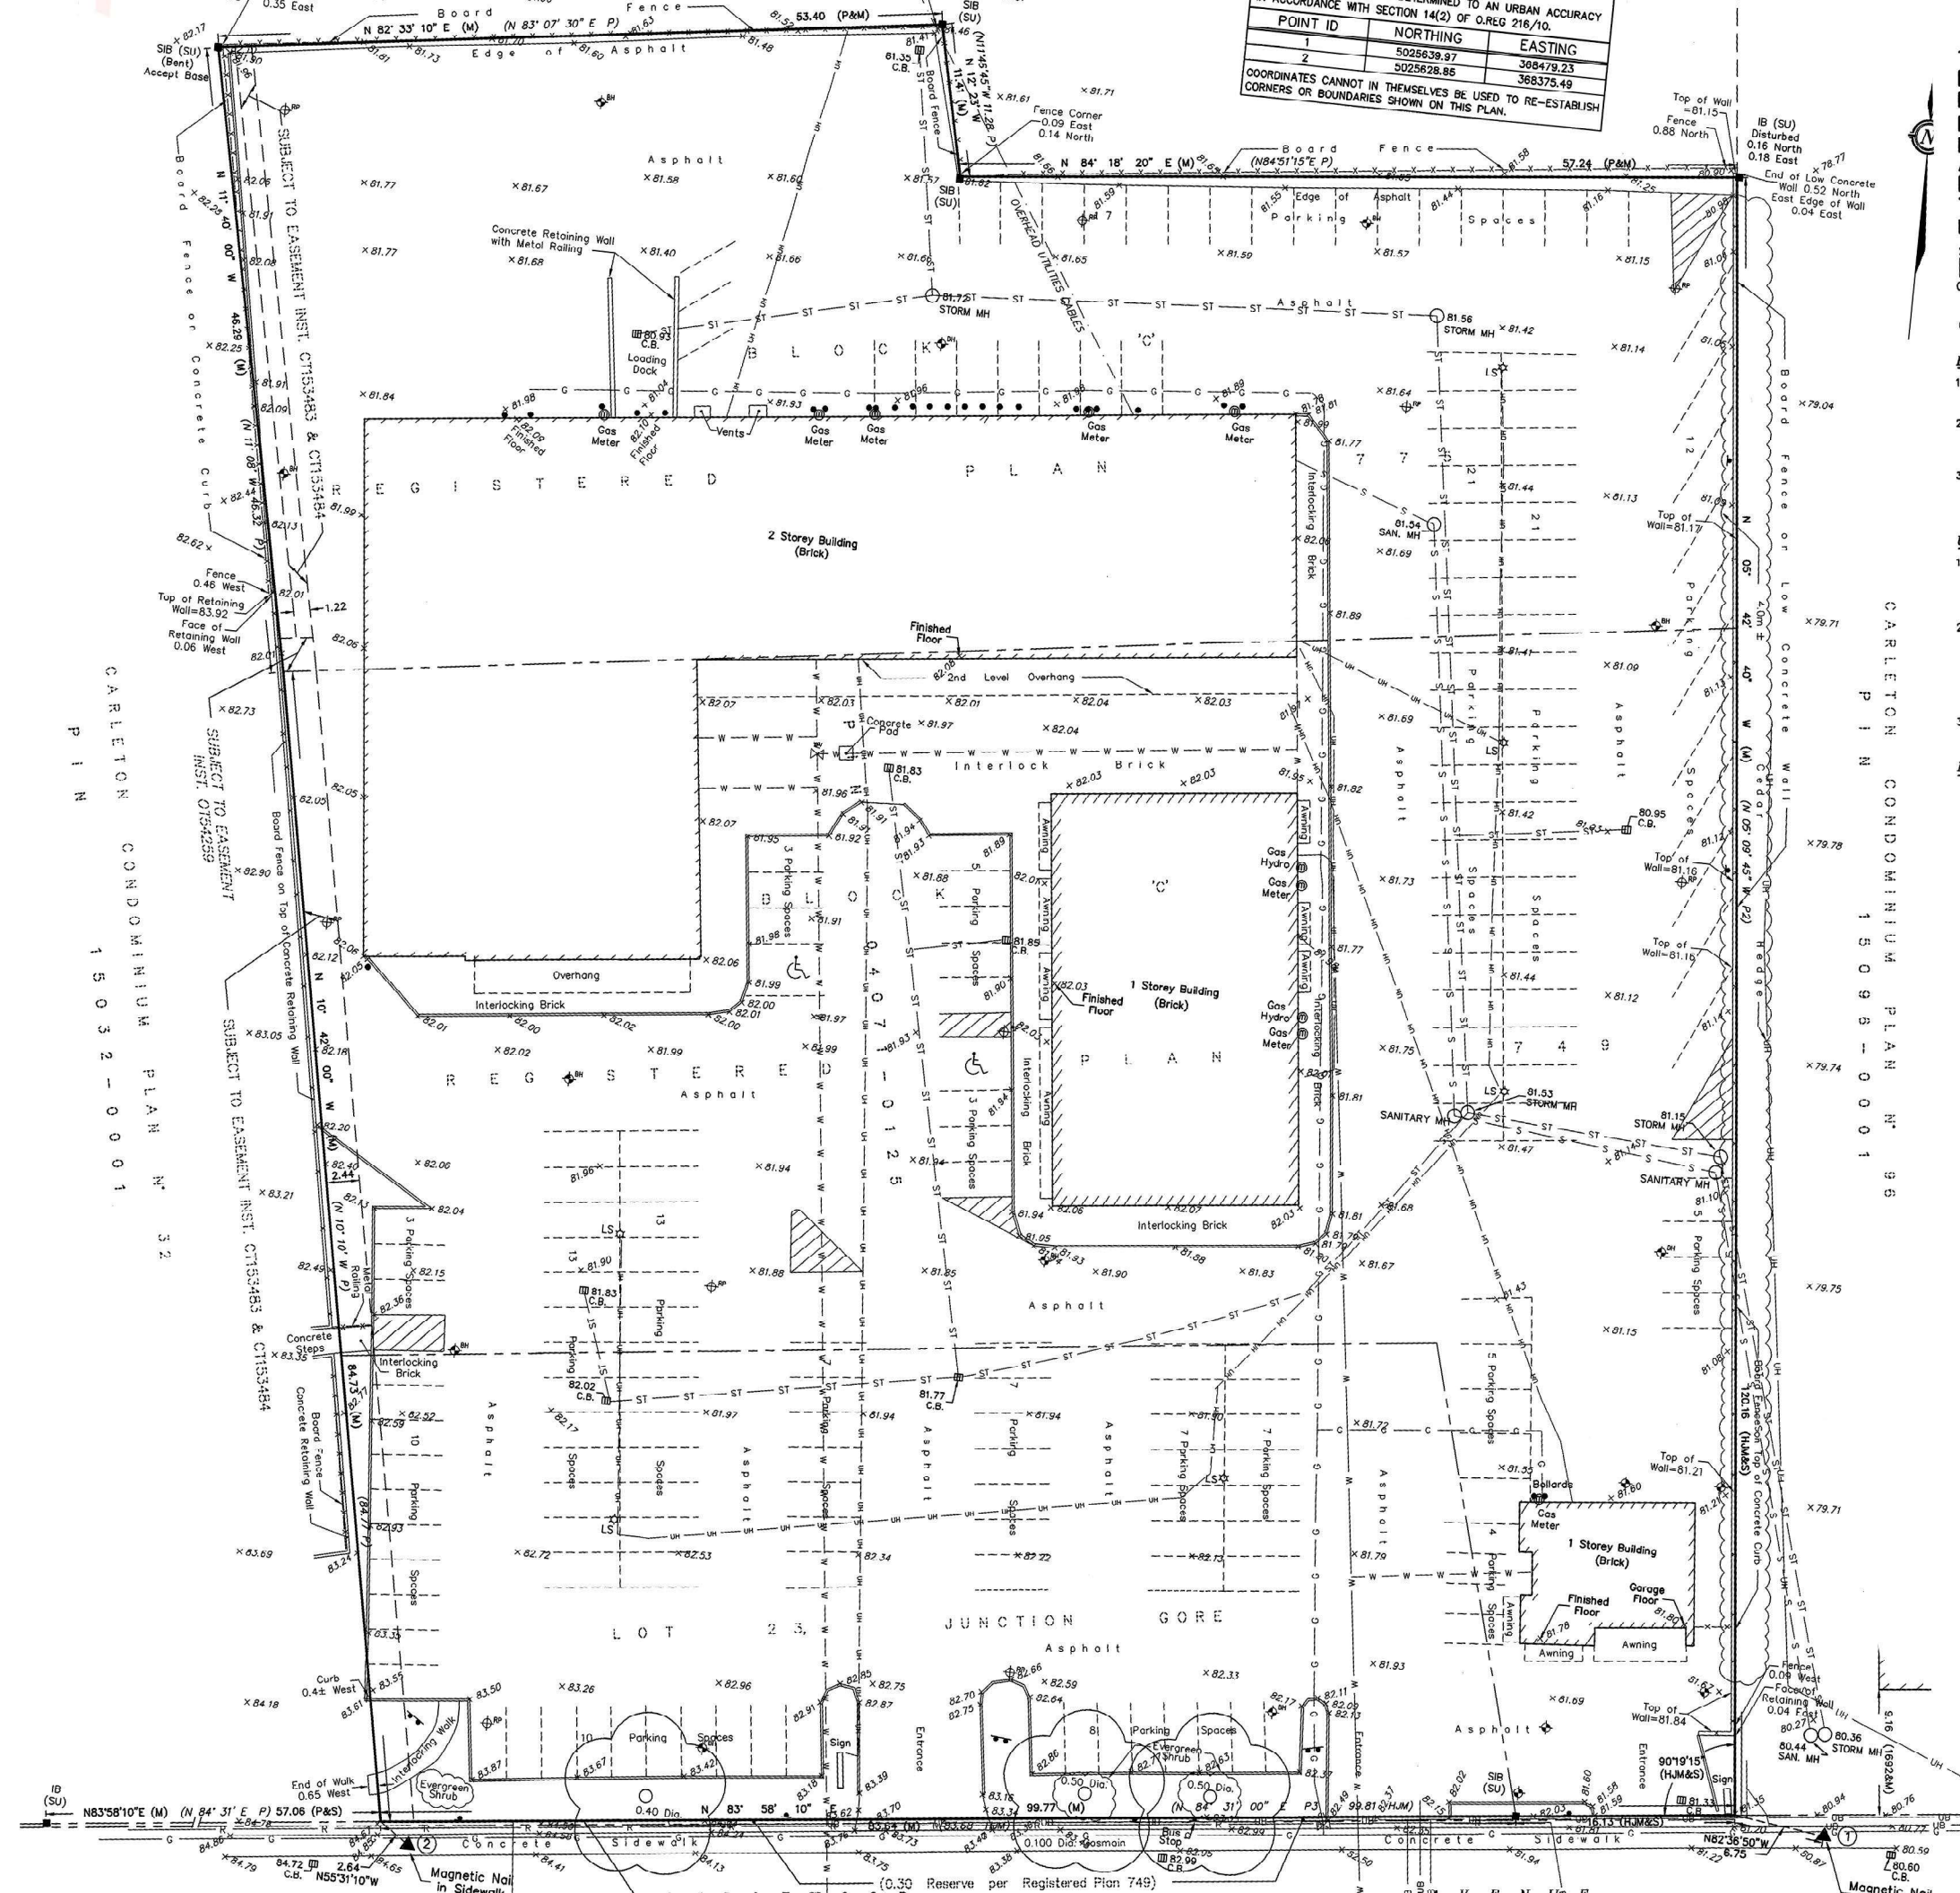
TOPOGRAPHIC SURVEY OF
PART OF BLOCK 'C'
REGISTERED PLAN 749,
PART OF BLOCK 'C'
REGISTERED PLAN 775
AND
PART OF LOT 23, JUNCTION GORE
TOWNSHIP OF GLOUCESTER
Now CITY OF OTTAWA

- BEARINGS ARE GRID, DERIVED FROM OBSERVED REFERENCE POINTS (O) AND (P) BY REAL TIME NETWORK OBSERVATIONS AND ARE REFERRED TO THE CENTRAL MERIDIAN, 76°30'W LONGITUDE MTM ZONE 9, (NAD83 ORIGINAL).
- DISTANCES ARE GROUND AND CAN BE CONVERTED TO GRID BY MULTIPLYING BY THE COMBINED SCALE FACTOR 0.999942.

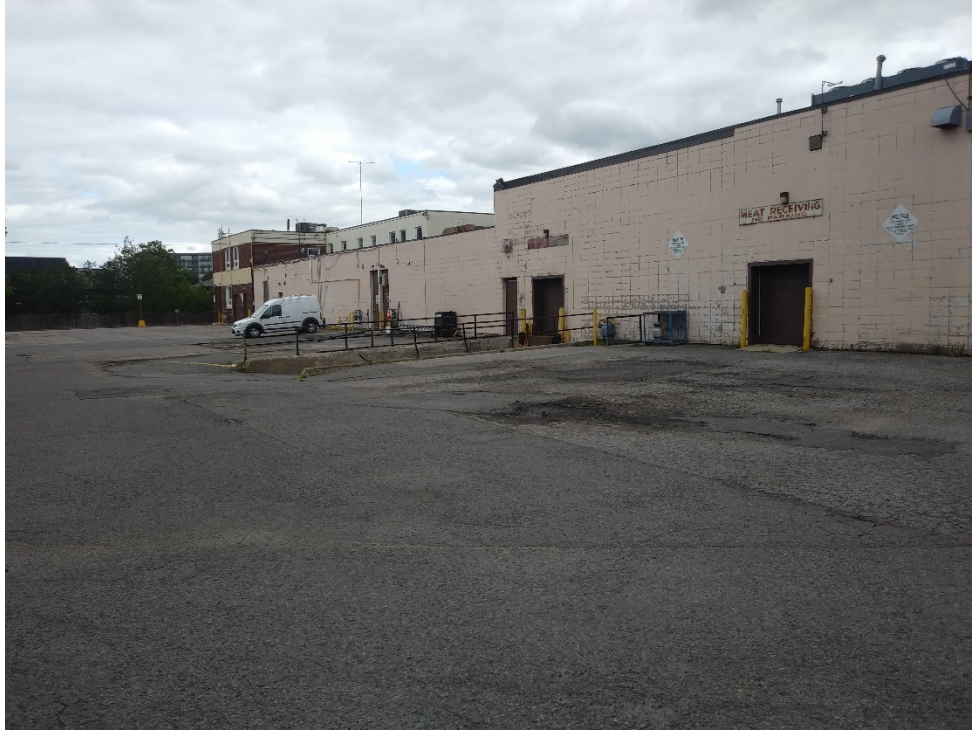
Photograph 3: View of the north side of the Phase One Property looking southeast. View shows the north side of the north commercial building, including the loading dock for the former grocery store and the natural gas meters for the commercial units.
