1186-1194 Wellington Street West, Hintonburg

HERITAGE CONSIDERATIONS REVIEW

WELLDAL LIMITED PARTNERSHIP
JUNE 25, 2021 100% SUBMISSION

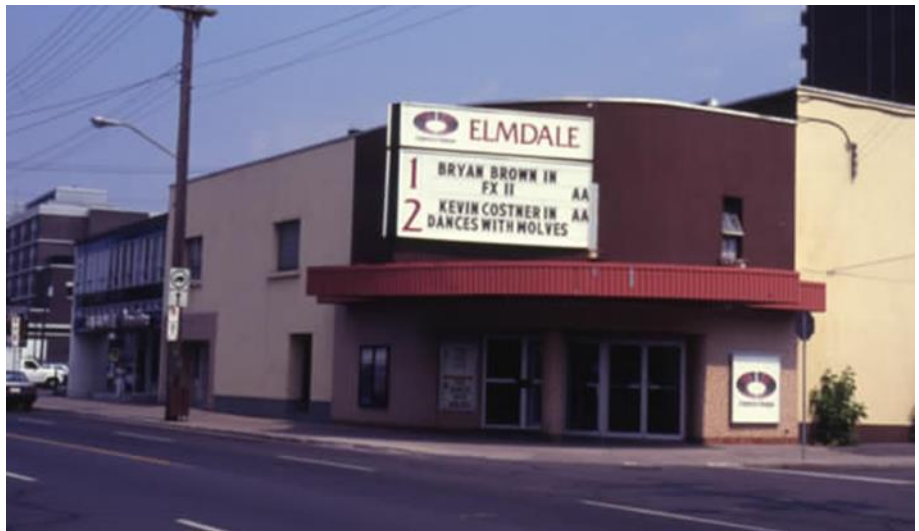
21 Elmdale Theatre, corner of Hamilton Avenue and Wellington West, 1991, showing early renovations that removed the original heritage fabric. *City of Ottawa Archives, CA024334*

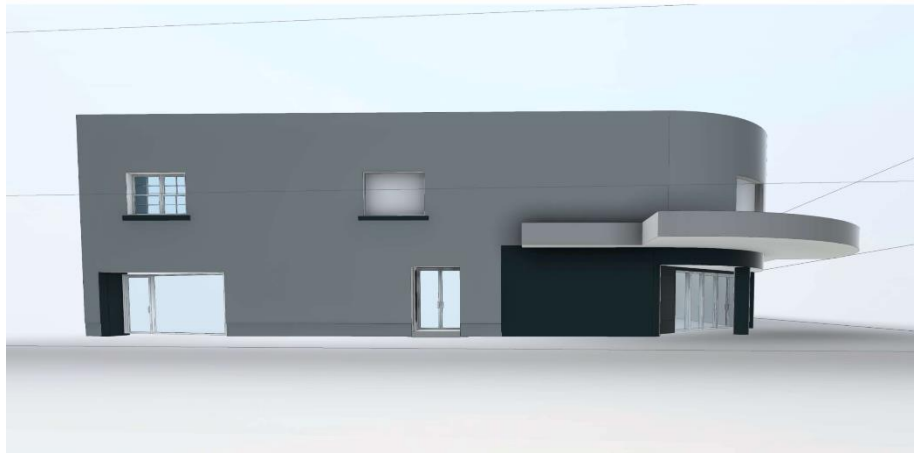
- 24 Photo capture of 3D Building Information Model (BIM) of the property, Wellington elevation. *If/Then Architecture Inc.*

As part of the site investigations of heritage assets, MTBA retained subconsultants If/Then Inc, to scan the existing conditions of the site. Using 3D laser scanning technology, If/Then provided MTBA with point clouds and a 3D model. This process allows for an accurate recording of ‘as-is’ condition of the property and its heritage assets.

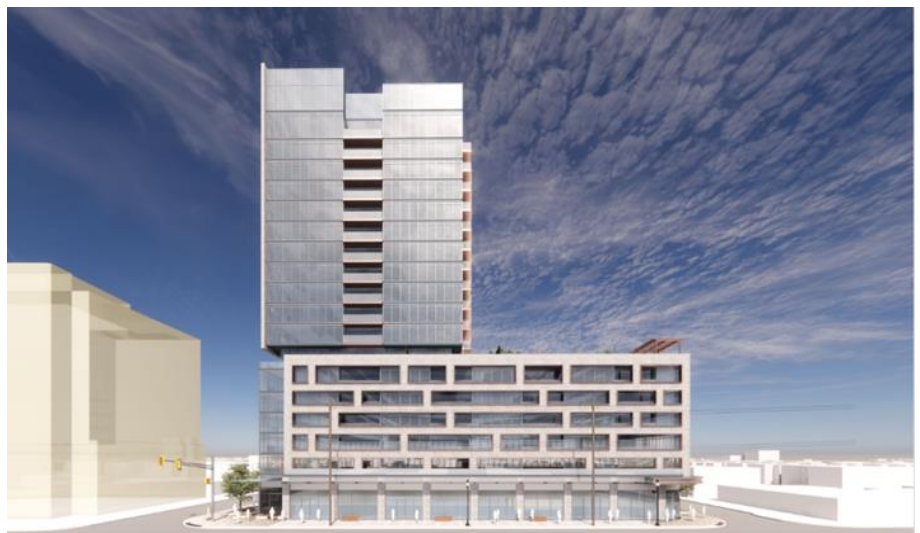
53 Wellington St W Elevation. *DIALOG.*

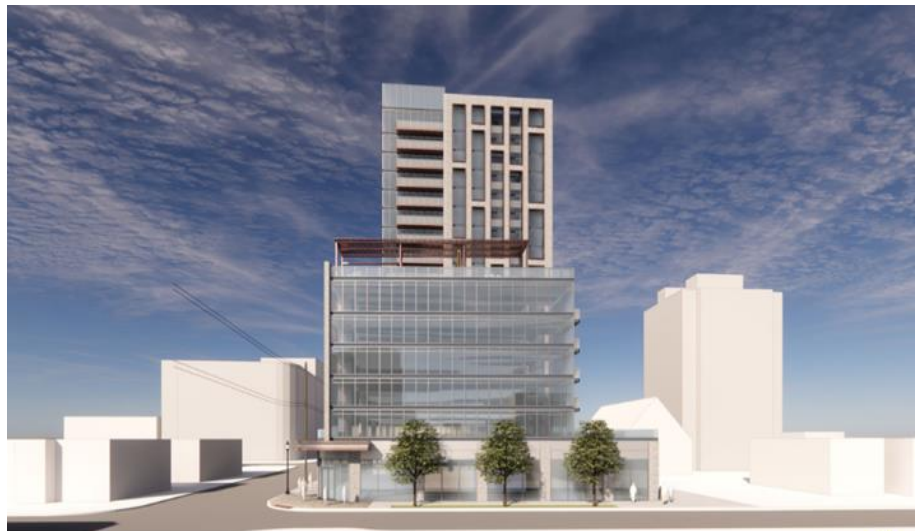
54 Hamilton Ave N Elevation. *DIALOG.*

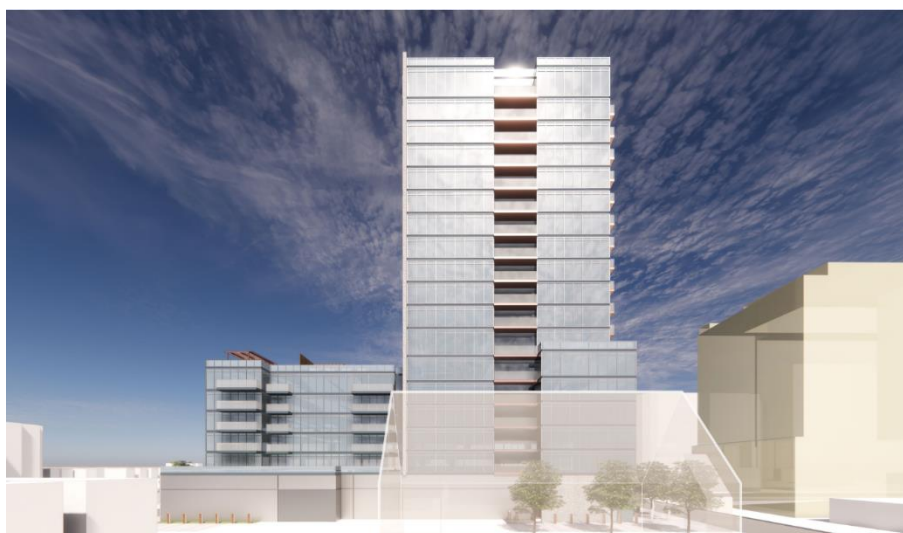
56 South Elevation along rear laneway.
DIALOG.

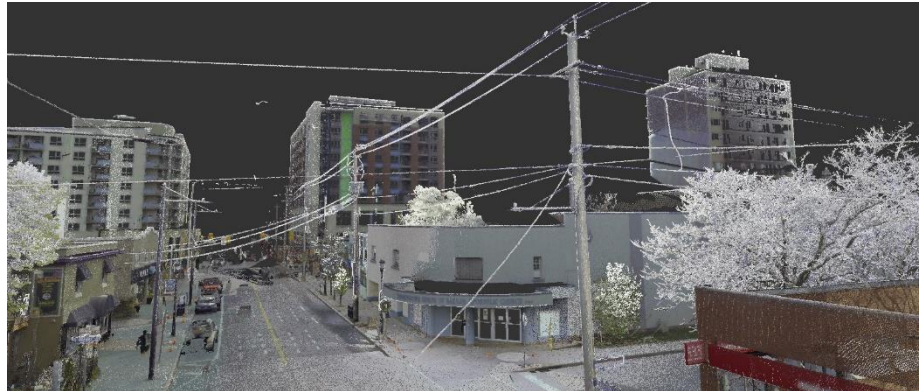
- 1 3D Scan of site looking east along Wellington St W. *If/Then Architecture Inc.*

As part of the site investigations of heritage assets, MTBA retained subconsultants If/Then Inc, to scan the existing conditions of the site. If/Then provided MTBA with point clouds and a 3D BIM (Building Information Model) model using 3D laser scanning technology. Laser scanning allows for an accurate recording of 'as-is' conditions of the property and its heritage assets. The scans then generate point clouds of information that can be used as a baseline for the creation of a BIM model.

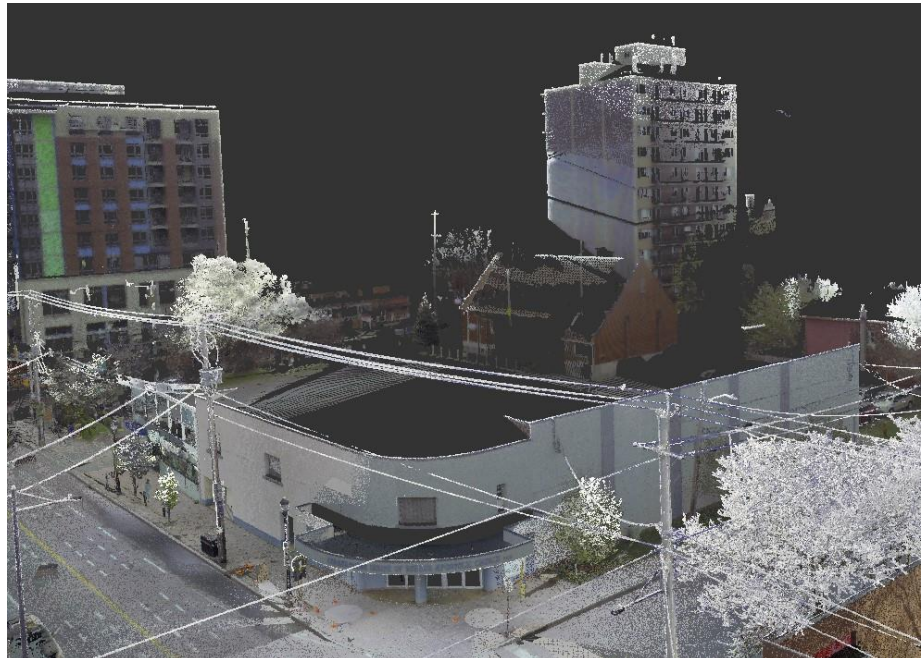
- 2 3D Scan of site looking southeast at corner of Wellington St W and Hamilton Ave N. *If/Then Architecture Inc.*

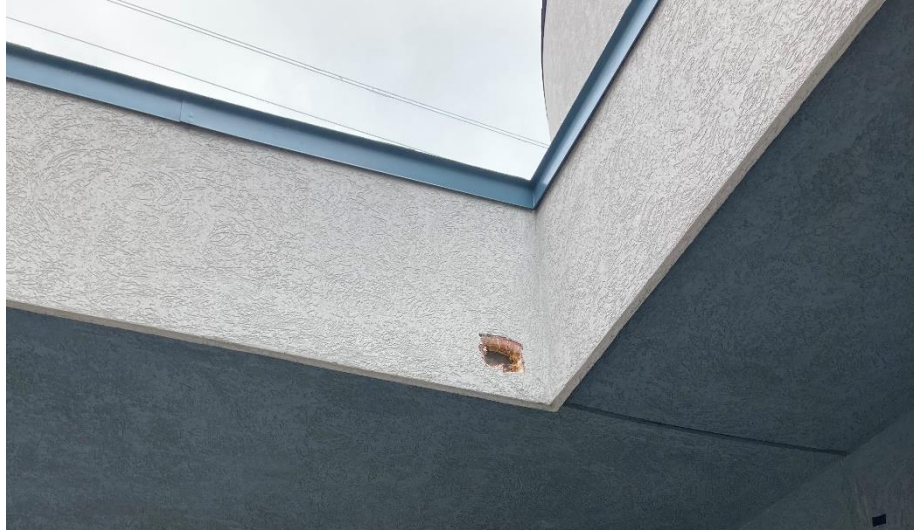
- 1 Canopy fascia (Investigations 1&2): Location of Investigative Opening – where curved marquee meets flat section, western façade of building.

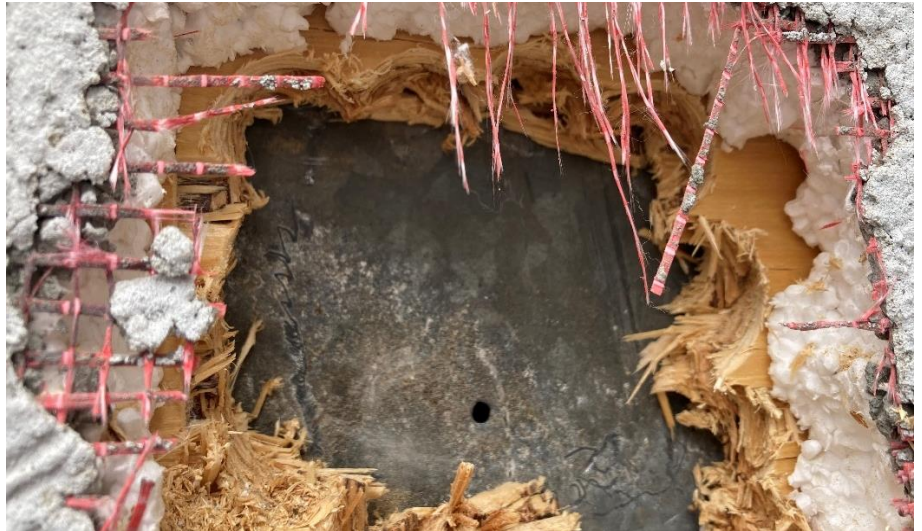
- 2 Canopy fascia (Investigations 1&2): Opening of parging revealed mesh, Styrofoam and wood layers. Aluminum (or tin) sheet layer required additional investigation.

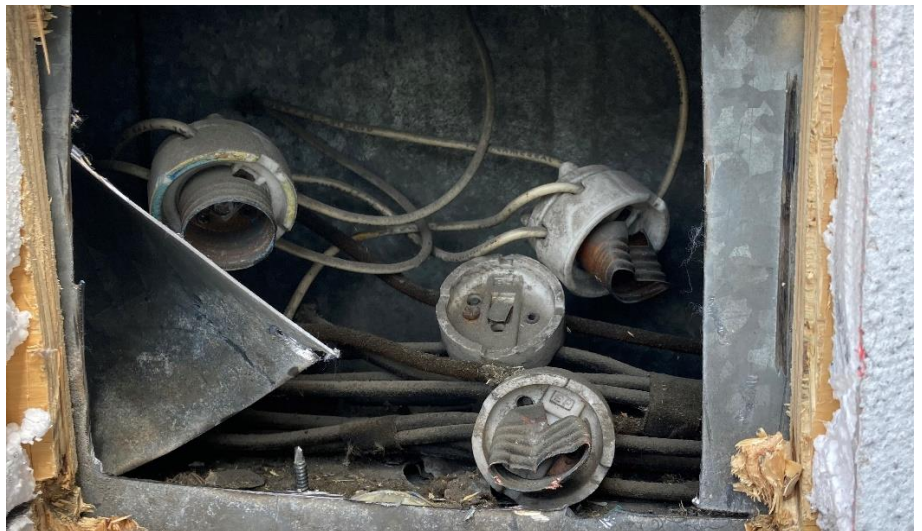
- 3 Canopy fascia (Investigations 1&2): Opening of metal plate revealed original lighting fixture, original wire and ceramic insulators/sockets. No other original fabric of the marquee could be seen.

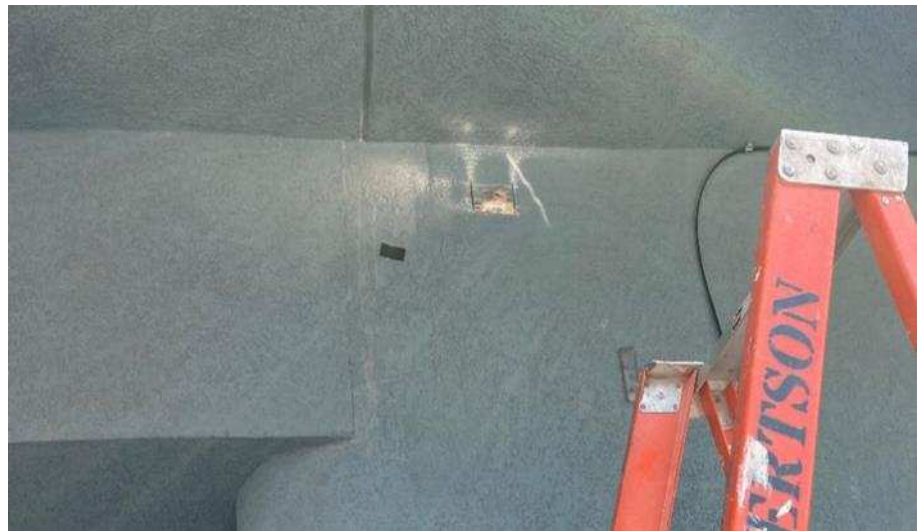
5 Canopy Fascia Upper Wall (Investigation 4 & 5): Location of Opening.

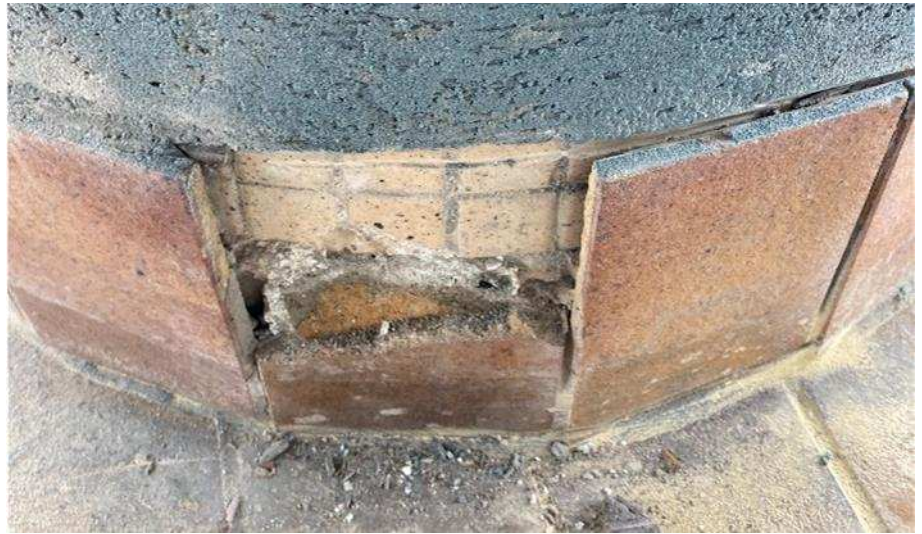
- 7 Column base (Investigation 6): Base tile removed to examine if original hard polished finish, or vitrolite, remains behind existing tile or parging. Investigation revealed ceramic tiling from previous renovation. Original Fabric not observed.

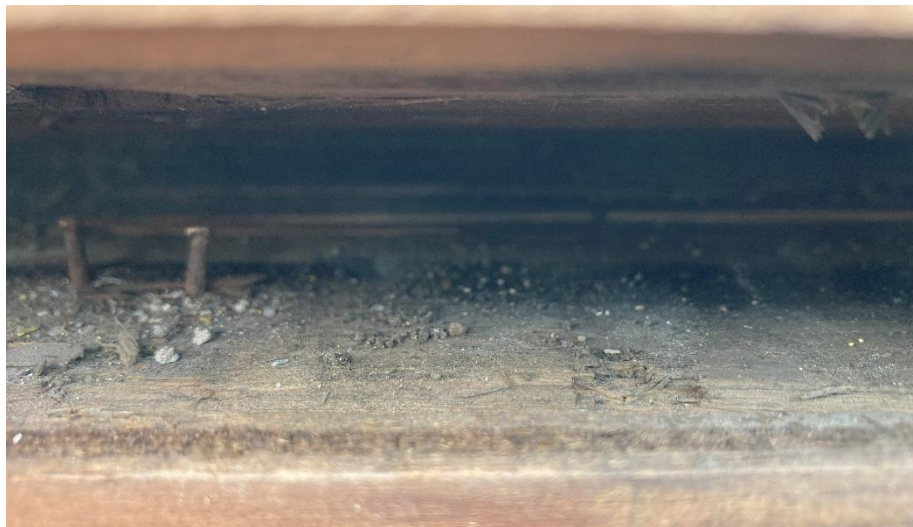
- 10 Lower Wall at Base (Investigation 7): Lower Wall at Base, investigation revealed wood board and parging layer. No scalloped or fluted wall observed.

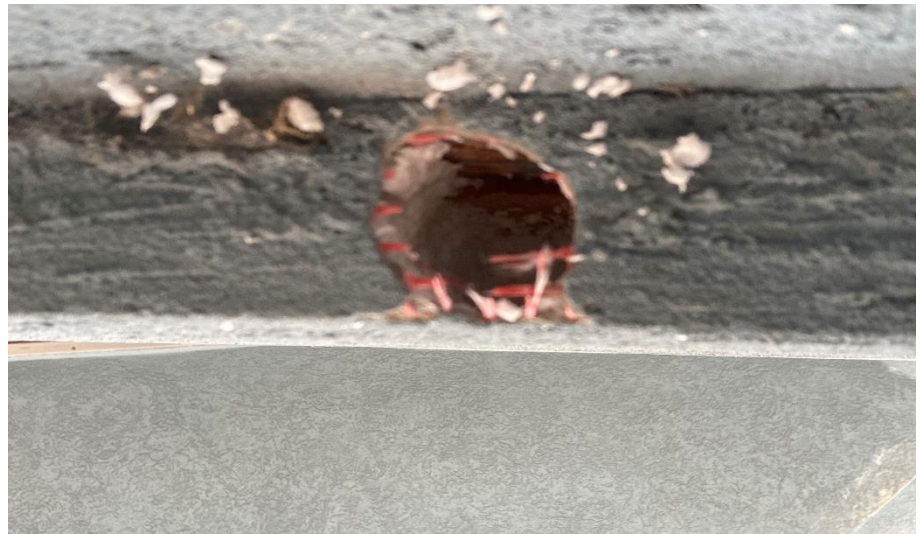
- 13 Former Ticket Booth
(Investigation 9): Removal of
parging revealed mesh and
Styrofoam with wood board.

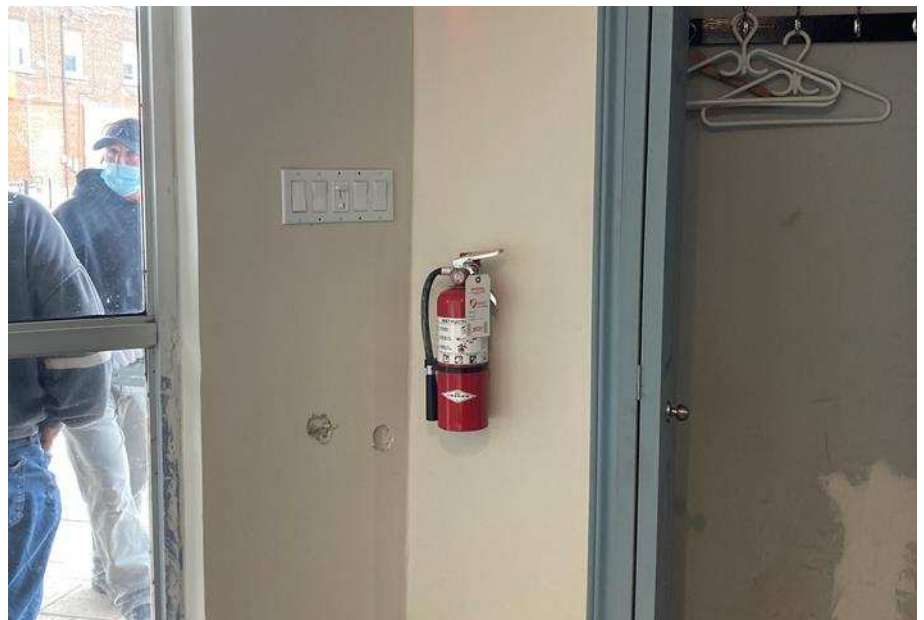
- 14 Former Ticket Booth Interior
(Investigation 9): Approach from
interior wall location.

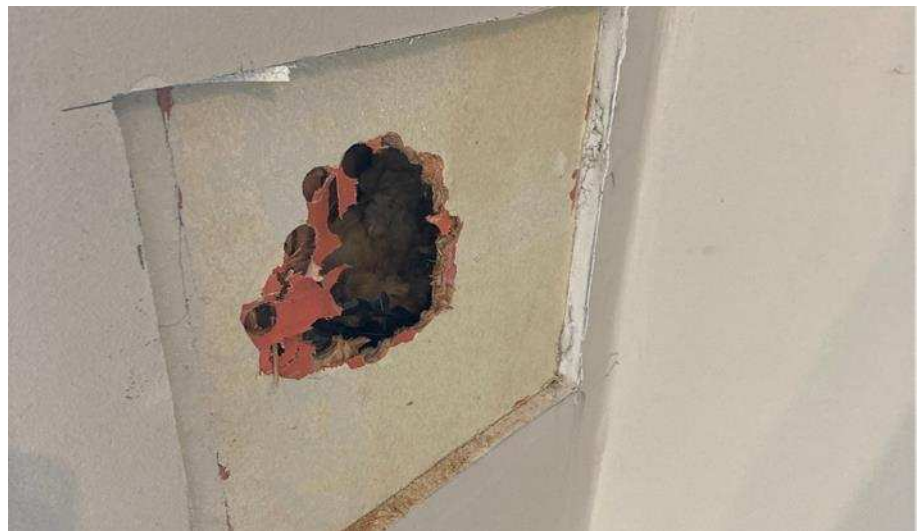
- 15 Former Ticket Booth Interior
(Investigation 9): Interior wall
investigation revealed drywall
(gyprock), layers of wall paper.

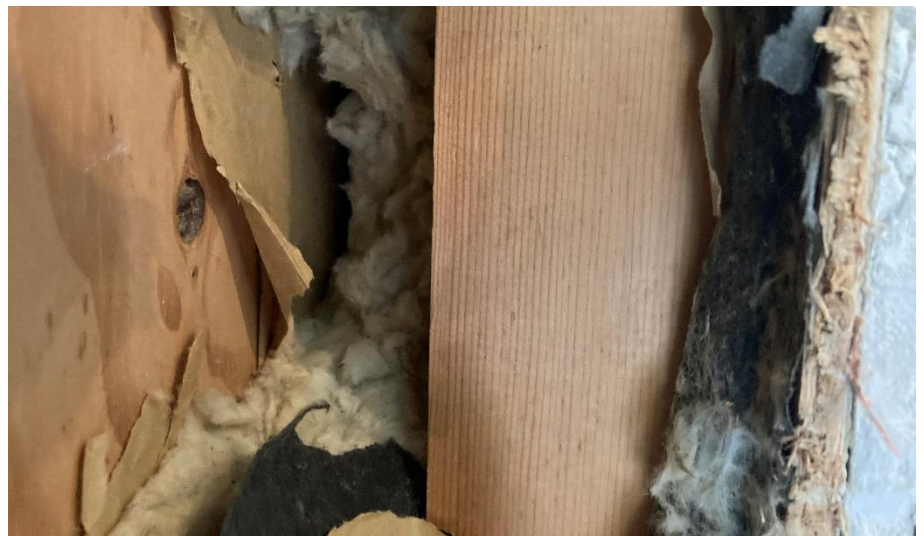
- 17 Former Ticket Booth Interior (Investigation 9): Wood framing examined. No original material found.

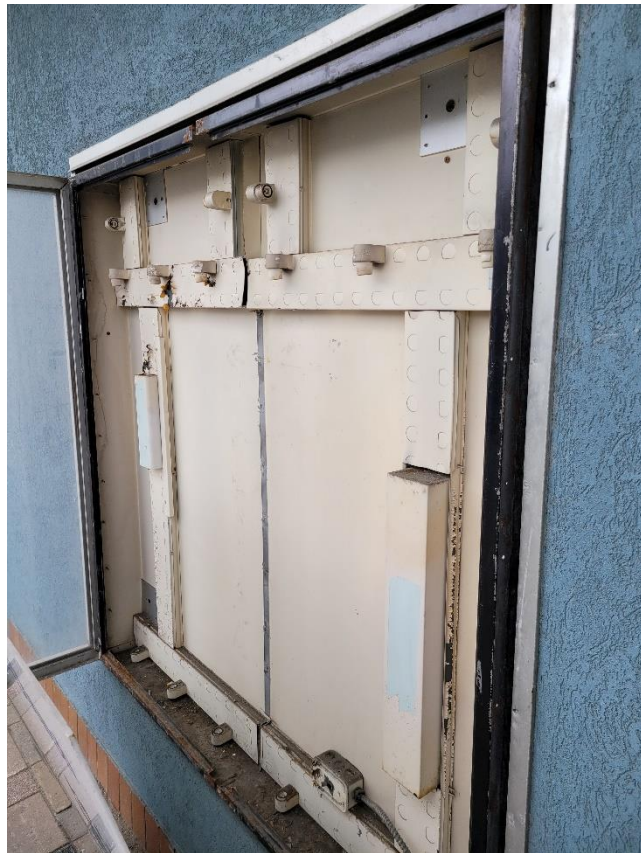
- 18 Eastern Signage Board
(Investigation 10): Investigation
10): Remaining original fabric
limited to lighting.

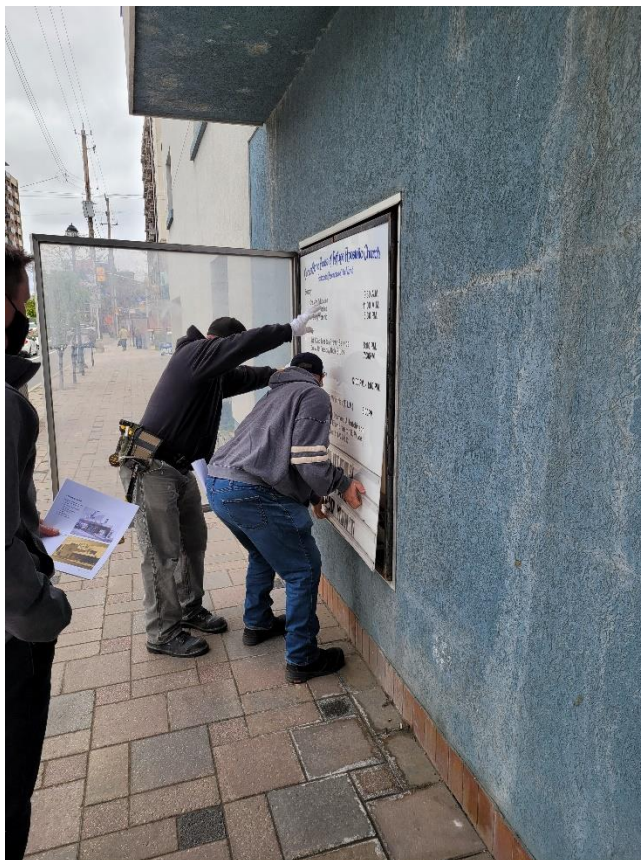
- 19 Eastern Signage Board
(Investigation 10): Removal of
existing signage to investigate if
original fabric including lighting
fixtures, the metal, expressive
hardware and polished finish
remain.
