**Servicing and Stormwater
Management Report – 2829
Dumaurier Avenue**

Stantec Project No. 160401596

March 20, 2023

Brigil Homes

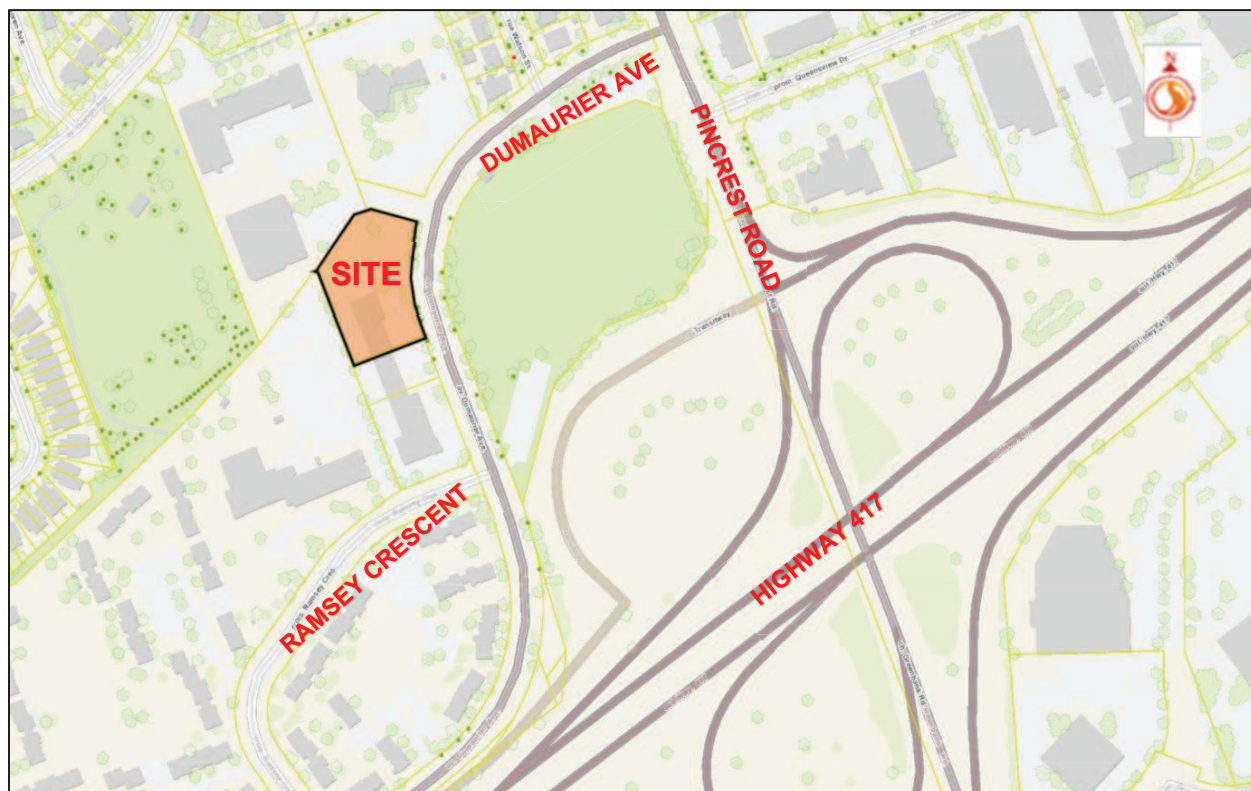
Figure 1: Key Plan (2829 Dumaourier Ave. Site highlighted in Orange)

Stantec Consulting Ltd. has been commissioned by Brigil Homes to prepare the following site servicing and stormwater management (SWM) report in support of an application for rezoning and site plan control approval for a proposed development located at 2829 Dumaourier Avenue situated off Pinecrest Road in the City of Ottawa. There is an existing commercial building on the southern end of the property which will be torn down to allow for the proposed development (see key plan in **Figure 1**).

The proposed development area (0.42 ha) consists of a 40-storey residential high-rise building with commercial space on the first floor. The building is to contain 422 units in total consisting of 259 one-bedroom units (@1.4ppu), 158 two-bedroom units (@ 2.1ppu), 5 three-bedroom units (@ 3.1ppu), and 300m² of commercial area. Parking is to be provided via 6 surface parking spots and two underground parking levels (P1 and P2). The site plan has been provided in **Appendix B**.

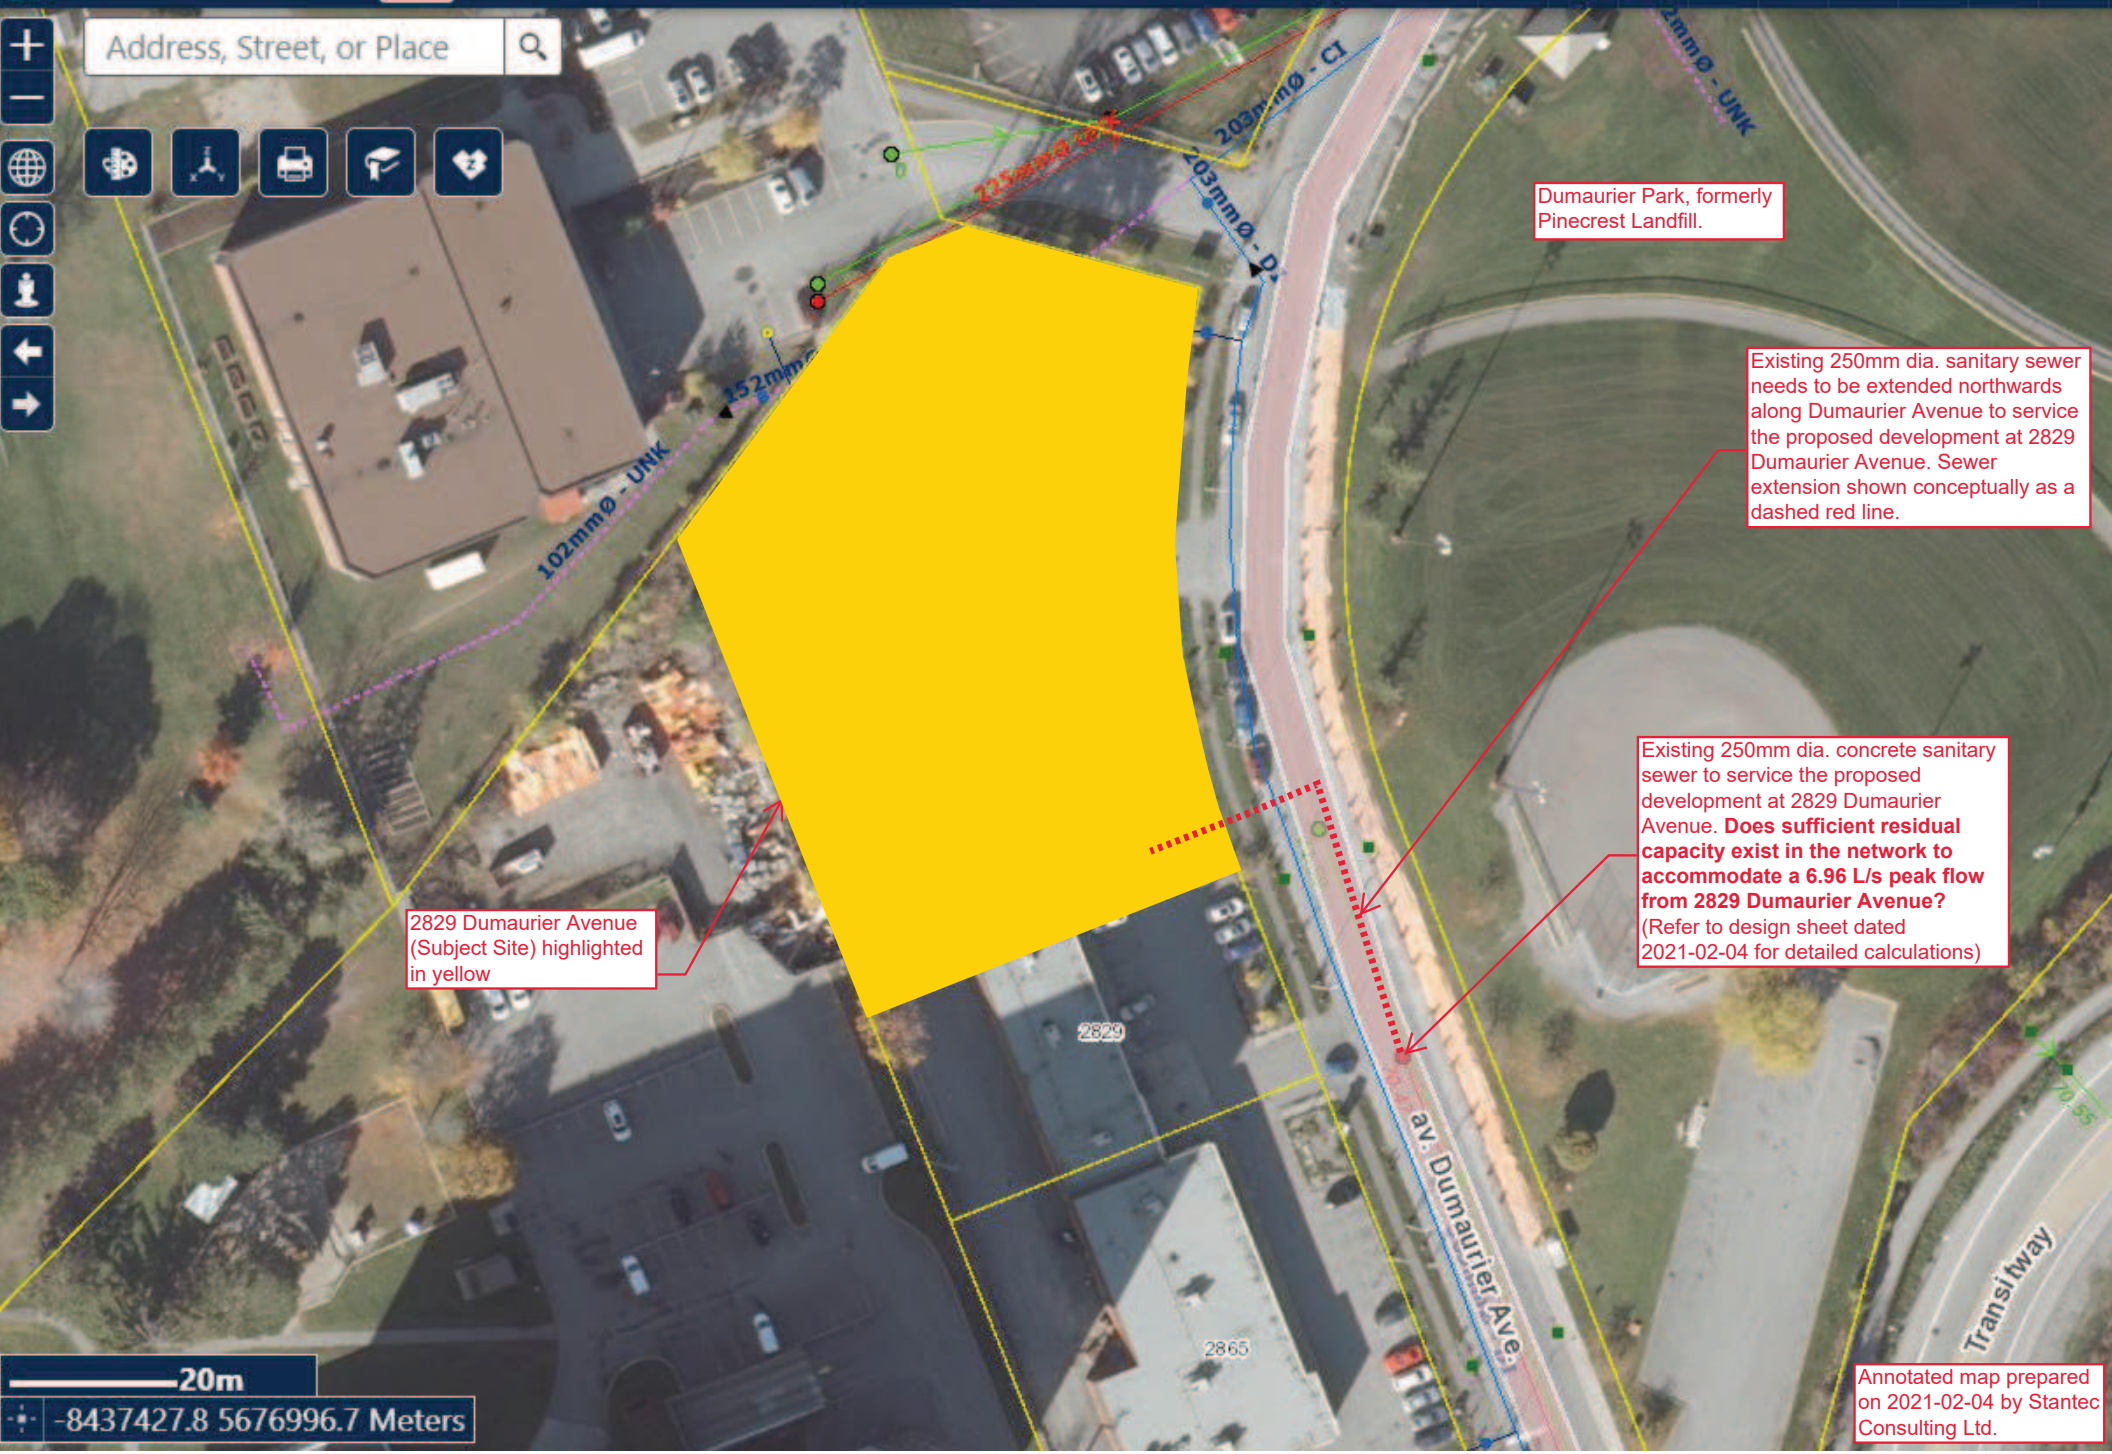
Dumaaurier Park, formerly Pinecrest Landfill.

Existing 250mm dia. sanitary sewer needs to be extended northwards along Dumaaurier Avenue to service the proposed development at 2829 Dumaaurier Avenue. Sewer extension shown conceptually as a dashed red line.

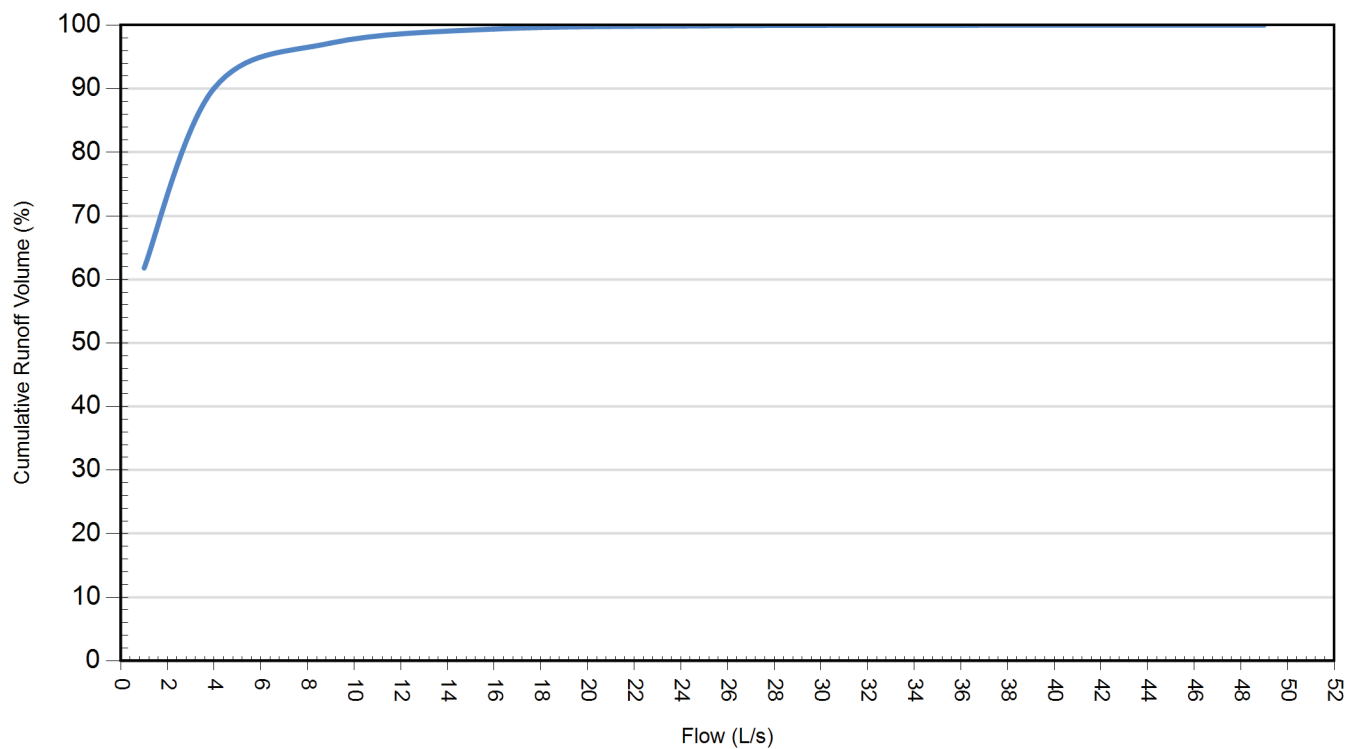
Cumulative Runoff Volume by Runoff Rate

For area: 0.17(ha), imperviousness: 99.90%, rainfall station: OTTAWA MACDONALD-CARTIER INT'L A
